Heavenly Mountain Resort

Mitigation and Monitoring Plan
Annual Report (October 2020 –
September 2021)

Prepared for
Tahoe Regional Planning Agency

May 2, 2022

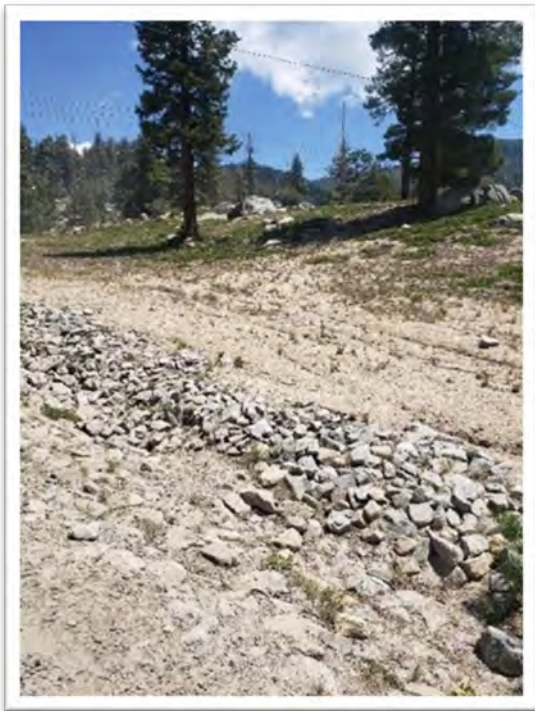
Groove Erosion Resistance – 2021 WMRP Project

This 2021 WMRP project is located along the summer access road between the lower Groove Lift terminal and the intersection with the Top-of-Tram summer access within approximately 500 feet of the Heavenly Valley Creek. Hot spots within 100-500 feet proximity from the stream are ranked as a medium risk of erosion (M). Areas along the road shoulder showed evidence of minor rilling and the beginning stages of further erosion, that would contribute sediment to the existing drainage system BMPs. Permanent drainage BMPs along the road consist of waterbars, rock-lined swales, and sediment basins that are maintained annually to remove accumulated sediment. Soil treatment for areas adjacent to the swales, included: ripping, wood chip incorporation, soil roughening, seeding, and mulch application ("rip and chip" treatment). In addition, waterbars along the road were rebuilt and the rock-lined ditches realigned. Improving erosion resistance of soils will reduce the source of sediment and improve effectiveness of the sediment capture BMPs.

Before: Exposed soils alongside road shoulder and rock-lined swale.

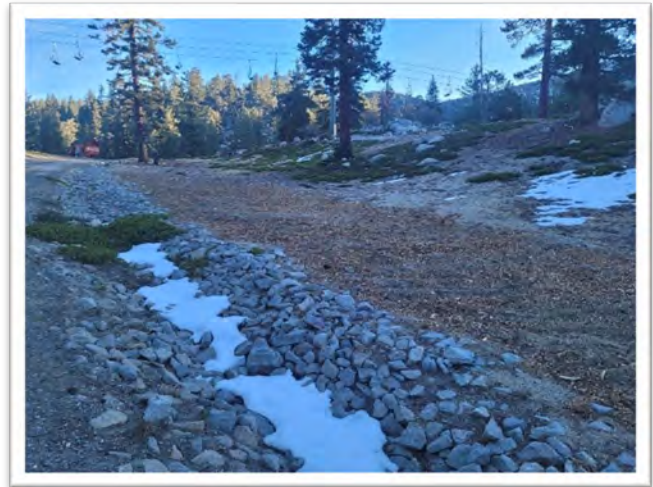
After: "Rip and chip" treatment on shoulder and refurbished rock-lined swale.

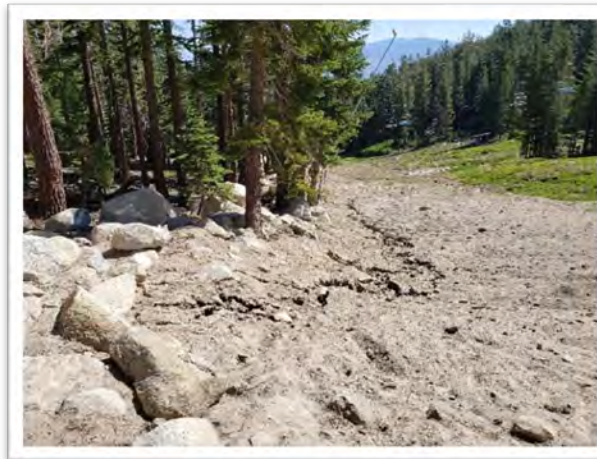
2020 Rill Formation

After the completion of the Olympic Snowmaking Line Upgrade project in 2018, portions of the ski trail were regraded and reseeded. Revegetation is a multiyear process and appears to be successful. However, after the heavy spring runoff in 2019, rilling and a gully started to occur at the steeper section of the ski trail below the summer access road. Identified as a 2020 WMRP project, a waterbar was built crossing the steep ski trail below the access road to intercept runoff. Woodchips were incorporated into the bottom of the swale consistent with techniques developed through the WMRP. Small rock checks were also placed along the swales to dissipate energy. Monitoring in 2021 showed that vegetation establishment continues to progress on the ski slope and waterbars are successfully reducing erosion and sediment transport.

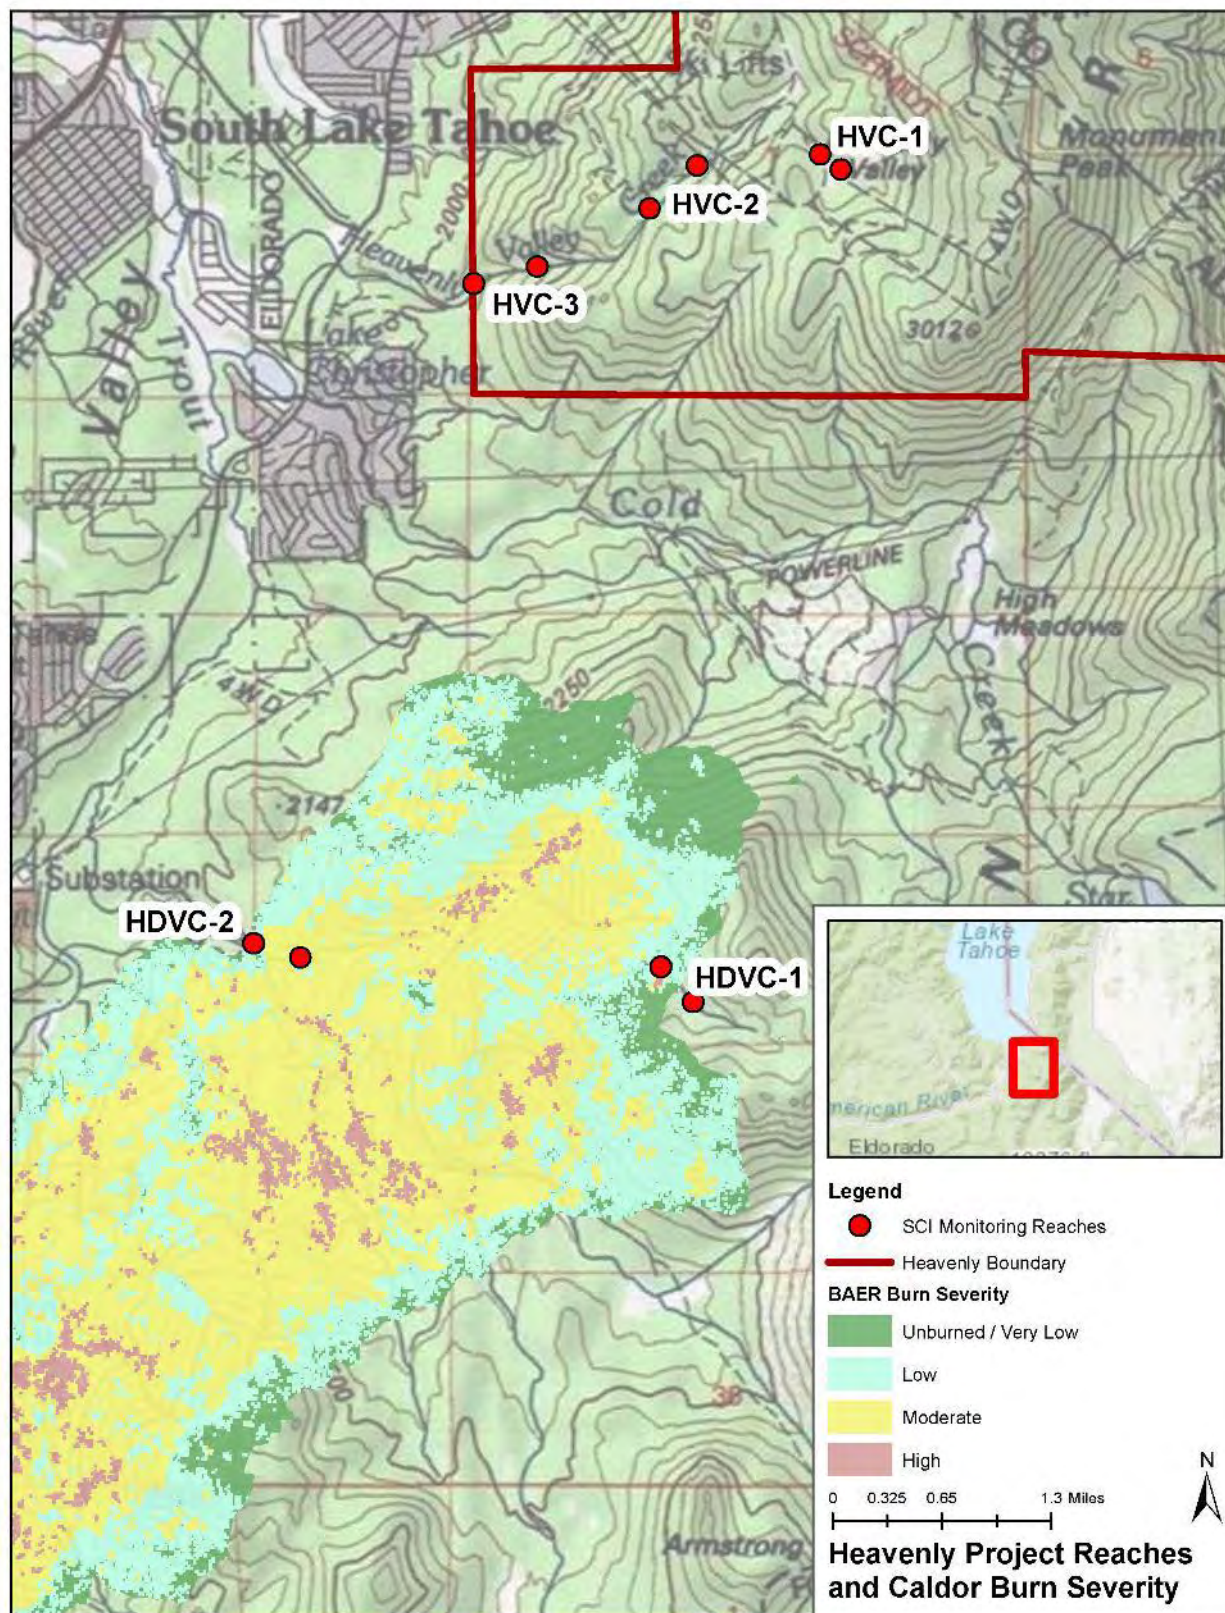
had the extensive volume of downed wood on the forest floor. The riparian corridor was largely intact, with leaves of alder and currant still present in October 2021. The rebar and plastic rebar caps marking the water quality cross-section did not burn. A bulldozer fire line had been laid across the forest floor and crossed the stream approximately 20 feet below the cross-section. It appeared that the volume of woody material and rocks at the crossing location allowed the heavy machinery to remain above the water surface. Subsequent sampling events in WY 2022 (not part of this report, but relevant to discuss in term of post-fire observations) have shown substantial sediment mobilization during the fall of 2021, in part due to a substantial storm event in late October (the storm event between October 24 and 26 delivered 7 inches of precipitation), as shown in Figures 3-12 to 3-13.

Figure 3-12 Hidden Valley Creek Reference Reach Site (43HDVC-5) in October 2021 (Post-Fire), Looking Upstream from Left Bank

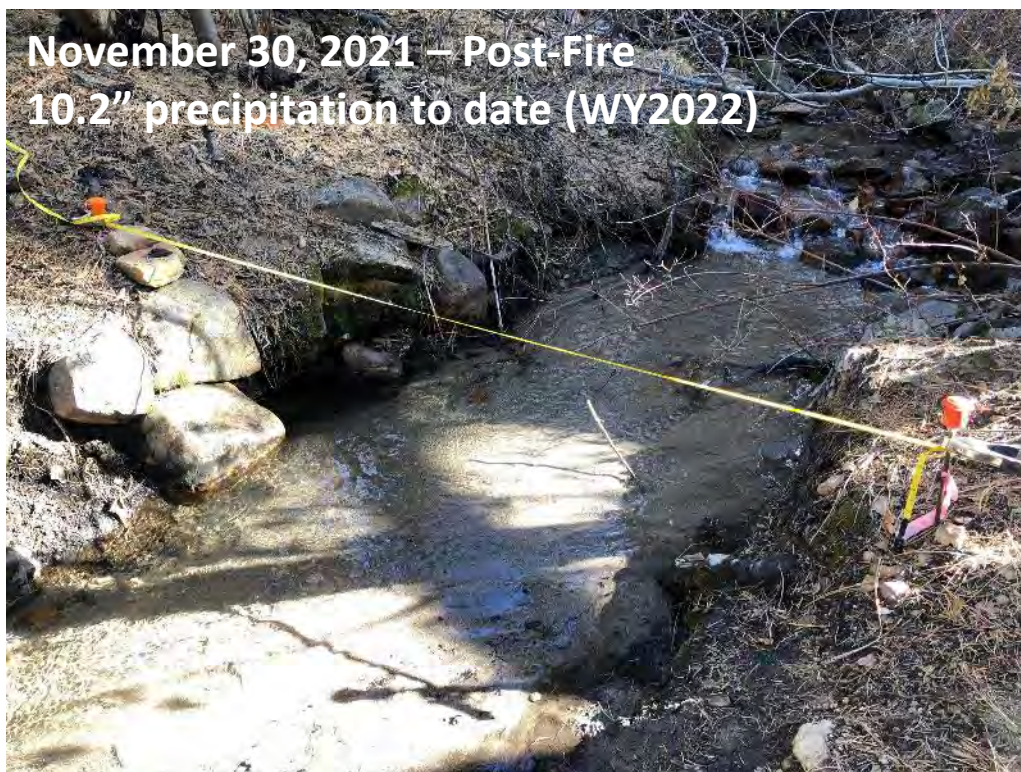
Figure 3-13 Hidden Valley Creek Reference Reach Site (43HDVC-5) in November 2021 (Post-Fire), Looking Upstream from Left Bank

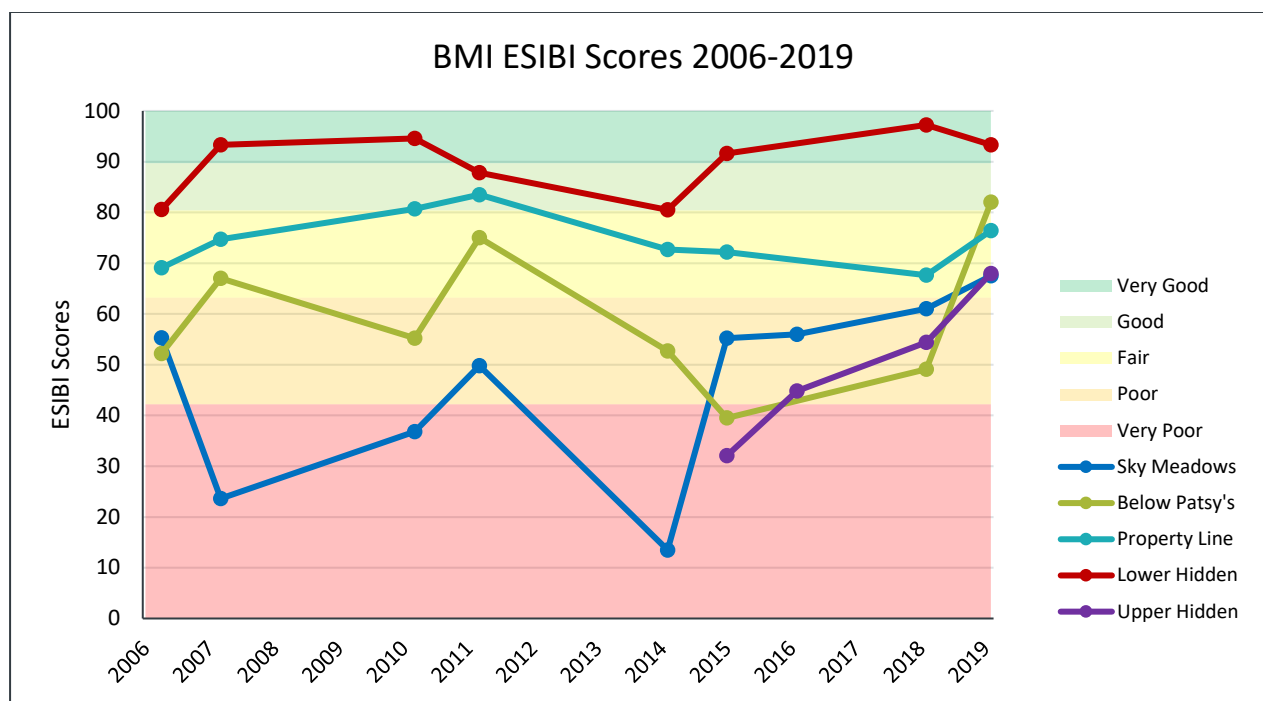
- Lower Hidden Valley Creek reference site (LHC-1) – Biotic conditions are *very good/supporting* according to ESIBI and *very likely intact* according to CSCI. The ESIBI score dropped slightly from 2018, although overall scores have improved since 2011. This site has been classified as being in *good/supporting* biotic condition and as either *very likely intact* or *likely intact* since BMI sampling began in 2006.

- Upper Hidden Valley Creek reference site (LHC-2) – Biotic conditions improved from the 2018 scores to the *fair/supporting* conditions according to the ESIBI, although they are still considered *likely altered* according to the CSCI. Both threshold scores have improved over time, with a slight drop in CSCI scores in 2019, although sampling at this site only began in 2015.

Figure 5-3 BMI ESIBI Scores for 2006–2019 by Sampling Site

The 2019 BMI data show an improvement over the 2014 and 2015 data at all sites, with all sites categorized as *fair* or better according to the ESIBI scoring matrix and all sites categorized as *possibly altered* or better, with the exception of the Upper Hidden Valley Creek reference reach site (LHC-2), under the CSCI scoring methodology. The Upper Hidden Valley Creek undisturbed reference site (LHC-2) had the lowest CSCI score in 2019, though the scoring trend for ESIBI at this site is in the positive direction.

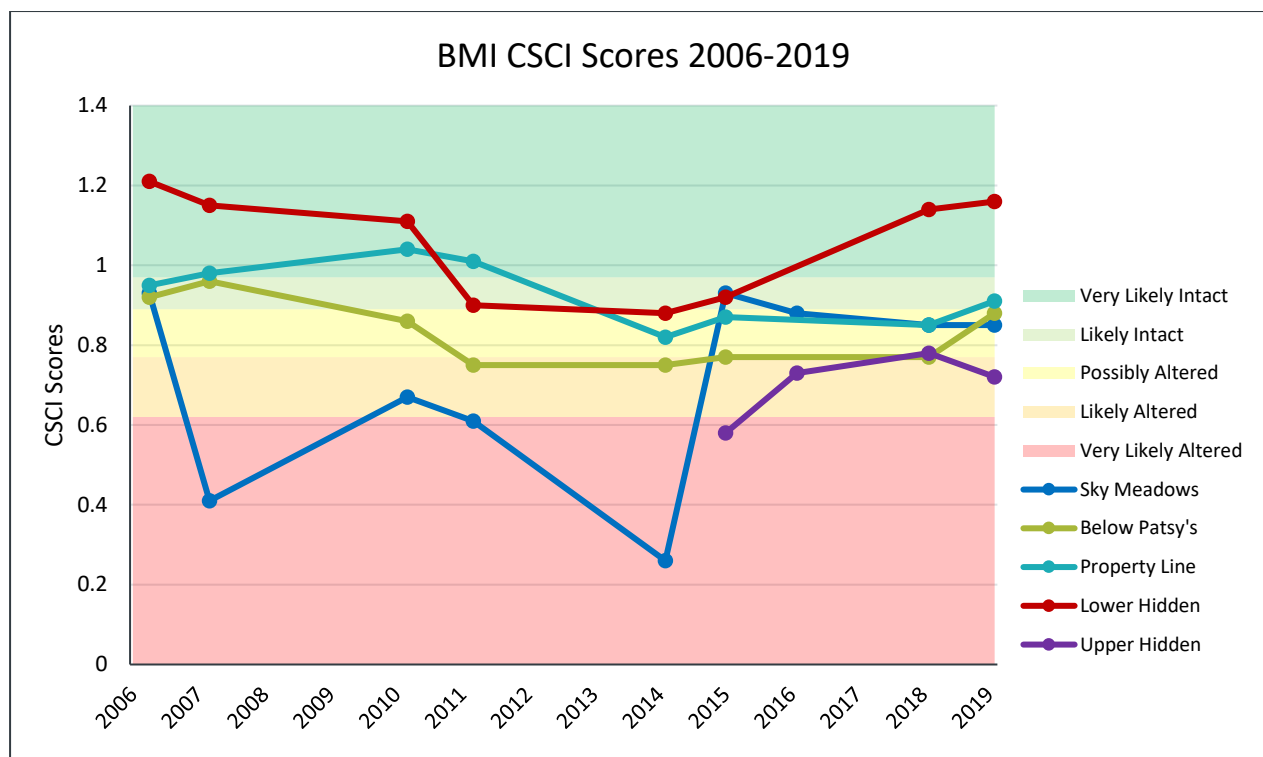
Figure 5-4 BMI CSCI Scores for 2006–2019 by Sampling Site

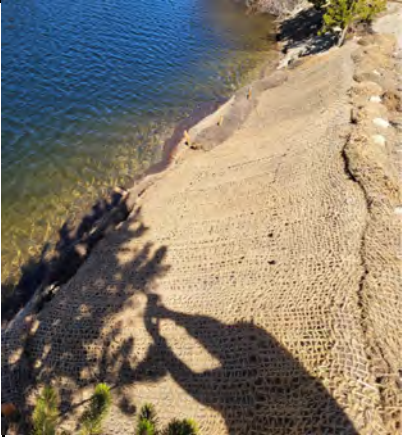
Location	Date	Notes/Observations/Problems Identified	Corrective Measures Taken	Photos
Cal Dam	10/1/2021	Slope stabilization on east side of the reservoir remains effective. 401 WQC marked as historical effective 12/30/21	n/a

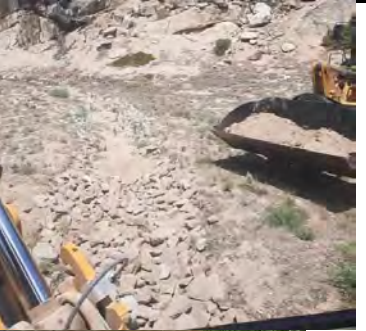
All Mountain	10/1/2021	Mountain roadways used by employees and vendors inspected and in good condition.	Ongoing maintenance taking place, including addition of road base, maintaining water bars. Data provided to USFS as part of annual roads report.	 
All Mountain	10/1/2021	Rope lines in place along roadways to prevent unauthorized "off road" driving. Triple rope lines used in Draba areas on Upper Mountain.	Ropes to be removed prior to first snow for winter season.	
Maggie's & Hellwinkles	10/1/2021	Sediment basins and energy dissipaters are in good condition, maintained and cleaned out post storm events	Sediment basins have adequate capacity and are ready for winter	
Creek Area & Groove	10/1/2021	Rock Lined channels are in good shape. Rock Lined ditch at Groove chair has plenty of remaining sediment holding capacity.	Routine maintenance was done on the rock lined ditch around the base terminal of Groove chair.

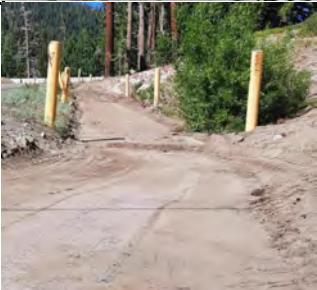
Boulder Base Parking Lot	9/20/2021	Snow storage basins cleaned out of sediment. Material hauled off.	Sediment basins have adequate capacity and are ready for winter

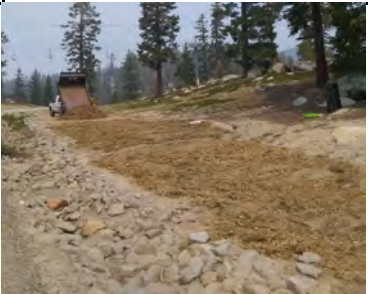
All Mountain	10/1/2021	Gullies and rills on slopes and roadways ok. After any major rain events our Trails Maintenance Crews and Heavy Equipment Operators address any problems right away.	Middle Section of Groove Trail identified as a Hot Spot due to riling. Crew performed a "rip and chip" treatment, seeded and irrigated.

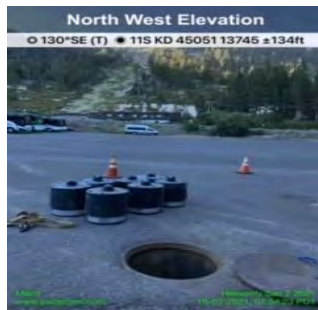
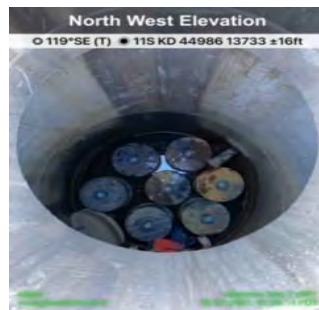
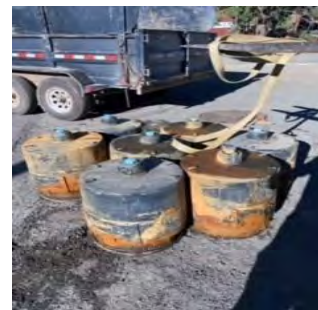
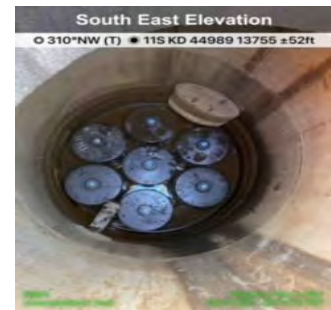
Unit #3

Cartridge bay
Maintenance completed with new filters installed.

New filters installed

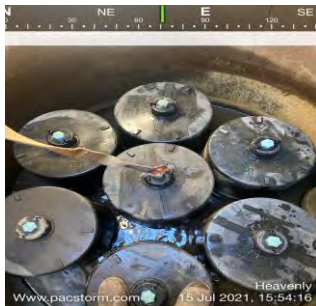
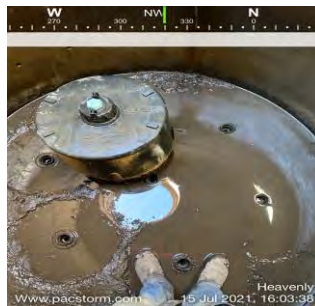
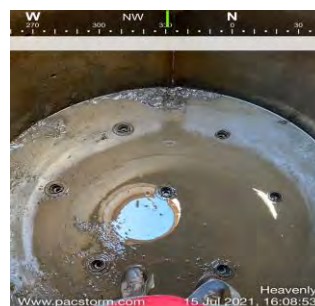
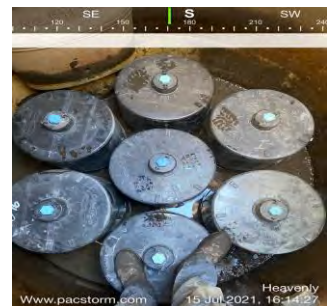
Unit #9

Cartridge bay

New filters installed

Maintenance completed with new filters installed.

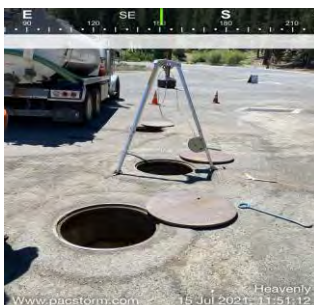
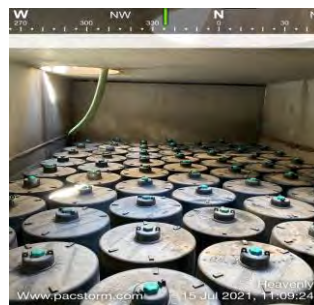
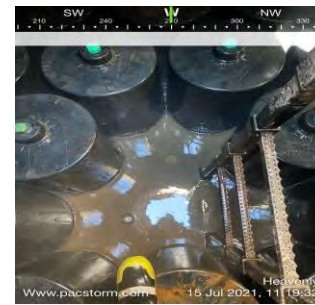
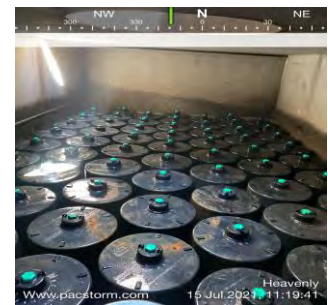
Unit #4

Partial maintenance with sediment removal due to filters are not impacted.

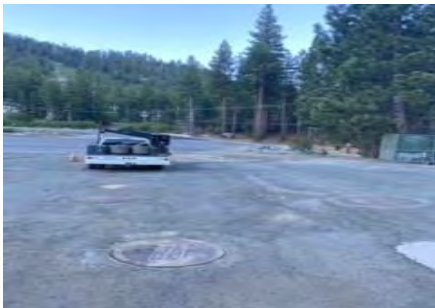
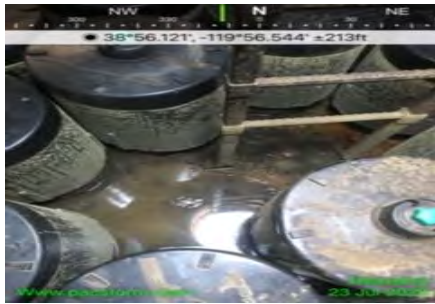
Unit #5

Partial maintenance

No filter replaced

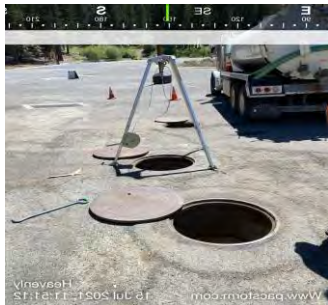
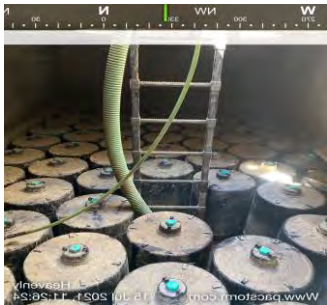
Unit #11

Partial maintenance

No filters replaced

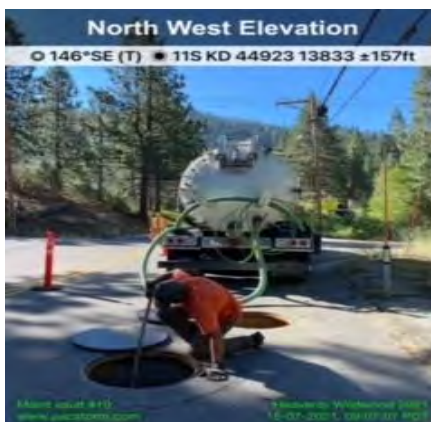
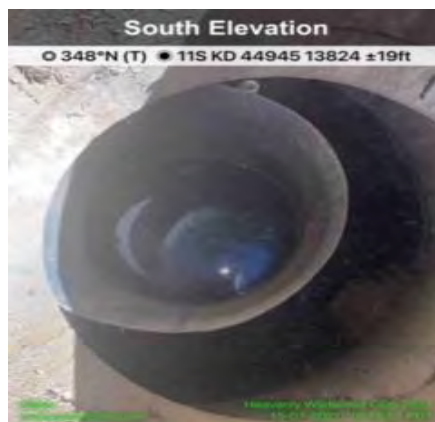
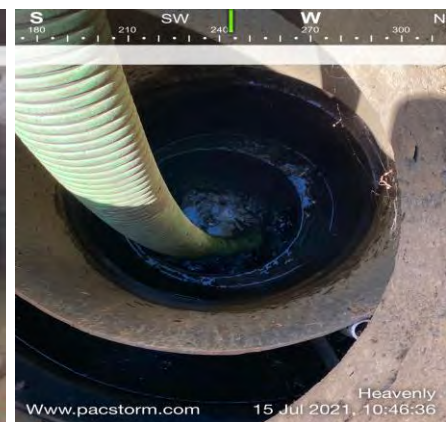
CDS unit had sediment and static water removed.

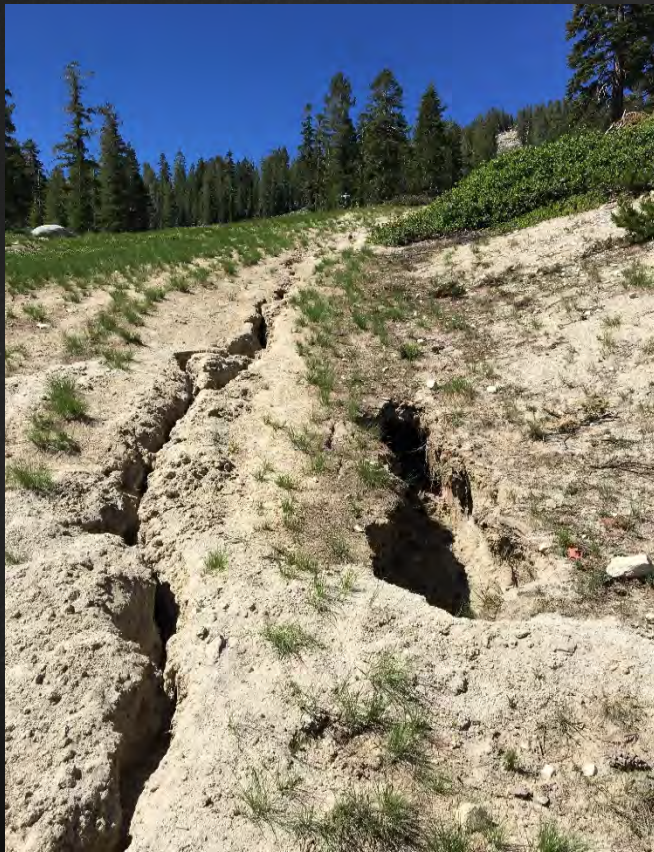
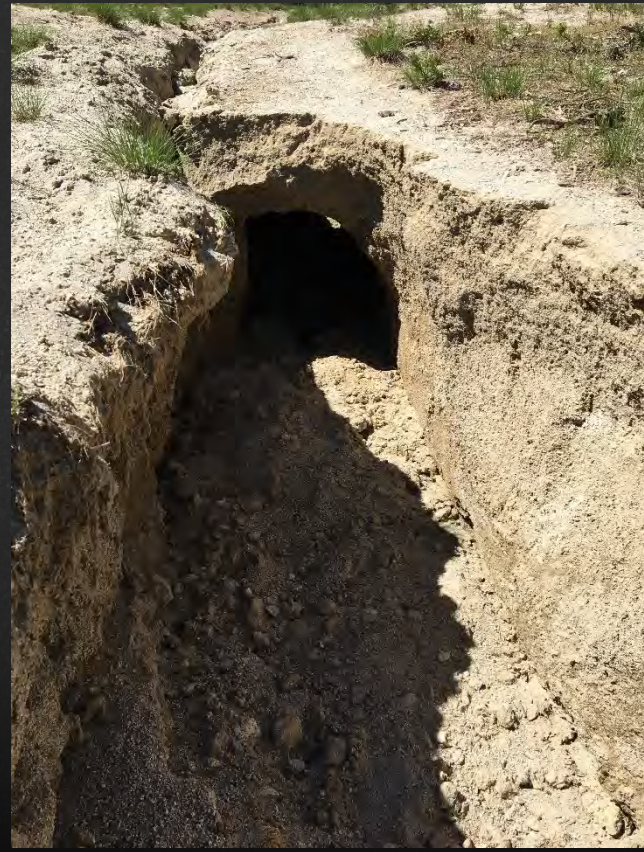
Erosion-Large Rill down ski run

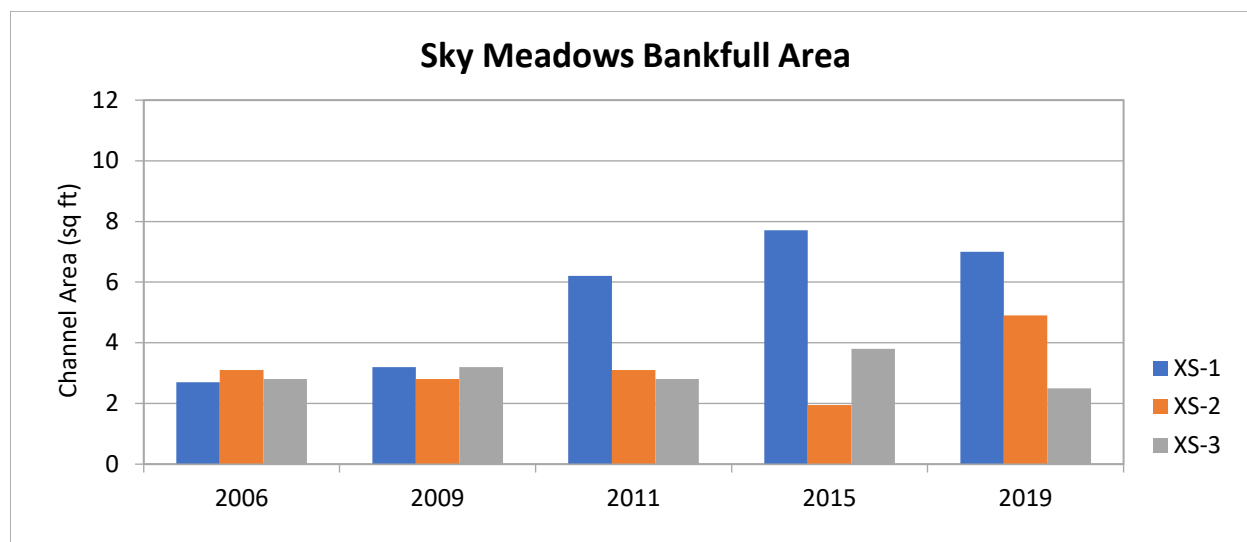
Figure H-1 Bankfull Area – Sky Meadows

The net scour/fill change from 2006 to 2019 (Figure H-2) was small at XS-2 and XS-3; however, both the channel area and net fill/scour at XS-1 has increased over time relative to the 2006 observations. It appears that this section of the reach is both widening and becoming more incised, although incision rates appeared to be stabilizing in 2019. This cross-section is directly above the California Dam snowmaking pond.

Conversely, upstream XS-3 has experienced sediment deposition (or fill) over time. As discussed in Chapter H.1.3, 2019 observations show the channel through the low-gradient meadow appears to be widening, braiding, and experiencing deposition, resulting in a greater bankfull area. This entire reach is within in a meadow, located where the stream slope decreases as it enters the lower gradient meadow, dissipating energy and allowing sediment deposition. The channel exhibits evidence of lateral channel migration, particularly at the upstream section, that is natural for alluvial meadow channels, whereby bank erosion on one side of the channel is offset by sediment fill on the other. At XS-3, the repeat surveys suggest that both lateral migration and some aggradation have occurred. Across the entire reporting period, the channel shifted laterally and bed elevations have shifted slightly, having experienced both scour and fill.

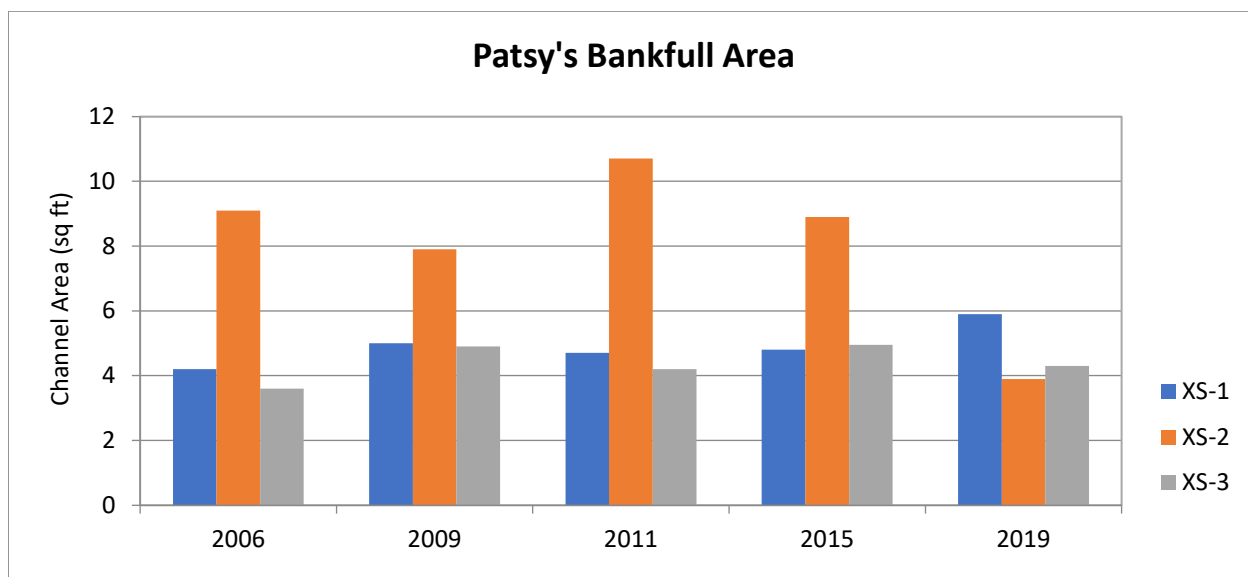
Figure H-3 Bankfull Area – Patsy's

The bankfull area geometry of Patsy’s (HVC-2) XS-1 and XS-3 have remained very similar between 2006 and 2019 (Figure H-3). XS-2 shifted dramatically in 2019, having experienced substantial deposition (Figure H-4), bringing it more line with the bankfull sizes of XS-1 and XS-3. The natural alignment and size of XS-2 may have been suitable for the deposition of material that was moved downstream.

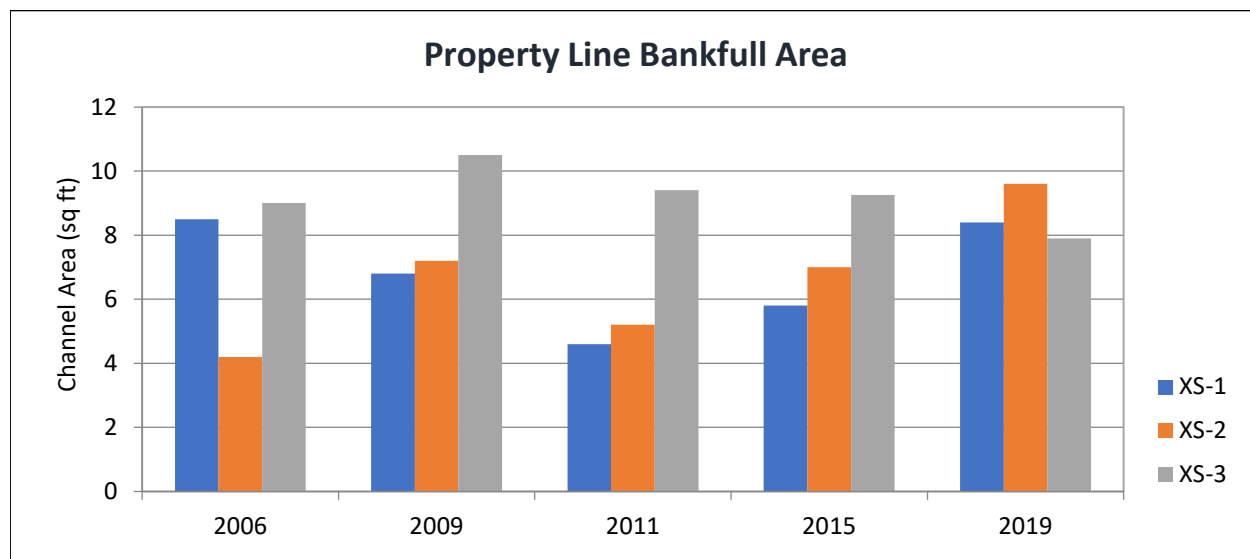
Figure H-5 Bankfull Area – Property Line

The bankfull area geometry of Property Line (HVC-3) XS-1 and XS-3 has remained consistent over time (Figure H-5) compared to 2006 data. XS-2 has experienced scour over the reporting period, particularly between 2015 and 2019 (Figure H-6). Little to no scour has occurred at XS-3 over the period of record. Fill and scour values in 2015 and 2009 at XS-1 and XS-3 are similar, suggesting a potential link in these values during low-flow water conditions (drought).

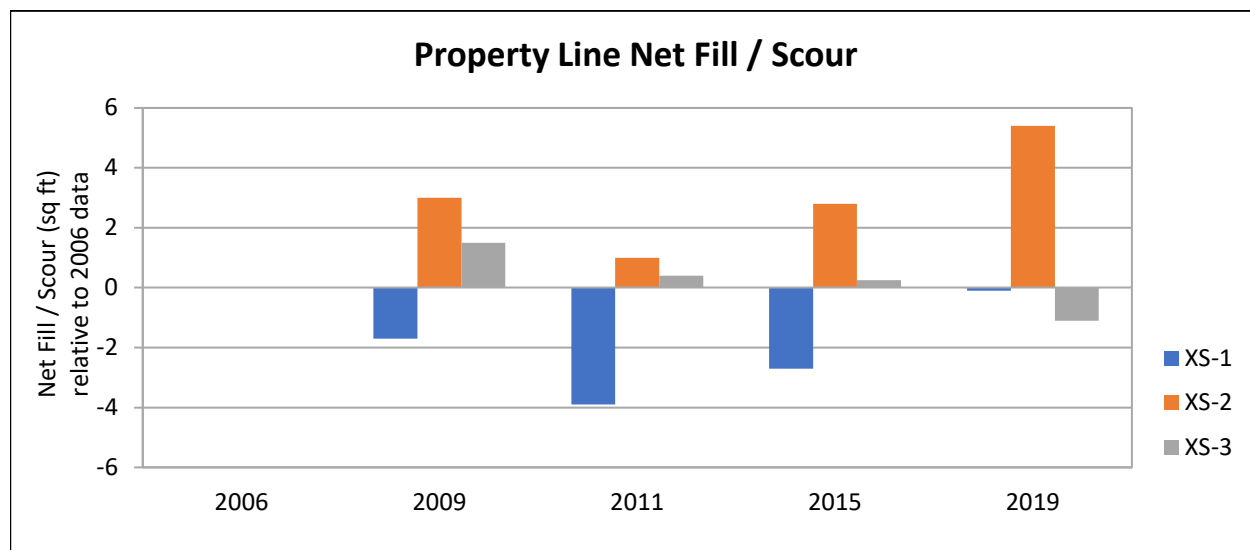
Figure H-6 Net Fill/Scour – Property Line

XS-1 and XS-2 show a rise in the channel bed between 2009 and 2011, but the channel bed dropped in 2015 and 2019. XS-1 and XS-2 also indicate some lateral migration. In the past, the thalweg at XS-2 was at the approximate center of the channel, but in 2015 and 2019, the thalweg was located along the left bank, increasingly so for each monitoring year and so much so that in 2019, the headpin was under water. Sediment is being deposited along the right bank and aggrading the channel. Sediment deposit is likely due to downed logs in the reach that are slowing water velocities, allowing sediment and fine

material to fall out. An angled downed log at XS-2 has also created a step-pool at the cross-section transect line.

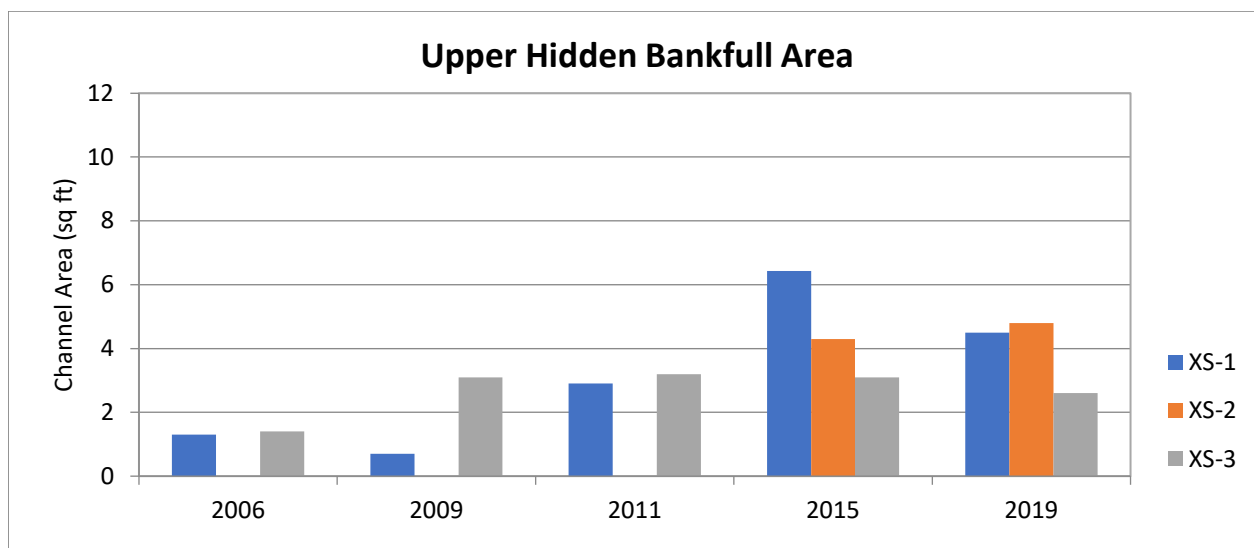
Figure H-7 Bankfull Area – Upper Hidden Valley Creek

The Upper Hidden Valley Creek reference reach (HDVC-1) cross-sections showed some variability and have typically exhibited scour, but only XS-1 and XS-3 have been located reliably in the past. Data from XS-2 are only available for 2015 and 2019. The bankfull area at all cross-sections at Upper Hidden Valley Creek is very small but increased over time at XS-1 and XS-2 (Figure H-7). The net scour/fill changes indicate that scour at all cross-sections has occurred, even though the absolute magnitude has been small (Figure H-8). XS-1 has demonstrated the most variability.

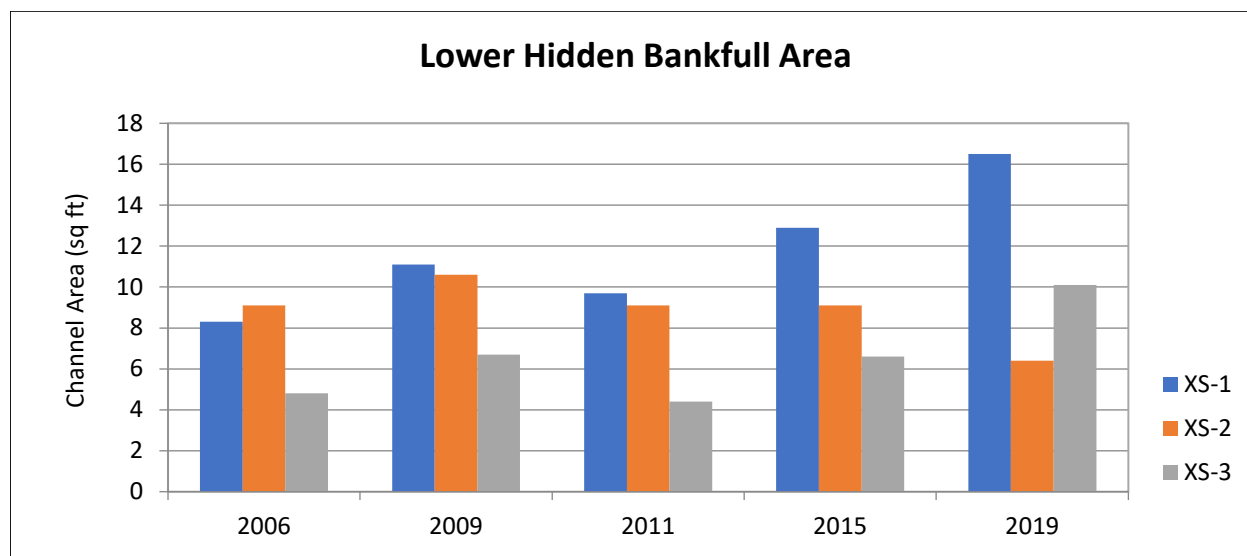
Figure H-9 Bankfull Area – Lower Hidden Valley Creek

The Lower Hidden Valley Creek reference reach (HDVC-2) cross-sections have some differences across cross-sections, since XS-1 and XS-2 are larger than XS-3. However, all three exhibited similar changes in channel area over time, with the exception of changes in 2019 (Figure H-9). The net scour/fill changes indicate that scour was dominant relative to 2006, except at XS-2, which experienced scour in 2009, followed by deposition in 2019. Scour at XS-1 and XS-3 has increased over time (Figure H-10).

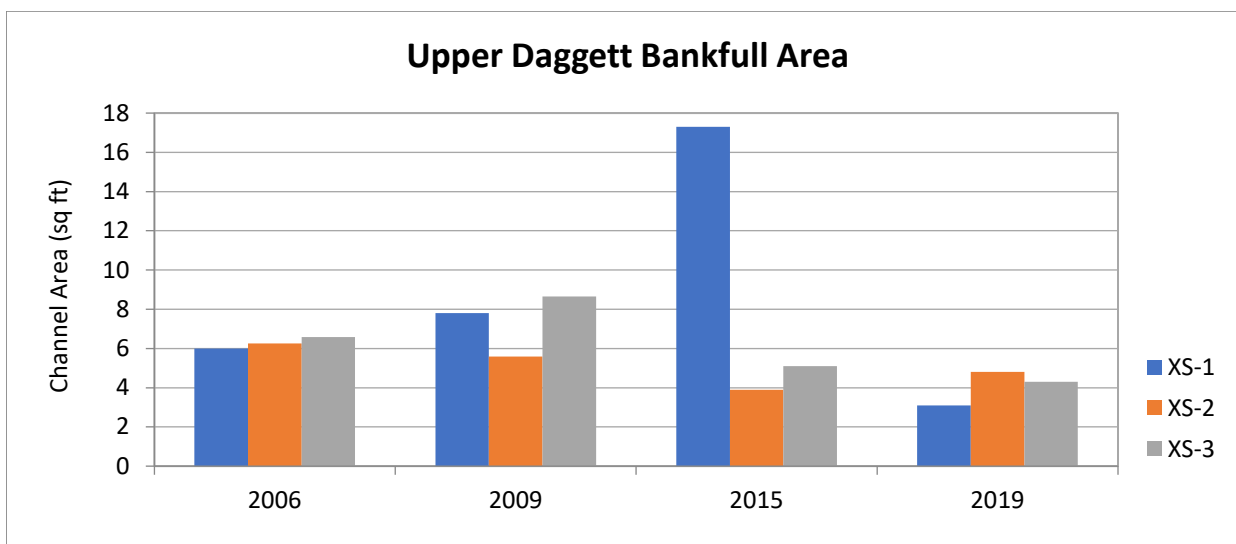
Figure H-13 Bankfull Area – Upper Daggett

The channel cross-section geometry of Upper Daggett (DC-1) saw an increase in area at XS-1 in 2015 due to channel widening, with a slight decrease in bankfull channel area at XS-2 and XS-3 (Figure H-13); however, XS-1 stabilized to pre-2015 conditions in 2019, and XS-2 and XS-3 remained consistent. The 2015 net scour/fill compared to the 2006 area increased substantially at XS-1, but deposition was observed at all three cross-sections in 2019 (Figure H-14). Emergency repairs of East Peak Dam in early summer 2015 created uncontrolled runoff, which may have altered flows into Daggett Creek (increased volume, velocity, and scour), potentially accounting for cross-sectional changes seen during surveys later in 2015.

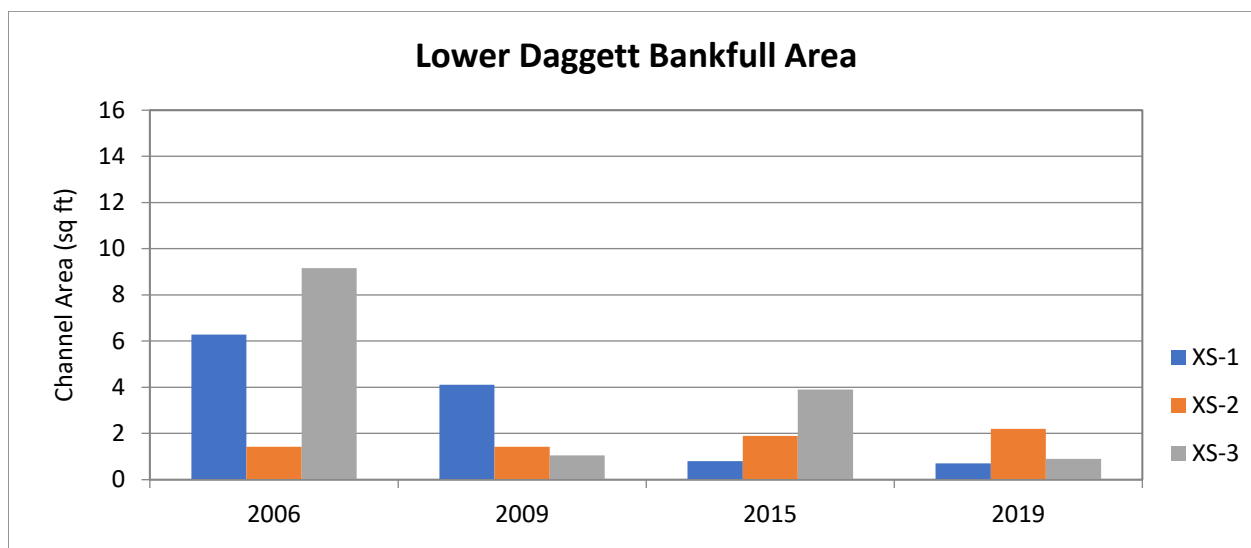
Figure H-15 Bankfull Area – Lower Daggett

The channel cross-section geometry at Lower Daggett Creek (DC-2) varies by cross-section following 2006 for XS-1 and XS-3 (Figure H-15). The bankfull channel area at XS-2 is very small, and has remained fairly consistent over the monitoring period. XS-3 and XS-1 channel area was relatively large in 2006, and both have experienced substantial deposition (Figure H-16) and both channel areas have drastically reduced in size. However, depositional rates appear to have tapered off and stabilized over time.

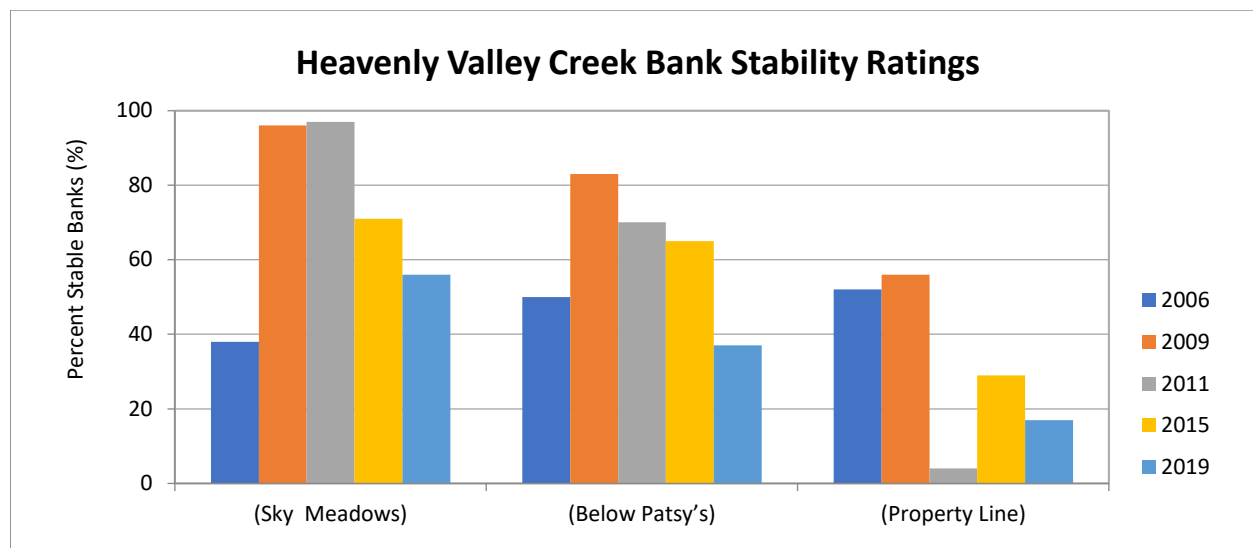
Figure H-17 Bank Stability – Heavenly Valley Creek

The Sky Meadows reach exhibits the most stable streambank measurements over the monitoring period, with the average percentage of stability at 72 percent. The stability at Sky Meadows is likely associated with the high vegetation cover (primarily graminoids) present in the meadow complex. The Patsy's reach stability average over the monitoring period is 61 percent, while the Property Line reach stability average over the same time frame is 32 percent. The reason for the decline in stability at the Property Line reach in 2011 is uncertain, although it may be due to variability in surveyors across the years. It is possible that differences in LWD (LWD observed in 2011 was 50 percent of that observed in 2009) and/or rock material along the banks and/or aggradation changes occurred during higher flows in 2011. Stability at the Property Line reach increased in 2015, but the reach experienced a slight decline again in 2019. Drought conditions from 2012 to 2015 likely account for the decreased stability and vegetation cover at both the Sky Meadows and Patsy's reaches; however, stability at these reaches continued to decline through 2019, despite above-average or average precipitation conditions preceding 2019. Stability at the Property Line reach increased in 2015, but experienced a slight decline again in 2019.

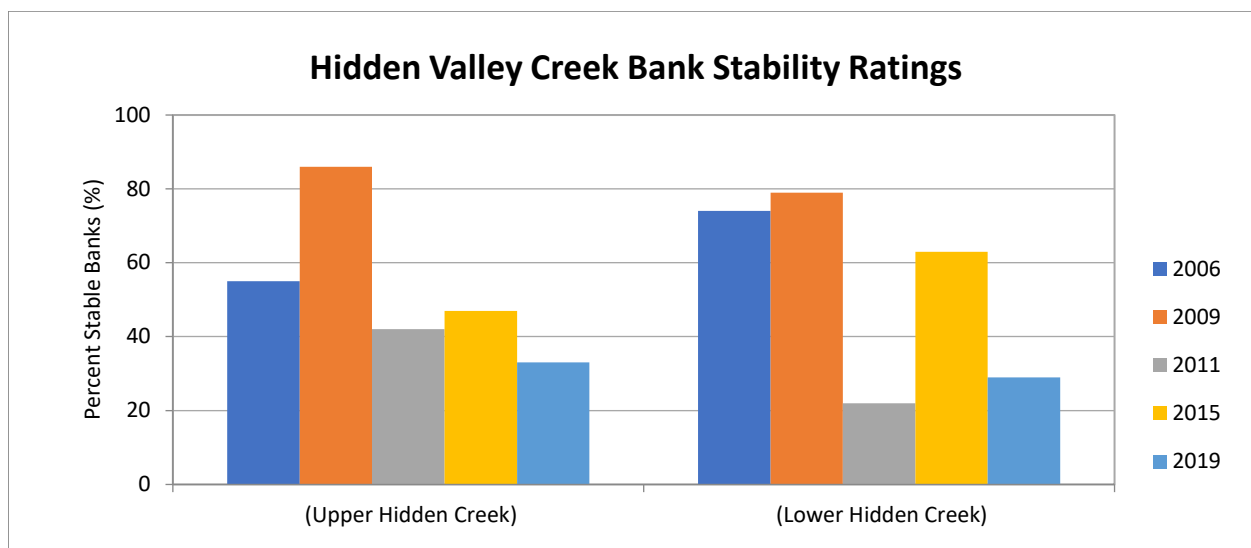
Figure H-18 Bank Stability – Hidden Valley Creek

The percent of stable banks along Hidden Valley Creek varied over time at the two reaches (Figure H-18), but similar to Heavenly Valley Creek, all stability ratings were the highest in 2009 (86 percent at Upper Hidden Valley Creek and 79 percent at Lower Hidden Valley Creek). The Lower Hidden Valley Creek reference reach displays a similar pattern to the Property Line reach, with a decline of stability in 2011, followed by subsequent increases in 2015. Stability increased at both reference reach locations in 2015; however, the increase did not meet or exceed the 2006 observations. Stability at both reaches also experienced a decline in 2019.

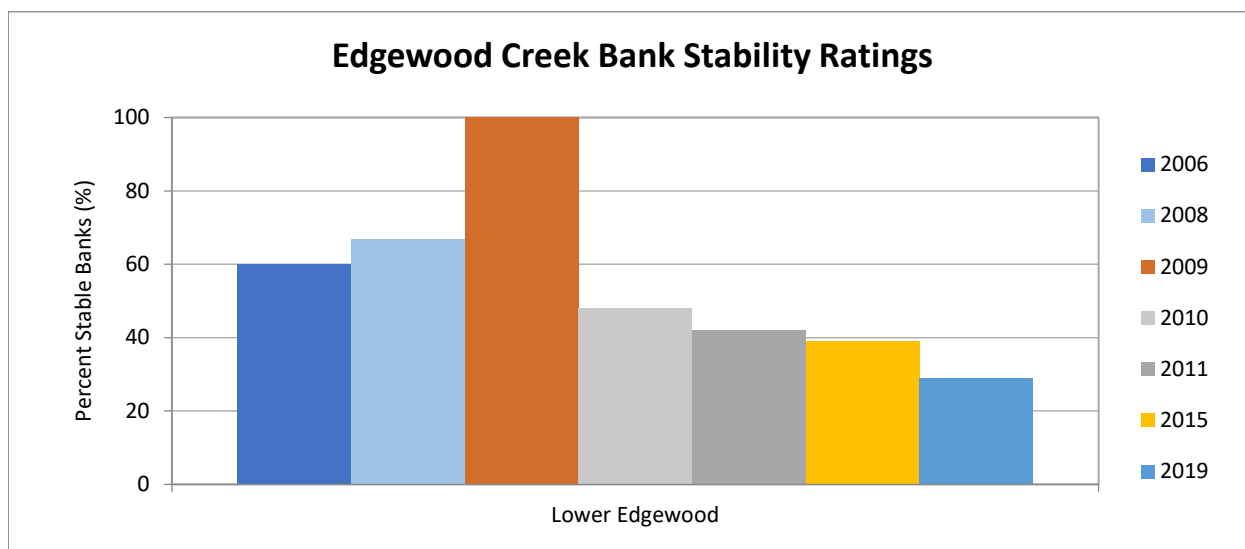
Figure H-19 Bank Stability – Lower Edgewood Creek

The percent of stable banks along Lower Edgewood Creek varied over time and has steadily decreased since its peak in 2009 (Figure H-19). The Lower Edgewood stability chart correlates with the Patsy’s reach along Heavenly Valley Creek, which showed an initial improvement in stability in 2009, followed by a slow decline. Stability measurements were not collected along Upper Edgewood Creek, with the exception of 2015. Should future measurements be collected at Upper Edgewood Creek, 2015 will be used as the baseline for comparison.

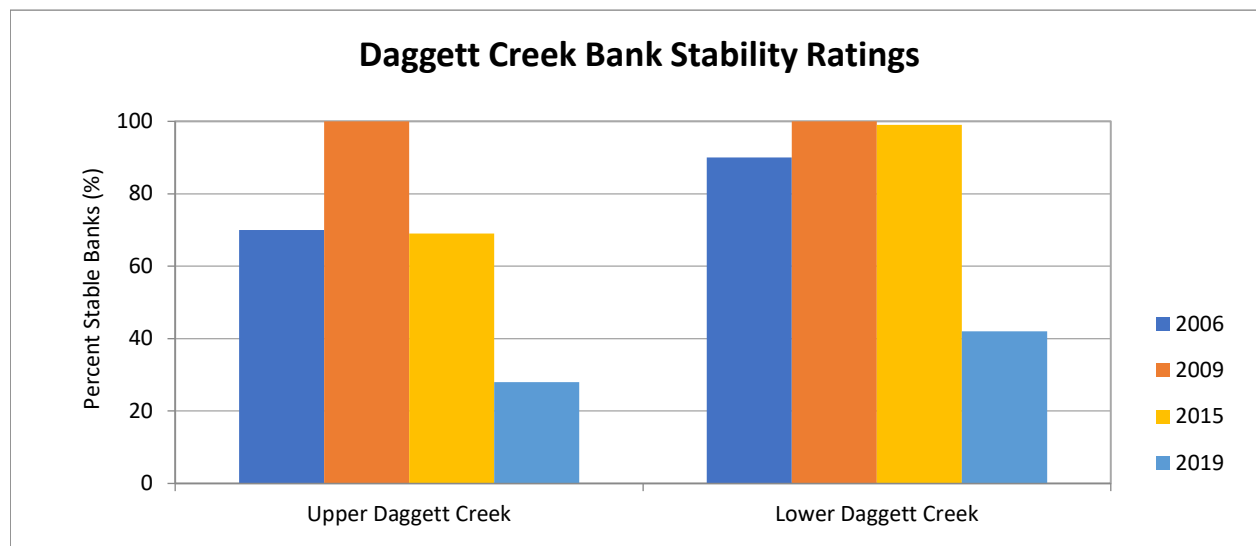
Figure H-20 Bank Stability – Daggett Creek

The percent of stable banks along Upper Daggett Creek (Figure H-20) displayed the same pattern of increased stability between 2006 and 2009 and decreased stability in 2015. Bank stability observations further declined (by over 50 percent) in 2019.
