Heavenly Mountain Resort Mitigation and Monitoring Plan Annual Report

October 2009 – October 2010

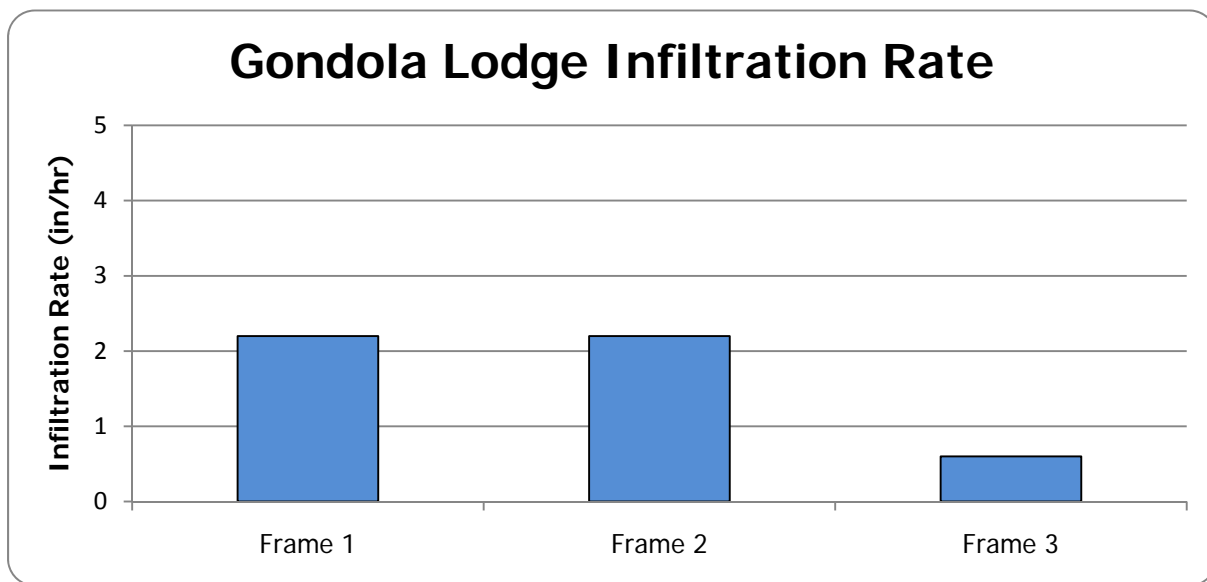
At the Gondola Lodge, the slope was relatively flat, which did not allow for typical rainfall simulation and runoff sample collection. Instead, the rainfall simulator was used to measure the steady state infiltration rate. Steady state infiltration rates ranged from 0.6 to 2.2 in/hr, with an average infiltration rate of 1.6 in/hr (Figure 21). Typical undisturbed soils of granitic parent material can have infiltration rates greater than 4 in/hr.

Figure 21. Gondola Lodge Infiltration Rate. Each of the 3 rainfall frames is presented here. Pre-treatment infiltration monitoring was conducted in 2010.

The penetrometer DTR was 5 inches, with a standard deviation of 0.8 inches. This relatively shallow DTR likely resulted in the low infiltration rates presented above.

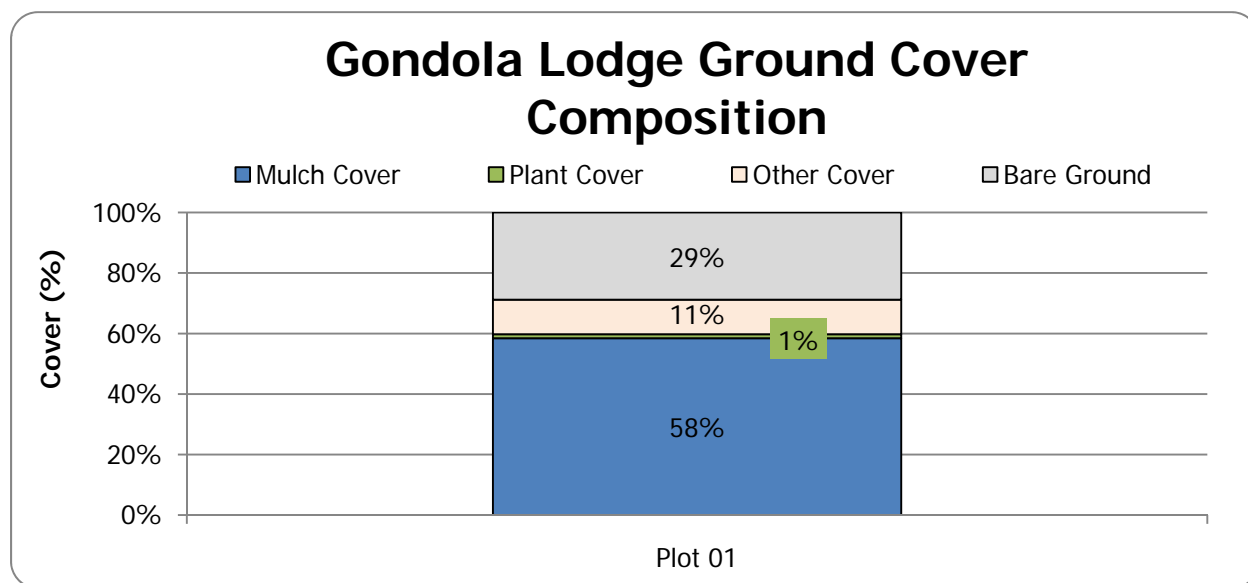
Total cover at the Gondola Lodge was 71%, with 58% mulch cover, 11% other cover, and 1% understory plant cover (Figure 22). Bare soil was 29% of the ground composition. Overstory (or foliar) plant cover was 14% (no graph).

Figure 22. Gondola Lodge Ground Cover Composition. Pre-treatment monitoring was conducted in 2010.

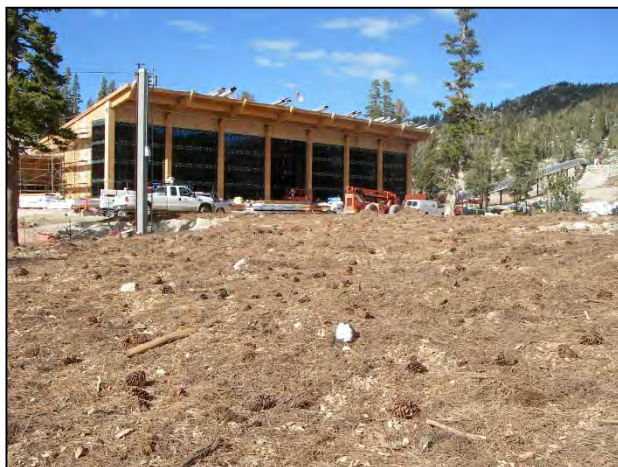
Figure 24. Gondola Lodge site, immediately following treatment, October 2010. The treated spoils are visible in the foreground.

of 20 to 24 inches using the bucket of an excavator. The entire area was then fertilized, seeded and mulched. The surface of the fill area was left in a slightly roughened condition to reduce the potential for erosion during snowmelt and saturated soil conditions. These treatments are summarized in Table 10. In 2011, the treatment area will be planted with mountain pride (*Penstemon newberryi*) and sulphur flower buckwheat (*Eriogonum umbellatum*) and irrigated using a temporary overhead system.

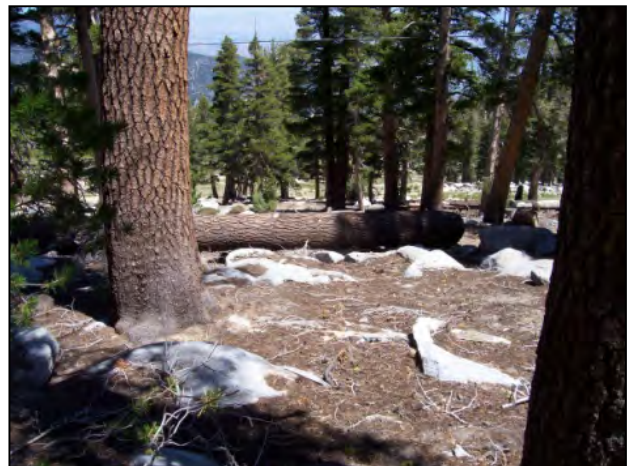
Photos from the cleared and uncleared ski run show no notable changes in surface conditions or evidence of erosion (Figure 29, Figure 30, Figure 31, and Figure 32).

Figure 30. Northbowl uncleared ski run, 2010 (photo point 3). Note the fallen tree in the background that was not present in 2008.

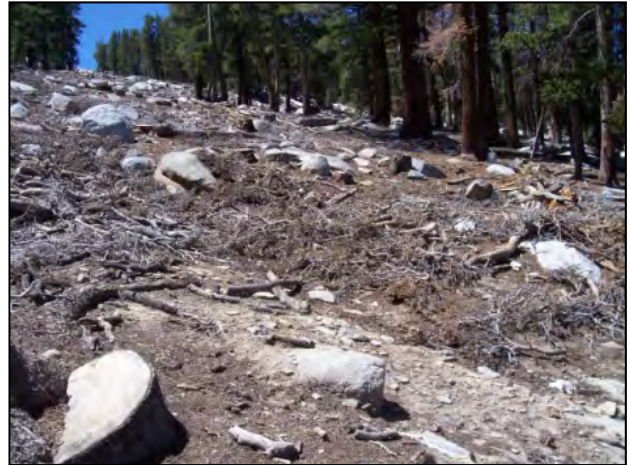
Figure 32. Northbowl cleared ski run, 2010 (photo point 1).

In 2010, visual erosion assessment and photo documentation were conducted. No evidence of erosion was observed and no notable changes in site conditions were evident. Therefore, the success criterion was met and no management responses are necessary.

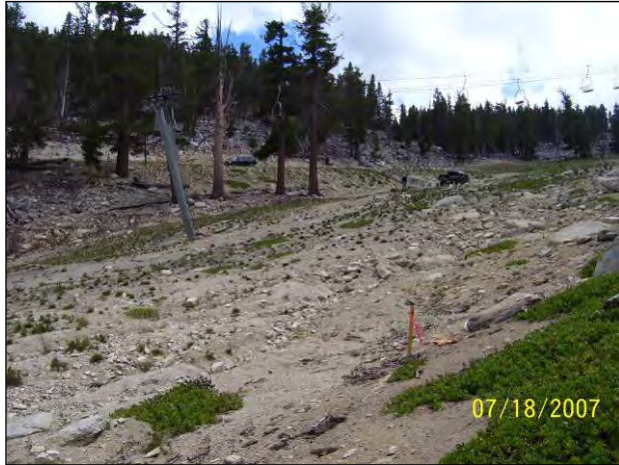
Olympic lift bottom is a disturbed area that encompasses the current bottom lift terminal and a portion of the Olympic Downhill ski run that funnels to the lift terminal (Figure 37 and Figure 38). This site is at an elevation of 8,561 feet AMSL on rocky soil derived from granitic parent material and faces northeast. Before treatment, non-native plants were present. The surrounding vegetation includes an overstory of red fir (*Abies magnifica*), whitebark pine (*Pinus albicaulis*), and Western white pine (*Pinus monticola*), with an understory of pinemat manzanita (*Arctostaphylos nevadensis*). The treatment area is dominated by a non-native fescue (*Festuca trachyphylla*). The tree canopy cover is less than 10%, the solar exposure is 70%, and the slope angle is 20 degrees. Rills and gullies caused by water erosion were observed throughout the site pre-treatment.

Figure 37. Olympic lift bottom, Olympic Downhill ski run, pre-treatment, 2007.

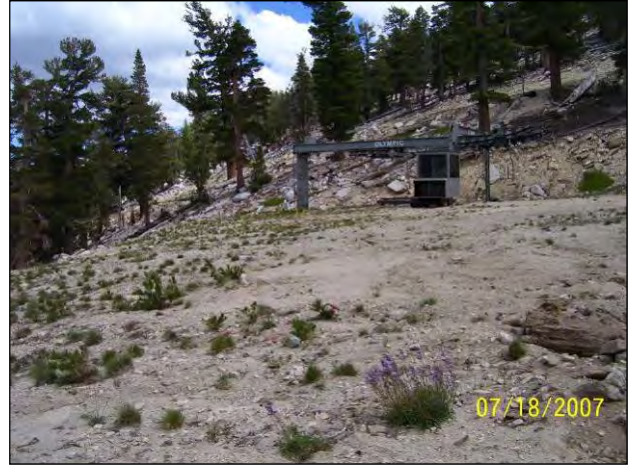
Figure 38. Olympic lift bottom, old bottom terminal, pre-treatment, 2007.

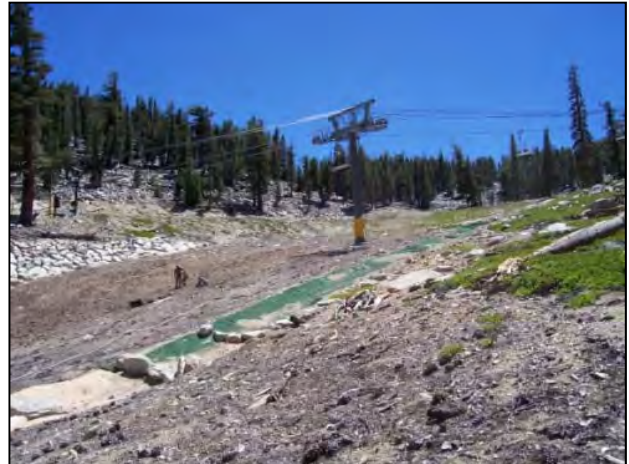
Figure 44. Olympic lift bottom, treatment area A, post-treatment, 2010. The re-mulched area is on the left.

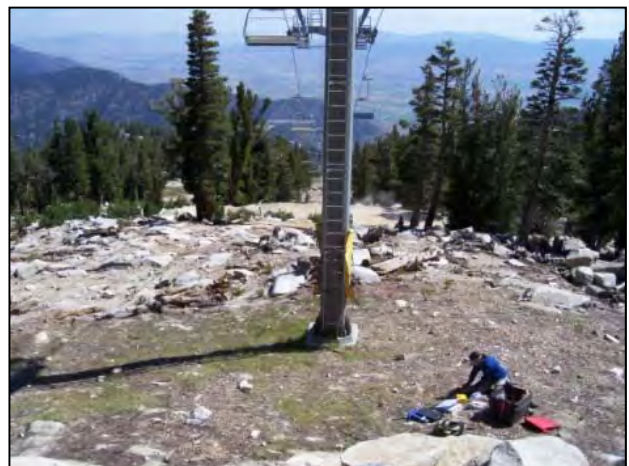
Figure 54. Olympic lift top, post-treatment, 2010. Note presence of vegetation.

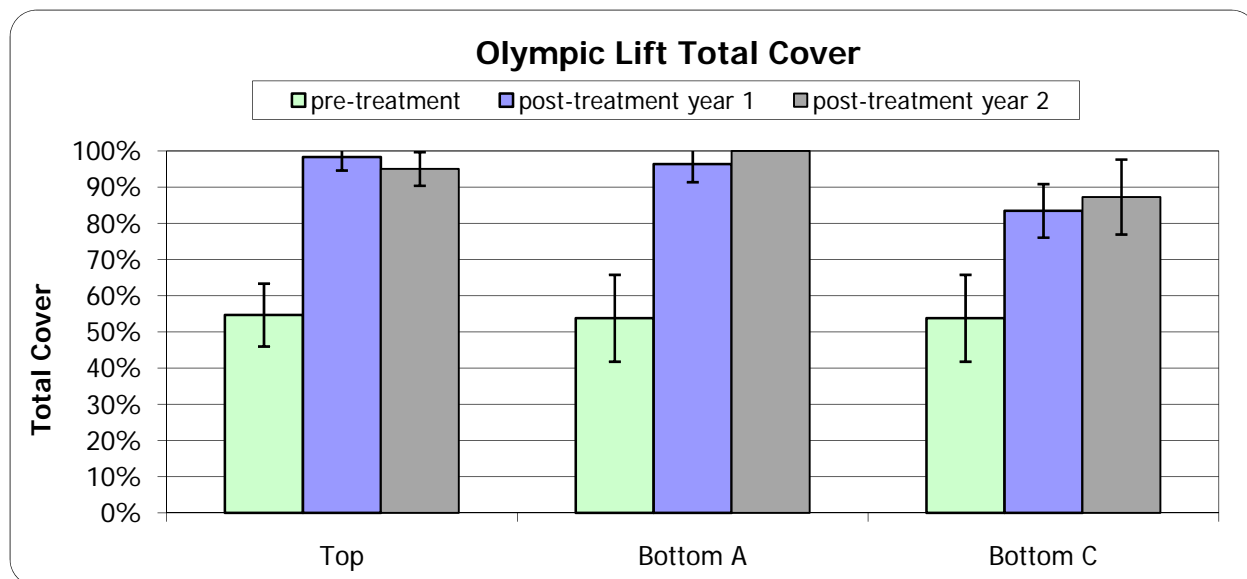
The 2009 year 1 post-treatment total cover at the Olympic lift top (98%) was 78% higher than the 2007 pre-treatment total cover (55%; Figure 57). The 2009 year 1 post-treatment total cover at the Olympic lift bottom A (96%) was 75% higher than the pre-treatment total cover (55%). The 2009 year 1 post-treatment total cover at the Olympic lift bottom C (83%) was 51% higher than the pre-treatment total cover (55%). The success criterion, which states that the post-treatment total cover must be greater than 70%, was met for all plots.

In 2010, the year 2 post-treatment total cover was 95% at the Olympic lift top, 100% at Olympic lift bottom A, and 87% at Olympic lift bottom C. The success criterion of 70% total cover was met at each plot.

Figure 57. Olympic Lift Total Cover. The error bars denote one standard deviation above and below the mean. Pre-treatment data was collected in 2007 and post-treatment data was collected in 2009 (year 1) and 2010 (year 2).

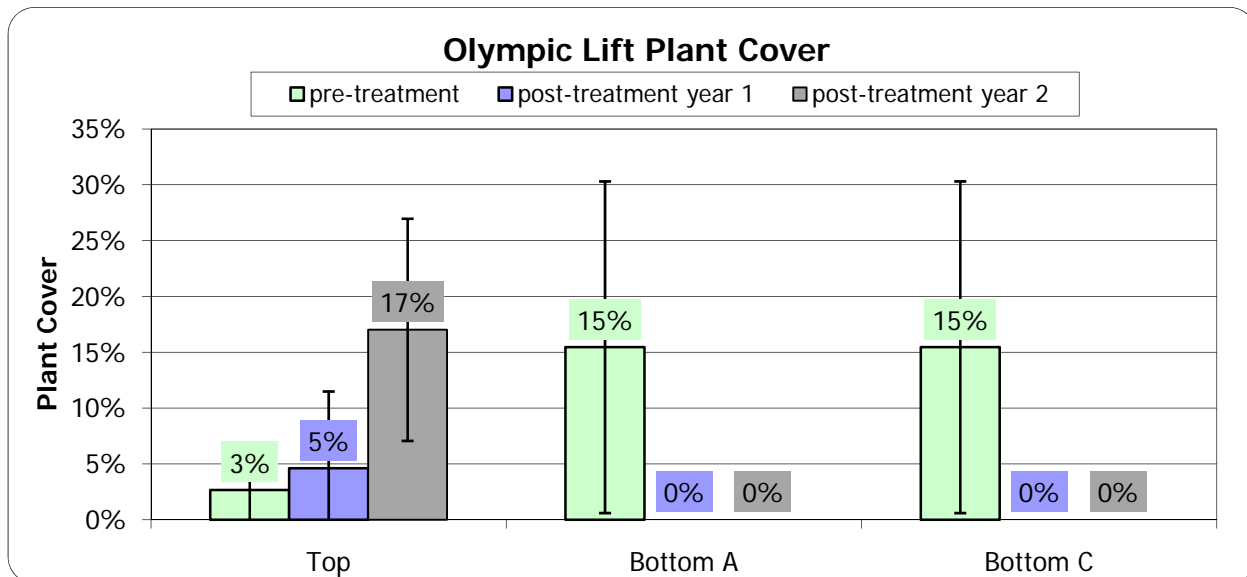
The 2009 year 1 post-treatment plant cover at the Olympic Lift top (5%) was similar to the 2007 pre-treatment total cover (3%, Figure 58). The plant cover was dominated by grasses that were not mature enough to be identified.

The 2010 year 2 post-treatment total cover at the Olympic lift bottom A and C was 0%. Ocular estimates indicated that there was approximately 4% cover by native plants at Olympic bottom C that was not captured during cover point monitoring. However, this cover was by some non-native species, such as clover (*Melilotus sp.*), which could be of concern if the cover increases. Ocular estimates at Olympic lift bottom A indicated no species were present. The success criterion, which states that the post-treatment plant cover be at least 10%, was not met for the Olympic lift bottom plots.

Figure 58. Olympic Lift Plant Cover. The error bars denote one standard deviation above and below the mean. Pre-treatment data was collected in 2007 and post-treatment data was collected in 2009 in 2010.

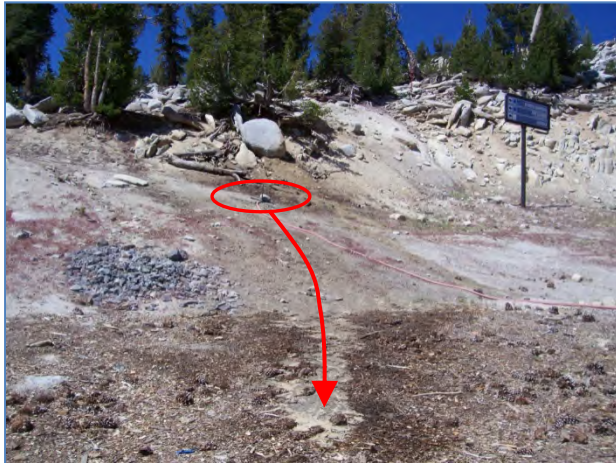
In 2010, a leaky sprinkler (likely due to down-draining) near the maintenance building resulted in rill formation, erosion, and sedimentation of soil at the Olympic lift top plot A (Figure 59). Approximately 30-40 square feet of the plot was affected.

Figure 59. Olympic lift top terminal. Erosion and sedimentation from irrigation. The sprinkler head is circled and the red arrow shows the water flow path.

Unmet Success Criterion	Management Response	Follow-up Action
		4. Ensure sprinkler heads and irrigation systems are maintained to preclude leaking. Place heads above water connection point to prevent drain-down leakage	
Top	Plant cover criterion was met in the designated monitoring area; however, large areas of zero plant cover existed and are addressed here	For low cover areas only (as determined and marked by IERS staff): Alternative 1: Remove mulch, apply fertilizer, apply seed, replace mulch then irrigate with low-flow heads (MP rotator or equivalent) for one season Alternative 2: Apply seed over mulch, then use spring rake to ensure soil-seed contact then irrigate with low-flow heads (MP rotator or equivalent) for one season	1. Implementation monitoring during seeding, fertilizing, or mulching activities 2. Germination assessment after 1 month of irrigation 3. Visual erosion assessment

Newly re-treated areas and the road improvements at Olympic top should be closely watched throughout the season, particularly during and immediately after rain events, to ensure that no erosion is occurring. At Olympic top, it is important ensure that surface runoff is no longer concentrating and causing erosion. The irrigation systems should be regularly inspected to ensure that failures or drain-down leakage is not occurring.

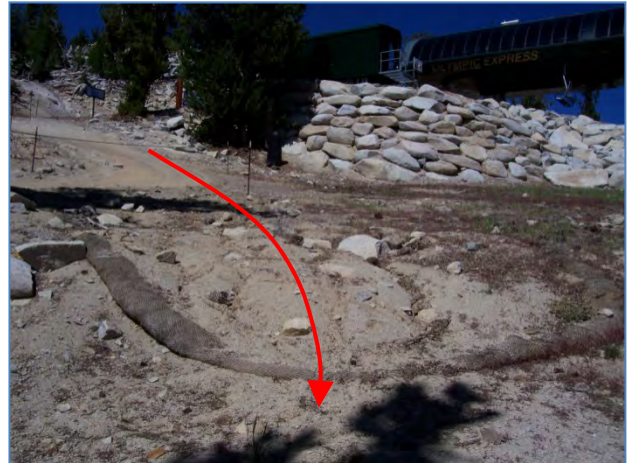
In 2010, road erosion resulted in sediment delivery from the road onto the Olympic lift top treatment area C (Figure 60). The sediment originated from several places along the road and overwhelmed a wattle as shown.

Figure 60. Olympic lift top terminal. Erosion and sedimentation originating from the road and moving towards the restoration area.

Unmet Success Criterion	Management Response	Follow-up Action
Top	Visual Erosion Assessment	<ol style="list-style-type: none"> 1. Assess water flows to determine the source of the road erosion issue 2. Implement road drainage improvements such that water is collected/infiltrated without causing erosion 3. Remove sediment in treatment areas. 	<ol style="list-style-type: none"> 1. Inspection of road drainage improvements during and after implementation 2. Visual erosion assessment after rain events (after road improvements are completed)

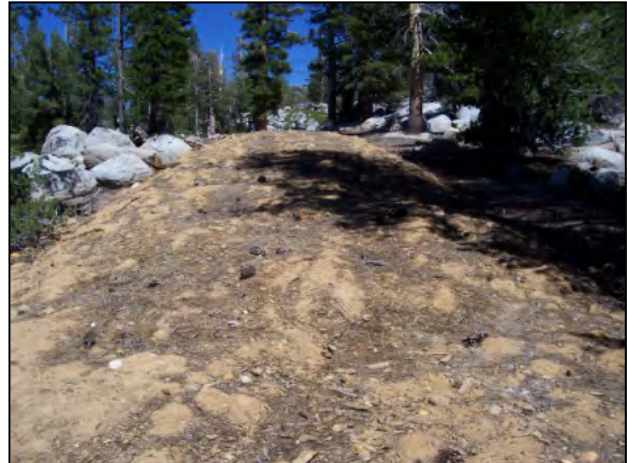
Figure 82. Mid Station Road, treatment area A, post-treatment, 2010 (photo point 6). Bare areas can be seen.

In 2010, a large visual change occurred at Mid-Station Road. Many small mounds of bare soil appeared in the upper part of plot A (Figure 82). These mounds are likely a result of rodent or small animal activity, though the source is not entirely clear. A small number of these mounds were present in 2009 and one rainfall simulation frame was unknowingly placed on one of these mounds, creating a high level of sediment in the runoff. In 2010, splash detachment from rain events was evident on the mounds, indicating water erosion. The mounds/bare soil covered approximately 35% (ocularly estimated) of the entire plot, which encompasses a larger area than the monitoring plot than where cover was conducted on transects. There was a lower concentration of mounds where the transects were placed (Figure 85).

Unmet Criterion	Management Response	Follow-up Action
Road	Plant Cover	<p>Alternative 1: Remove mulch, apply fertilizer, apply seed, replace mulch then irrigate with low-flow heads (MP rotator or equivalent) for one season</p> <p>Alternative 2: Apply seed over mulch, then use spring rake to ensure soil-seed contact then irrigate with low-flow heads (MP rotator or equivalent) for one season</p>	<ol style="list-style-type: none"> 1. Implementation monitoring during seeding, fertilizing, or mulching activities 2. Germination assessment after 1 month of irrigation 3. Visual erosion assessment
Road	Visual Erosion Assessment	Additional mulching after implementing alternative 1 or 2 above to achieve total cover criterion. Mulch should be applied to 2 inches.	<ol style="list-style-type: none"> 1. Implementation monitoring during mulching activities 2. Visual erosion assessment (captured above as follow-up for plant cover criterion)

Newly re-treated areas should be closely watched throughout the season, particularly during and immediately after rain events, to ensure that no erosion is occurring. Any sign of rodent activity should be immediately noted and followed closely. The irrigation systems should be regularly inspected to ensure that failures or drain-down leakage is not occurring.

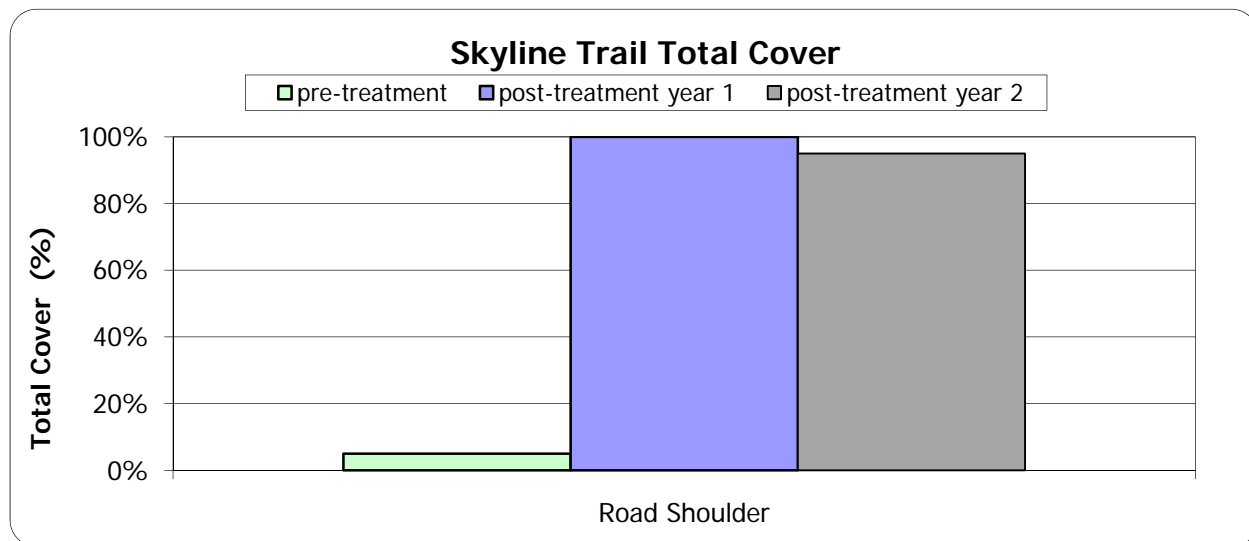
In 2009, the year 1 post-treatment total cover at the Skyline Trail road shoulder (100%) was approximately 1900% greater than the pre-treatment ocular estimate of total cover in 2008 (5%; Figure 106). The criterion, which states that the post-treatment total cover must be greater than 70%, was met.

In 2010, the year 2 post-treatment total cover ocular estimate at the road shoulder was 95%. The criterion, which states that the post-treatment total cover must be greater than 70%, was met.

Figure 106. Skyline Trail Total Cover. The pre-treatment and post-treatment year 2 total covers are ocular estimates. Pre-treatment measurements were conducted in 2008, while post-treatment measurements were conducted in 2009.

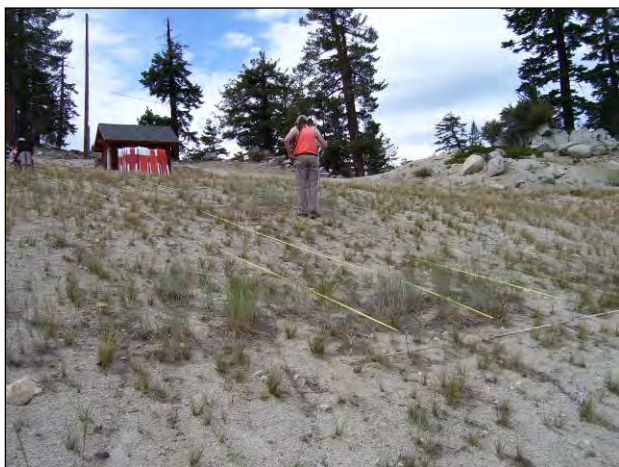
Figure 109. Gun Barrel top terminal slope monitoring area, pre-treatment, August 2008.

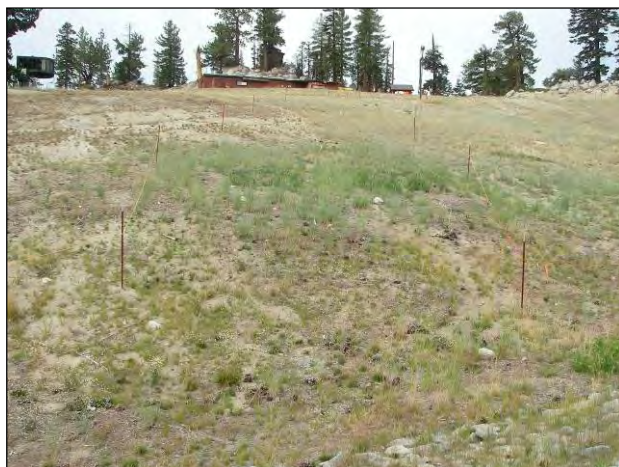
Figure 110. Gun Barrel top terminal slope, pre-treatment, August 2008. Water line installation area is between the T-stakes.

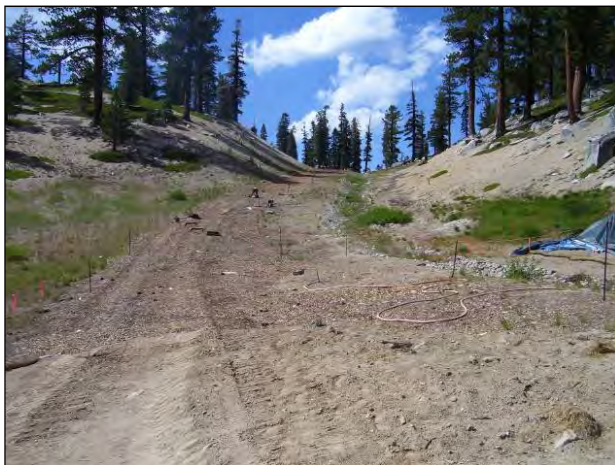
Figure 125. Treatment areas E, F and G, post-treatment, August 2009. Heavy machinery tracks are visible (photo point A).

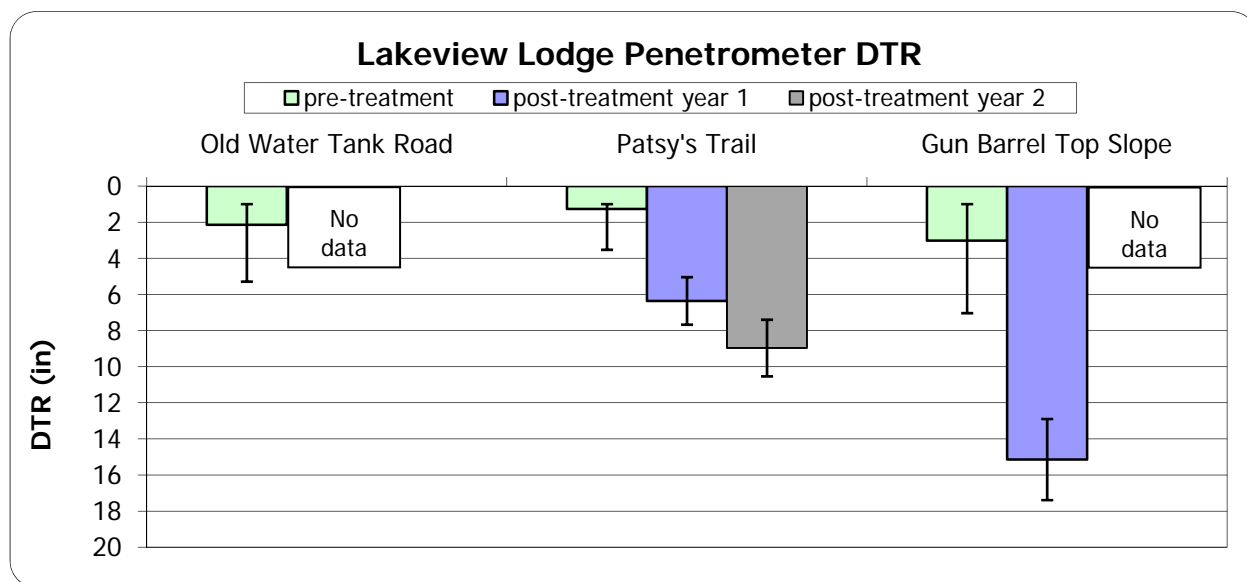
In 2008, the pre-treatment penetrometer DTR at the old water tank road was 2.0 inches (Figure 128). In 2009, the year 1 post-treatment penetrometer DTR at Patsy's trail (6.4 inches) was 5.1 inches deeper than the pre-treatment DTR in 2008 (1.3 inches). The post-treatment penetrometer DTR at the Gun Barrel top slope (15.1 inches) was 12.1 inches deeper than the pre-treatment penetrometer DTR (3.0 inches). The success criterion, which states the post-treatment DTR cannot be more than 4.0 inches shallower than the pre-treatment DTR, was met.

In 2010, the year 2 post-treatment penetrometer DTR at Patsy's trail was 9 inches, which was 7.7 inches deeper than the pre-treatment DTR in 2008 (1.3 inches). The success criterion, which states the post-treatment DTR cannot be more than 4.0 inches shallower than the pre-treatment DTR, was met.

Figure 128. Lakeview Penetrometer Depth to Refusal (DTR). Post-treatment measurements were not taken at the old water tank road. Error bars represent one standard deviation above and below the mean. Pre-treatment measurements were conducted in 2008, while post-treatment measurements were conducted in 2009 and 2010. Post-treatment data collection for the old water tank road is planned for 2012.

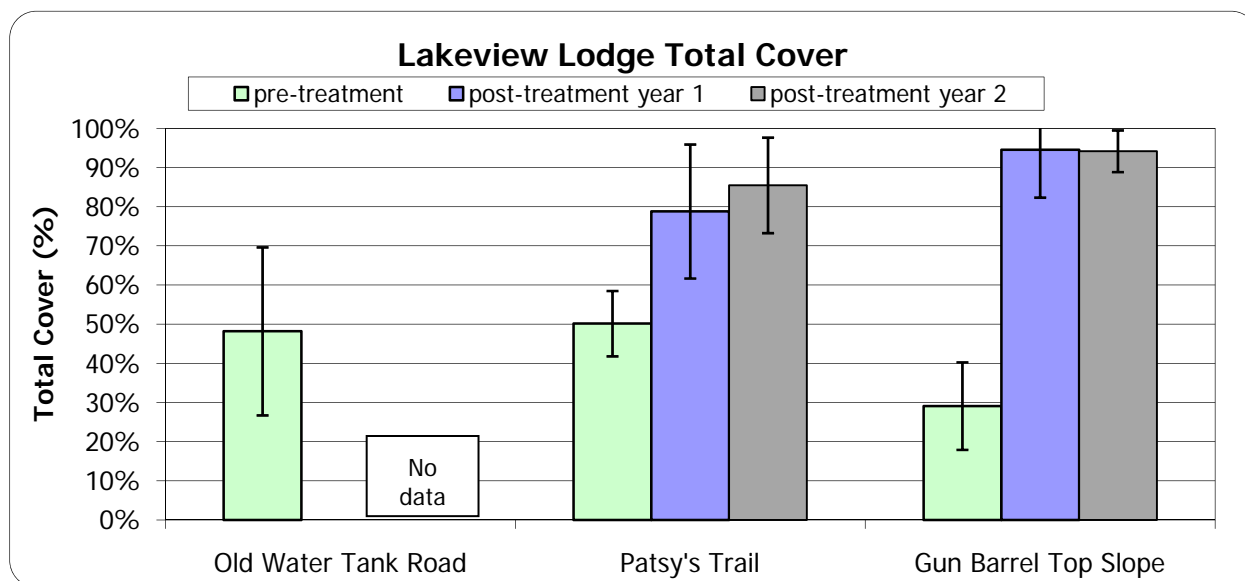
In 2007, the pre-treatment total cover at the old water tank road was 48% (Figure 129). The total cover consisted of 11% cover by mulch and 36% cover by gravel/rocks. In 2009, the year 1 post-treatment total cover at Patsy's Trail (79%) was 58% higher than the pre-treatment total cover in 2007 (50%). The mulch cover, which increased from 33% to 76%, accounted for most of the gain in total cover. In 2009, the year 1 post-treatment total cover at the Gun Barrel top slope (95%) was 228% higher than the pre-treatment total cover in 2007 (29%). The mulch cover increased from 24% to 95% post-treatment. The success criterion, which states that the total cover must be greater than 70%, was met for both plots.

In 2010, the year 2 post-treatment cover was 85% at Patsy's trail and 94% at the Gun Barrel top slope. The success criterion, which states that the total cover must be greater than 70%, was met for both plots.

Figure 129. Lakeview Lodge Total Cover. Post-treatment measurements were not taken at the old water tank road. The error bars denote one standard deviation above and below the mean. Pre-treatment measurements were conducted in 2008, while post-treatment measurements were conducted in 2009 and 2010. Post-treatment data collection for the old water tank road is planned for 2012.

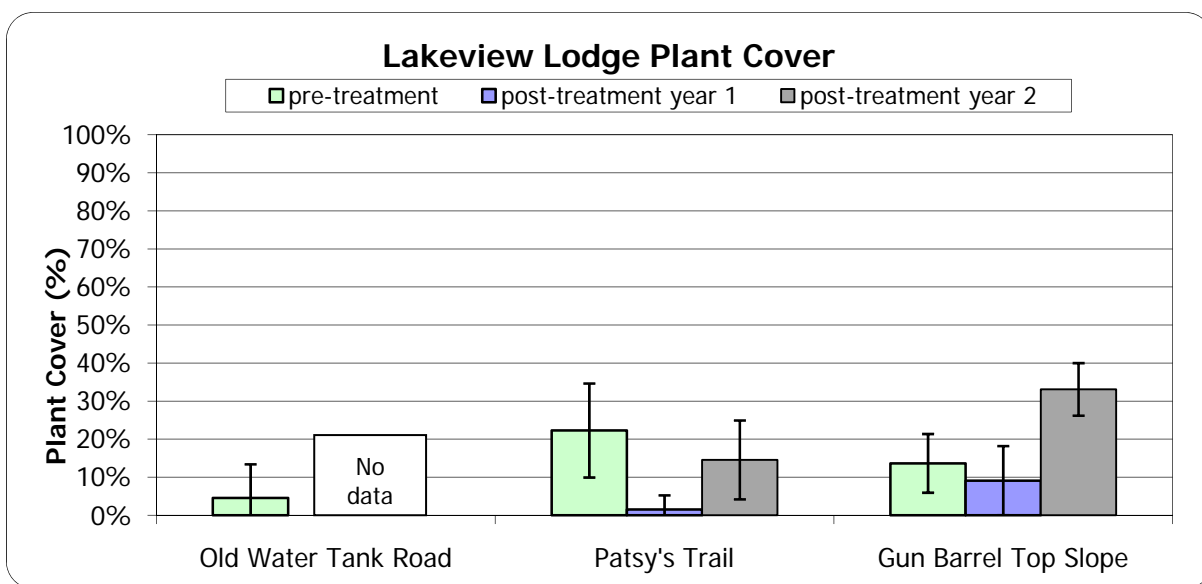
In 2008, the pre-treatment plant cover was 5% at the old water tank road (Figure 130). In 2009, the year 1 post-treatment plant cover at Patsy's Trail (2%) was 91% lower than the pre-treatment plant cover in 2007 (22%). In 2009, the year 1 post-treatment plant cover at the Gun Barrel top slope (9%) was 36% lower than the pre-treatment plant cover in 2008 (14%). The success criterion, which states the post-treatment plant cover must be at least 10%, was not met for either plot.

In 2010, the year 2 post-treatment plant cover at Patsy's Trail was 15% while it was 33% at the Gun Barrel top slope. The success criterion, which states the post-treatment plant cover must be at least 10%, was met for both plots.

Figure 130. Lakeview Lodge Plant Cover. The error bars denote one standard deviation above and below the mean. Pre-treatment measurements were conducted in 2008, while post-treatment measurements were conducted in 2009 and 2010. Post-treatment data collection for the old water tank road is planned for 2012.

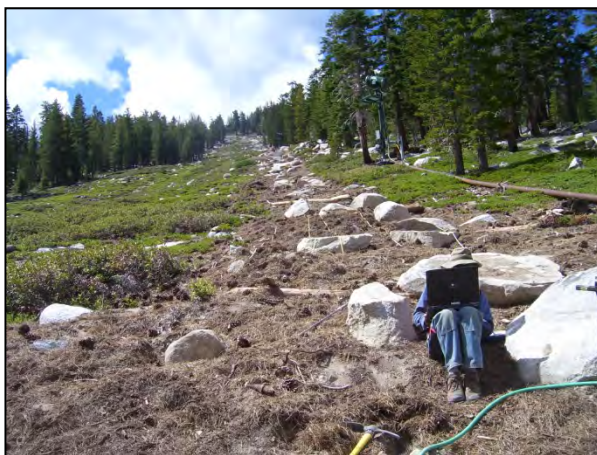
Figure 141. Stagecoach snowmaking, treatment area B, August 2010.

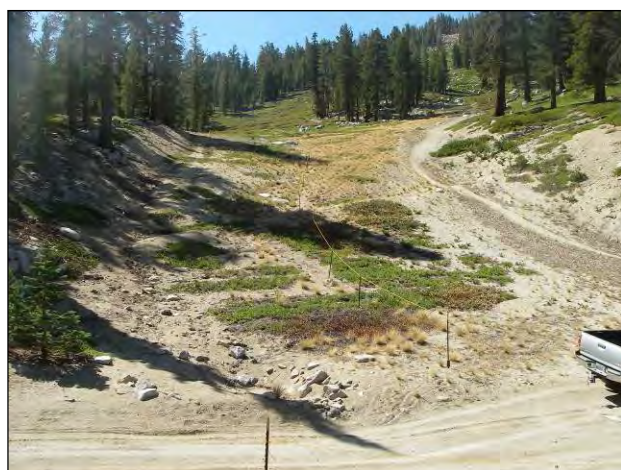
Figure 142. Stagecoach snowmaking, treatment area C, pre-treatment, August 2008

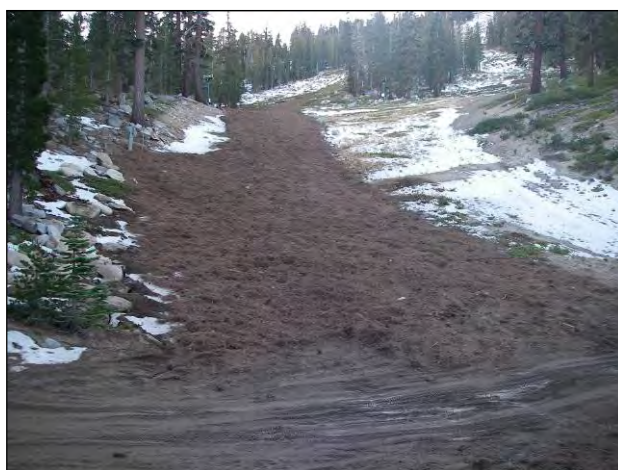
Figure 143. Stagecoach snowmaking, treatment area C, post-treatment, November 2008.

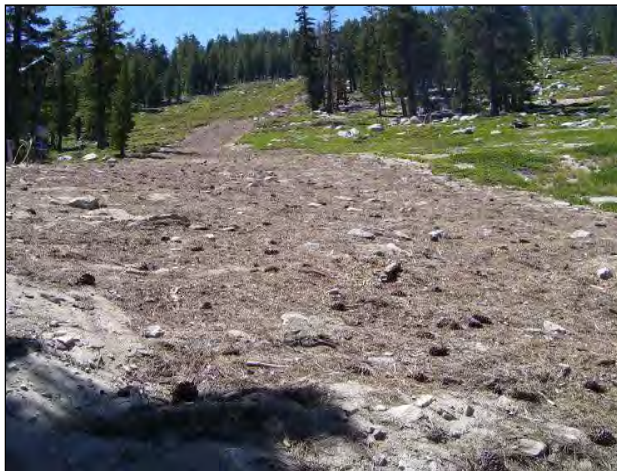
Figure 144. Stagecoach snowmaking, treatment area C, post-treatment, August 2009.

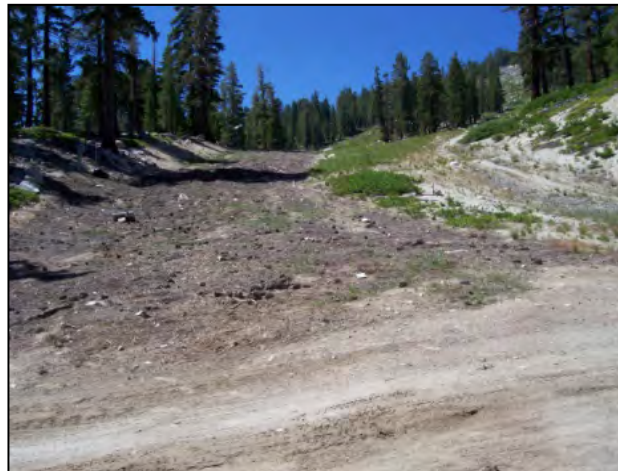
Figure 145. Stagecoach snowmaking, treatment area C, post-treatment, August 2010.

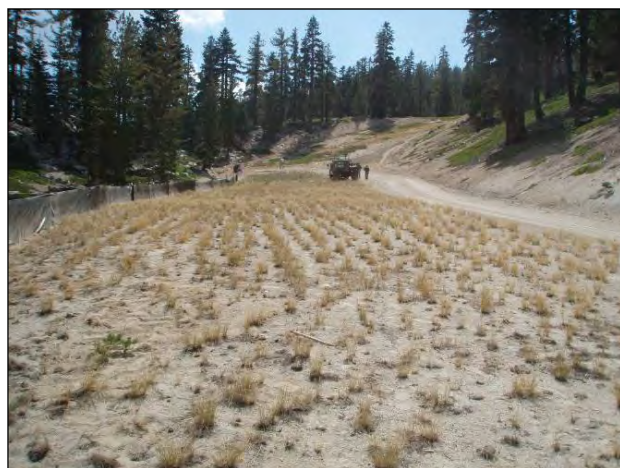
Figure 146. Stagecoach snowmaking, treatment area C (roadside), pre-treatment, August 2008

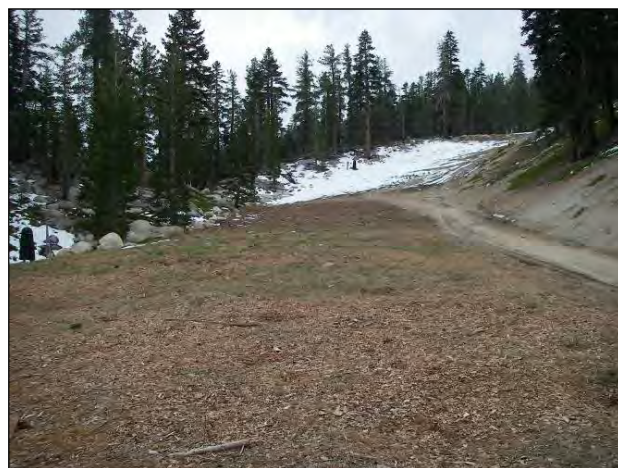
Figure 147. Stagecoach snowmaking, treatment area C (roadside), post-treatment, October 2009.

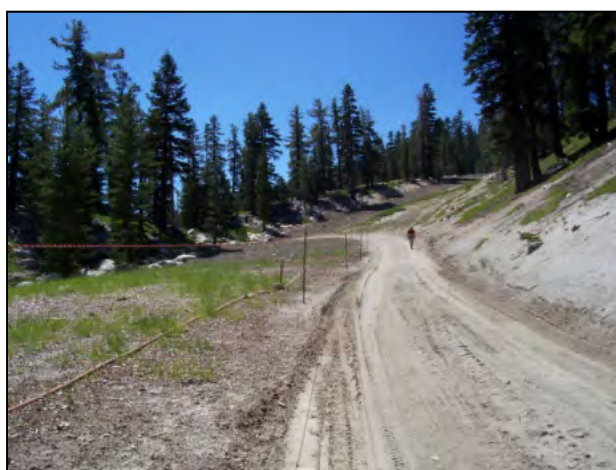
Figure 148. Stagecoach snowmaking, treatment area C (roadside), pre-treatment, August 2010.

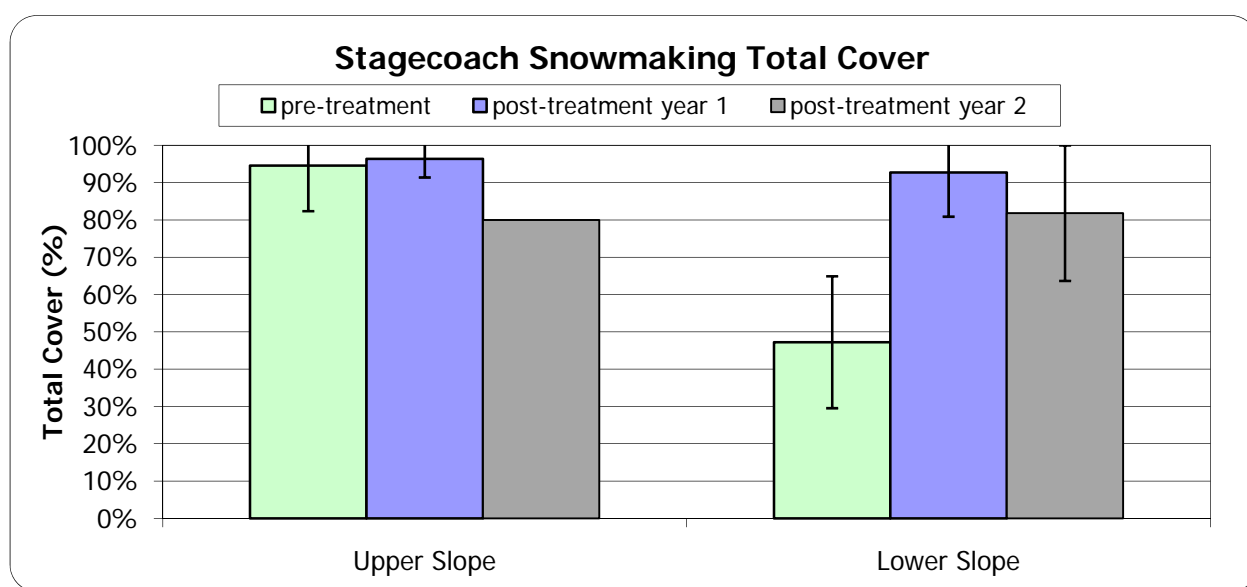
In 2009, the year 1 post-treatment total cover at the Stagecoach upper slope (96%) was similar to the pre-treatment total cover in 2008 (95%; Figure 149). The 2009 year 1 post-treatment total cover at the Stagecoach lower slope (93%) was nearly double the pre-treatment total cover in 2008 (47%). The 2010 year 2 post-treatment total cover was 82% at the lower slope and 80% at the upper slope (ocularly estimated). The success criterion, which states that the post-treatment total cover must be greater than 70% post-treatment, was met for both plots in 2009 and 2010.

Figure 149. Stagecoach Snowmaking Total Cover. Error bars denote one standard deviation above and below the mean. Pre-treatment data was collected in 2008 and post-treatment data was collected in 2009 and 2010. The upper slope post-treatment year 2 data was ocularly estimated.

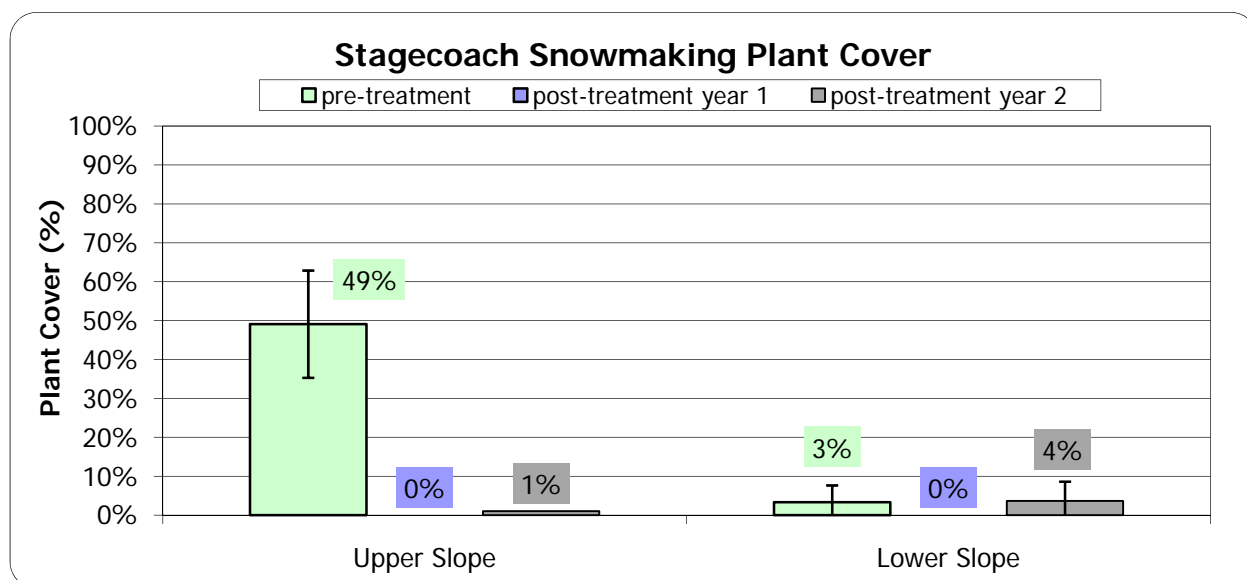
In 2009, the year 1 plant cover at the Stagecoach upper slope decreased from 49% pre-treatment (2008) to zero post-treatment (Figure 150). The plant cover at the Stagecoach lower slope decreased from 3% to zero in year 1 post-treatment. In 2010, the Stagecoach lower slope year 2 plant cover was 4% and the upper slope year 2 plant cover was 1% (ocularly estimated). The success criterion, which states that the post-treatment plant must be 10% or greater, was not met for either plot in either 2009 or 2010.

Figure 150. Stagecoach Snowmaking Plant Cover. The error bars denote one standard deviation above and below the mean. Pre-treatment data was collected in 2008 and post-treatment data was collected in 2009 and 2010. The plant cover data in 2010 was collected on transects for the lower slope and was ocularly estimated for the upper slope.

In 2010, the plant cover success criterion was not met for either plot. Additionally, at the Stagecoach lower slope, penetrometer monitoring (triggered by unmet success criteria in 2009) confirmed that there is a large area of compacted soil that does not meet the penetrometer (soil compaction) success criterion. Two alternative treatment approaches are presented in Table 32 to achieve the plant cover success criterion for the upper slope treatment area. However, alternative 1 is recommended for the lower 10-30 meters of the lower slope treatment area because soil loosening is required to meet the penetrometer success criterion. Alternative 2 is less labor-intensive than alternative 1. If alternative 2 is implemented at the upper slope or the upper part of the lower slope, the germination assessment after 1 month will indicate whether the low-effort seeding technique was successful, as plants will have germinated in this timeframe. If seed germination is not sufficient one month after implementation of alternative 2, the site will need to be re-treated using alternative 1.

Unmet Criterion	Management Response	Follow-up Action
Upper Slope	Plant Cover	<p>Alternative 1: Remove mulch, apply fertilizer, apply seed, replace mulch then irrigate with low-flow heads (MP rotator or equivalent) for one season</p> <p>Alternative 2: Apply seed over mulch, then use spring rake to ensure soil-seed contact, then irrigate with low-flow heads (MP rotator or equivalent) for one season</p>	<ol style="list-style-type: none"> 1. Implementation monitoring during seeding, fertilizing, or mulching activities 2. Germination assessment after 1 month of irrigation 3. Visual erosion assessment

Unmet Criterion	Management Response	Follow-up Action
Lower Slope	Plant Cover	<p>Alternative 1 (necessary for compacted lower 10-30 meters and optional for the rest of the slope): Remove mulch, apply amendments, till amendments to 12", apply fertilizer, apply seed, replace mulch, then irrigate with low-flow heads (MP rotator or equivalent) for one season.</p> <p>Alternative 2: Apply seed over mulch, then use spring rake to ensure soil-seed contact then irrigate with low-flow heads (MP rotator or equivalent) for one season</p>	<ol style="list-style-type: none"> 1. Implementation monitoring during seeding, fertilizing, or mulching activities 2. Germination assessment after 1 month of irrigation 3. Visual erosion assessment
Lower Slope	Visual Erosion Assessment	<ol style="list-style-type: none"> 1. Assess road drainage patterns and treatment alternatives 2. Implement road drainage improvements such that water is collected/infiltrated without causing erosion 3. Remove sediment deposited in treatment areas 4. Place irrigation heads above connection point so drain-down leakage does not occur 	<ol style="list-style-type: none"> 1. Inspection of road drainage improvements during and after implementation 2. Visual erosion assessment after rain event (after road improvements are completed)

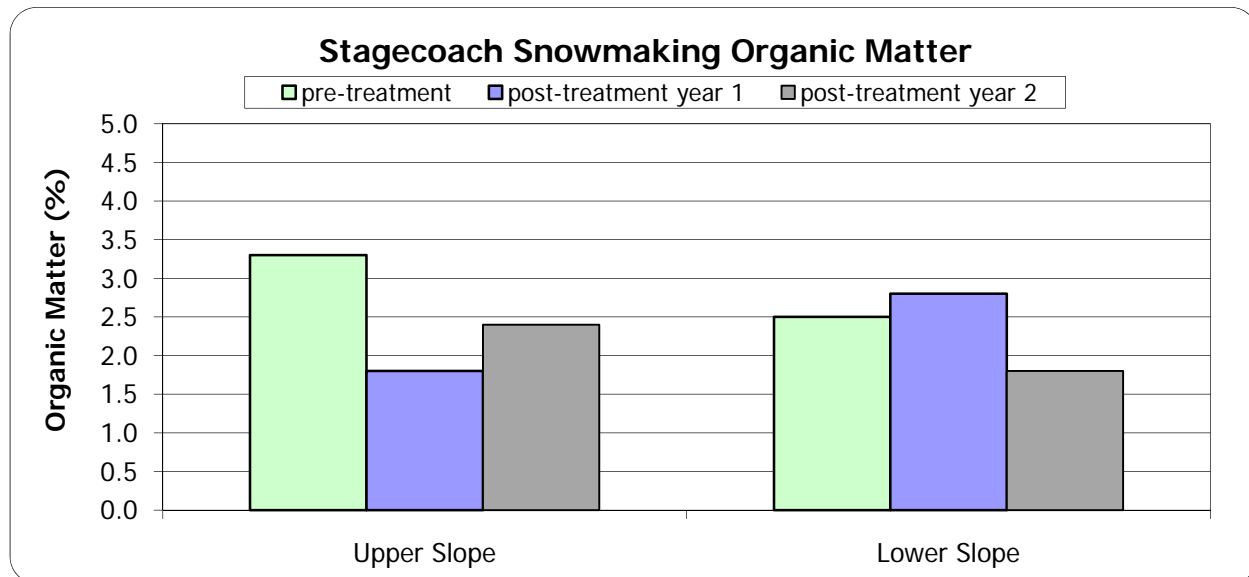
In 2009, the year 1 post-treatment organic matter content at the Stagecoach upper slope (1.8%) was 46% or 1.5 percentage points lower than the pre-treatment organic matter content in 2008 (3.3%; Figure 151). The 2009 year 1 post-treatment organic matter content at the Stagecoach lower slope (2.8%) was 12% higher than the pre-treatment organic matter content in 2008 (2.5%).

The success criterion, which states the post-treatment organic matter content must be no more than 1.5 percentage points lower than the pre-treatment organic matter content, was met for both the upper slope and the lower slope in both 2009 and 2010.

Figure 151. Stagecoach Organic Matter. Pre-treatment samples were collected in 2008 and post-treatment samples were collected in 2009 and 2010.

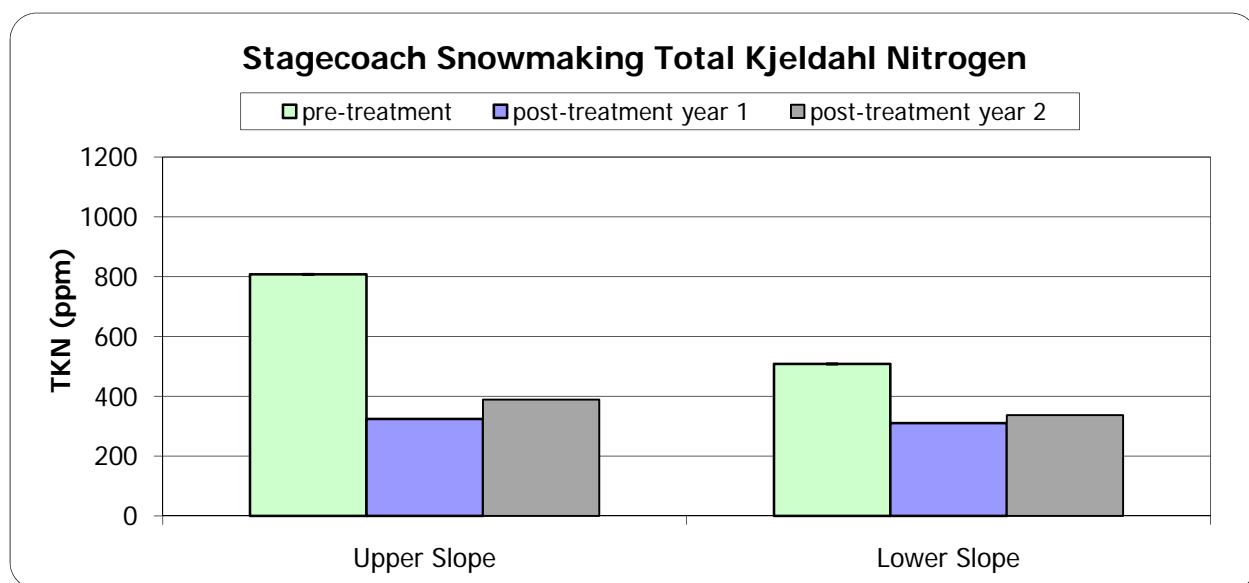
In 2009, the year 1 post-treatment TKN at the Stagecoach upper slope (324 ppm) was 60% or 484 ppm lower than the pre-treatment TKN in 2008 (808 ppm; Figure 152). The 2009 year 1 post-treatment TKN at the Stagecoach lower slope (310 ppm) was 39% or 198 ppm lower than the pre-treatment TKN in 2008 (508 ppm). In 2010, the year 2 post-treatment TKN was 389 ppm at the upper slope and 337 ppm at the lower slope. A success criterion for TKN was not used in 2009.

Figure 152. Stagecoach Snowmaking Total Kjeldahl Nitrogen (TKN). Pre-treatment samples were collected in 2008 and post-treatment samples were collected in 2009 and 2010.

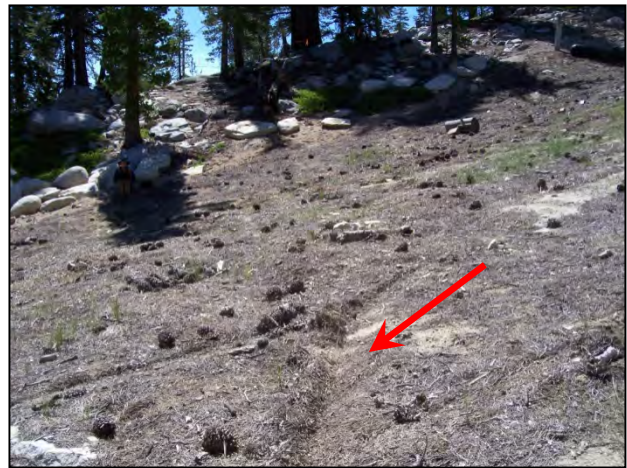
In 2010, at the upper slope, no major signs of erosion were present. However, at the lower slope, several areas of concern were documented. Tire tracks were observed going both across and up the slope (Figure 153 and Figure 154). Additionally, concentrated drainage from the road upslope of the lower treatment area caused rilling, gullying, and deposition in the lower treatment area (Figure 155, Figure 156, Figure 157 and Figure 158). The success criterion, which states that no visible signs of rills, gullies, sediment transport, or sediment deposition can be present, was met for the upper slope, but was not met for the lower slope in 2010. Concentrated drainage from roads has also caused erosion problems on several other restoration projects at Heavenly.

Figure 154. Stagecoach lower slope, August 2010. Red arrow points to tire tracks headed across the slope.

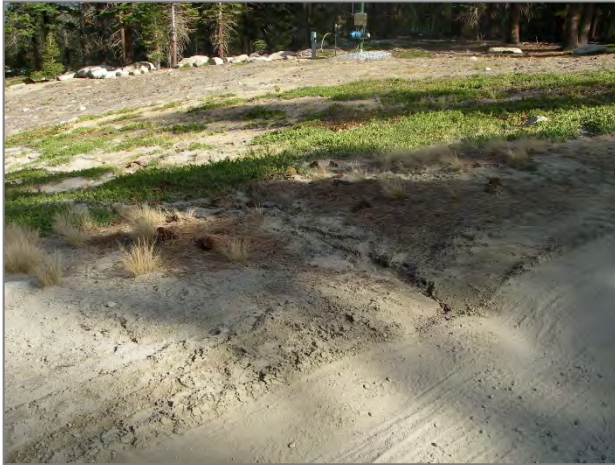
Figure 155. Concentrated road drainage causing erosion at the top of the Stagecoach lower slope, October 2010.

In 2010, the Stagecoach lower slope did not meet the visual erosion assessment success criterion as a result of concentrated runoff from the road upslope, which caused substantial erosion for 200-300 feet and deposited sediment on the treatment area. Road drainage patterns in this area should be fully assessed to generate treatment alternatives before implementing drainage improvements.

Continued observation of the area where the rills, gullies, and sedimentation occurred in 2009 and 2010 is necessary during and immediately after rain events, even after road repairs. The entire area should closely watch to ensure that the water flow assessment was correct and that the proper road repairs were conducted. It is recommended that Heavenly expand efforts to minimize disturbance of the lower slope plot by installing fencing and signage, particularly due to its close proximity to the Tahoe Rim Trail and its history of vehicle traffic.

Additionally, concentrated drainage from the road system has caused erosion issues on several projects (Olympic lift top, Lakeview Lodge Gun Barrel slope, and Stagecoach lower slope). Heavenly staff are constantly improving drainage on the roadway network throughout the resort. However, greater emphasis should be placed on evaluating and improving road drainage near recently completed restoration projects (i.e. not only at stream crossings). Areas of erosion caused by roadway drainage (Olympic lift top, Lakeview Lodge Gun Barrel slope, and Stagecoach lower slope) should be prioritized for BMPs and added to the 2011 summer maintenance work list.

- **Identify, assess and resolve road system drainage issues**, particularly those that are impacting recently treated areas. Nearly all erosion issues observed at restoration projects were related to concentrated run-on from roads upslope of treatment areas.
