Heavenly Mountain Resort Mitigation and Monitoring Plan Annual Report

October 2009 – October 2010

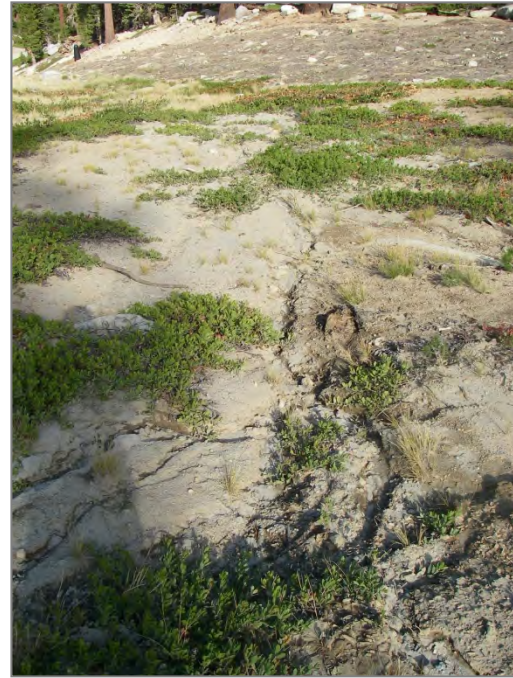
Figure 156. Rill from road drainage heading toward Stagecoach lower slope treatment area, August 2010.

In 2010, the Stagecoach lower slope did not meet the visual erosion assessment success criterion as a result of concentrated runoff from the road upslope, which caused substantial erosion for 200-300 feet and deposited sediment on the treatment area. Road drainage patterns in this area should be fully assessed to generate treatment alternatives before implementing drainage improvements.

Continued observation of the area where the rills, gullies, and sedimentation occurred in 2009 and 2010 is necessary during and immediately after rain events, even after road repairs. The entire area should closely watch to ensure that the water flow assessment was correct and that the proper road repairs were conducted. It is recommended that Heavenly expand efforts to minimize disturbance of the lower slope plot by installing fencing and signage, particularly due to its close proximity to the Tahoe Rim Trail and its history of vehicle traffic.

Additionally, concentrated drainage from the road system has caused erosion issues on several projects (Olympic lift top, Lakeview Lodge Gun Barrel slope, and Stagecoach lower slope). Heavenly staff are constantly improving drainage on the roadway network throughout the resort. However, greater emphasis should be placed on evaluating and improving road drainage near recently completed restoration projects (i.e. not only at stream crossings). Areas of erosion caused by roadway drainage (Olympic lift top, Lakeview Lodge Gun Barrel slope, and Stagecoach lower slope) should be prioritized for BMPs and added to the 2011 summer maintenance work list.

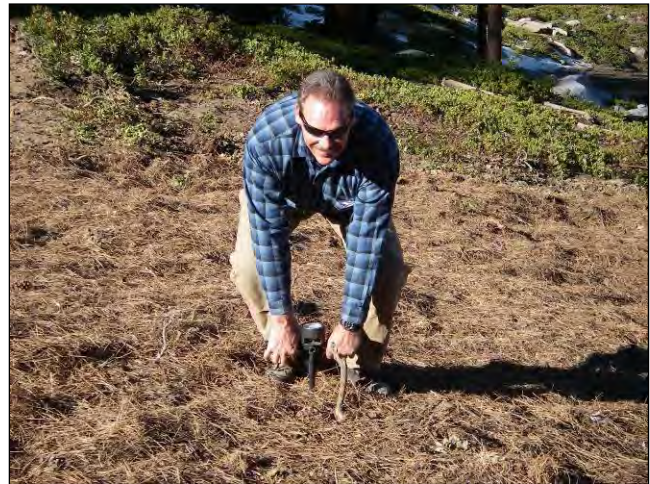
Figure 159. Jim Larmore measures tilling depth with a cone penetrometer.

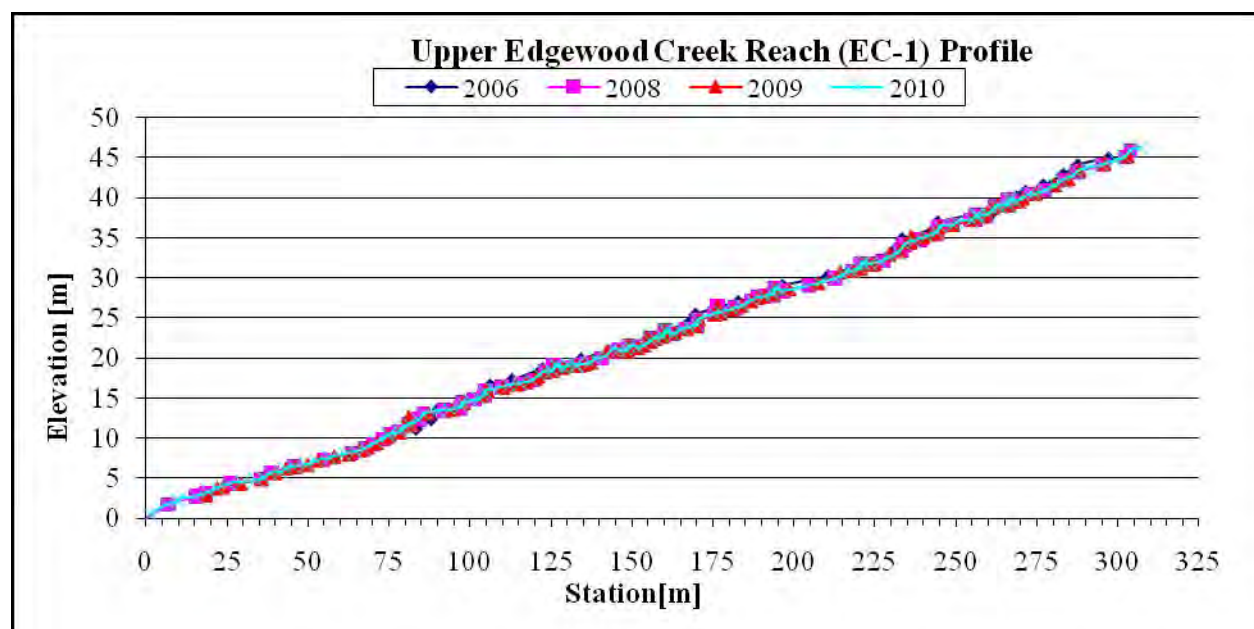
Figure 5-2 Upper Edgewood Creek Reach (EC-1) Profile

The EC-1 reach exhibits characteristics of an “Aa+” type channel using the Rosgen channel classification method (Rosgen 1996). It is very steep (14 percent), somewhat entrenched, and confined. The channel resembles a gully and has a step/pool morphology resulting from the large number of downed trees in the channel (Rosgen 1996). This classification has not changed since the 2006 monitoring of EC-1.

Established in 2006, the profile was taken along the entire reach length along the dry bed. Elevation and station measurements are graphed relative to the downstream end of the reach. The downstream end of the reach is point zero, zero. The profile of the Upper Edgewood Reach shows a fairly uniform slope throughout the surveyed reach.

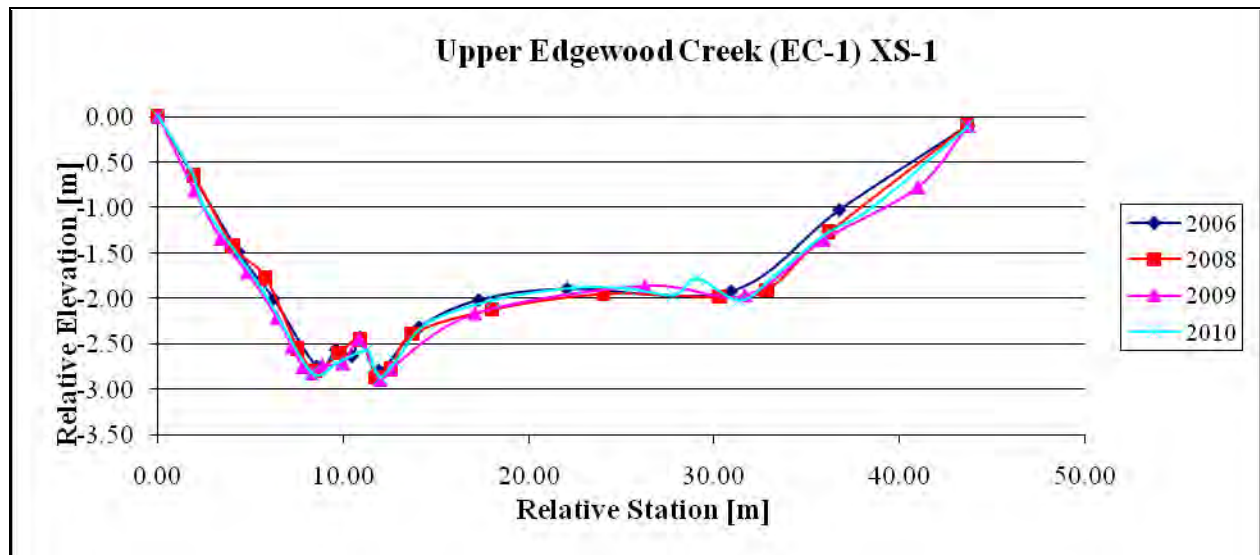
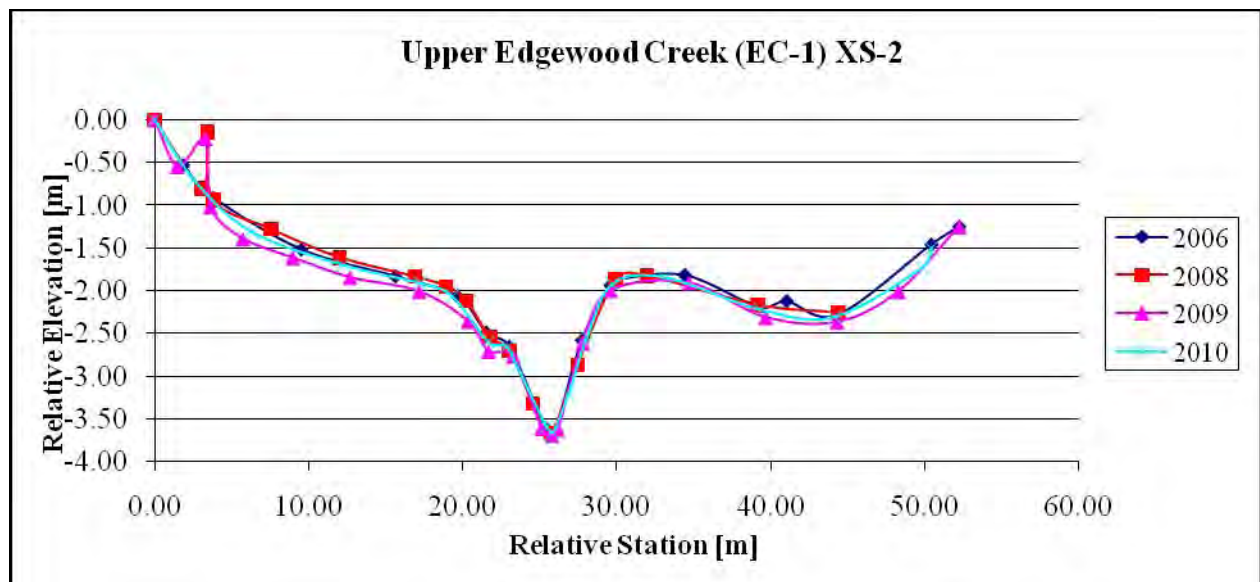
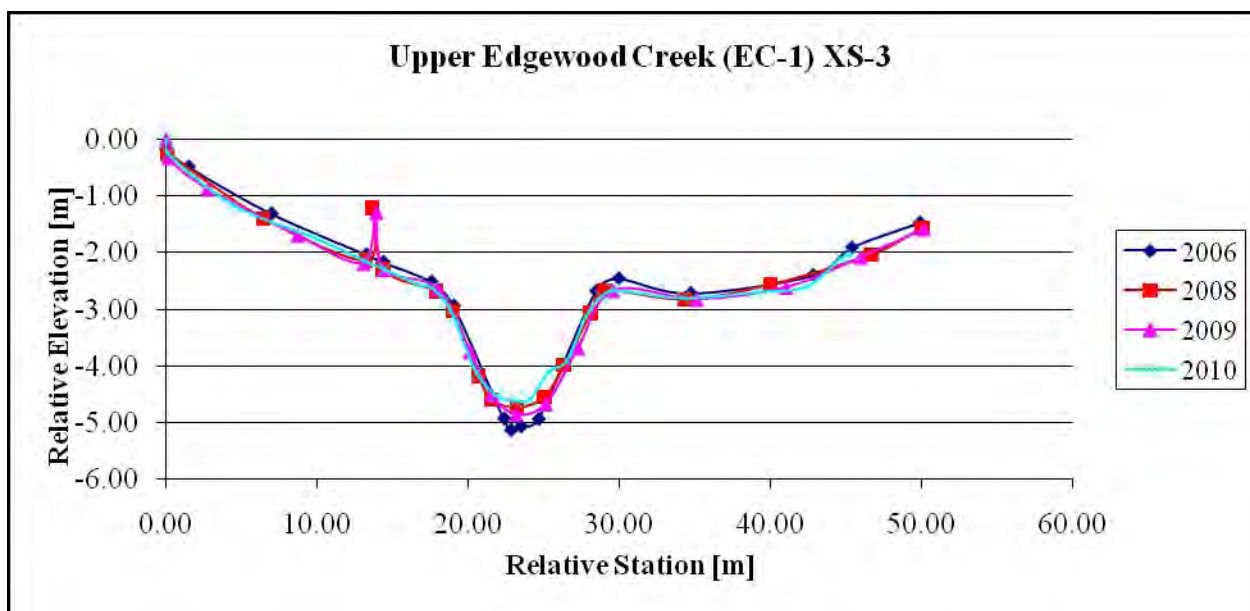
Figures 5-3a through 5-3c represent permanent cross-sections for reach EC-1, Upper Edgewood, along Edgewood Creek. Established in 2006, cross-sections XS-1, XS-2, and XS-3 are graphed from rebar monuments. Elevation and station measurements are graphed relative to the left bank (as viewed looking downstream) rebar stake. The top of the rebar stake on the left bank is the zero elevation, zero point (starting station). The graphical representation of these cross sections show very minute changes in the channel shape.

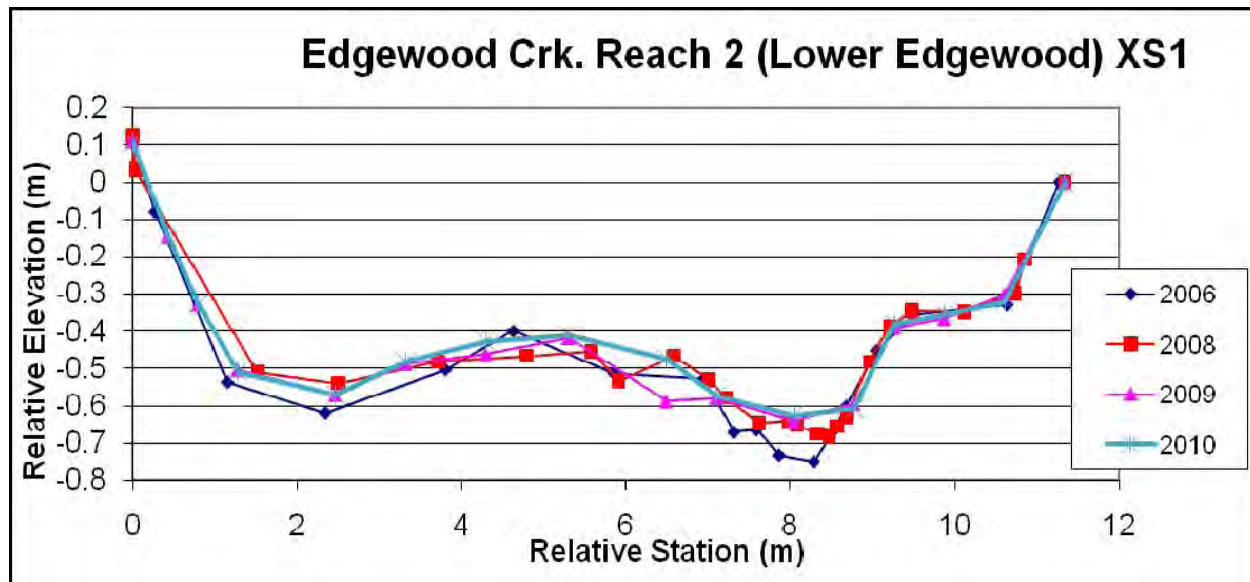
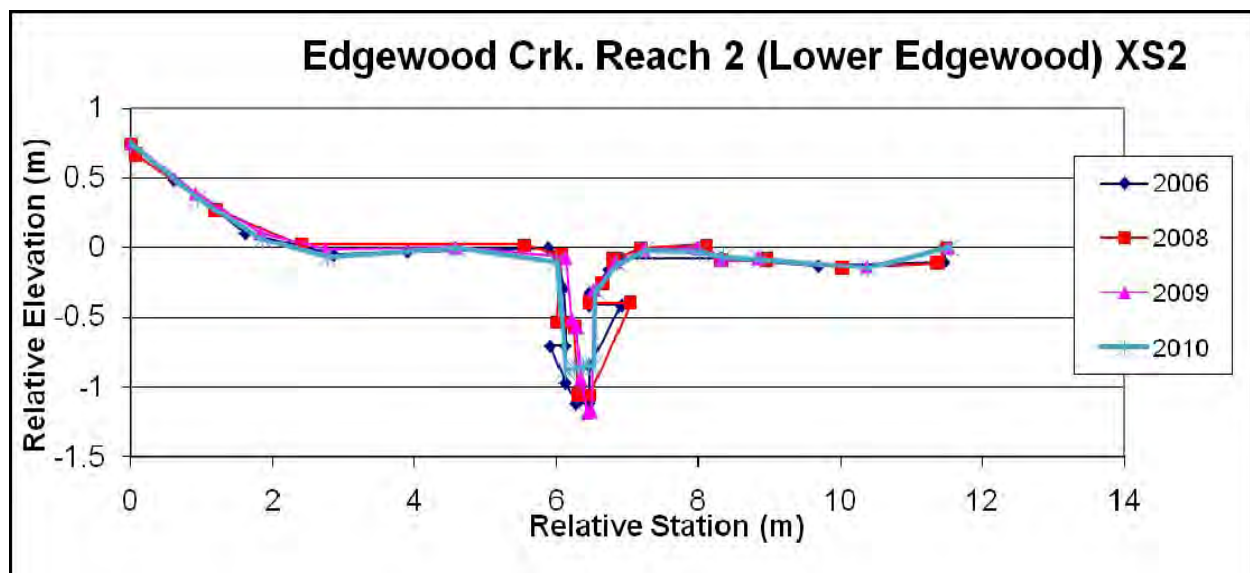
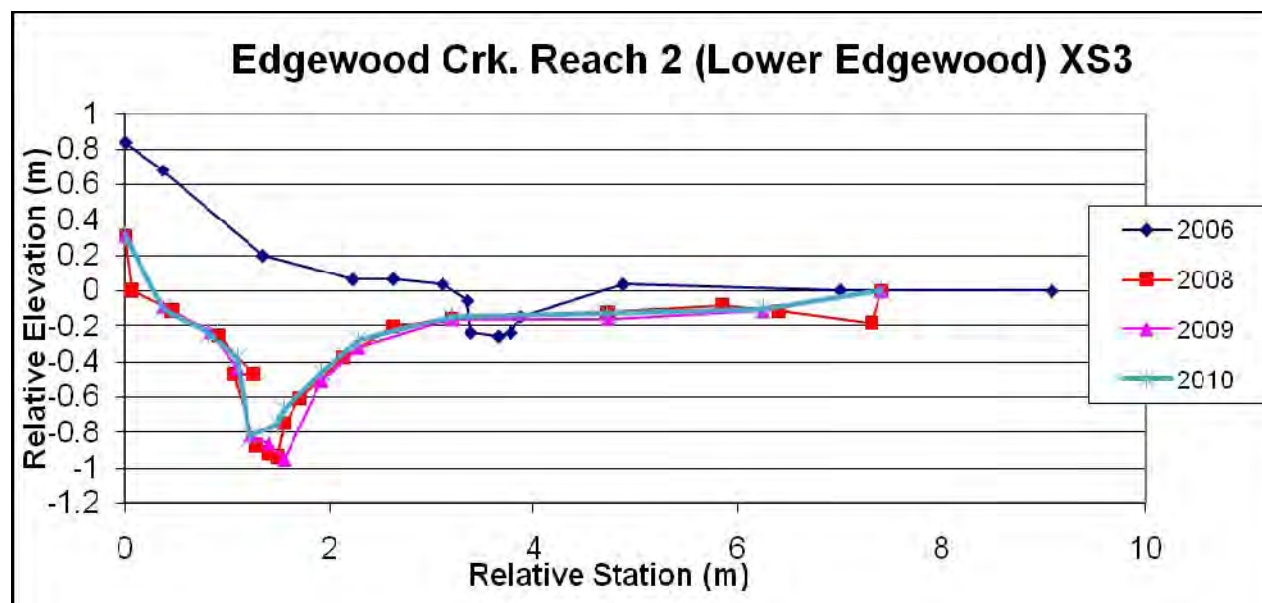
Permanent cross-sections XS-1 and XS-2 for Edgewood Creek's Lower Edgewood reach, EC-2, are graphed and presented in Figures 5-4a through 5-4c. The most upstream cross-section, XS-3, had to be relocated in 2008 due to restoration activities destroying the permanent monument. The new location is directly below the rock grade control structure constructed as part of the Lower Edgewood Restoration Project completed in 2007. The cross-sections for XS-3 are graphed and presented in Figure 5-4c. Lower Edgewood Creek's channel morphology is highly influenced by dense riparian vegetation that supplies a large amount of wood to the channel which creates complex channel morphology. The plot for cross-section XS-2 (Figure 5-4b) illustrates how banks along the reach are often undercut on both sides. Some of these undercuts are caused by large tree roots on the banks. All three cross sections show a decrease in the mean depth of the channel due to sediment deposition. Cross-section XS-3 (Figure 5-4c), new in 2008, has undercutting on its left bank as the result of a large root from a nearby mature aspen tree. This cross-section is located directly downstream of the last constructed plunge pool in the Lower Edgewood Restoration Project. Future years of data collection at this point will reveal the effects of the restoration upstream.

Figure 5-4c Permanent cross-sections for reach EC-2, Lower Edgewood, along Edgewood Creek, XS3. The cross-section location was moved in 2008, after a restoration project was completed in 2007.

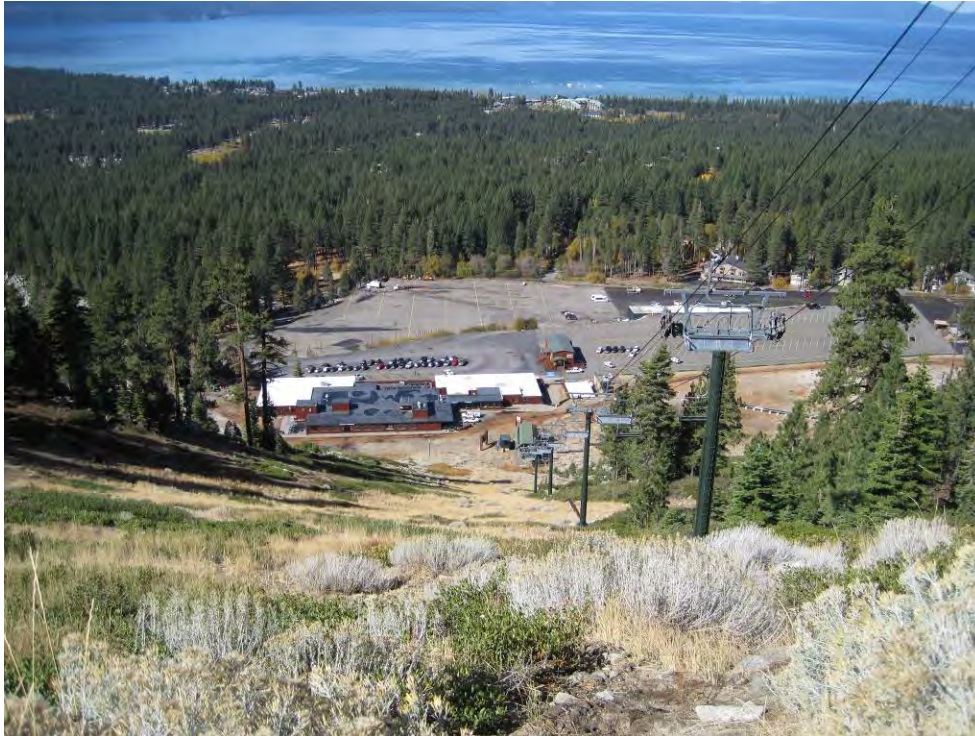
Gunbarrel Ski Run - looking west from top of slope (2009)

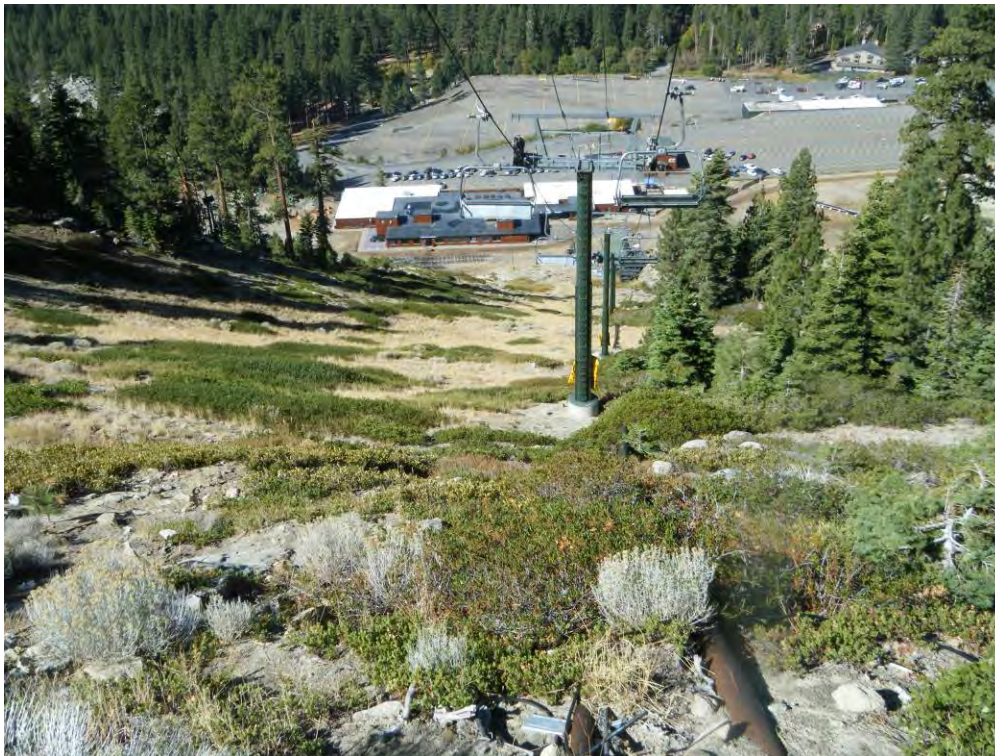
Gunbarrel Ski Run - looking west from top of slope (2010)

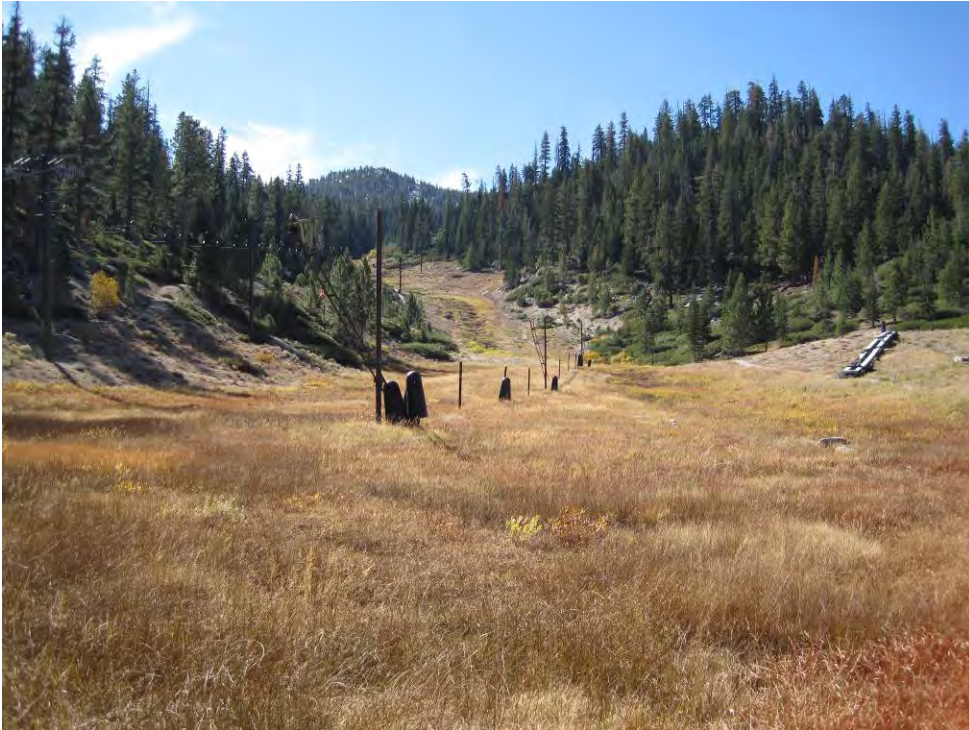
Edgewood Ski Run - looking upslope (2009)

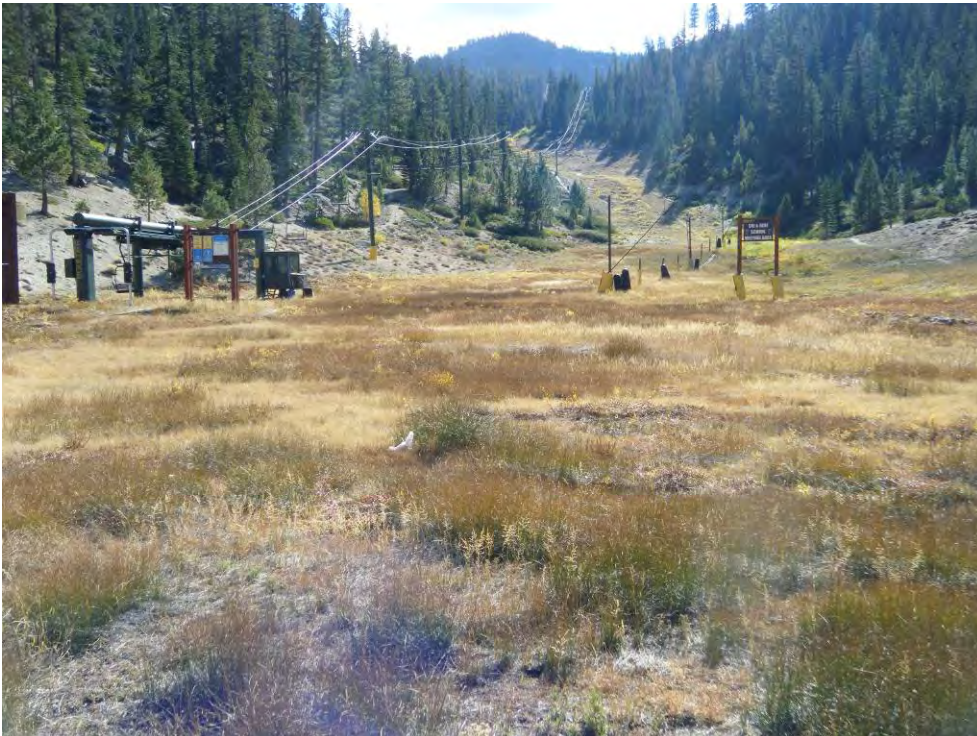
Edgewood Ski Run - looking upslope (2010)

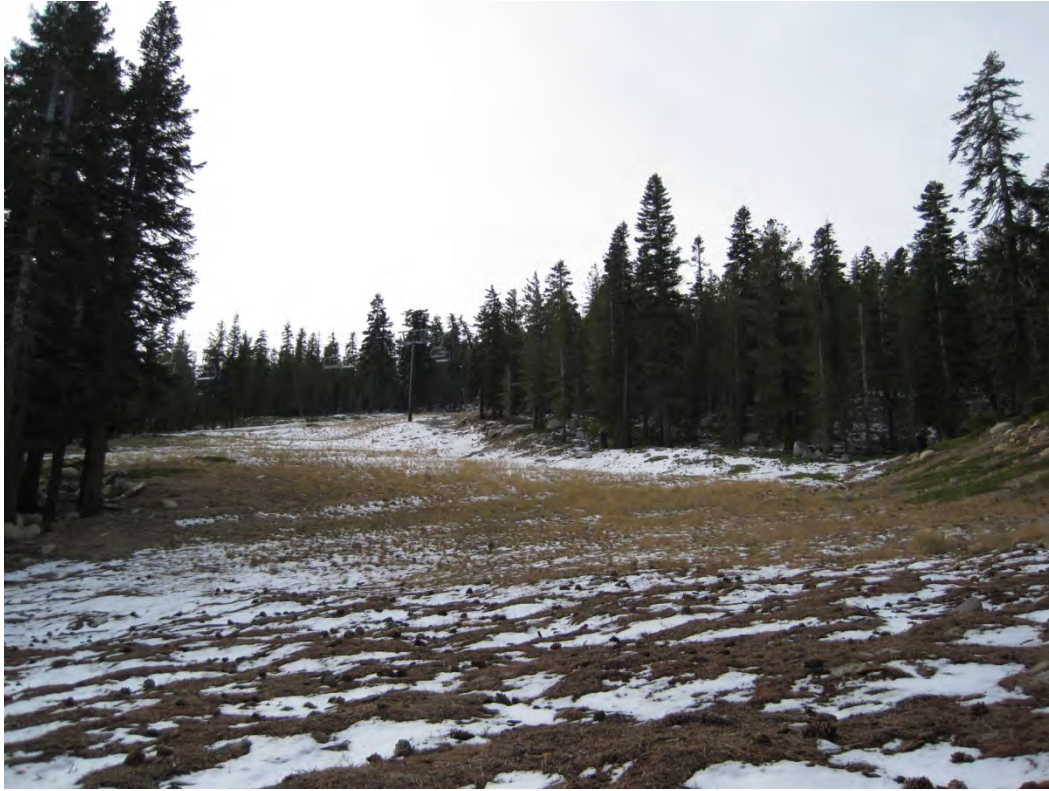
Lower Olympic Ski Run - looking upslope (2009)

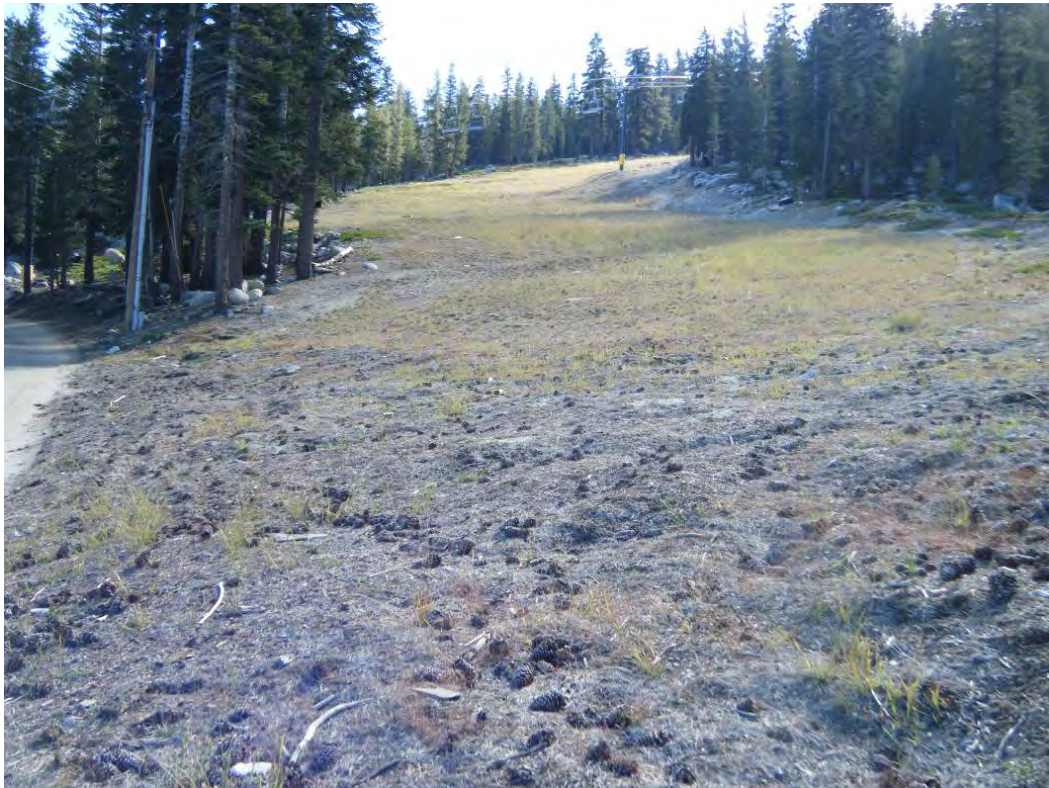
Lower Olympic Ski Run - looking upslope (2010)

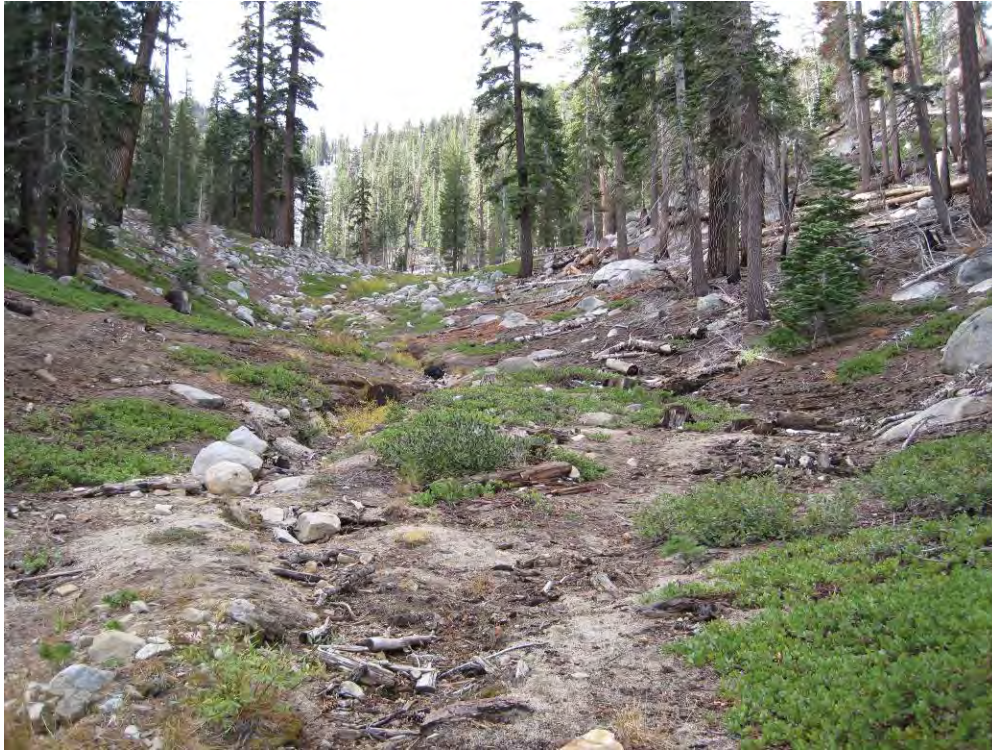
Boulder Chute - looking upslope to the southwest (2009)

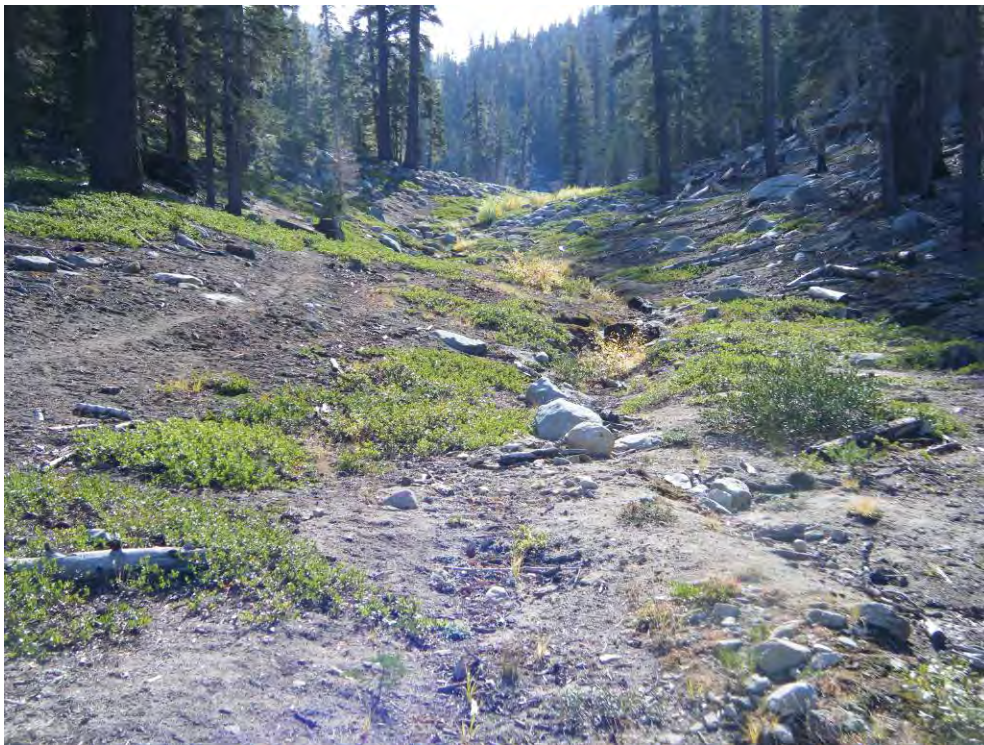
Boulder Chute - looking upslope to the southwest (2010)

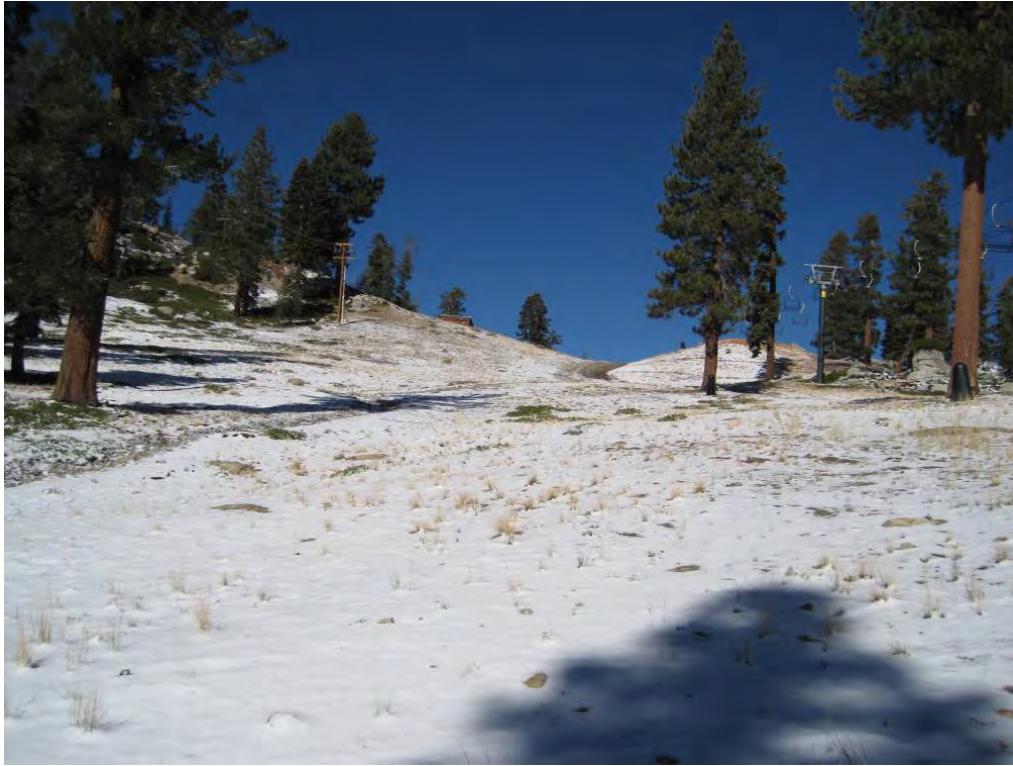
Groove Ski Run - looking upslope towards the northwest (2009)

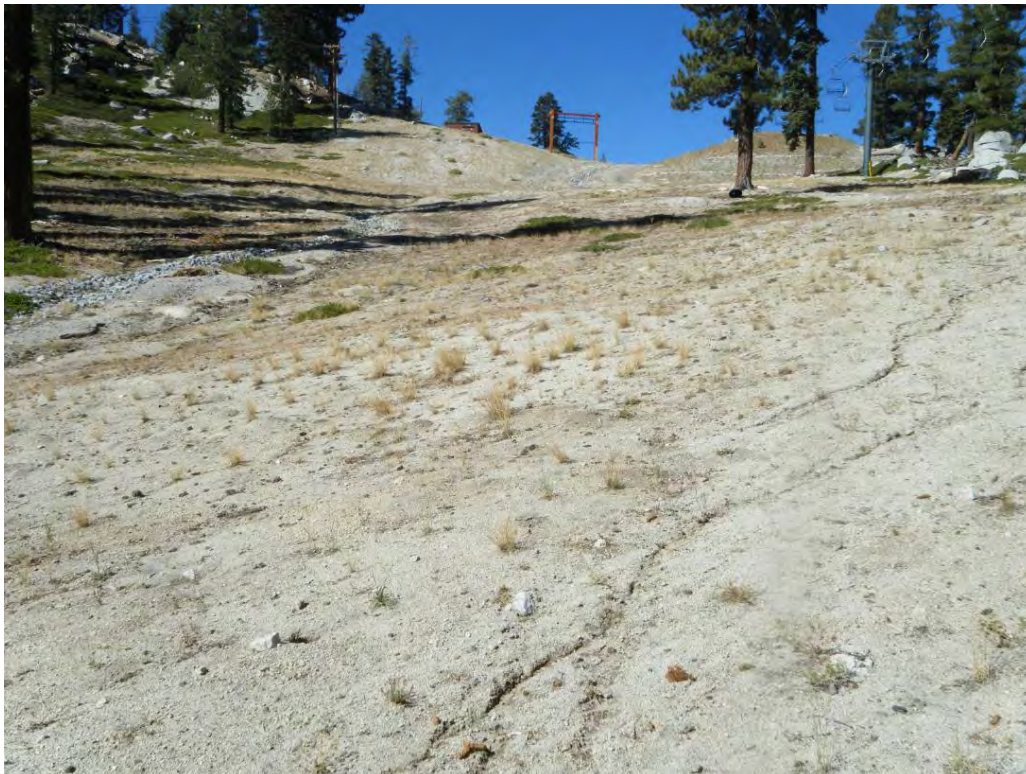
Groove Ski Run - looking upslope towards the northwest (2010)

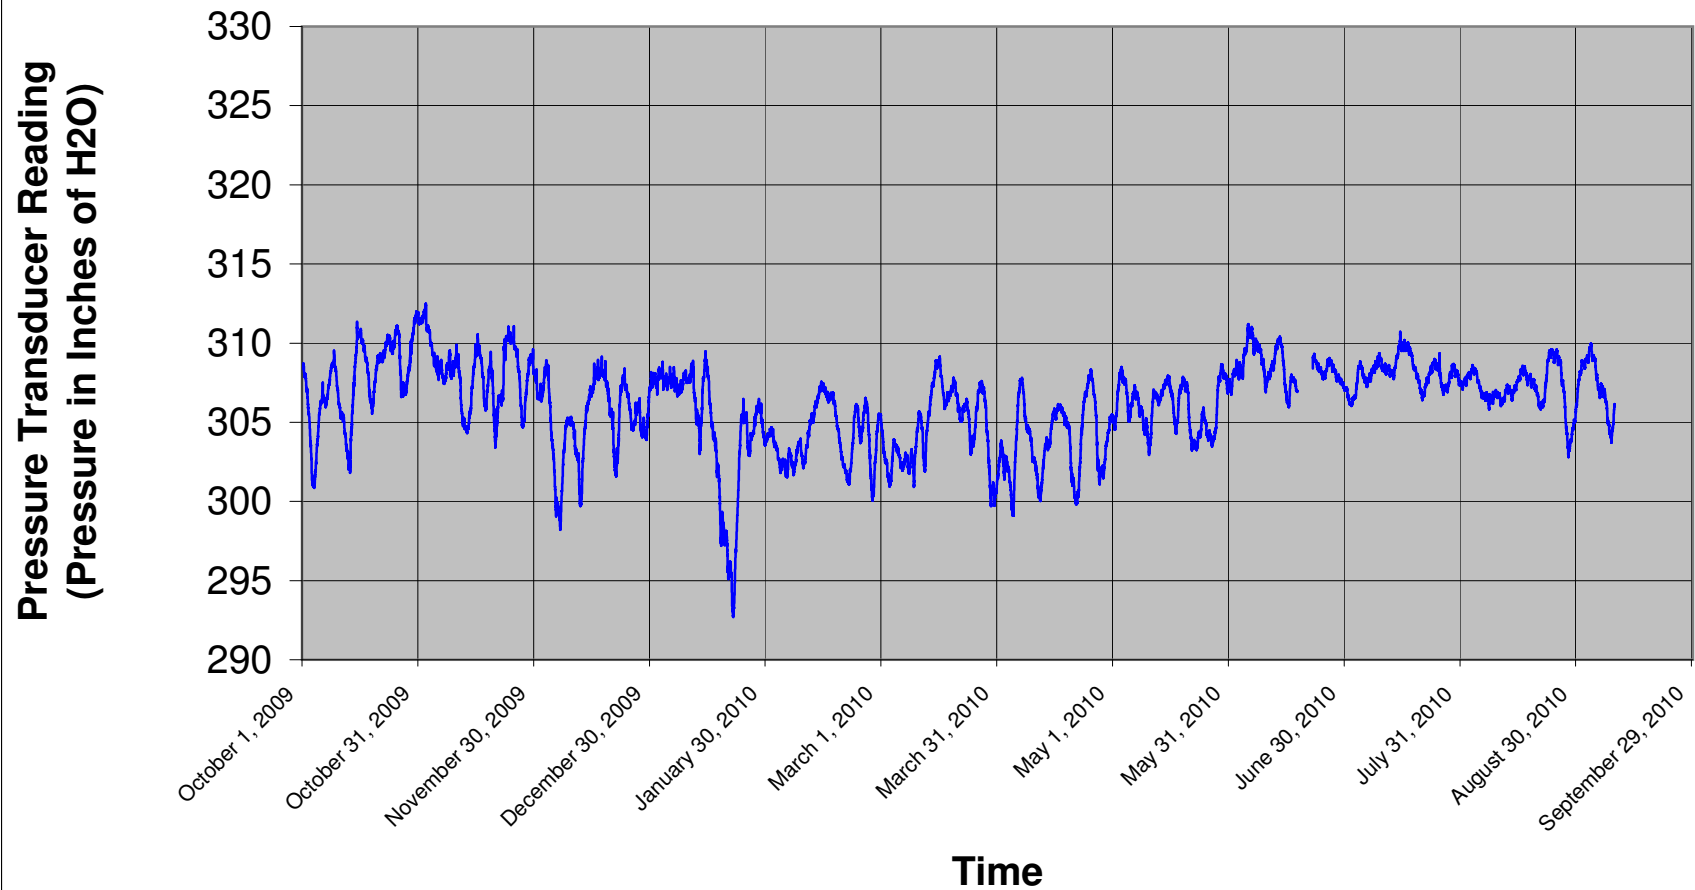
**Figure 1. Daggett Creek Transducer Readings
2010**

The gauge on Daggett Creek installed below East Peak Lake in 2004 consists of a pressure transducer mounted in a perforated pipe at a confined natural section of Daggett Creek. Resource Concepts, Inc. periodically downloads the data and maintains the gauge. Pressure data is collected continuously at 15-minute intervals. Data was downloaded from the gauge three times during the water year (on October 14, 2009, June 18, 2010 and September 10, 2010). Due to problems with the field laptop and connectors for the pressure transducer, there are two gaps in the 2010 water year data: June 18th through June 22nd, and September 9th through October 1st. We anticipate being able to retrieve the data from September 9th 2010 to the present once the gauge is accessible this spring (typically late May), and we can bring the equipment into the office to download the data. The attached Figure 1 graphs the pressure data collected.

If the Nevada Division of Water Resources concurs, RCI will recommend removal of the gauge. Alternative methods can be used to demonstrate compliance with water rights permits, thereby making the gauge unnecessary. If this is not acceptable to the State, the gauge may be able to be used for supplementary monitoring. If in-stream discharge measurements must be continued, a permanent cross section (flume or V-notch weir) and new pressure transducer may be required.

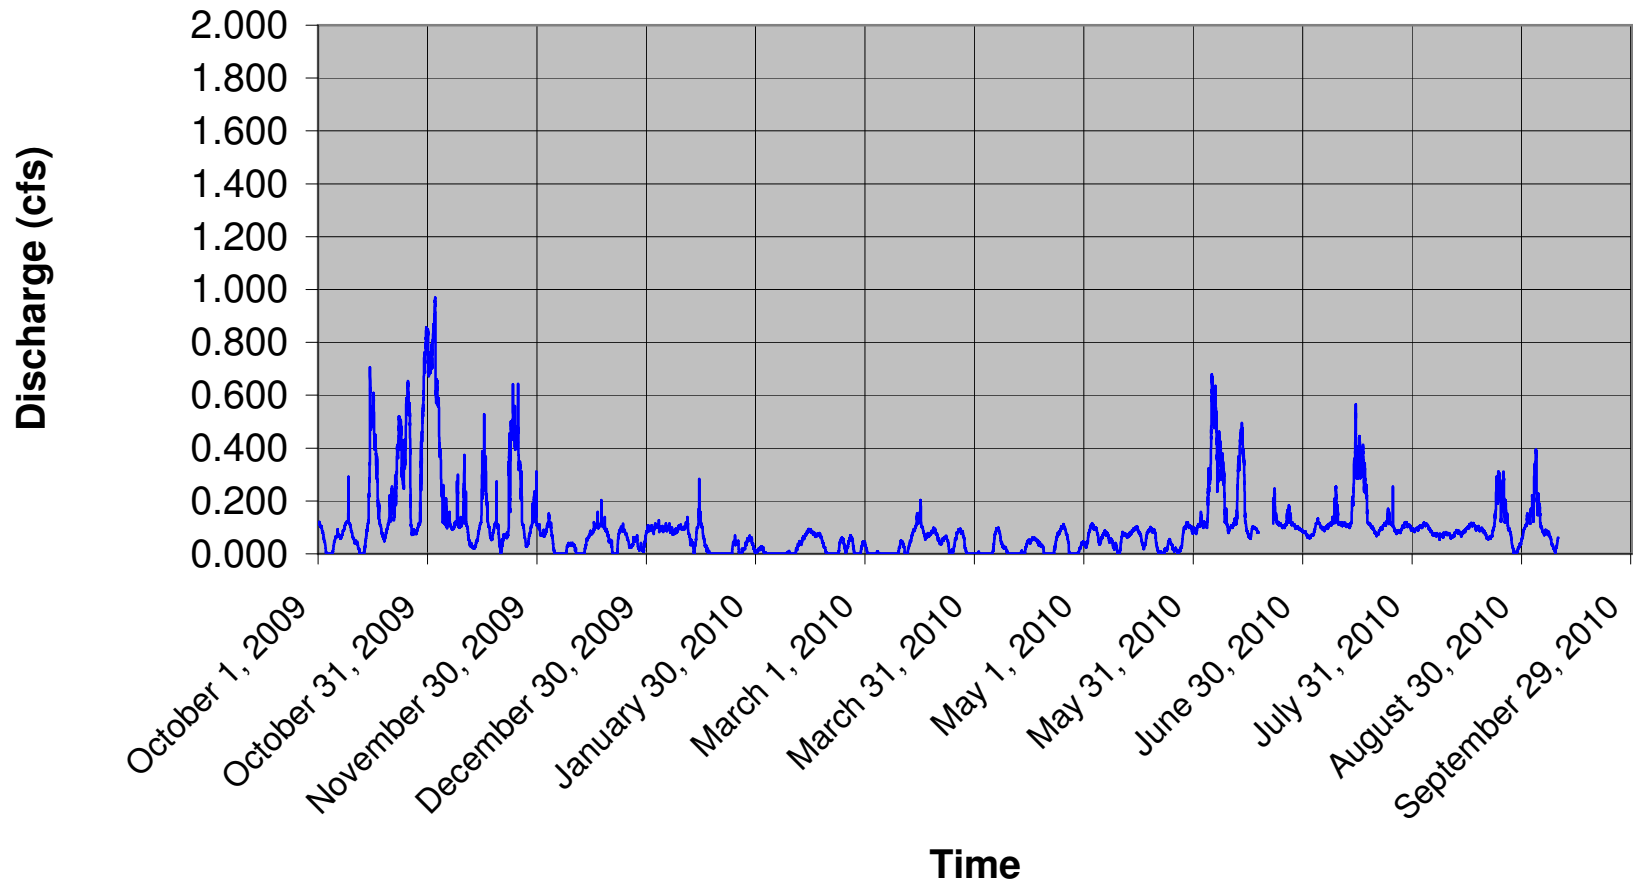
**Figure 2. Daggett Creek Estimated Discharge
2010**

RCI staff also makes stream discharge measurements when checking the gauge, in order to develop a relationship between pressure depth and stream discharge. Lower base flow is typically too shallow for a propeller type discharge meter, so a portable 60 degree v-notch weir is used to measure flow. For higher flows, we use a Swoffer (propeller type) flow meter to measure discharge. A rating curve has been developed from the in-stream measurements collected to estimate discharge from the pressure transducer/depth readings recorded by the gauge. This curve was adjusted in 2010 to take into account the most recent measurements collected in coordination with the Nevada Division of Water Resources. Figure 2 graphs the estimated discharge.
