Table 1. Heavenly Erosion Hot Spot Summary Matrix (Sky Basin Drainage Area – Upper CA-1 Watershed)

APPENDIX 3.1-G
MOTT CANYON (WATERSHED
NV-1) EROSION ASSESSMENT

MOTT CANYON (NV-1) EROSION ASSESSMENT

August 2014

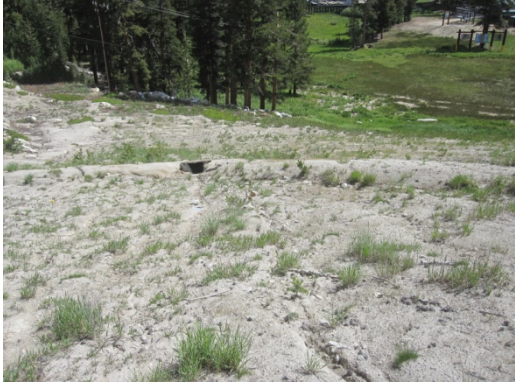
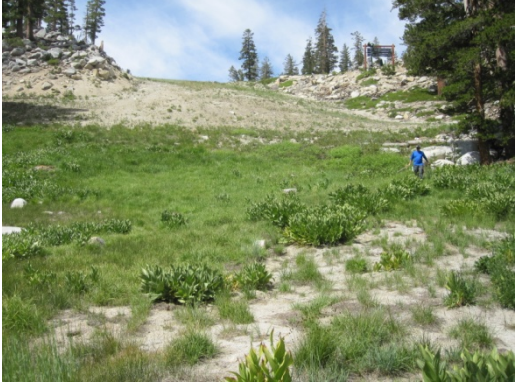
35	road	M	N	N	H	H	H	bare, compacted vehicle turnaround and access to Sky lift	maintain wood chip mulch cover on turnaround area near creek (~500sf)

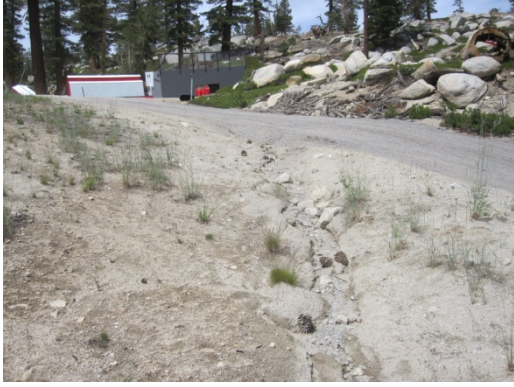
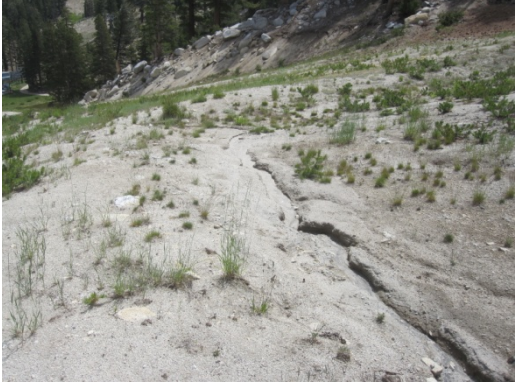
39	ephemeral drainage	H	Y	Y	L	H	L	large ephemeral drainage; lots of woody debris in flow line and moderate mulch cover in surrounding areas	no action recommended
40	water bar	H	Y	Y	L	M	L	many water bars on high roller ski run above and below summer road; many have failures where they have overtopped, causing erosion downslope	rehab water bars at failure points and convert into infiltration swales through soil loosening, wood chip incorporation (~10,000-15,000sf)
41	water bar	H	Y	Y	L	H	M	ski run (upper ridge run) with ~6 eroding water bars that direct runoff into large drainage that eventually outlets at the Canyon lift base and connects to Sky Meadow; many water bars have failures.	rehab water bars at failure points and convert into infiltration swales through soil loosening, wood chip incorporation (~10,000-15,000sf)

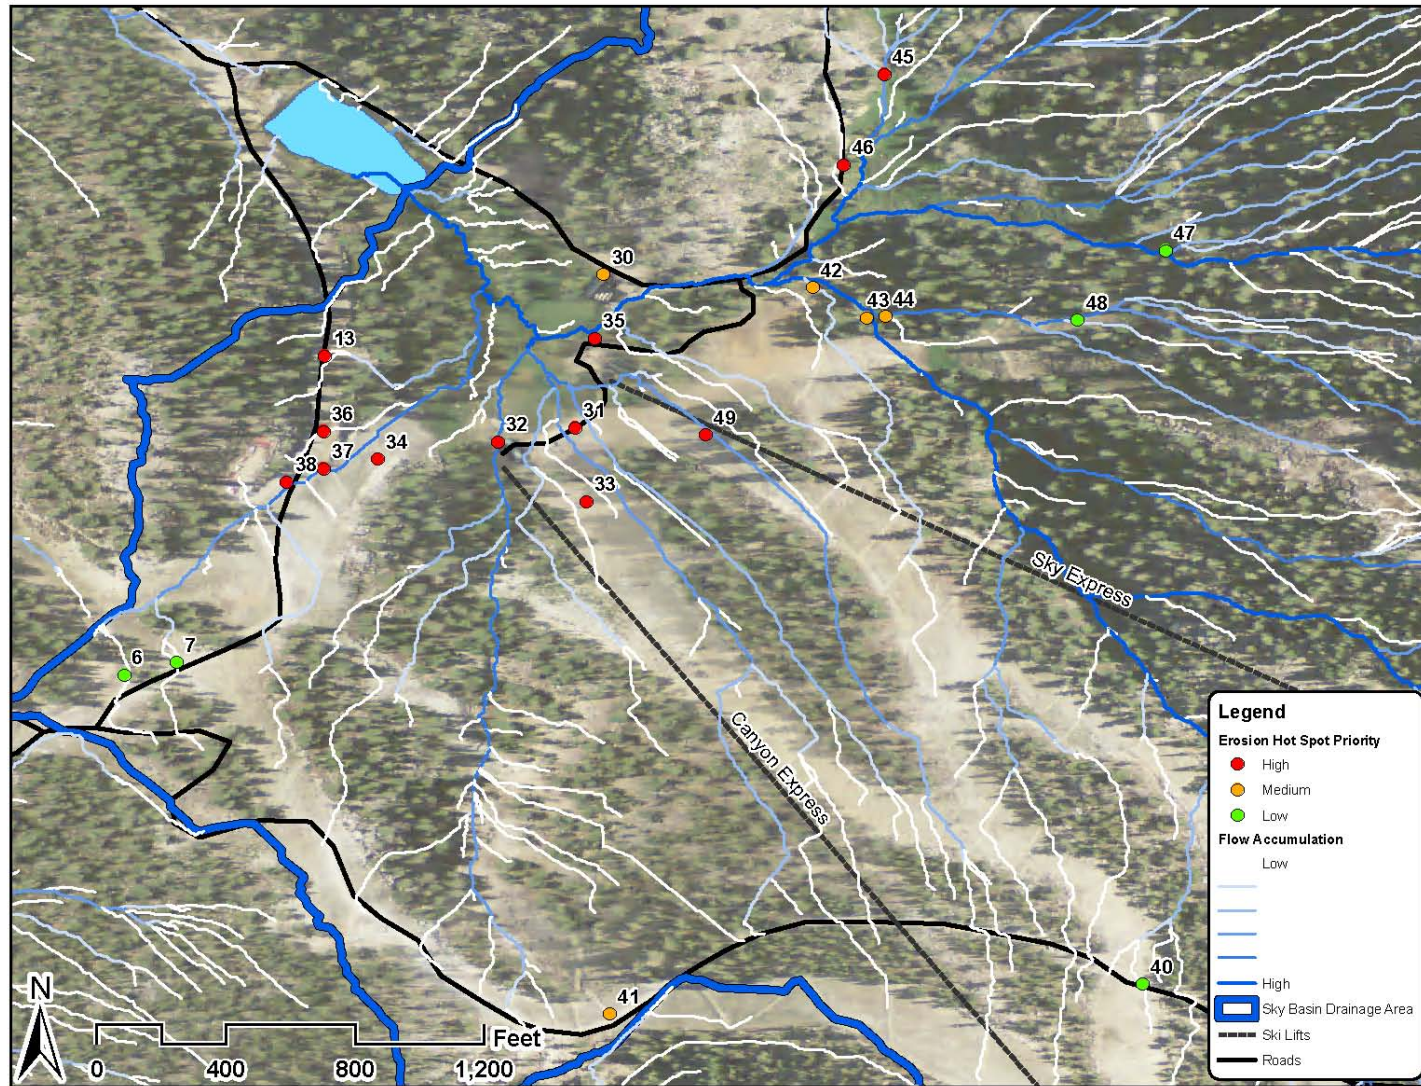
Figure 1. EfRA Summary Map showing hot spots in Sky Basin (CA-1).

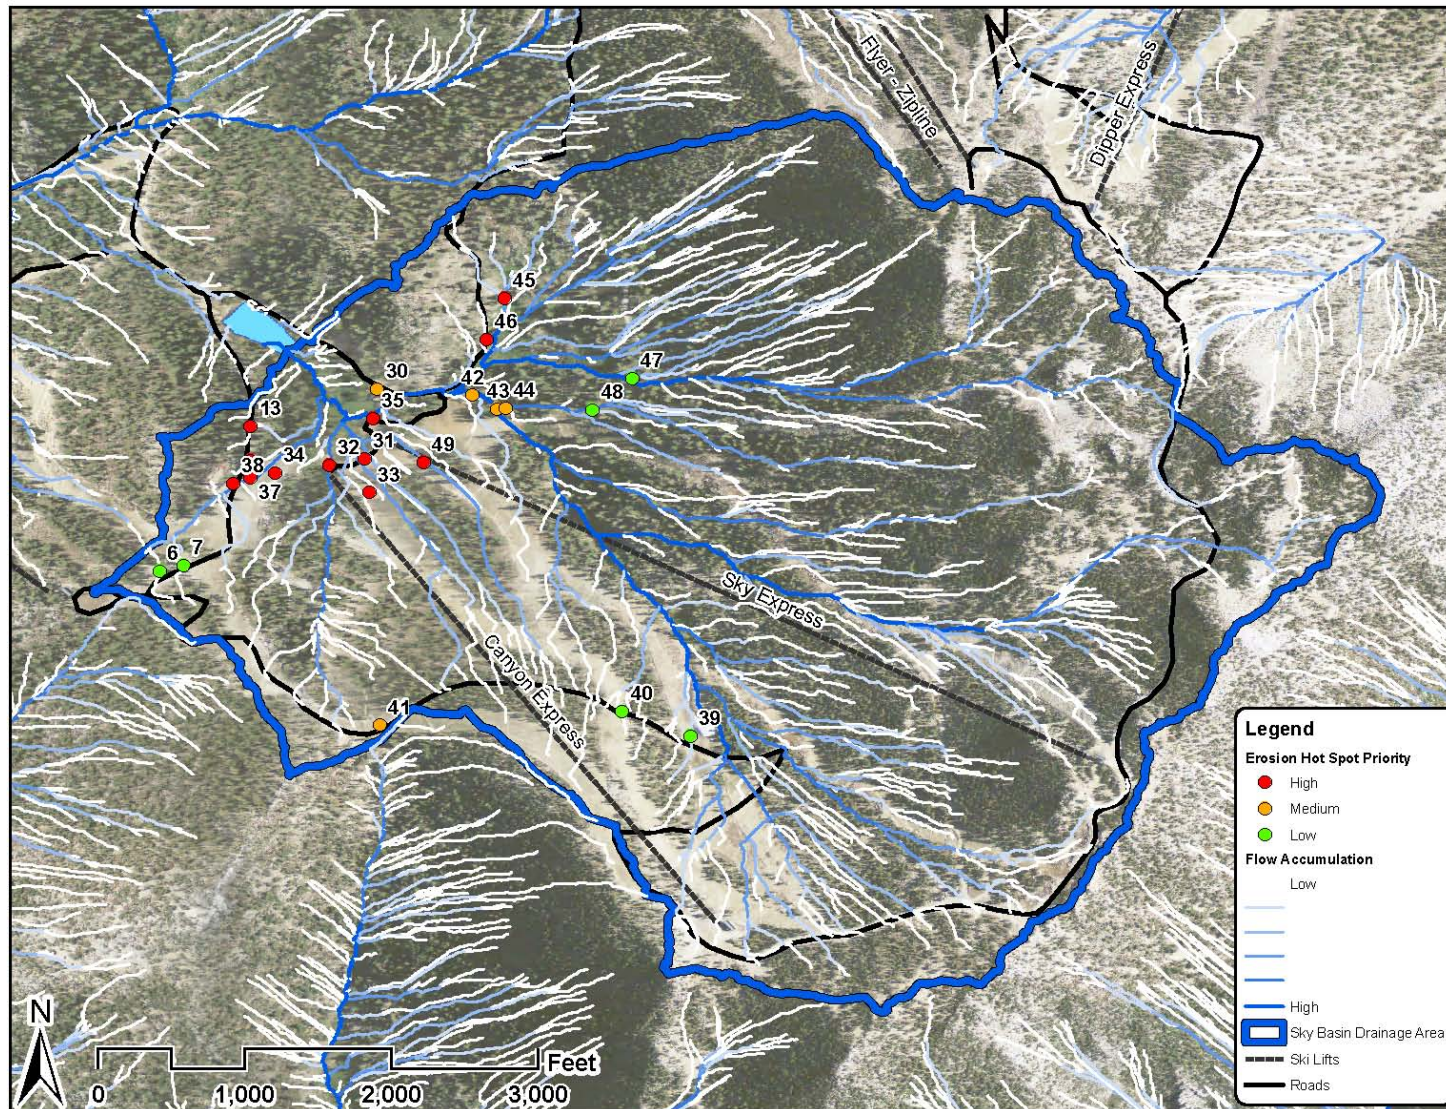
Figure 2. Summary Map showing hot spots in Sky Basin (CA-1), zoomed out to show entire Sky Basin drainage area.
