SKY BASIN (UPPER CA-1 WATERSHED) EROSION ASSESSMENT

Kevin Drake, CPESC

August 2014

MOTT CANYON (NV-1) EROSION ASSESSMENT

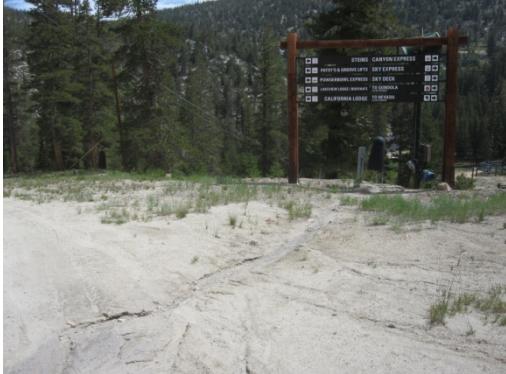
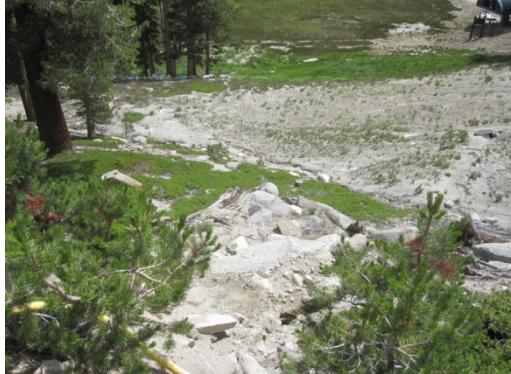
Hot Spot #	Type	Erosion Risk	Active Erosion	Active Deposition	Proximity to Stream/SEZ	Connectivity to Stream/SEZ	Overall Priority	Problem Description	Treatment Recommendation(s)
								base, which is ~20ft from creek channel	
36	water bar	H	Y	Y	M	H	H	water bar draining road is causing erosion under large ski run sign, compromising power box, and contributing runoff and sediment to ski run below (lower ridge run - hot spot 34)	create spreading/infiltration area at water bar outlet and add pine needle filter berms to trap sediment (~500sf)
37	water bar	H	Y	Y	L	H	H	road drainage collects at V-shaped water bar with culvert direct to meadow; erosion along water bar (head cutting); water bar overtopped at culvert inlet, causing erosion downslope	rehab water bars and convert to infiltration swales; rake out and mulch rills (~1000sf)
38	water bar	H	Y	Y	L	H	H	road drainage directed along water bar on ski run; erosion along water bar and downslope where water bar overtopped	rehab water bars and convert to infiltration swales; also rebuild water bar on roadway; ; rake out and mulch rills on ski run (~1000sf)

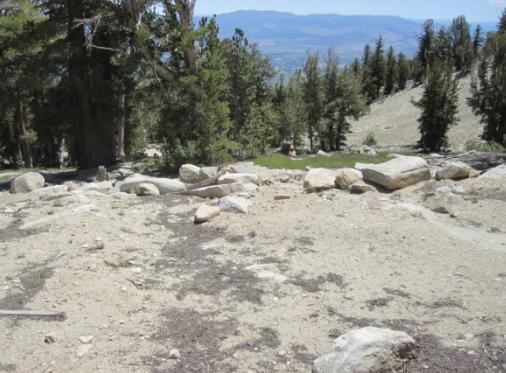
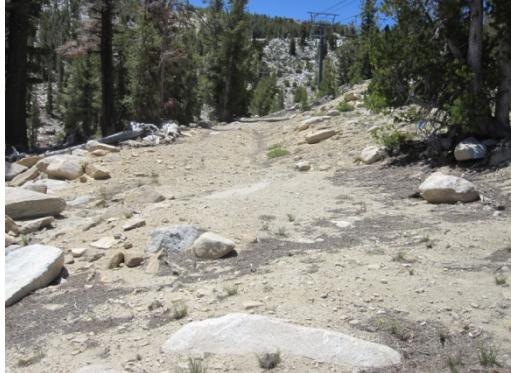
Hot Spot #	Feature Type	Hot Spot-Proposed Trail Interaction	Erosion Risk	Active Erosion	Active Depos.	Prox to stream or SEZ	Connect. to stream or SEZ	Overall Priority	Problem Description, Notes	Mitigation Recommendations
9	water bar	Y	M	Y	Y	L	M	H	proposed trail switchback at end of water bar (major depositional area)	shift trail alignment away from water bar depositional area
10	proposed trail	Y	M	Y	Y	L	H	H	proposed trail switchback very near dipper drainage with a few rills just upslope of proposed trail and connecting to dipper drainage	shift trail alignment away from dipper drainage and existing rills
11	water bar	Y	M	Y	Y	L	L	H	proposed trail switchback near water bar outlet with visible rilling	shift trail alignment away from water bar drainage area
12	road	N	L	N	N	L	M	L	old road - mitigation opportunity	decommission old road
13	proposed trail	Y	L	N	N	L	H	H	proposed trail switchback close to dipper drainage and in area with heavy Manzanita understory	shift trail alignment away from dipper drainage and out of heavily-vegetated area

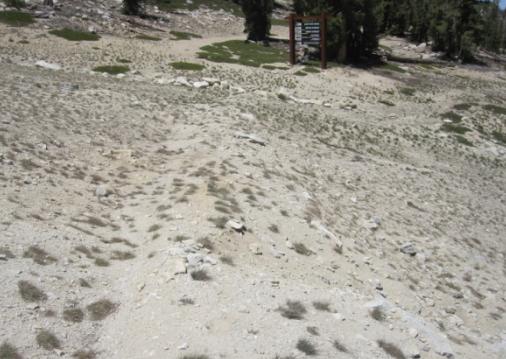
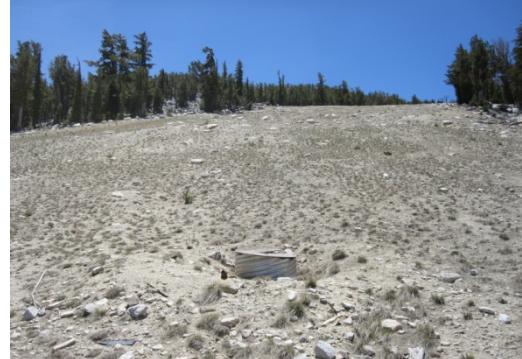
14	water bar	N	H	Y	Y	L	H	M	several blown out water bars on Big Dipper ski run; mitigation opportunity - not in proposed trail alignment	rebuild water bars and create infiltration capacity on the upslope sides through soil restoration treatment; rake out rills downslope; construct mulch berms or infiltration strips on ski run to prevent further erosion by slowing/disbursing flow
15	depositional area	N	H	Y	Y	L	M	M	depositional area at lower end of dipper drainage	address erosion through source control upslope
16	drainage	Y	M	Y	Y	L	M	H	proposed trail alignment crosses defined drainage	shift proposed trail alignment (location of switchback) to avoid crossing drainage
17	road	N	M	Y	Y	L	M	L	old road to avalanche gun - mitigation opportunity	decommission old road (~8 ft avg width x 1290 ft length; northernmost 100 ft is ~20 ft width)
18	road	N	L	N	N	L	L	L	short loop/turnaround road - mitigation opportunity	decommission turnaround section of road (~12ft x 100ft)

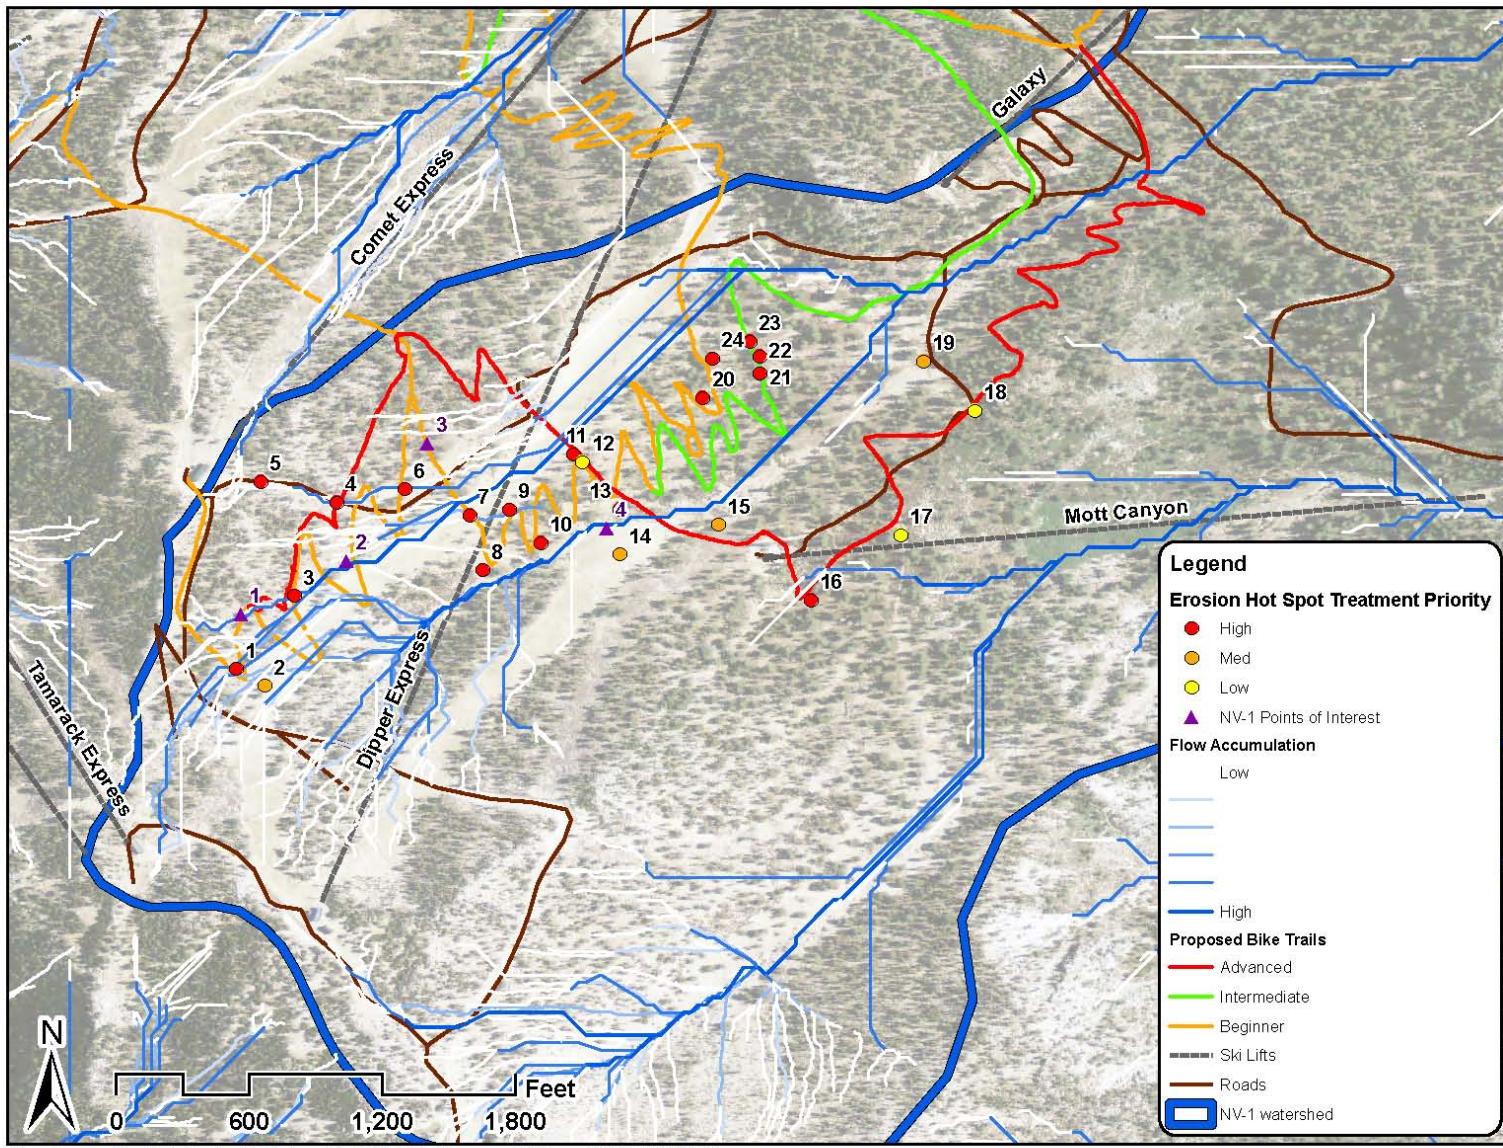
Figure 1. EfRA Summary Map showing hot spots in NV-1 watershed, zoomed in to hot spot locations.

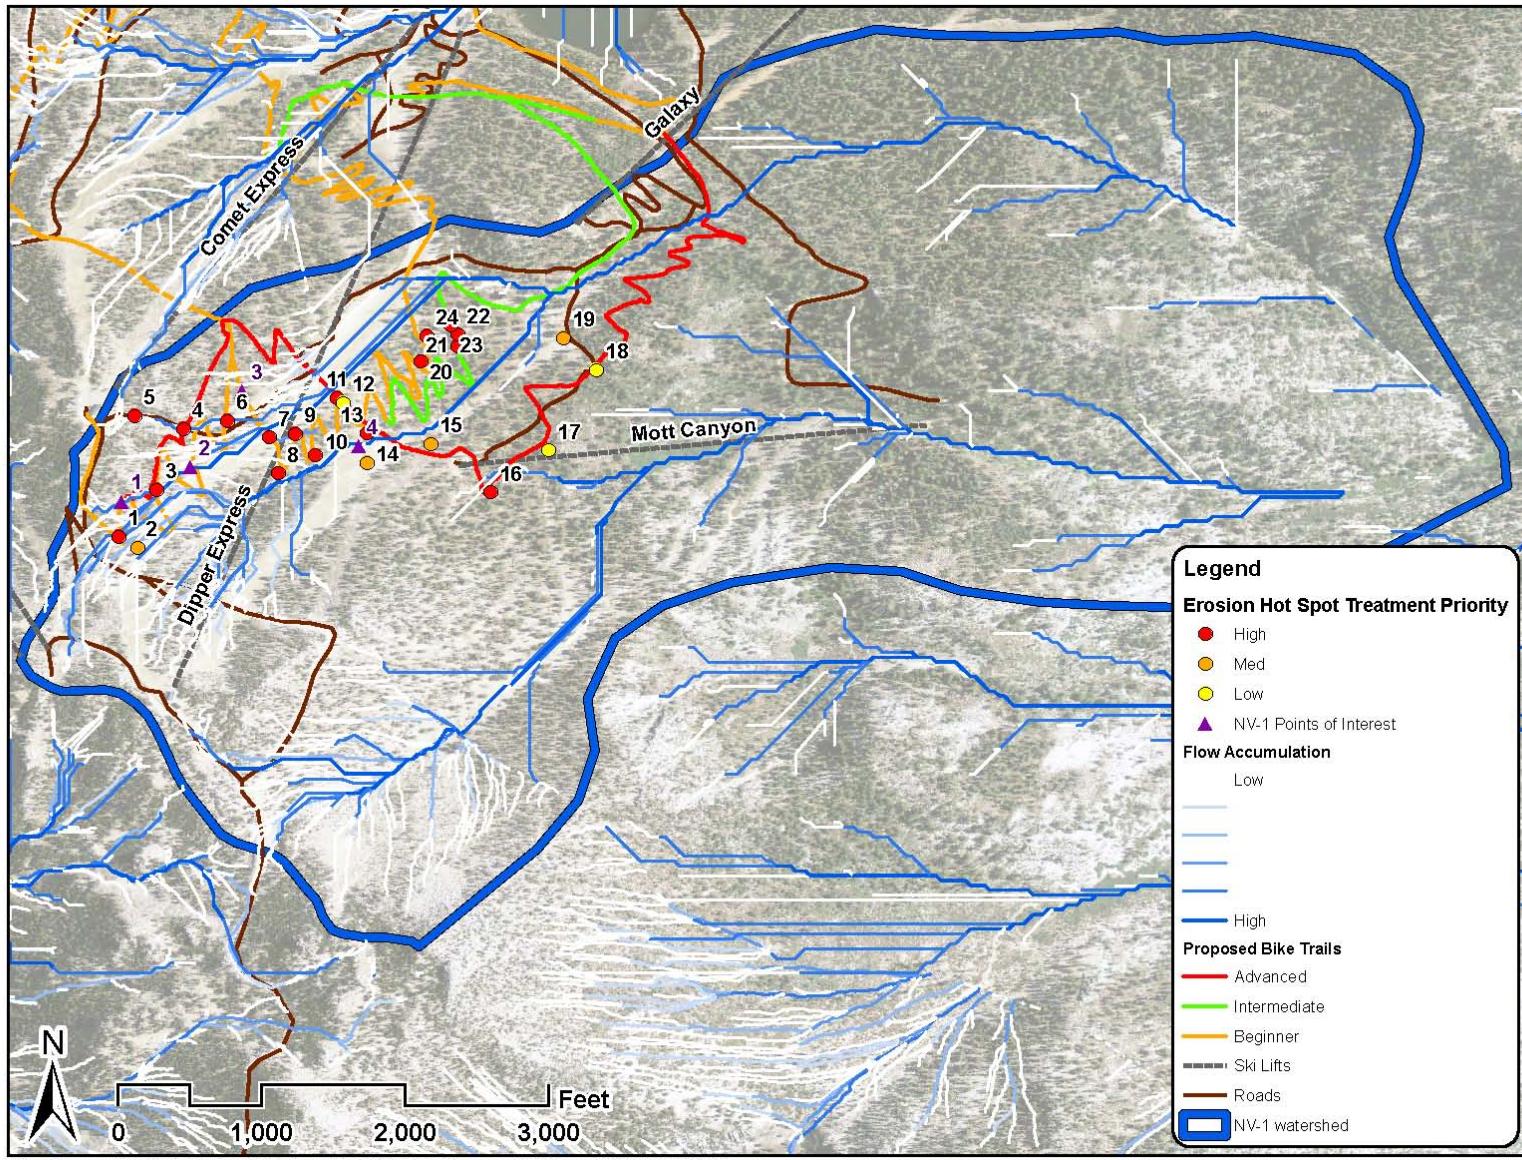
Figure 2. EfRA Summary Map showing hot spots in Mott Canyon (NV-1), zoomed out to show entire NV-1 watershed.
