Heavenly Mountain Resort Mitigation and Monitoring Plan Annual Report

October 2008 – October 2009

April 30, 2010

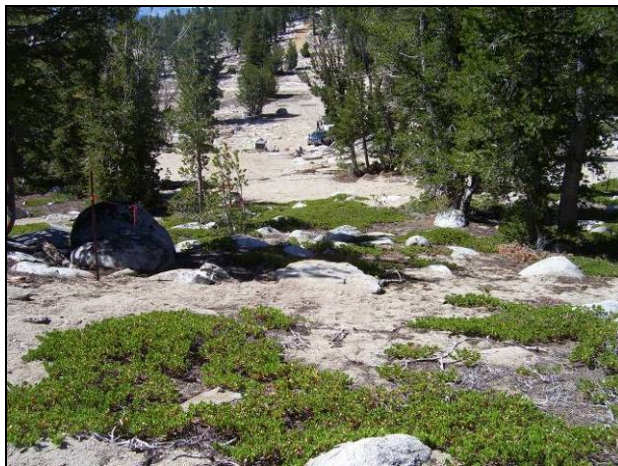
The tubing lift was constructed in a mostly open area with some Western white pine (*Pinus monticola*) and a sparse understory of pinemat manzanita (*Arctostaphylos nevadensis*), buckwheat (*Eriogonum sp.*), penstemon (*Penstemon sp.*), and Western needlegrass (*Achnatherum occidentale*; Figure 19). No non-native species were observed. Most of the granitic parent material soil was bare; however, there was a sparse mulch cover by pine needles near the forested areas. There were some medium to large rocks that are visible above the surface. Excavation observed during pre-treatment monitoring indicated that many of the rocks were large boulders with the majority of their mass below the surface. The site is gently sloped (10 degrees), faces 181 degrees south, and had a summer solar exposure of 86%. The site elevation is approximately 9,150 feet AMSL.

Figure 19. Tubing Lift, before construction, 2009

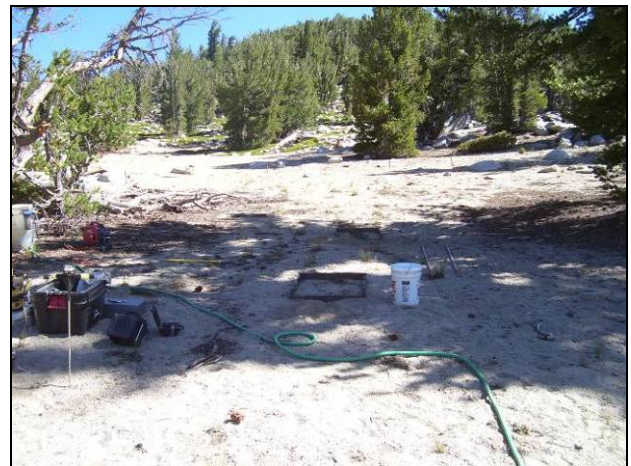
The tubing lanes were constructed in an open area with very few Western white pine (*Pinus monticola*) and a very sparse understory of pinemat manzanita (*Arctostaphylos nevadensis*), buckwheat (*Eriogonum sp.*), penstemon (*Penstemon sp.*), and Western needlegrass (*Achnatherum occidentale*; Figure 20). No non-native species were observed. Most of the soil was bare; however, there was a very sparse mulch cover by pine needles near the forested areas. There were some medium to large rocks that are visible above the surface. The site is gently sloped (10 degrees), faces 181 degrees south, and had a summer solar exposure of 91%. The site elevation is approximately 9,150 feet AMSL.

Figure 20. Tubing Lanes, before construction, 2009

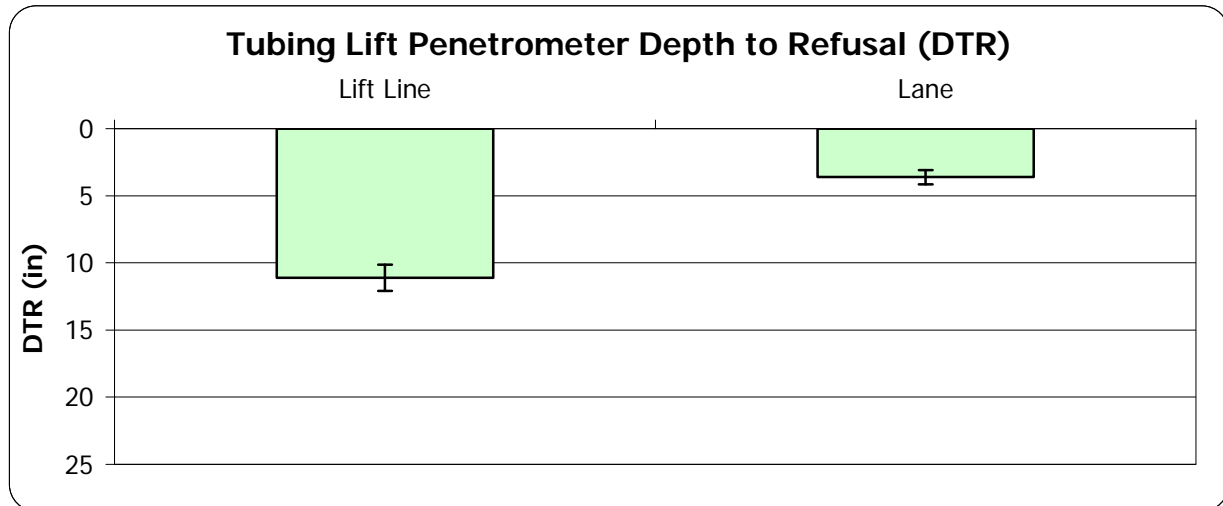
The penetrometer DTR at the lift line was 11.1 inches, compared to 3.6 inches at the tubing lane (Figure 22).

Figure 22. Tubing Lift Penetrometer Depth to Refusal (DTR). The penetrometer DTR at the lift line was 11.1 inches, compared to 3.6 inches at the lane. The error bars denote one standard deviation above and below the mean.

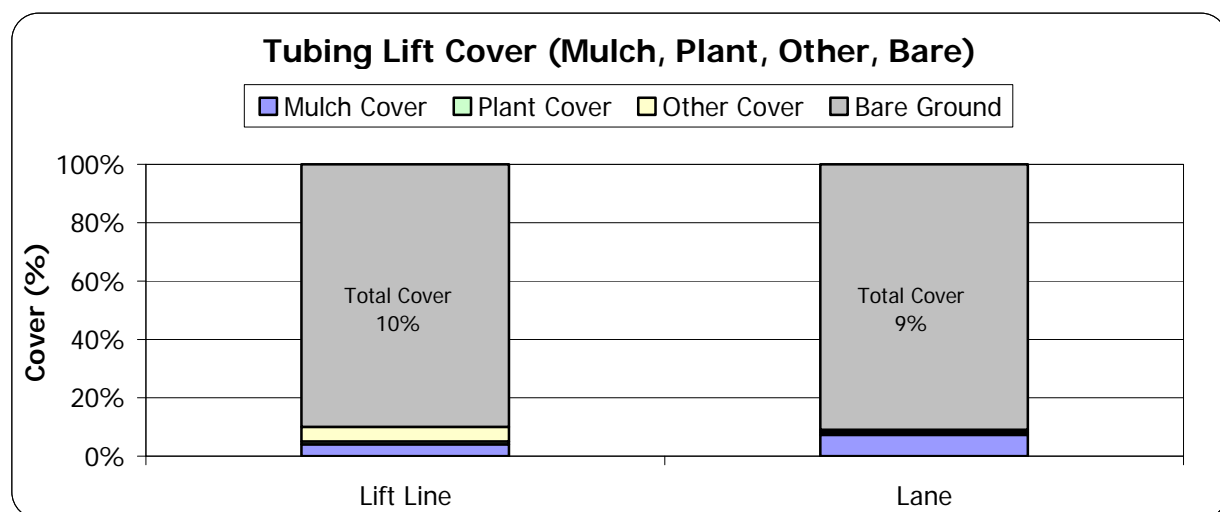
Total cover at the tubing lift line (10%) was similar to the total cover (9%) at the tubing lane (Figure 23). Both had high proportions of bare soil: 90% at the lift line and 89% at the tubing lane. Understory plant cover (not including canopy cover) was 1% at both the tubing lift line and the tubing lane (no graph).

Figure 23. Tubing Lift Cover (Mulch, Plant, Other, Bare). Total plant cover at the lift line was 10%, compared to total cover at the tubing lane, which was 9%.

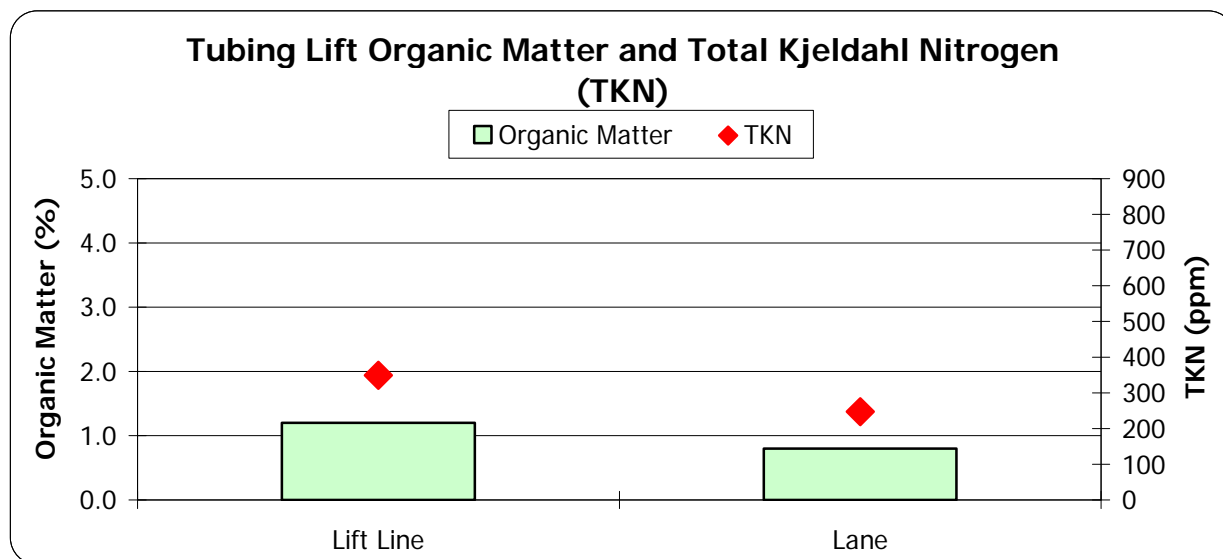
Organic matter content at the tubing lift line was 1.3%, compared to 0.8% at the tubing lane (Figure 24). Total Kjeldahl nitrogen (TKN) at the tubing lift line was 349 ppm, compared to 247 ppm at the tubing lane.

Figure 24. Tubing Lift Organic Matter and Total Kjeldahl Nitrogen (TKN). At the tubing lift line, organic matter content was 1.3% and TKN was 349 ppm. At the tubing lane, the organic matter content was 0.8% and the TKN was 247 ppm.

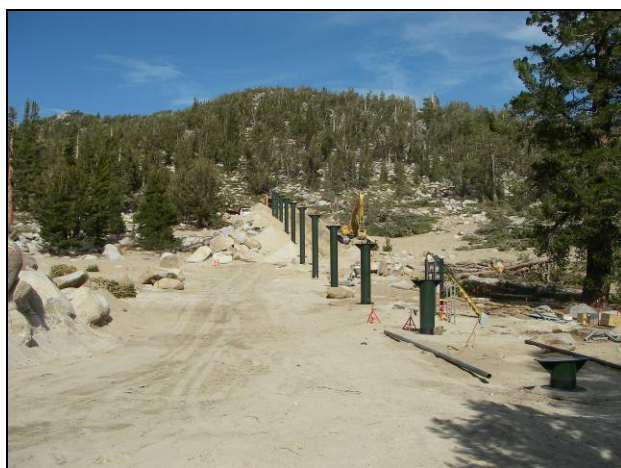
Figure 25. Tubing lift, treatment area A, near start of construction, August 2009.

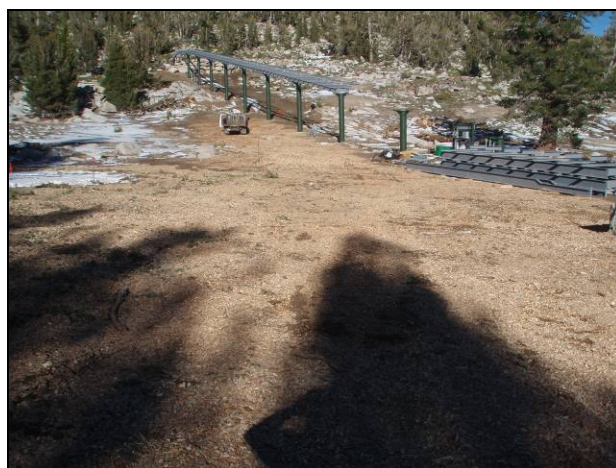
Figure 26. Tubing lift, treatment area A, with wood chips covering soil during construction, October 2010.

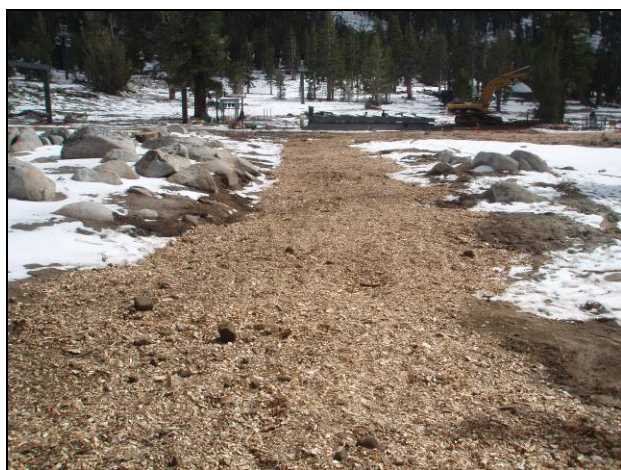
Figure 27. Tubing lift, snowmaking lateral covered in wood chips during construction, treatment area A, October 2009.

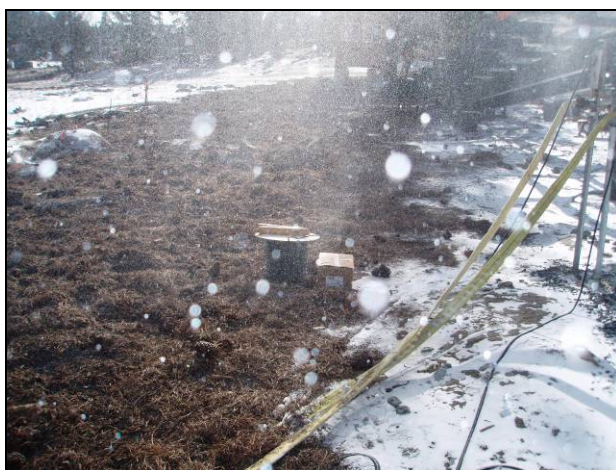
Figure 28. Tubing lift, access road winterized with wood chips (tilled) and pine needle mulch after construction, December 2010.

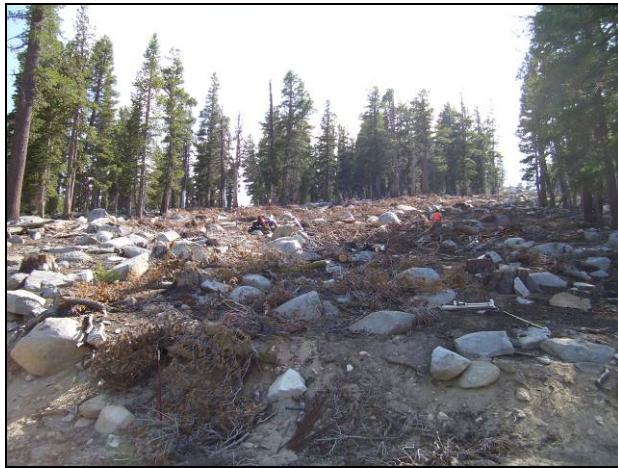
The cleared run was cut in a forested area with lodgepole pine (*Pinus contorta*) and Western white pine (*Pinus monticola*; Figure 30). There is no canopy cover and very little vegetation exists. No non-native species were observed. Large boulders, ranging from one to five feet in diameter, and tree stumps that are one to two feet tall are scattered throughout the cleared area. Tree branches from the glading process were left on the run, and are up to 15 feet long. Rills and gullies were present at the toe of the ski slope, where it meets the access road. The soil derived is from granitic parent material. Little vegetation was present in the cleared area. The site is moderately sloped (20 degrees), faces 52 degrees northeast, and had a summer solar exposure of 73-79%. The site elevation is approximately 9,025 feet AMSL.

Figure 30. North Bowl cleared ski run, 2008.

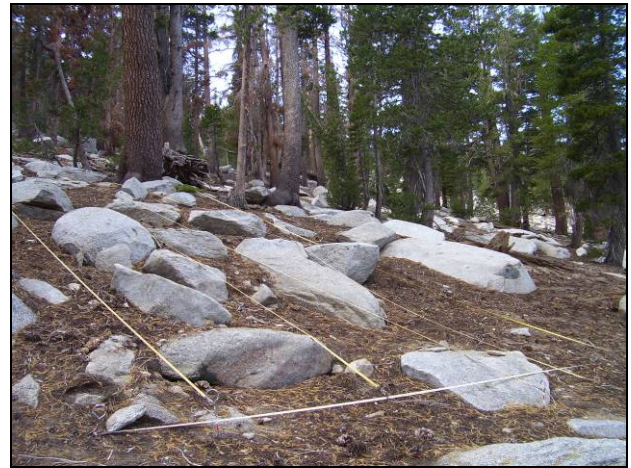
The uncleared reference site is adjacent to the cleared run. The dominant trees are lodgepole (*Pinus contorta*) and western white pine (*Pinus monticola*) and the area contained many large boulders, ranging from one to five feet in diameter (Figure 31). No erosion was observed in the reference area, but animal disturbance was seen throughout. Little understory vegetation was present and no non-native species were observed. The slope, aspect, and elevation are identical to that of the cleared run. The solar exposure at the reference area ranges from 29-35% during the summer months.

Figure 31. North Bowl uncleared reference site, 2008.

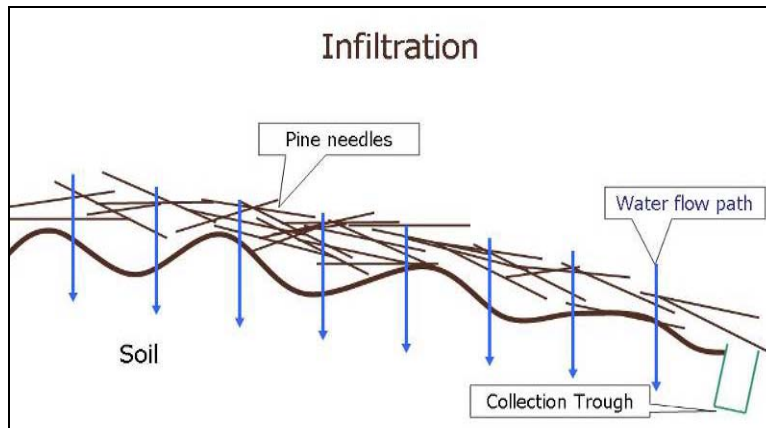
Figure 32. Water infiltrating through pine needle mulch into soil.

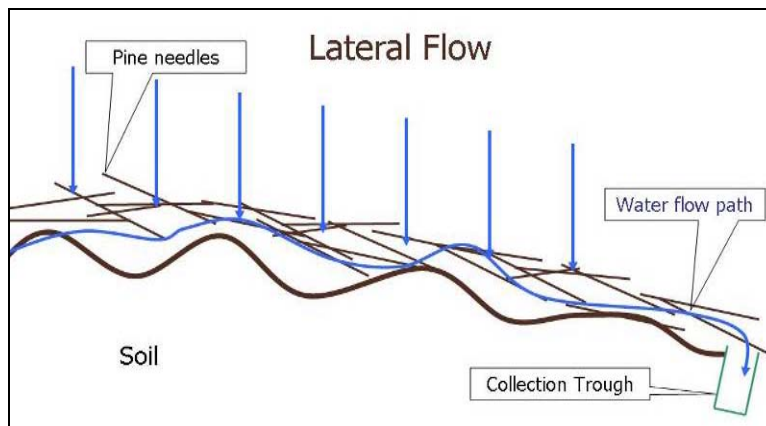
Figure 34. Water flowing laterally through pine needle mulch into collection trough. The water does not reach the soil surface; therefore, it is not known whether the water can infiltrate into the soil.

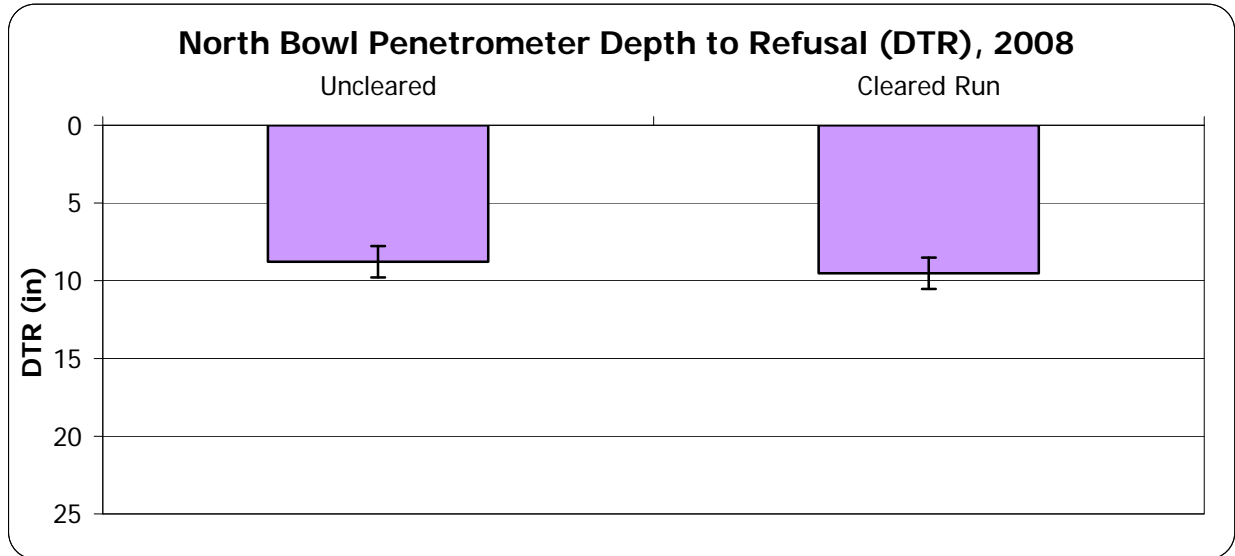
Penetrometer DTRs were similar between the cleared run (9.5 inches) and the reference area without clearing (8.8 inches; Figure 36). The success criterion for penetrometer states that the DTR at the cleared run has to be no more than 4.0 inches shallower the DTR at the reference area. Since the DTR at the cleared run was 0.7 inches deeper than at the reference area, the success criterion was met.

Figure 36. North Bowl Penetrometer Depth to Refusal (DTR), 2008. Penetrometer DTRs were similar between the cleared run (9.5 inches) and the reference area without clearing (8.8 inches). The error bars represent one standard deviation above and below the mean.

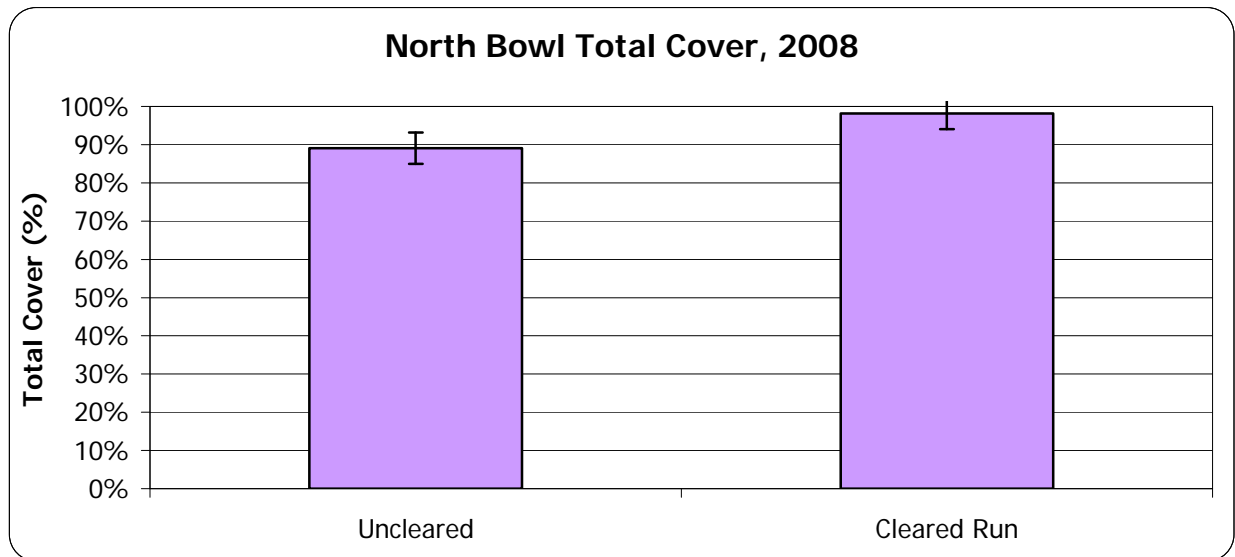
Total cover at the cleared run (98%) was 9 percentage points higher than the total cover (89%) at the uncleared run (Figure 37). The difference in total cover at the cleared run compared to the uncleared run can be accounted for by the difference in mulch cover at the cleared run (84%) compared to the uncleared run (76%). The cleared run most likely had higher mulch cover because branches from the removed trees were left on the ground. The success criterion for total cover, which states that the total cover at the cleared run must be no more than 15 percentage points less than the total cover at the reference area, was met.

Figure 37. North Bowl Total Cover, 2008. The cleared run had slightly more mulch cover and less bare soil than the uncleared run. The error bars represent one standard deviation above and below the mean.

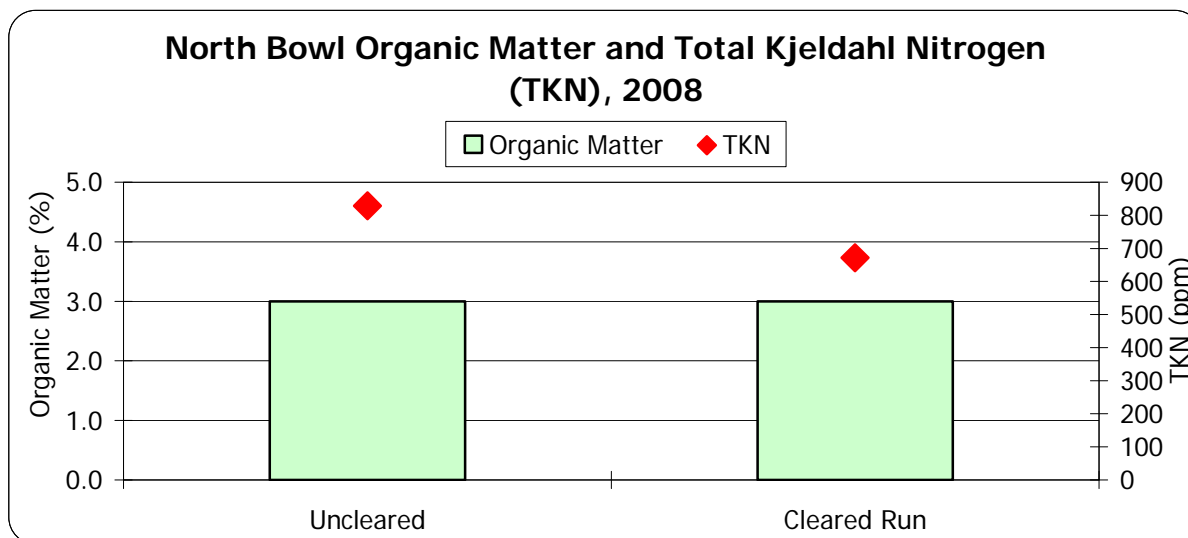
The organic matter content for soil at the cleared run and the uncleared reference area were both 3% (Figure 38). The success criterion, which states that the cleared run organic matter content must be no more than 1.5 percentage points lower than that of the reference area level, was met. The TKN for the cleared run (672 ppm) was 157 ppm lower than the TKN the uncleared run (829 ppm). A success criterion for TKN was not used in 2009, as discussed in Appendix B.

Figure 38. North Bowl Organic Matter and Total Kjeldahl Nitrogen (TKN), 2008. The organic matter content for the cleared run and the reference area was 3%. The TKN for the cleared run was 157 ppm or 19% lower than the TKN for the uncleared run.

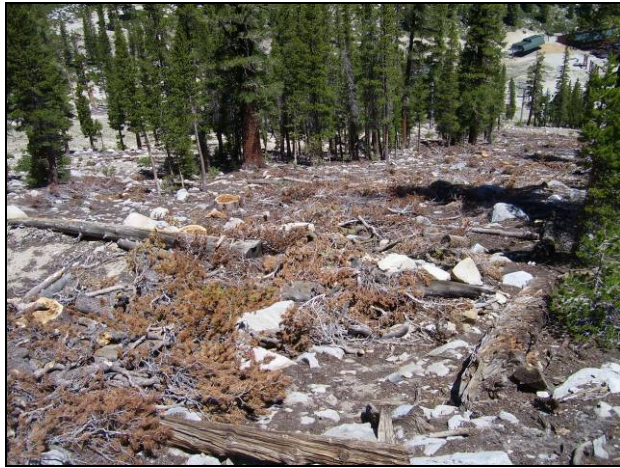
This cleared run was cut in a forested area with lodgepole pine (*Pinus contorta*) and Western white pine (*Pinus monticola*; Figure 40). There is no canopy cover and little understory vegetation was present in the cleared area. No non-native species were observed. Large rocks, tree branches, and stumps were scattered throughout the cleared area. The soil is derived from granitic parent material. The site is moderately sloped (19 degrees), faces northwest, and had a summer solar exposure of 68-79%. The site elevation is approximately 8,922 feet AMSL.

Figure 40. Orion II run cleared area.

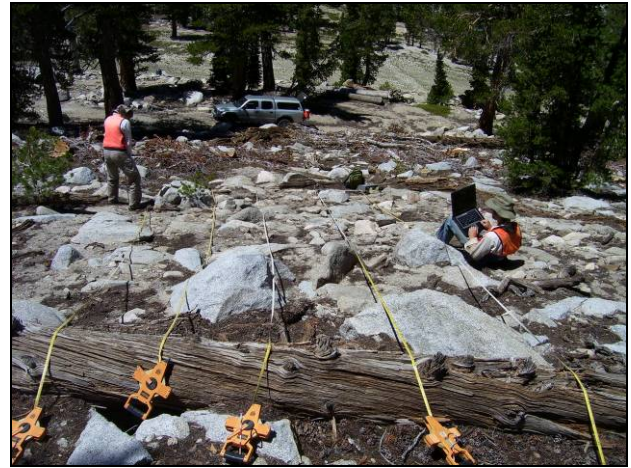
This reference site is in a forested area adjacent to the cleared run with lodgepole pine (*Pinus contorta*) and Western white pine (*Pinus monticola*; Figure 41). There is no canopy cover in the area sampled, but variable canopy cover in the surrounding areas. Very little understory vegetation exists. No non-native species were observed. The soil is derived from granitic parent material with approximately 40% coarse fragments greater than 0.5 inches in diameter. The site is moderately sloped (21 degrees), faces northwest, and has a summer solar exposure of 74-86%. The site elevation is approximately 8,964 feet AMSL.

Figure 41. Orion II uncleared reference area. The cleared run is visible just in front of the truck.

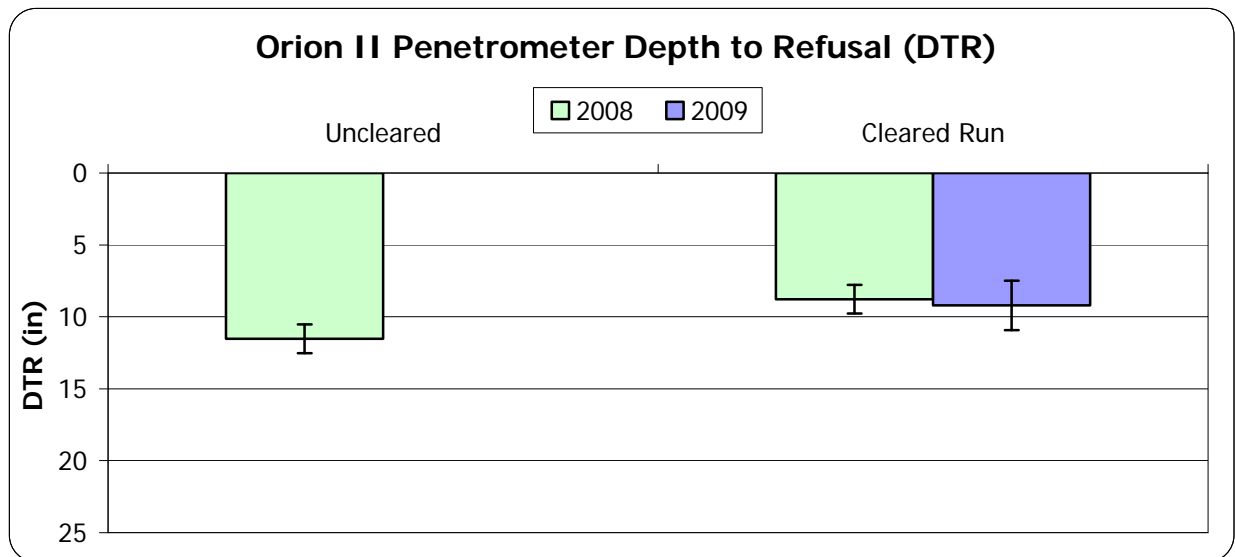
In 2008, the penetrometer DTR at the cleared run, 8.8 inches, was 2.7 inches shallower than the DTR at the reference run without clearing, 11.5 inches (Figure 46). In 2009, the penetrometer DTR at the cleared run was 9.2 inches, which was 2.3 inches shallower than the DTR at the reference run without clearing. The success criterion, which states the cleared run DTR should be no more than 4 inches shallower than the reference area, was met.

Figure 46. Orion II Penetrometer Depth to Refusal (DTR). The penetrometer DTR at the cleared run, was 2.7 inches shallower than the DTR at the uncleared run in 2008 and 2.3 inches uncleared run in 2009. The error bars denote one standard deviation above and below the mean.

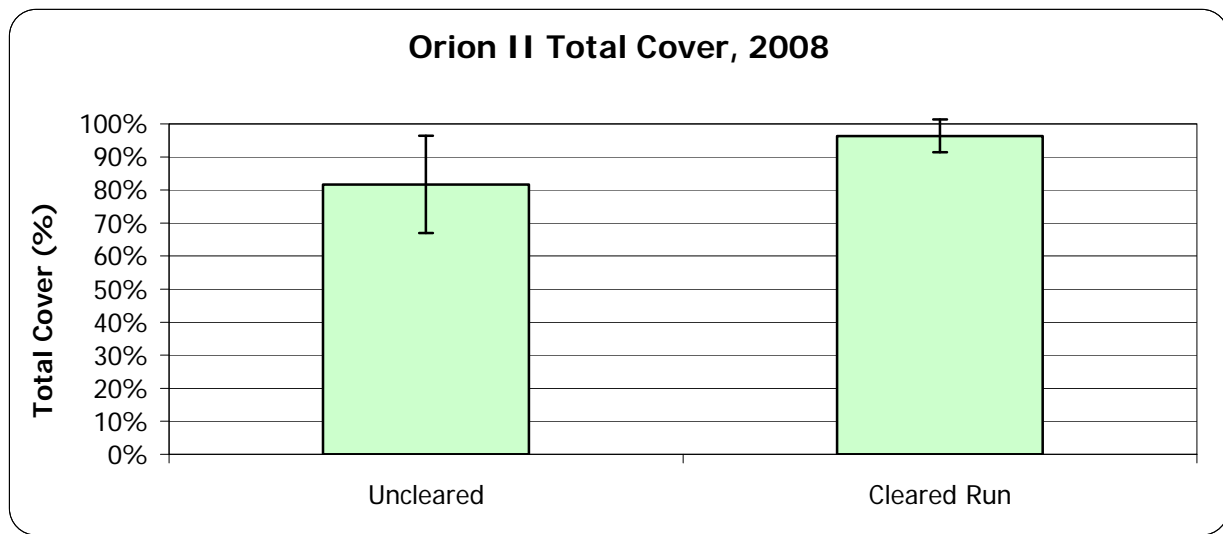
The total cover at the cleared run (96%) was 14 percentage points higher than the total cover at the uncleared run (82%, Figure 47). The total cover composition was different at each plot. The cleared run had a high proportion of mulch, while the uncleared run had a high proportion of rocks. The success criterion for total cover, which states that total cover at the cleared run should be not more than 15 percentage points below that of the reference area, was met.

Figure 47. Orion II Total Cover, 2008. The total cover at the cleared run (96%) was 14 percentage points or 17% higher than the total cover at the uncleared run (82%). The error bars denote one standard deviation above and below the mean.

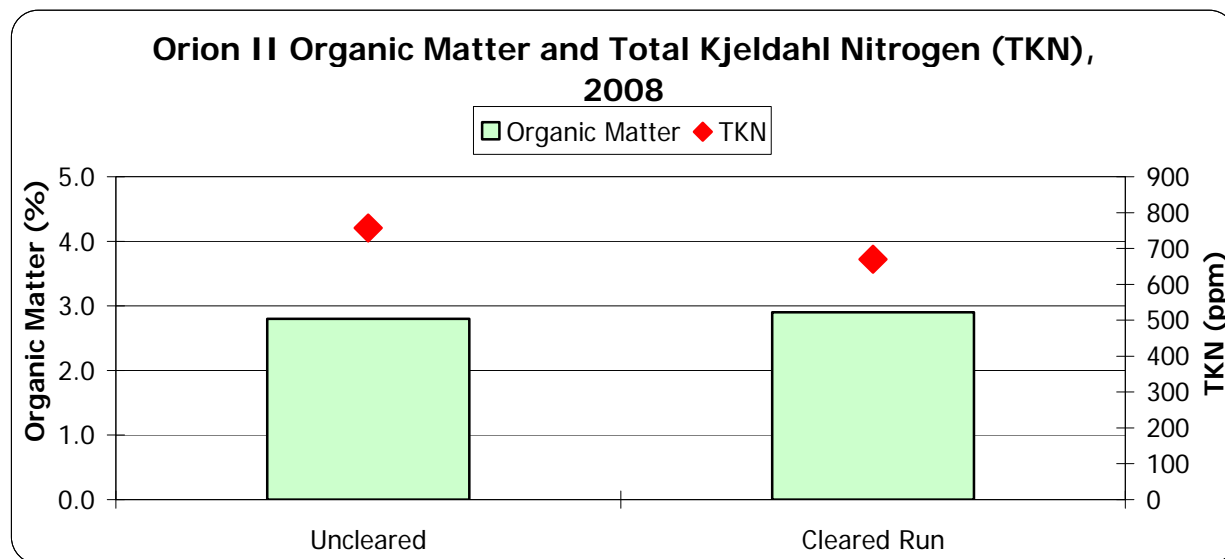
Organic matter levels were similar at the cleared run (2.9%) compared to the reference area (2.8%; Figure 48). The success criterion for organic matter, which states that the organic matter at the cleared run has to be no more than 1.5 percentage points less than at the reference area, was met. TKN levels were 87 ppm or 11% lower at the cleared run (670 ppm) compared to the reference area (757 ppm; Figure 48). A success criterion for TKN was not used in 2009, as discussed in Appendix B.

Figure 48. Orion II Organic Matter and Total Kjeldahl Nitrogen (TKN), 2008. Organic matter levels were similar at the cleared run (2.9%) compared to the reference area (2.8%) TKN levels were lower at the cleared run (670 ppm) compared to the reference area (757 ppm).

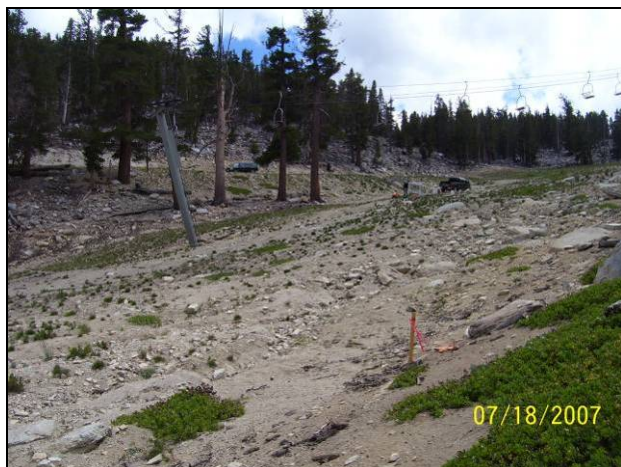
Figure 50. Olympic Lift Bottom, Olympic Downhill ski run, pre-treatment, 2007.

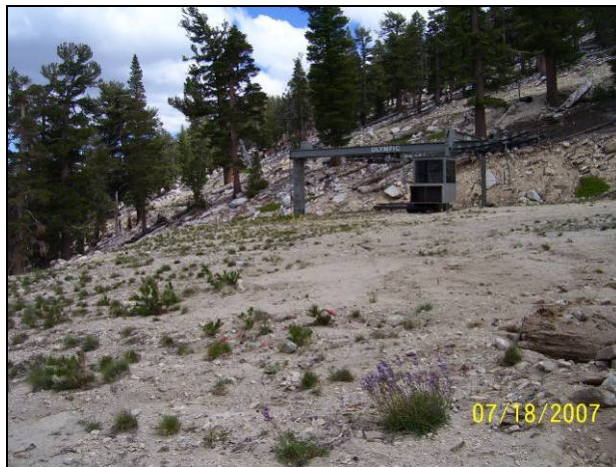
Figure 51. Olympic Lift Bottom, old bottom terminal, pre-treatment, 2007.

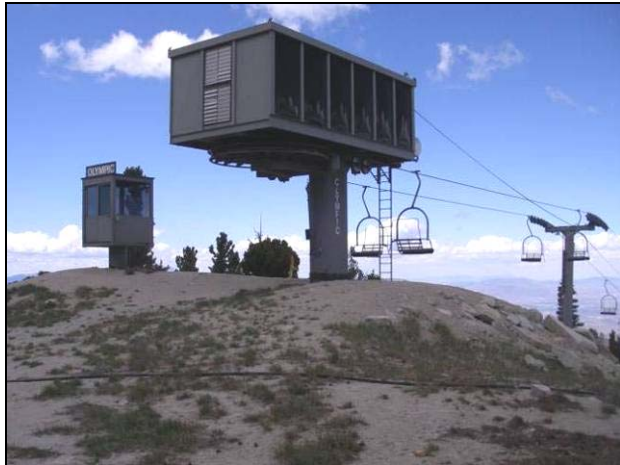
Figure 60. Olympic lift top, pre-treatment, 2007.

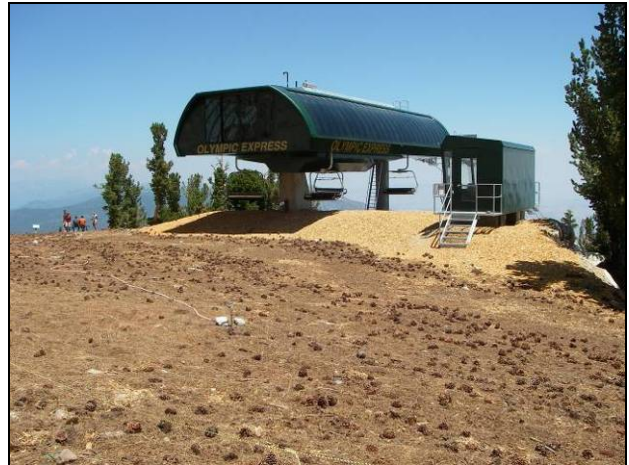
Figure 61. Olympic lift top, post-treatment, 2008.

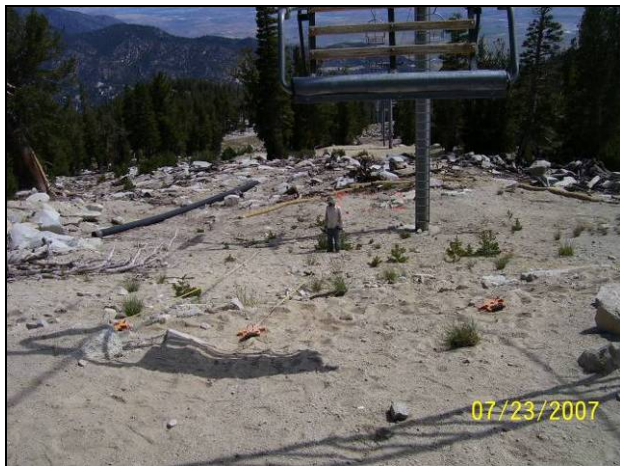
Figure 62. Olympic lift top, pre-treatment, 2007.

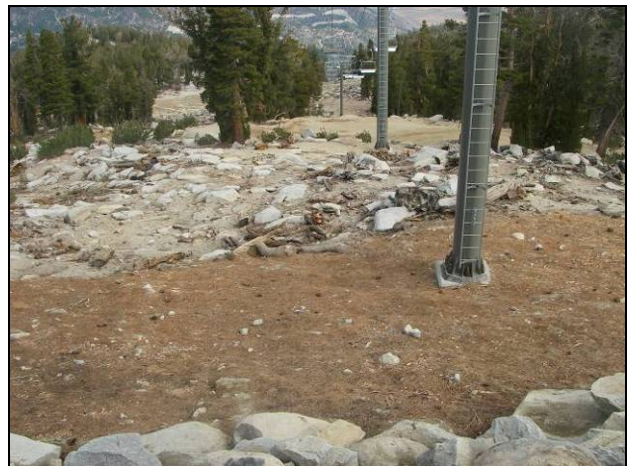
Figure 63. Olympic lift top, post-treatment, 2008.

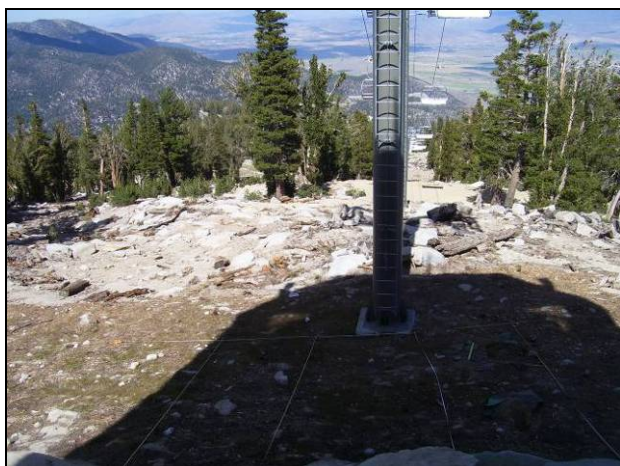
Figure 64. Olympic lift top, post-treatment, 2009.

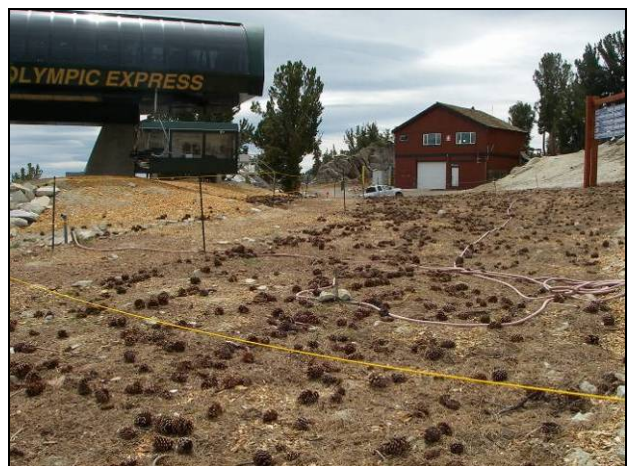
a foot trail between treatment areas A and B, fenced off the treatment areas, and posted educational signage to keep visitors from disturbing the recently treated revegetation areas (Figure 65). These treatment area protection measures proved to be very effective during summer 2008. These treatments were partially implemented in 2007 and completed in 2008.

Figure 65. Olympic lift top, treatment area protection.

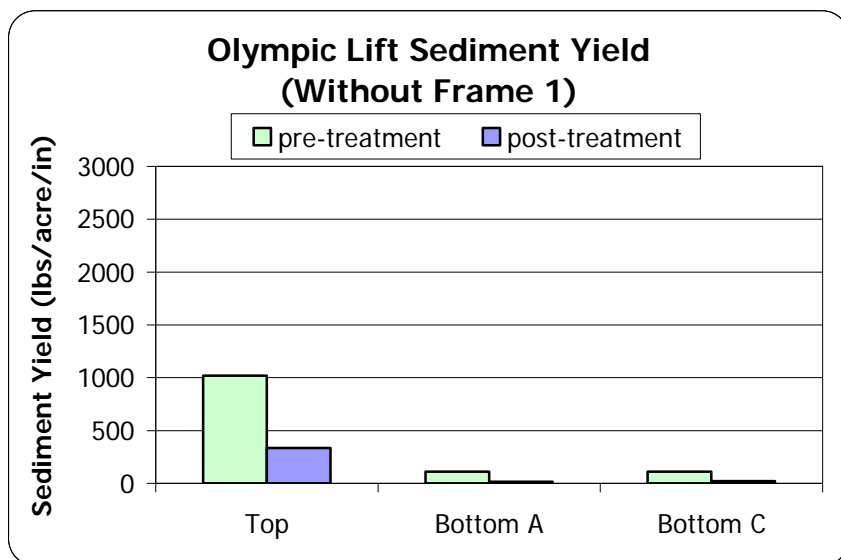
Figure 67. Olympic Lift Sediment Yield. After Frame 1 was removed from bottom C (see sidebar), the sediment yield decreased by 82% from 113 lbs/acre/in to 20 lbs/acre/in.

It was noted during the simulation that slight hydrophobic conditions may have been present at Frame 1.

The similarly high penetrometer depths for each frame indicate that compaction did not lead to the higher sediment yield. Data collected under hydrophobic conditions cannot be compared to those collected under non-hydrophobic conditions. Figure 67 shows bottom C results without the Frame 1 sediment yield.

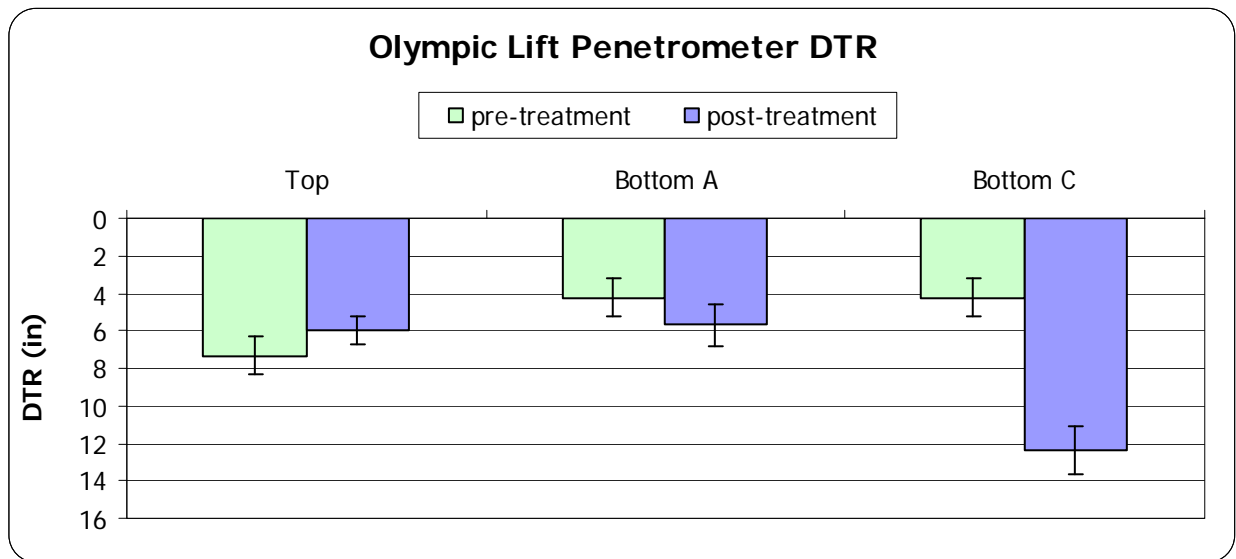
The post-treatment penetrometer DTR at the Olympic lift top (6 inches) was 1.3 inches shallower than the pre-treatment DTR (7.3 inches; Figure 70). The post-treatment penetrometer DTR at the Olympic lift bottom A (5.7 inches) was 1.5 inches shallower than the pre-treatment DTR (4.2 inches). The post-treatment penetrometer DTR at the Olympic lift bottom C (12.3 inches) was 8.2 inches deeper than the pre-treatment DTR (4.2 inches). The success criterion, which states that the post-treatment DTR must be no more than 4.0 inches shallower than the pre-treatment DTR, was met for all plots.

Figure 70. Olympic Lift Penetrometer DTR. The penetrometer DTR at the Olympic lift top was 1.3 inches shallower post-treatment. The penetrometer DTR at the Olympic lift bottom was 1.5 to 8.2 inches deeper post-treatment. The error bars denote one standard deviation above and below the mean.

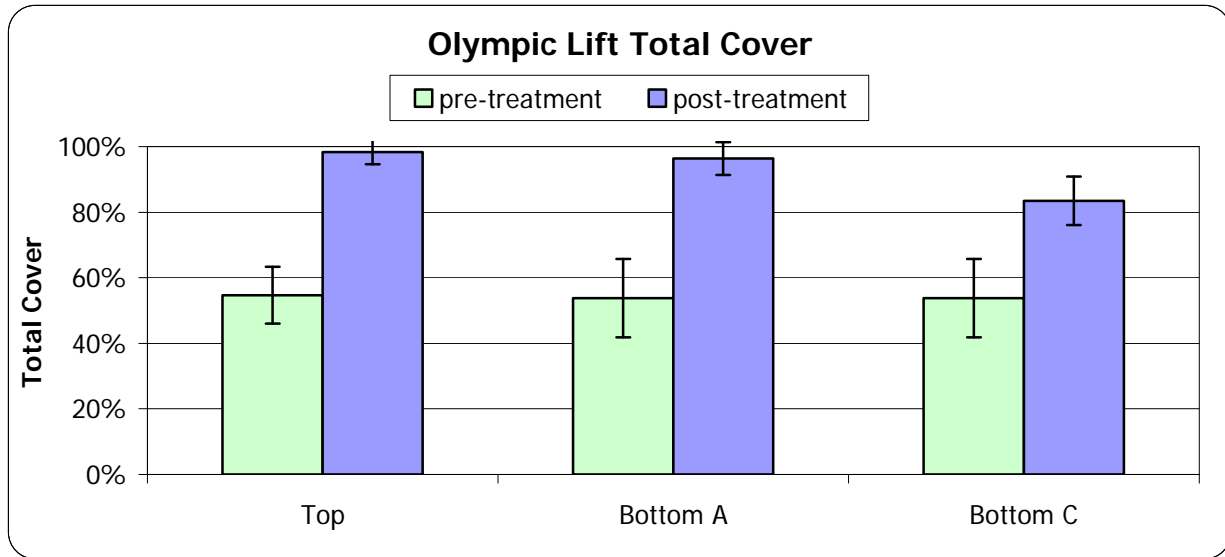
The post-treatment total cover at the Olympic lift top (98%) was 78% higher than the pre-treatment total cover (55%; Figure 71). The post-treatment total cover at the Olympic lift bottom A (96%) was 75% higher than the pre-treatment total cover (55%). The post-treatment total cover at the Olympic lift bottom C (83%) was 51% higher than the pre-treatment total cover (55%). The success criterion, which states that the post-treatment total cover must be greater than 70%, was met for all plots.

Figure 71. Olympic Lift Total Cover. The post-treatment total cover increased by 51-78% post-treatment and the total cover for all plots was 83% or greater. The error bars denote one standard deviation above and below the mean.

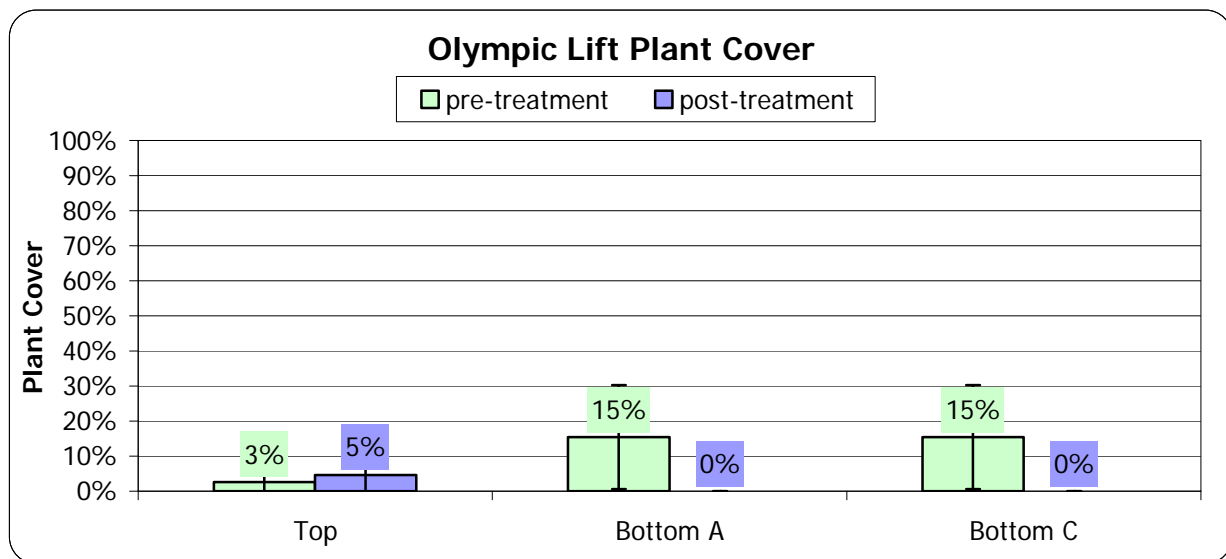
The post-treatment plant cover at the Olympic Lift top (5%) was similar to the pre-treatment total cover (3%, Figure 72). The plant cover was dominated by grasses that were not mature enough to be identified.

The post-treatment total cover at the Olympic lift bottom A and C was 0%, compared to 15% pre-treatment at both plots. Ocular estimates indicated that there was approximately 2% cover by native plants at both Olympic bottom A and C that was not captured during cover point monitoring. This indicates that native plants are beginning to establish. Although the plant cover was higher before restoration treatments, it was dominated by non-native species, which may not provide long-term protection against erosion when compared to deep-rooting native perennial grasses. The success criterion, which states that the post-treatment plant cover be at least 10%, was not met for the Olympic plots.

Figure 72. Olympic Lift Plant Cover. The post-treatment plant cover at the Olympic Lift Top (5%) was similar to the pre-treatment total cover (3%). The post-treatment total cover at the Olympic Lift Bottom A and C was 0%, compared to 15% pre-treatment. The error bars denote one standard deviation above and below the mean.

cover tend to be closely related. High-carbon soil amendments, which were used at this site, tend to reduce available nitrogen during decomposition, which can limit plant growth for several years. Another year of cover monitoring is recommended to better understand the long term trajectory for plant cover. If monitoring in 2010 indicates increasing trends, follow up treatments may not be necessary. However, if measurable plant cover is not present in 2010, treatment actions such as additional fertilizing, seeding and/or irrigation will be necessary to expedite vegetation establishment.

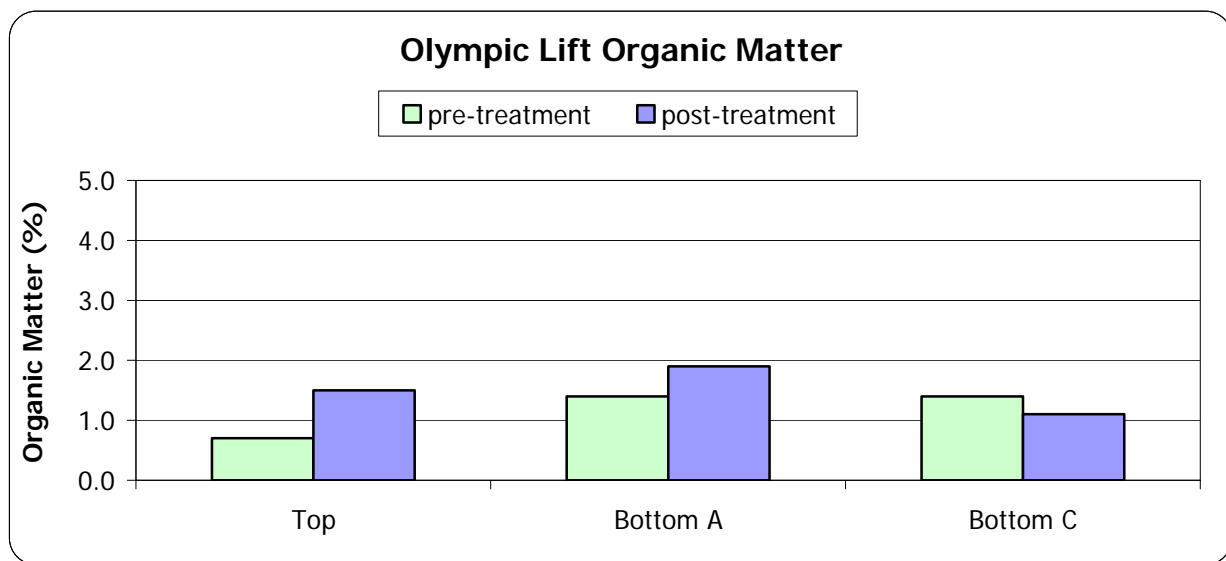
The post-treatment organic matter at the Olympic lift top (1.5%) was 114% higher than the pre-treatment organic matter (0.7%, Figure 73). The post-treatment organic matter at the Olympic lift bottom A (1.9%) was similar to the pre-treatment organic matter (1.4%). The post-treatment organic matter at the Olympic lift bottom C (1.1%) was similar to the pre-treatment organic matter (1.4%). The success criterion, which states that the post-treatment organic matter content must be no more than 1.5 percentage points lower than the pre-treatment organic matter, was met for all plots.

Figure 73. Olympic Lift Organic Matter. The organic matter at the Olympic lift top increased by 114% post-treatment, while at bottom A it increased by 36% post-treatment. The pre- and post-treatment organic matter contents at the Olympic lift bottom C were similar.

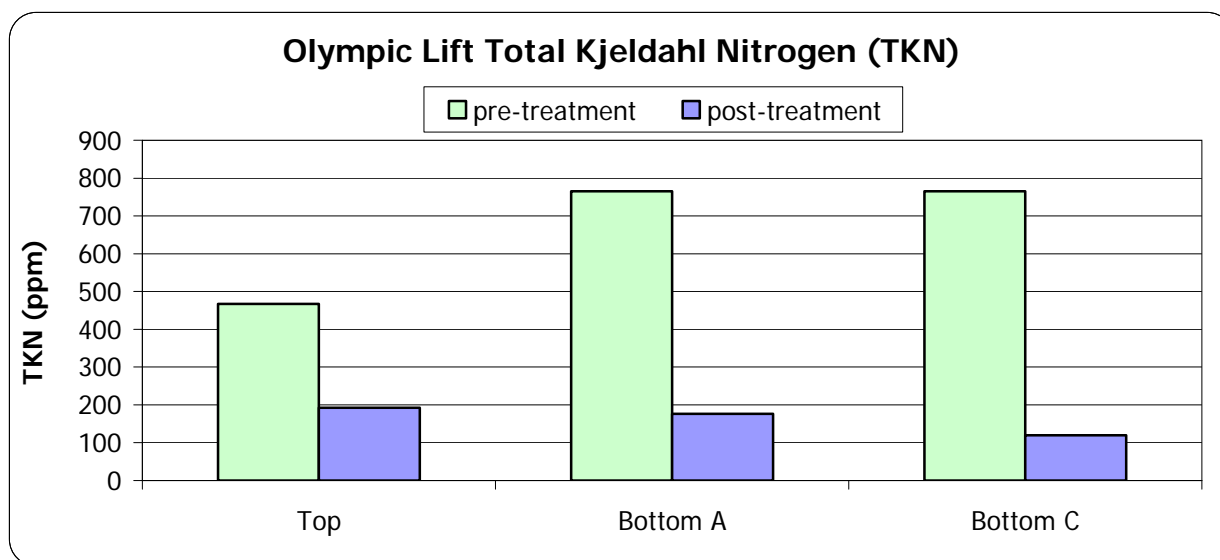
The post-treatment TKN at the Olympic lift top (192 ppm) was 175 ppm or 56% lower than the pre-treatment TKN (467 ppm, Figure 74). The post-treatment TKN at the Olympic lift bottom A (176 ppm) was 589 ppm or 77% lower than the pre-treatment TKN (765 ppm). The post-treatment TKN at the Olympic lift bottom C (120 ppm) was 645 ppm or 84% lower than the pre-treatment TKN (765 ppm). A success criterion for TKN was not used in 2009, as discussed in Appendix B.

Figure 74. Olympic Lift Total Kjeldahl Nitrogen (TKN). The post-treatment TKN decreased by 56% to 84% at the Olympic lift plots.

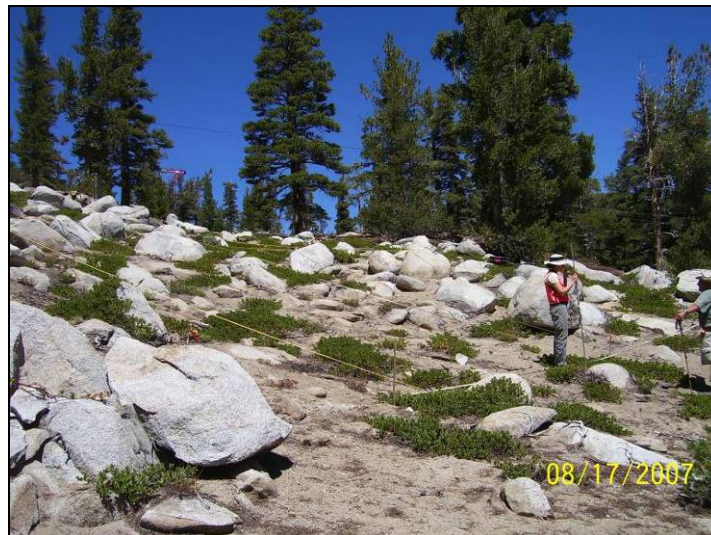
Figure 75. Heavenly Flyer bottom, pre-treatment, 2007.

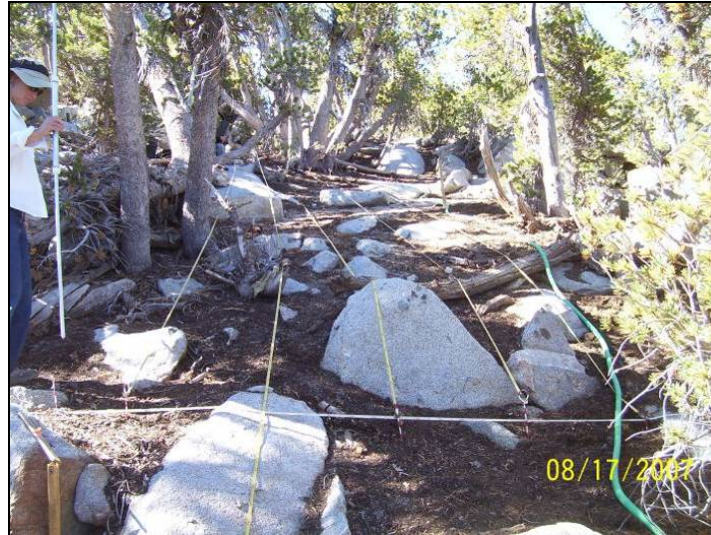
Figure 77. Heavenly Flyer Top, pre-treatment cover point monitoring, 2007.

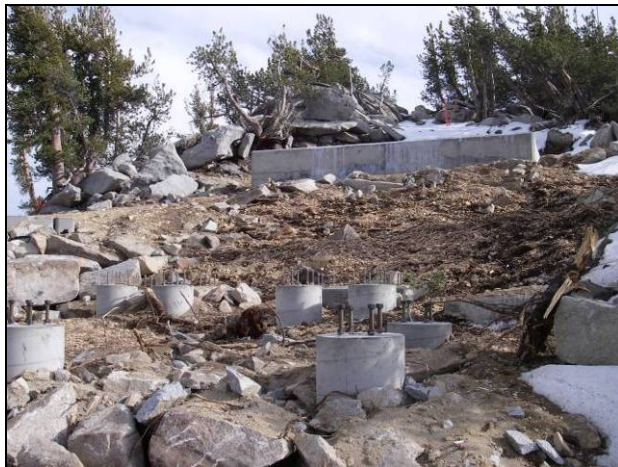
Figure 78. Heavenly Flyer top, during construction, 2007. Pre-treatment conditions (very dense thicket of pine) were difficult to photograph.

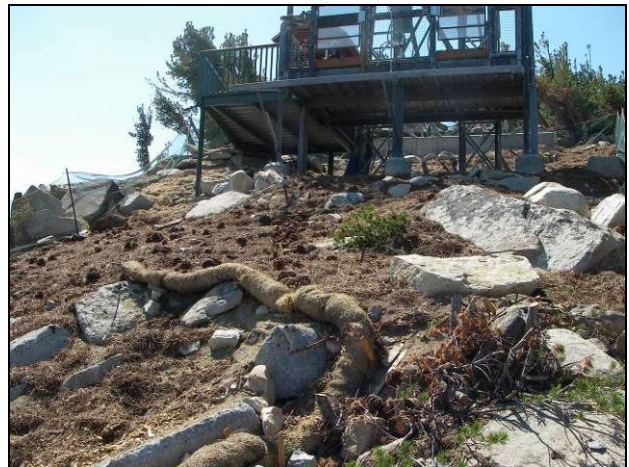
Figure 79. Heavenly Flyer top, post-treatment, 2007.

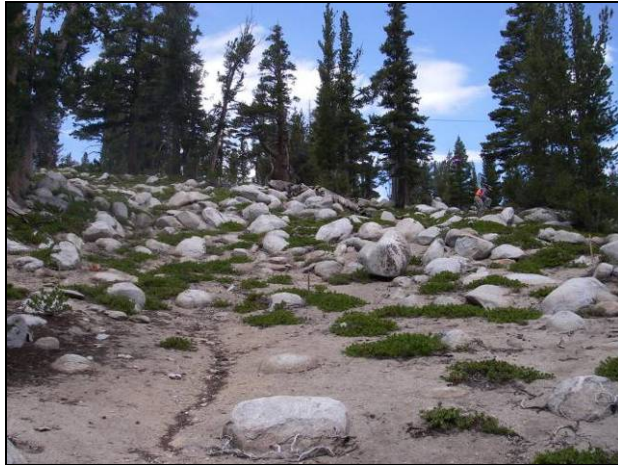
Figure 80. Heavenly Flyer bottom, pre-treatment, 2007.

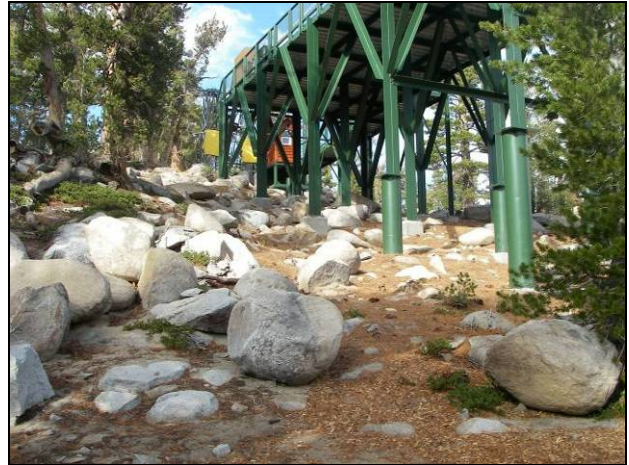
Figure 81. Heavenly Flyer bottom, post-treatment, 2008.
