Heavenly Mountain Resort Mitigation and Monitoring Plan Annual Report

October 2008 – October 2009

April 30, 2010

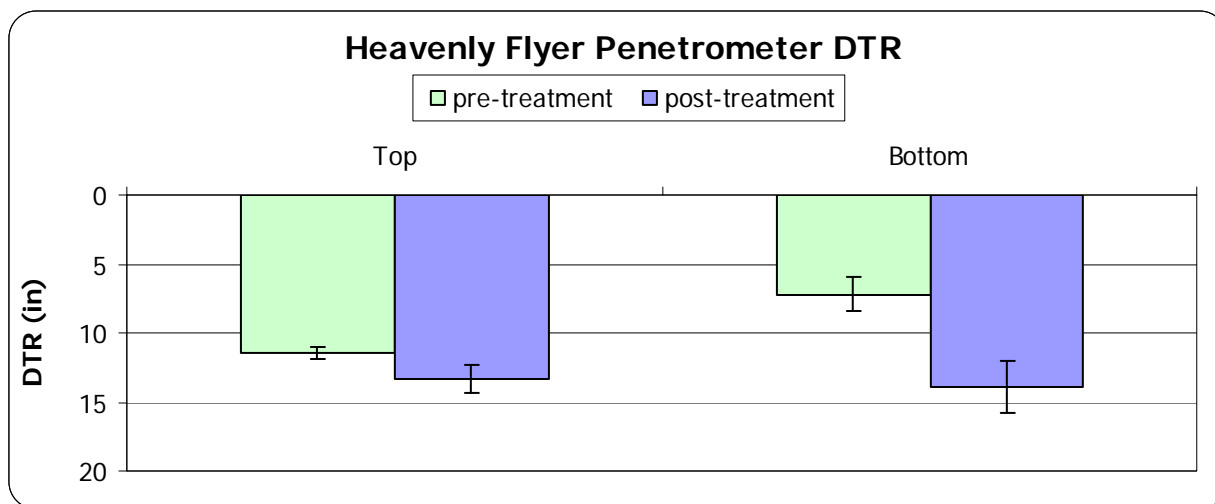
The penetrometer DTR at the Heavenly Flyer top post-treatment (13.3 inches) was similar to the DTR pre-treatment (11.4 inches; Figure 84). The penetrometer DTR at the Heavenly Flyer bottom post-treatment (14.0 inches) was 6.8 inches deeper than the DTR pre-treatment (7.2 inches). The success criterion, which requires the post-treatment DTR to be no more than 4.0 inches shallower than the pre-treatment DTR, was met.

Figure 84. Heavenly Flyer Penetrometer Depth to Refusal (DTR). The penetrometer DTR was similar pre- and post-treatment at the Heavenly Flyer Top. The DTR was 6.8 inches deeper post-treatment at the Heavenly Flyer Bottom. The error bars denote one standard deviation above and below the mean.

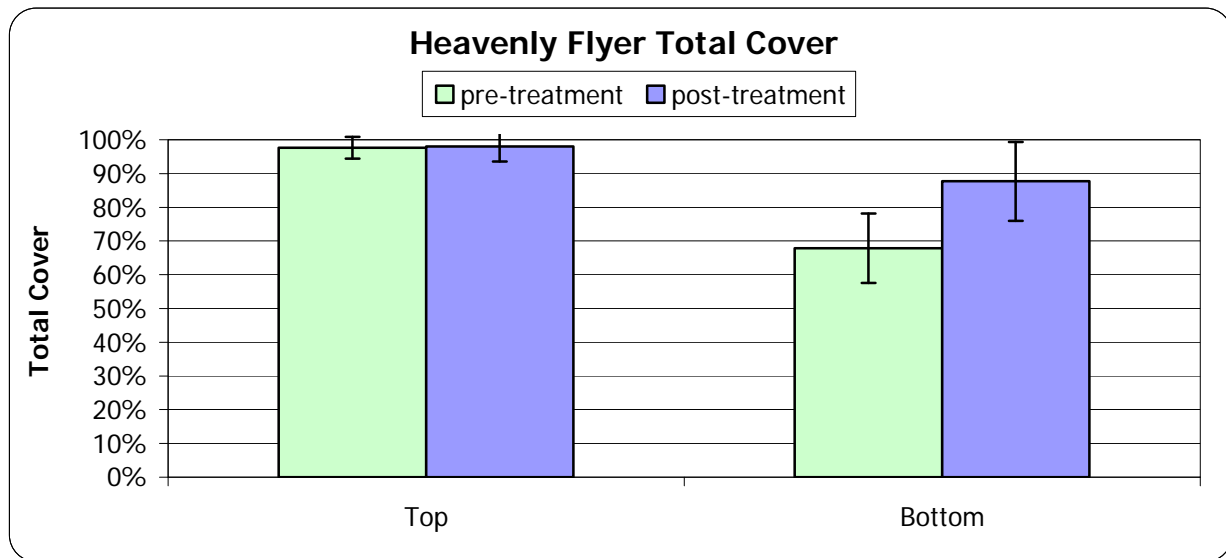
At the Heavenly Flyer top, the total cover post-treatment (98%) was the same as the total cover pre-treatment (98%, Figure 85). The cover composition changed from 58% mulch and 40% rocks/sand/gravel to 92% mulch and 6% rocks/sand/gravel. At the Heavenly Flyer bottom, the total cover post-treatment (88%) was 30% higher than the total cover pre-treatment (68%). Mulch cover increased from 42% to 72% following treatment. The success criterion, which is 70% total cover or greater, was met at both the Heavenly Flyer top and bottom.

Figure 85. Heavenly Flyer Total Cover. Total cover was similar pre- and post-treatment at the Heavenly Flyer top, and increased by 30% at the bottom. The error bars denote one standard deviation above and below the mean.

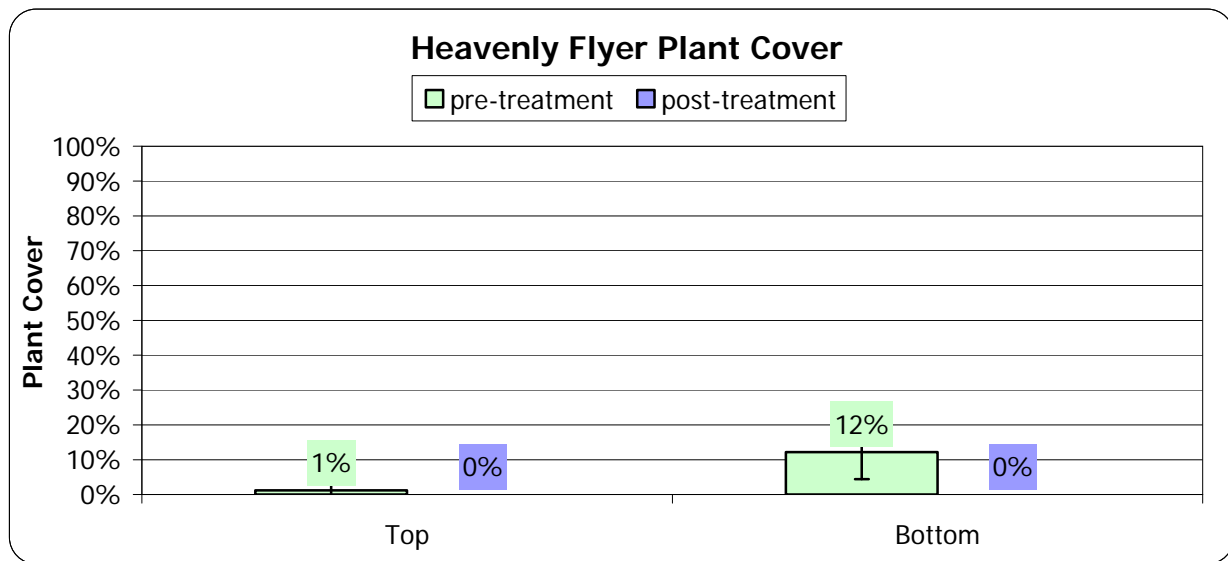
The post-treatment plant cover at Heavenly Flyer top (0%) was similar to the pre-treatment plant cover (1%; Figure 72). The post-treatment plant cover at the Heavenly Flyer bottom was 0%, compared to 12% pre-treatment. Ocular estimates indicated that there were trace amounts of cover by native plants (and one unknown species) at both plots that were not captured during cover point monitoring. This indicates that native plants are beginning to establish. The success criterion, which requires that post-treatment plant cover be at least 10%, was not met for either plot.

Figure 86. Heavenly Flyer Plant Cover. Plant cover was similar pre- and post-treatment at the Heavenly Flyer top, and decreased from 12% to zero at the bottom. The error bars denote one standard deviation above and below the mean.

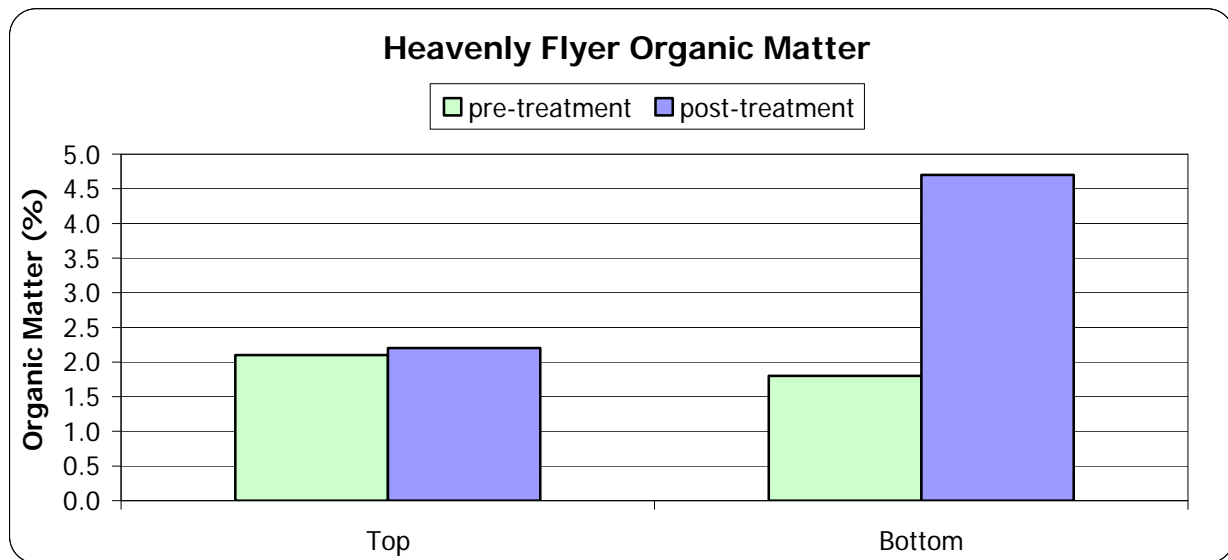
At the Heavenly Flyer top, the post-treatment organic matter (2.2%) was similar to the pre-treatment organic matter (2.1%; Figure 87). At the Heavenly Flyer bottom, the organic matter increased by 161% from 1.8% to 4.7%. The success criterion, which states that the post-treatment organic matter must be no more than 1.5 percentage points lower than the pre-treatment organic matter, was met for both the Heavenly Flyer top and bottom.

Figure 87. Heavenly Flyer Organic Matter. At Heavenly Flyer Top, organic matter content was similar pre- and post-treatment. At the Heavenly Flyer Bottom, it increased by 161% post-treatment.

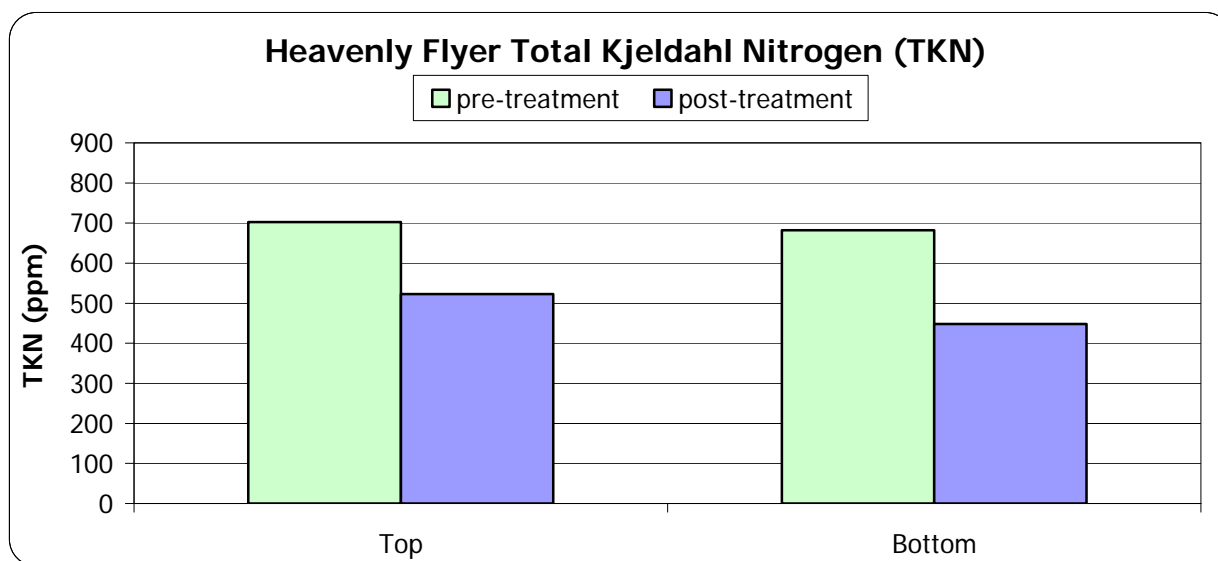
At the Heavenly Flyer top, the post-treatment TKN (523 ppm) was 26% lower than the pre-treatment TKN (703 ppm; Figure 88). At the Heavenly Flyer bottom, the post-treatment TKN (682 ppm) was 34% lower than the pre-treatment TKN (448 ppm). A success criterion for TKN was not used in 2009, as discussed in Appendix B.

Figure 88. Heavenly Flyer Total Kjeldahl Nitrogen (TKN). At the Heavenly Flyer top, the TKN decreased by 26% post-treatment. At the Heavenly Flyer bottom, the TKN decreased by 34% post-treatment

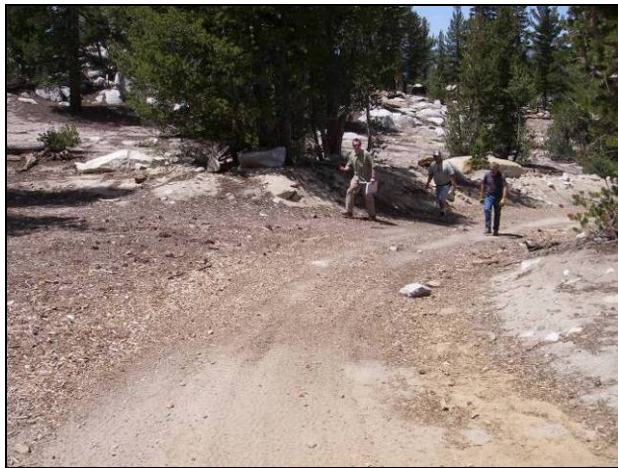
Figure 89. Mid Station Road, pre-treatment, 2007.

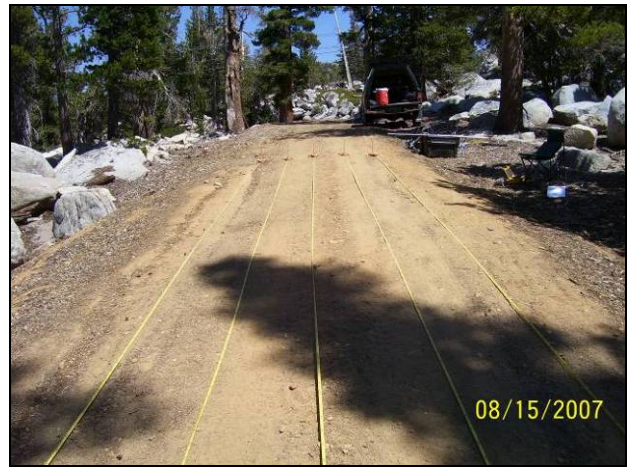
Figure 90. Mid Station Road, pre-treatment with monitoring transects, 2007.

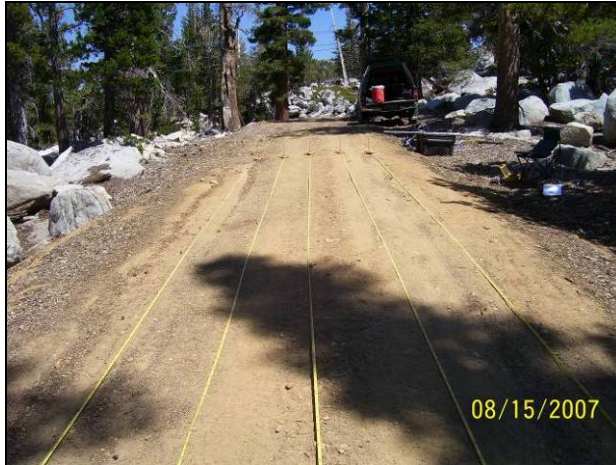
Figure 92. Mid Station Road, treatment area A, pre-treatment with monitoring transects, 2007.

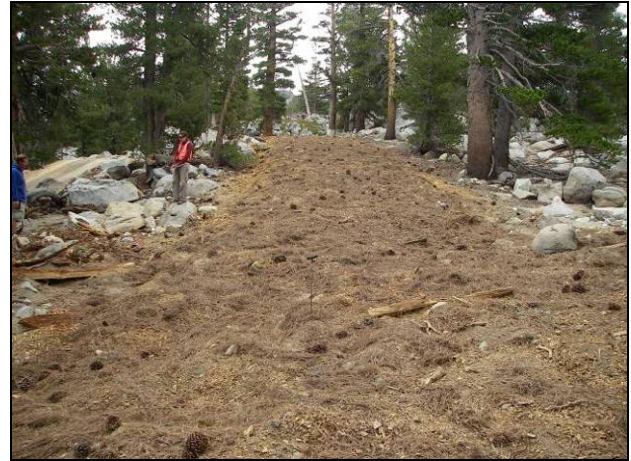
Figure 93. Mid Station Road, treatment area A, post-treatment, 2008.

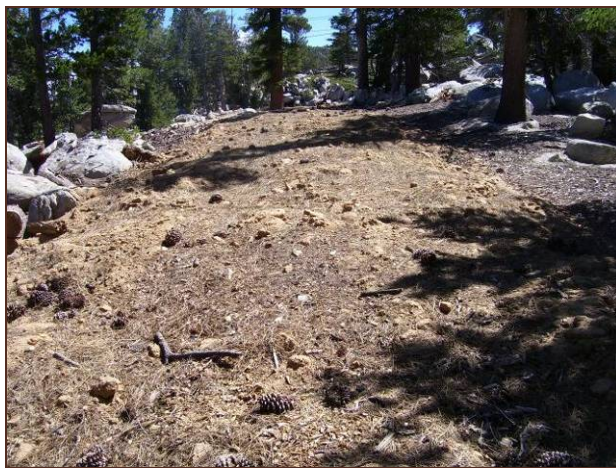
Figure 94. Mid Station Road, treatment area A, post-treatment, 2009.

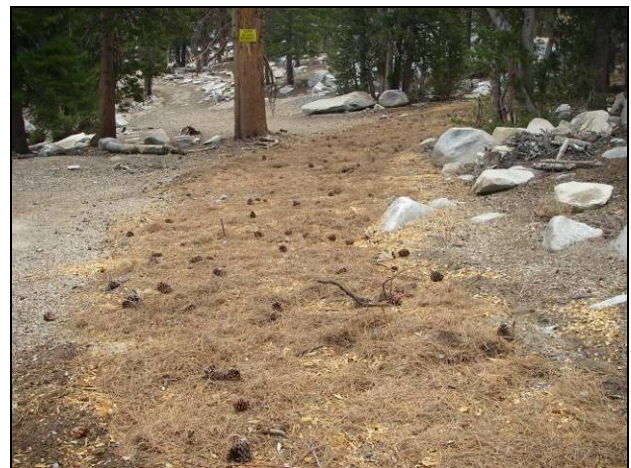
Figure 95. Mid Station Road, treatment area B, post-treatment, 2008.

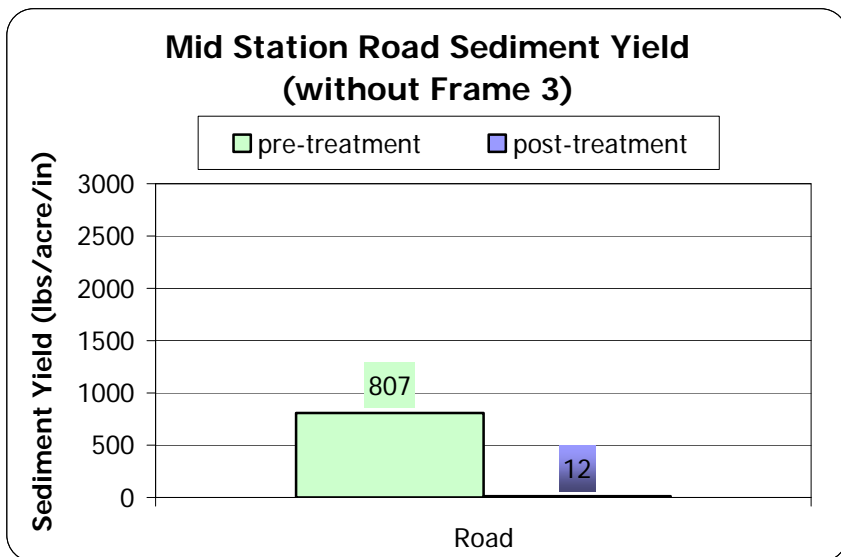
Figure 97. Mid Station Road Sediment Yield. When the Frame 3 outlier was removed, the post-treatment sediment yield was 99% lower compared to the pre-treatment sediment yield.

The high sediment yield at Frame 3 was most likely a result of the animal disturbance. Evidence of burrowing by a small rodent was observed in the frame immediately after the simulation.

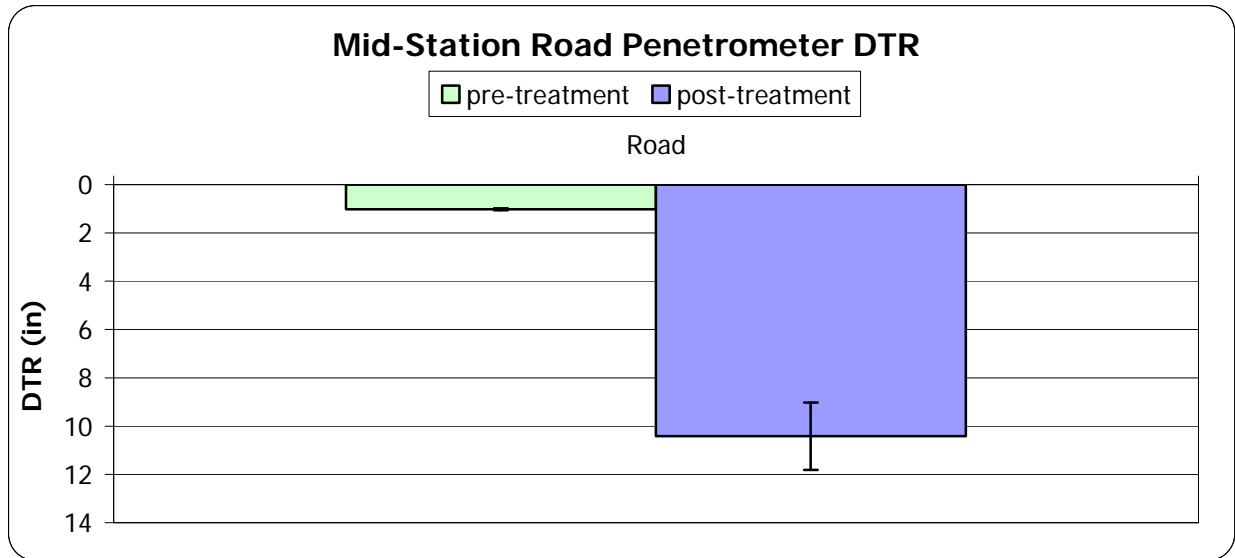
The depth to refusal at Mid Station Road post-treatment (10.4 inches) was 9.4 inches deeper than the pre-treatment DTR (1.0 inches; Figure 99). The success criterion, which dictates that the penetrometer DTR can be no more than 4.0 inches shallower than the pre-treatment DTR, was met.

Figure 99. Mid Station Road Penetrometer Depth to Refusal (DTR). The depth to refusal at Mid Station Road post-treatment was 10 times shallower than the pre-treatment. Error bars denote one standard deviation above and below the mean.

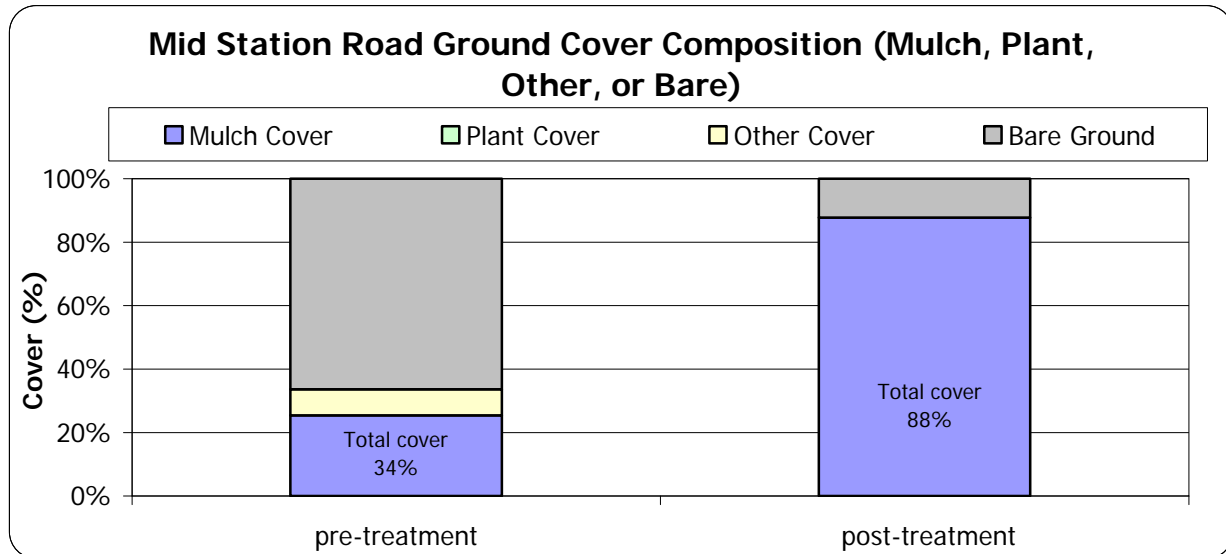
At Mid Station Road, the total cover post-treatment (88%) was 159% higher than the total cover pre-treatment (34%, Figure 100). The mulch cover increased by 252% from 25% to 88%. The success criterion, which states the total cover must be greater than 70% post-treatment, was met.

Figure 100. Mid Station Road Total Cover. At Mid Station Road, the total cover post-treatment was greater than 70% and 159% higher than pre-treatment total cover.

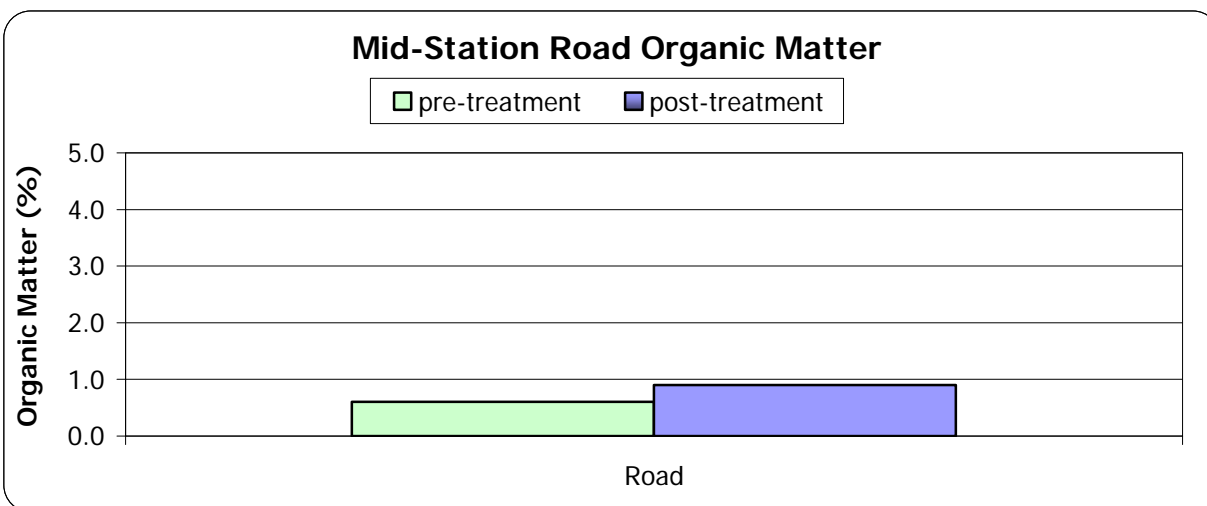
At Mid Station Road, the post-treatment organic matter (0.9%) was similar to the pre-treatment organic matter (0.6%; Figure 101). The success criterion, which states that the post-treatment organic matter must no more than 1.5 percentage points below the pre-treatment organic matter content, was met.

Figure 101. Mid Station Road Organic Matter. The post-treatment organic was similar to the pre-treatment organic matter.

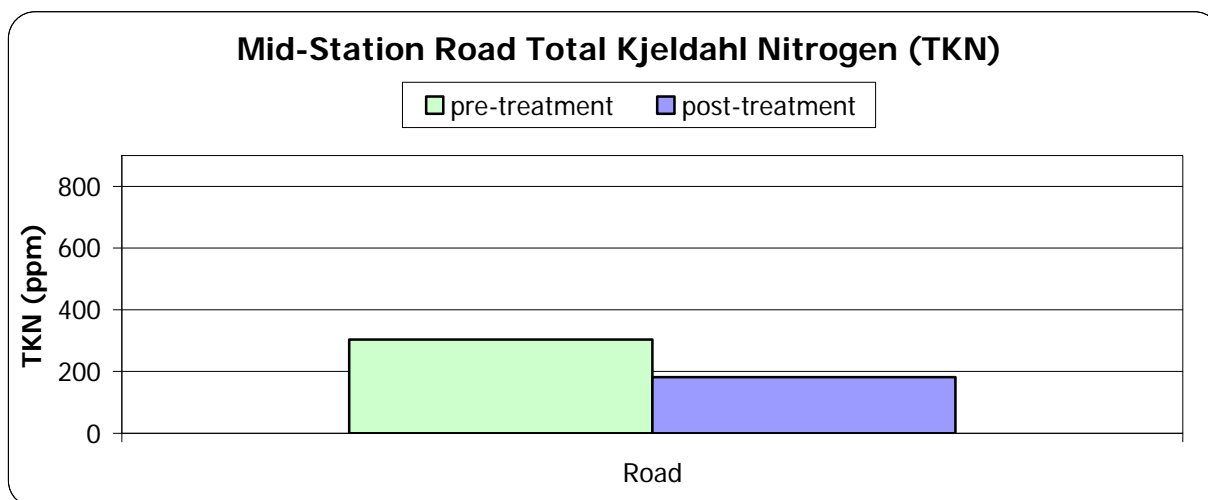
At Mid Station Road, the post-treatment TKN (182 ppm) was 40% or 122 ppm lower than the pre-treatment TKN (304 ppm; Figure 102). A success criterion for TKN was not used in 2009, as discussed in Appendix B.

Figure 102. Mid Station Road Total Kjeldahl Nitrogen (TKN). The post-treatment TKN was 40% lower than the pre-treatment TKN.

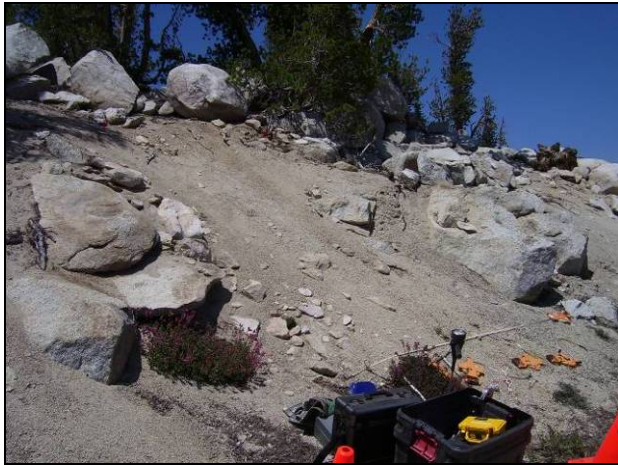
The cut slope, as the name implies, is a slope created from the construction the Skyline Trail (Figure 104, Figure 105, Figure 106, and Figure 107). It is very steep (approximately 33 degrees) and exhibited evidence of wind and water erosion pre-treatment. Rills were visible throughout the slope and pine needle movement from water erosion was apparent. Located at approximately 9,600 feet AMSL on an east-facing slope, it is in an exposed area that has greater than 90% solar exposure in the summer months. The soil is derived from granitic parent material and has a low proportion of rocks. Little vegetation is present at this high elevation site. Whitebark pine (*Pinus albicaulis*) are present with an understory of penstemon (*Penstemon sp.*) and buckwheat (*Eriogonum sp.*). Tahoe draba (*Draba asterophora var. asterophora*), a rare native plant, is present in the surrounding area.

Figure 104. Skyline Trail cut slope, pre-treatment, 2008.

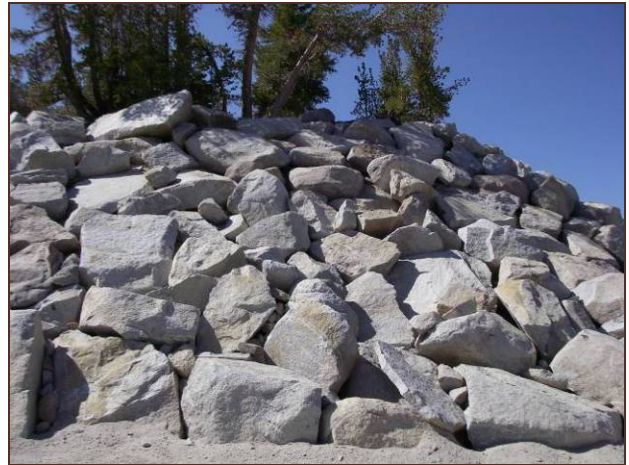
Figure 105. Skyline Trail cut slope, post-treatment, 2009.

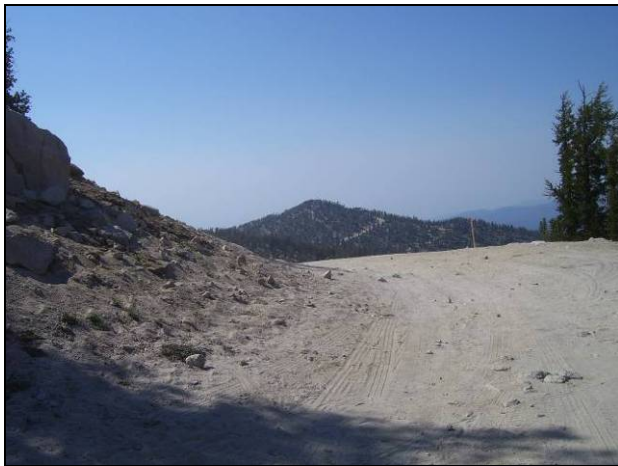
Figure 106. Skyline Trail cut slope and road shoulder, pre-treatment, 2008

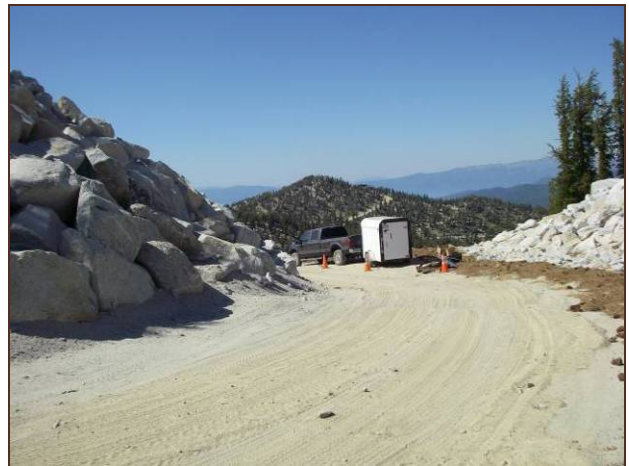
Figure 107. Skyline Trail cut slope and road shoulder, post-treatment, 2009

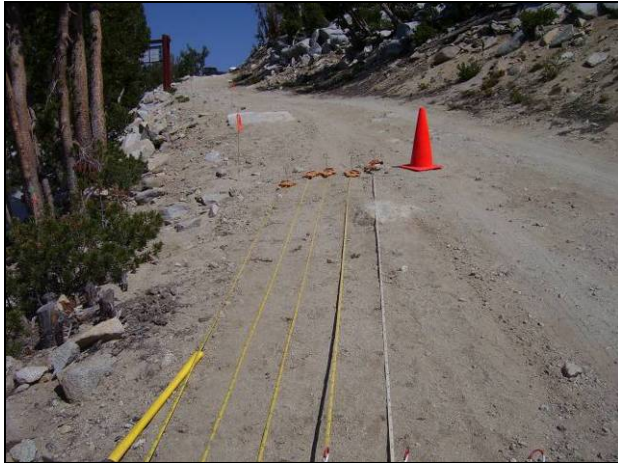
The road shoulder treatment area is located along the same road as the cut slope, just downhill at approximately 9,580 feet AMSL (Figure 108 and Figure 109). Pre-treatment, it was a very disturbed area, with evidence of foot traffic and tire tracks. Both rills and gullies were present. The area is gently sloped at approximately 8 degrees, faces west, and has a summer solar exposure of greater than 90%. The soil is derived from granitic parent material and has a low proportion of rocks. No vegetation was present within the sampling area and little vegetation is present in the surrounding area at this high elevation site, especially in the understory. Trees that are present include whitebark pine (*Pinus albicaulis*) and mountain hemlock (*Tsuga mertensiana*). Tahoe draba (*Draba asterophora* var. *asterophora*), a rare native plant, is present in the surrounding area.

Figure 108. Skyline Trail road shoulder monitoring area, pre-treatment, 2008.

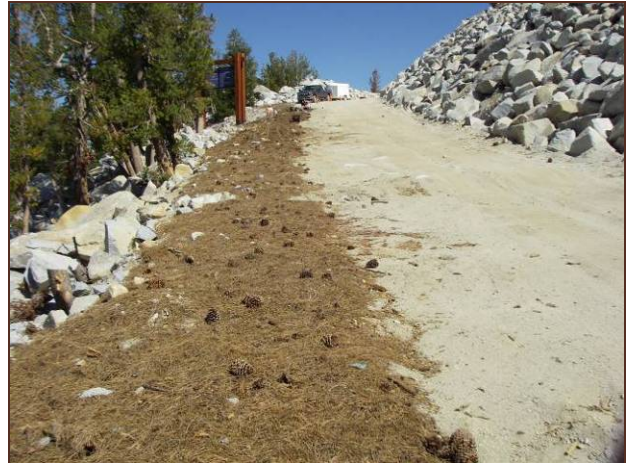
Figure 109. Skyline Trail road shoulder monitoring area, post-treatment, 2009.

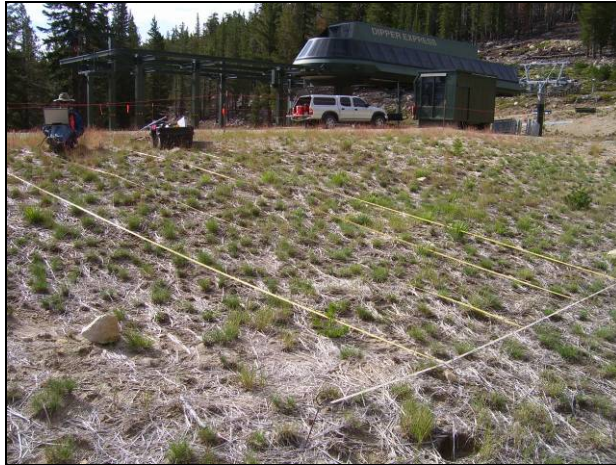
The Dipper bottom slope is located near the bottom terminal of the Dipper chairlift in a disturbed area (Figure 110 and Figure 111). Pre-treatment, there was evidence of water erosion, including rills and a drainage gully with sedimentation. There was also disturbance from small and large animals, including burrowing and grazing. This area is frequented by deer and coyotes, as feces were present throughout the site. The site is located on a west-facing slope at an elevation of 8,636 feet AMSL. The solar exposure for this gently sloped site (6 degrees) is greater than 95% during the summer because no canopy cover is present. The soil is derived from granitic parent material with approximately 40% composition by rocks greater than 0.5 inches in diameter. Species present in the surrounding area include greenleaf manzanita (*Arctostaphylos patula*), tobacco brush (*Ceanothus velutinus*), red fir (*Abies magnifica*), and Western white pine (*Pinus monticola*). There were three invasive species present within the monitoring area: common sheep sorrel (*Rumex acetosella*), creeping bentgrass (*Agrostis stolonifera*) and orchard grass (*Dactylis glomerata*). A mix of approximately 50% native species and 50% non-native species of forbs and shrubs were present. The high proportion of non-native species may be attributed to the straw mulch present at the site. Non-native seeds are often present in straw. A few native shrubs and tree seedlings were also present in the plot.

Figure 110. Skyline Trail Dipper bottom slope monitoring area, pre-treatment, 2008.

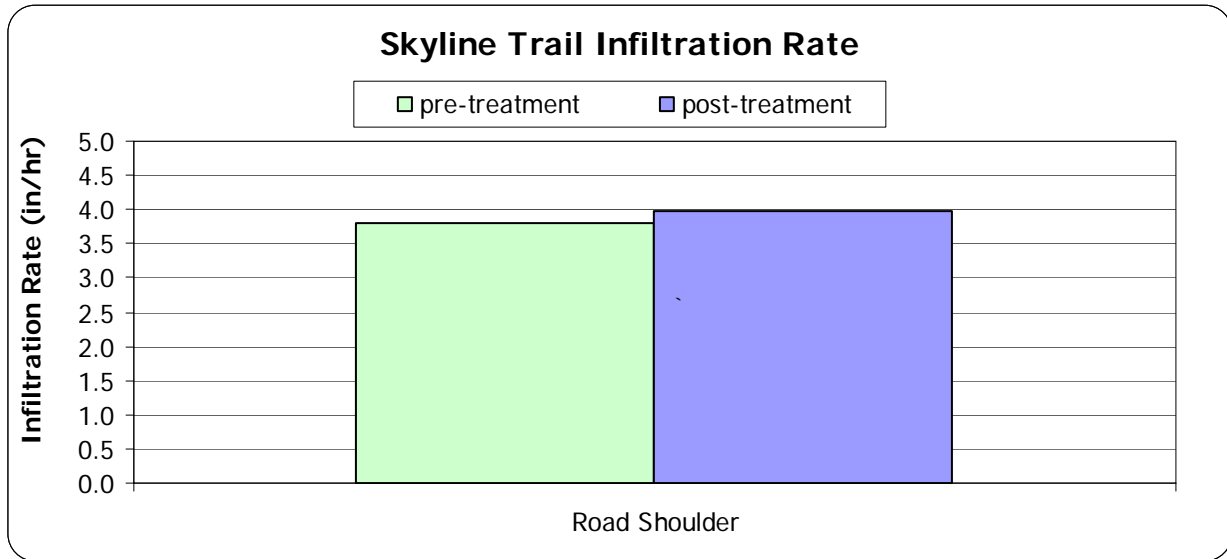
The post-treatment average infiltration rate at the Skyline Trail cut slope (4.0 in/hr) was similar to the pre-treatment average infiltration rate (3.8 in/hr; Figure 119). The success criterion, which states the post-treatment infiltration rate must be no more than 1.5 in/hr lower than the pre-treatment infiltration rate, was met.

Figure 119. Skyline Trail Infiltration Rate. The pre- and post-treatment infiltration rates were similar.

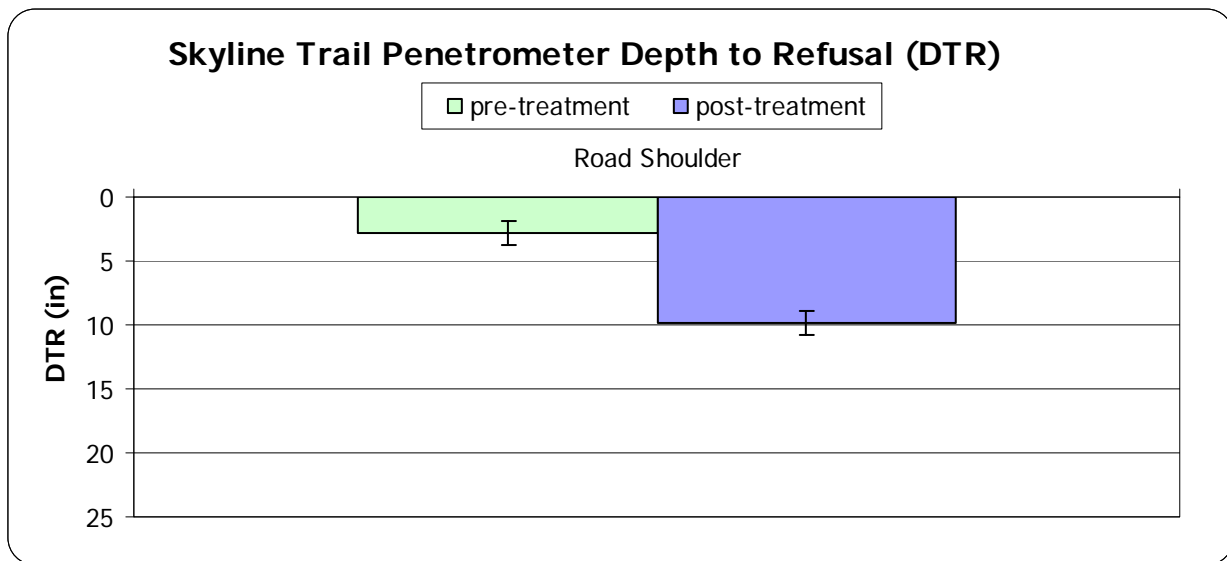
The post-treatment penetrometer DTR at the Skyline Trail road shoulder (9.8 inches) was 7 inches deeper than the pre-treatment DTR (2.8 inches, Figure 120). This meets the criterion, which states that the post-treatment penetrometer DTR must be no more than 4.0 inches shallower than the pre-treatment penetrometer DTR.

Figure 120. Skyline Trail Penetrometer Depth to Refusal (DTR). The post-treatment DTR was 7 inches deeper than the pre-treatment DTR. The error bars denote one standard deviation above and below the mean.

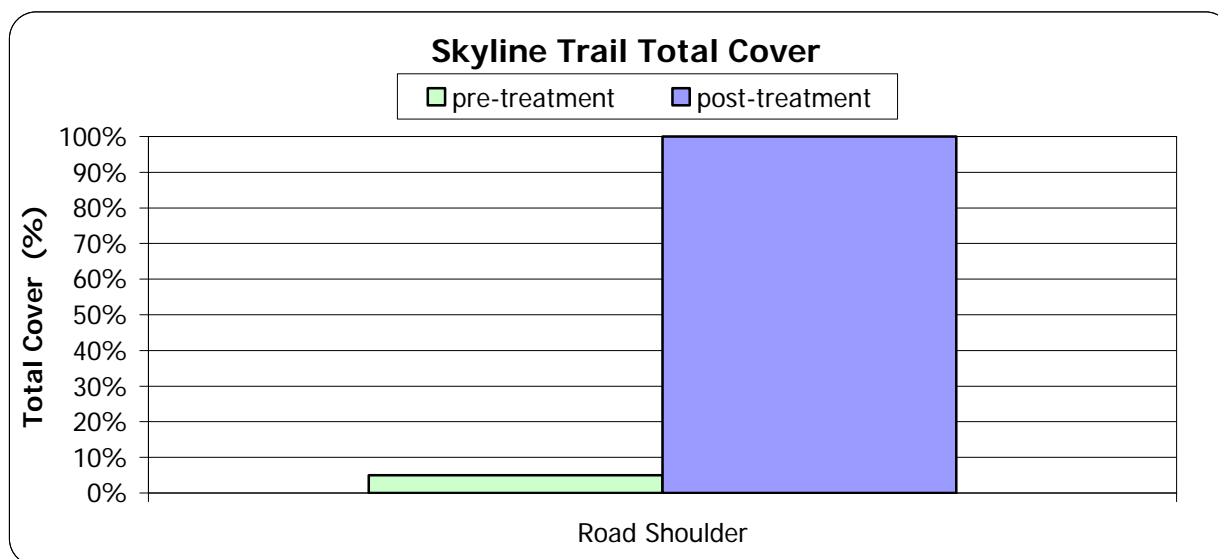
The post-treatment total cover at the Skyline Trail road shoulder (100%) was approximately 1900% greater than the pre-treatment ocular estimate of total cover (5%; Figure 121). The criterion, which states that the post-treatment total cover must be greater than 70%, was met.

Figure 121. Skyline Trail Total Cover. Total cover improved to 100% post-treatment. The pre-treatment total cover is an ocular estimate.

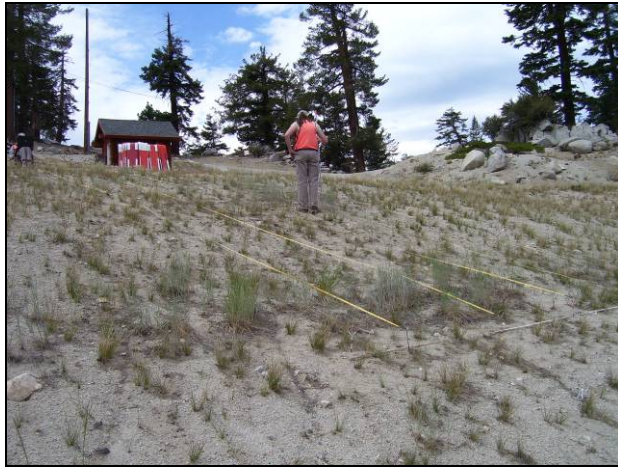
The Gun Barrel top terminal slope (Gun Barrel top slope) is a disturbed slope with a summer road that switchbacks through it (Figure 123 and Figure 124). The site is located on a northeast facing slope at an elevation of 8,303 feet AMSL. The site is moderately sloped (14 degrees), does not have any canopy cover, and a solar exposure of greater than 95% during the summer months. The soil is derived from granitic parent material with a low proportion of rocks greater than 0.5 inches in diameter. Conifers surround the area, which is dominated by red fir (*Abies magnifica*), Jeffrey pine (*Pinus jeffreyi*), and Western white pine (*Pinus monticola*). Greenleaf manzanita (*Arctostaphylos patula*) dominates the understory in the surrounding area. The monitoring area contains a variety of native and non-native forbs and grasses, with a few native shrub and tree seedlings. None of the non-native species are classified as invasive or noxious.

Figure 123. Gun Barrel top terminal slope monitoring area, pre-treatment, August 2008.

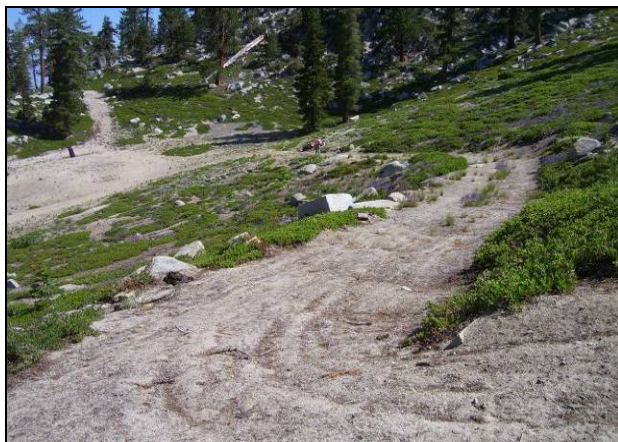
The old water tank road is an unpaved road that will be restored after the water tank is removed in 2010 (Figure 125 and Figure 126). Most of the road faces north-northwest at an elevation of approximately 8,261 feet AMSL. The road is gently sloped in mostly places, approximately 6 degrees. There is no canopy cover and the solar exposure is about 90% during the summer months. The solar exposure is lower at the southern part of the road near the existing water tank. The soil is derived from granitic parent material with a low proportion of rocks greater than 0.5 inches in diameter. Conifers surround the area, which is dominated by red fir (*Abies magnifica*), Jeffrey pine (*Pinus jeffreyi*), and Western white pine (*Pinus monticola*). Greenleaf manzanita (*Arctostaphylos patula*) dominates the understory, which also contain a variety of native forbs and grasses.

Figure 125. Old Water Tank Road, pre-treatment, looking downhill from the water tank site.

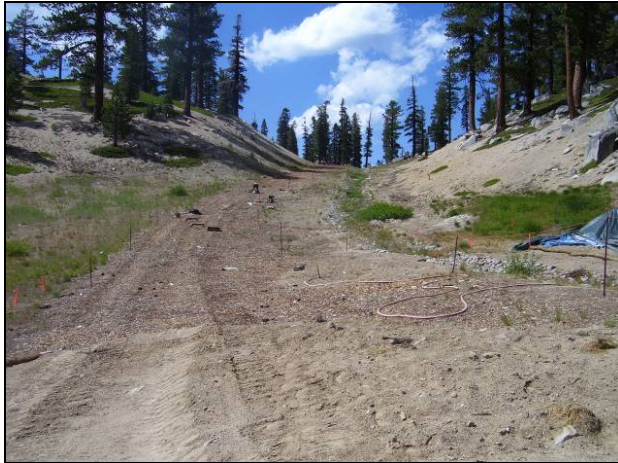
Figure 137. Treatment areas E, F and G, post-treatment, August 2009. Heavy machinery tracks are visible.

At Patsy's Trail in August 2009, heavy machinery tracks were observed as well as small bare areas created by burrowing animals in the monitoring plot (Figure 137). The area was treated again in fall 2009, and no further disturbances were observed. Therefore, the criterion, which states that no visible signs of rills, gullies, sediment transport, or sediment deposition can be present, was met.

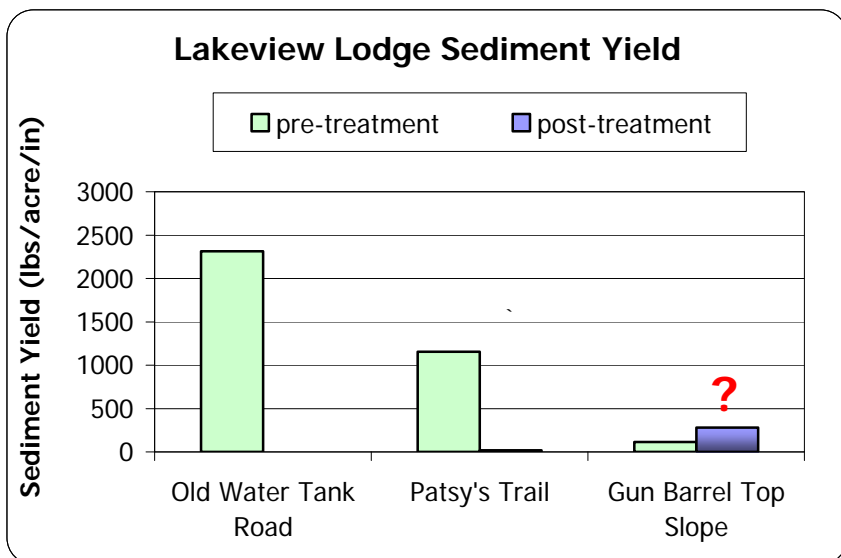
The pre-treatment sediment yield at the old water tank road was 2,314 lbs/acre/in (Figure 139). Post-treatment infiltration and sediment yield monitoring will be conducted in 2010 after the old water tank is removed.

The post-treatment sediment yield at the Gun Barrel top slope (280 lbs/acre/in) was 143% higher than the pre-treatment sediment yield (115 lbs/acre/in). This increase was a result of the strange runoff substance collected at Frame 1 (see the call out box next to Figure 139 for details). Without Frame 1 included, the post-treatment sediment yield was zero at the Gun Barrel top slope and the success criterion, which states that the post-treatment sediment yield must be no more than 100 lbs/acre/in higher than the pre-treatment sediment yield, was met (Figure 140).

Figure 139. Lakeview Lodge Sediment Yield. Sediment yield at the Gun Barrel top slope increased by 143% (from 115 to 280 lbs/acre/in) when Frame 1 was included. The post-treatment sediment yield at Patsy's trail was 19 lbs/acre/in, a 98% reduction. Runoff simulation was conducted at Patsy's Trail pre-treatment, while rainfall simulation was conducted post-treatment.

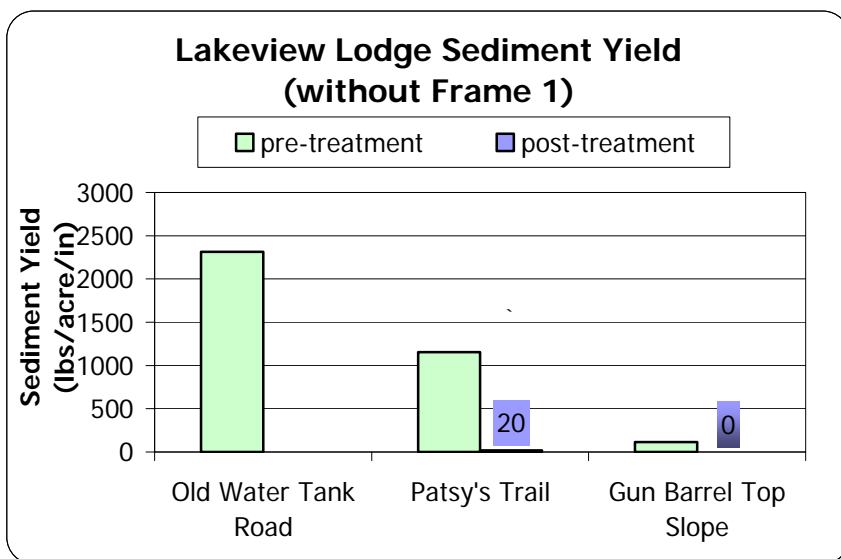
Figure 140. Lakeview Lodge Sediment Yield (Without Frame 1). Sediment yield at the Gun Barrel top slope decreased from 115 lbs/acre/in to zero when frame 1 was removed from the average. Runoff simulation was conducted at Patsy's Trail pre-treatment, while rainfall simulation was conducted post-treatment.

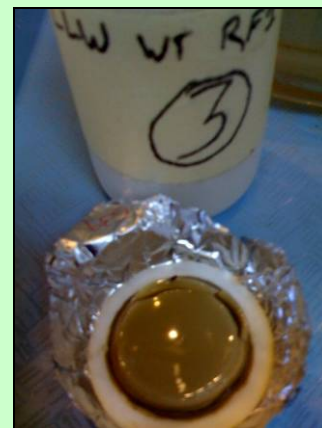
Frame 1 produced a highly cohesive gelatinous substance while filtering to determine sediment yield that has not been observed before (see photo below of filtered sample). Consultation with University of Davis faculty did not help to identify the substance.

Without this frame included in the average, the post-treatment sediment yield was zero, a decrease of 115 lbs/acre/in from pre-treatment.

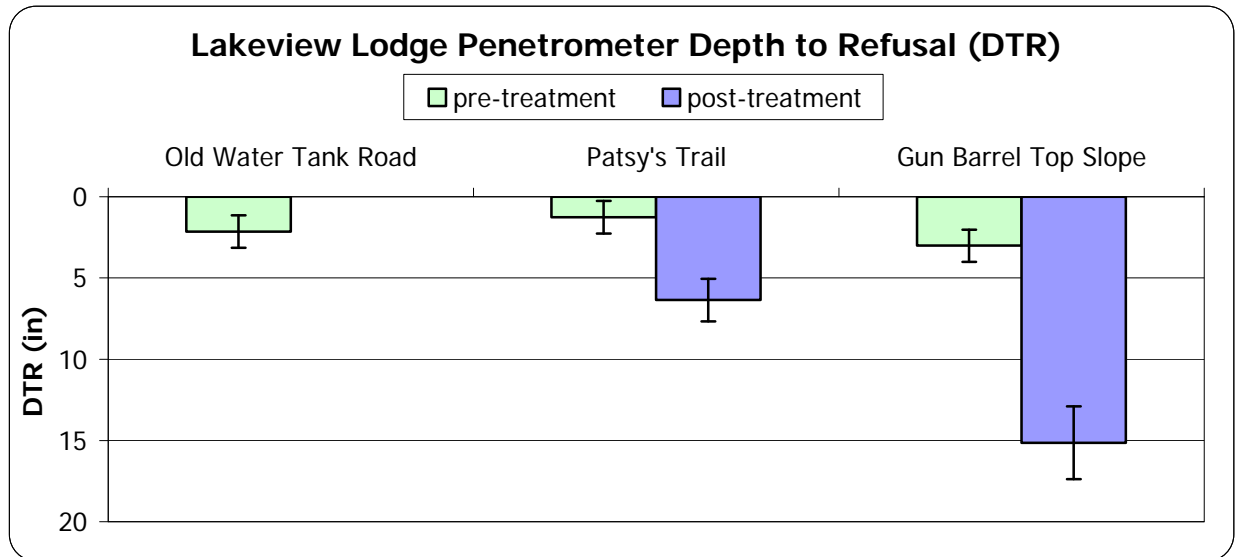
The pre-treatment penetrometer DTR at the old water tank road was 2.0 inches (Figure 142). The post-treatment penetrometer DTR at Patsy's trail (6.4 inches) was 5.1 inches deeper than the pre-treatment DTR (1.3 inches). The post-treatment penetrometer DTR at the Gun Barrel top slope (15.1 inches) was 12.1 inches deeper than the pre-treatment penetrometer DTR (3.0 inches). The success criterion, which states the post-treatment DTR cannot be more than 4.0 inches shallower than the pre-treatment DTR, was met.

Figure 142. Lakeview Penetrometer Depth to Refusal (DTR). Penetrometer DTR increased post-treatment at Patsy's Trail and Gun Barrel top slope by 5.1-12.1 inches. Post-treatment measurements were not taken at the old water tank road. Error bars represent one standard deviation above and below the mean.

Patsy's Trail was re-treated after post-treatment monitoring occurred in 2009; therefore, further penetrometer monitoring is recommended in 2010 to ensure that a tilling depth comparable to the 2009 treatment was achieved. Cover monitoring for 2010 is also recommended since the re-treatment will affect the total cover.

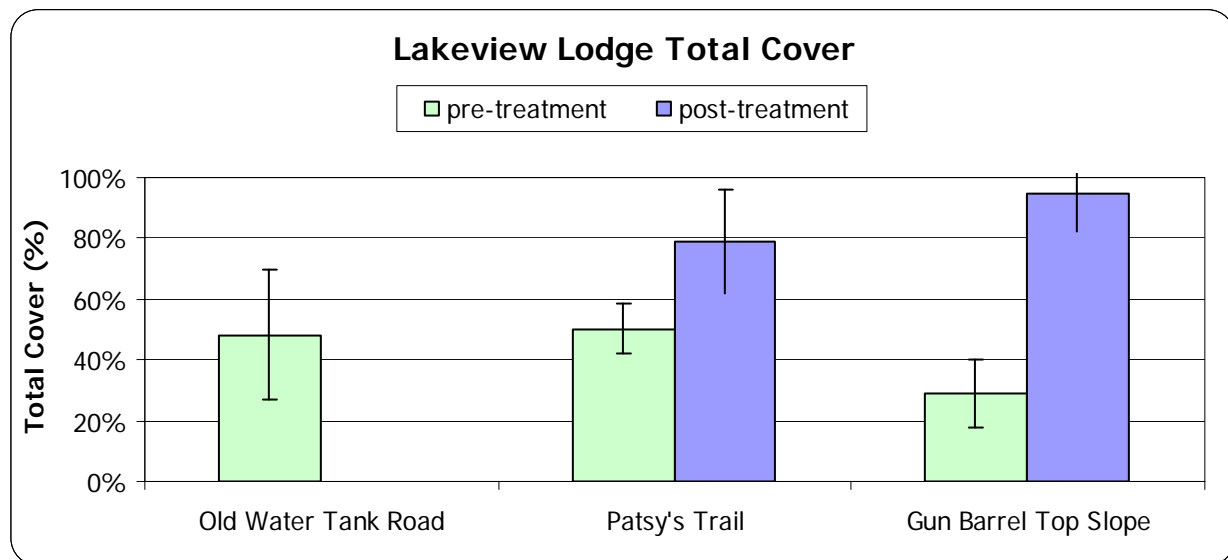
The pre-treatment total cover at the old water tank road was 48% (Figure 143). The total cover consisted of 11% cover by mulch and 36% cover by gravel/rocks. The post-treatment total cover at Patsy's Trail (79%) was 58% higher than the pre-treatment total cover (50%). The mulch cover, which increased from 33% to 76%, accounted for most of the gain in total cover. The post-treatment total cover at the Gun Barrel top slope (95%) was 228% higher than the pre-treatment total cover (29%). The mulch cover increased from 24% to 95% post-treatment. The success criterion, which states that the total cover must be greater than 70%, was met for both plots.

Figure 143. Lakeview Lodge Total Cover. Total cover increased by 58-228% post-treatment at Patsy's Trail and the Gun Barrel top slope. Post-treatment measurements were not taken at the old water tank road. The error bars denote one standard deviation above and below the mean.

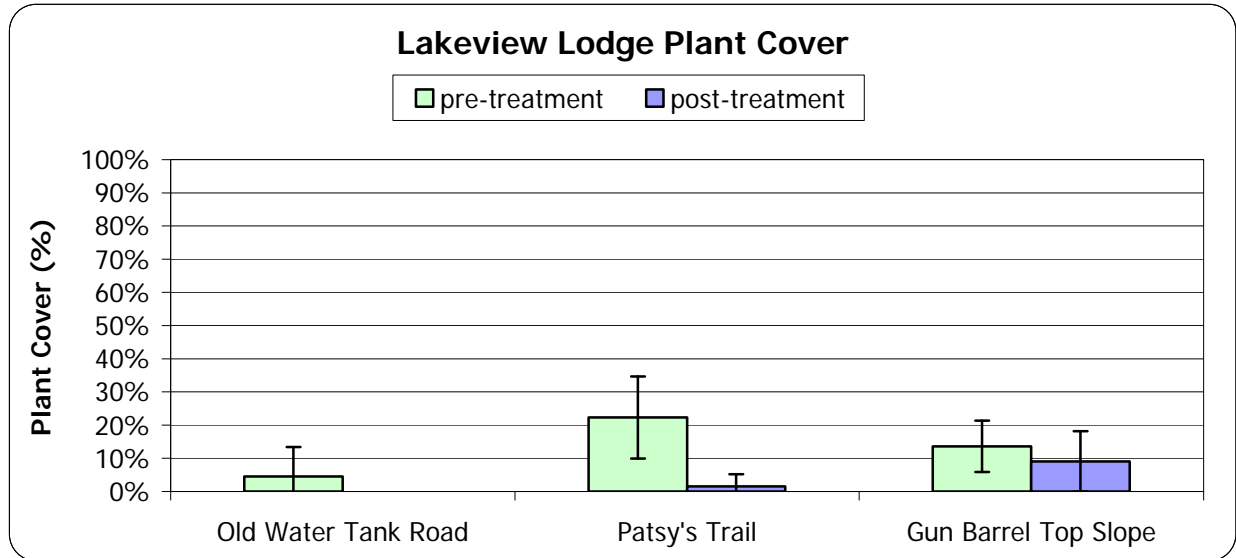
The pre-treatment plant cover was 5% at the old water tank road (Figure 144). The post-treatment plant cover at Patsy's Trail (2%) was 91% lower than the pre-treatment plant cover (22%). The post-treatment plant cover at the Gun Barrel top slope (9%) was 36% lower than the pre-treatment plant cover (14%). The success criterion, which states the post-treatment plant cover must be at least 10%, was not met for either plot.

Figure 144. Lakeview Lodge Plant Cover. Plant cover decreased at both sites following treatment post-treatment. Post-treatment measurements were not taken at the old water tank road. The error bars denote one standard deviation above and below the mean.

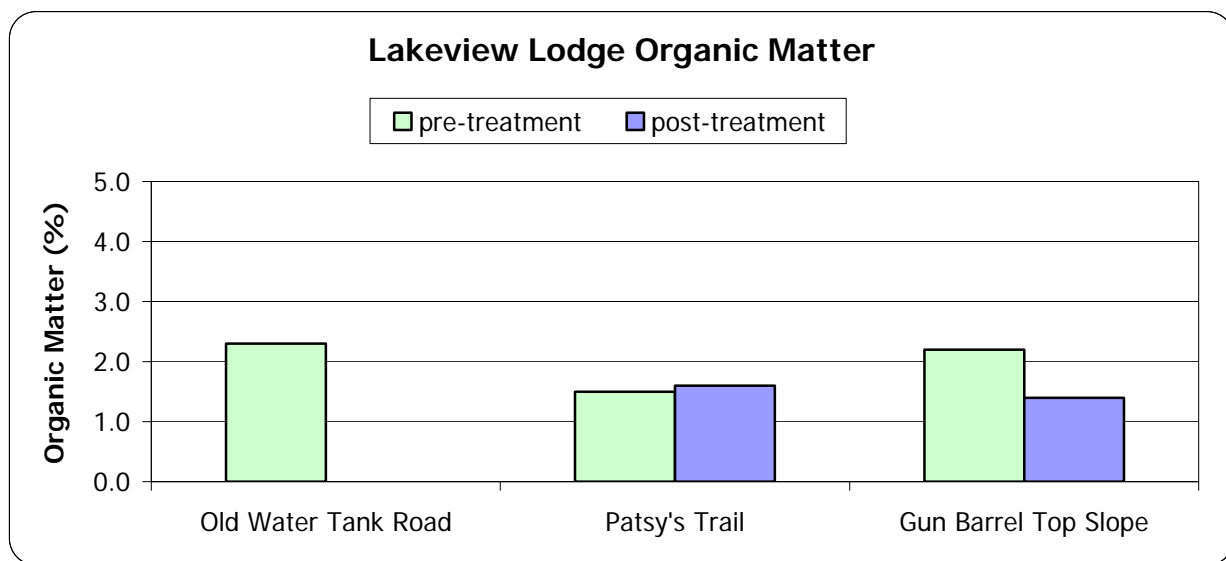
The pre-treatment organic matter content at the old water tank road was 2.3% (Figure 145). The post-treatment organic matter content at Patsy's Trail (1.6%) was similar to the pre-treatment organic matter content (1.5%). The post-treatment organic matter content at the Gun Barrel top slope (1.4%) was 36% or 0.8 percentage points lower than pre-treatment organic matter content (2.2%). The criterion, which states that the post-treatment organic matter content must be no more than 1.5 percentage points lower than the pre-treatment organic matter content, was met for both Patsy's Trail and the Gun Barrel top slope.

Figure 145. Lakeview Organic Matter Content. At Patsy's Trail, organic matter content did not change markedly pre- and post-treatment, while it decreased by 0.8 percentage points at the Gun Barrel top slope. Post-treatment measurements were not taken at the old water tank road.
