Heavenly Mountain Resort Mitigation and Monitoring Plan Annual Report

October 2008 – October 2009

April 30, 2010

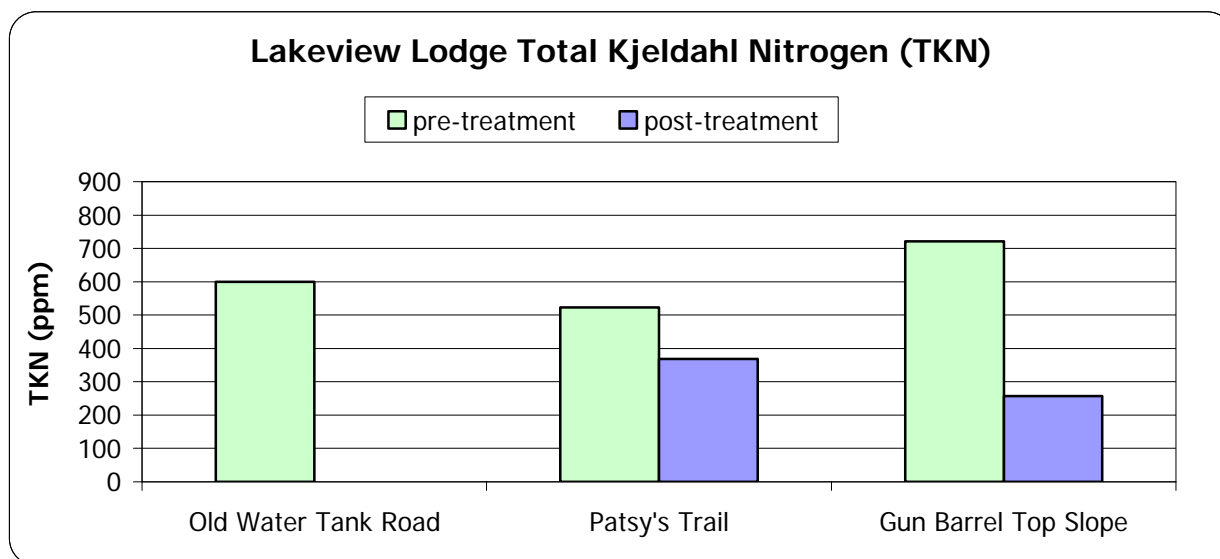
The pre-treatment TKN at the old water tank road was 600 ppm (Figure 146). The post-treatment TKN at Patsy's Trail (368 ppm) was 30% lower than the pre-treatment TKN (523 ppm). The post-treatment TKN at the Gun Barrel top slope (257 ppm) was 64% percent lower than the post-treatment TKN (721 ppm). A success criterion for TKN was not used in 2009, as discussed in Appendix B.

Figure 146. Lakeview Lodge Total Kjeldahl Nitrogen (TKN). TKN decreased by 30-64% at Patsy's Trail and the Gun Barrel top slope. Post-treatment measurements were not taken at the old water tank road.

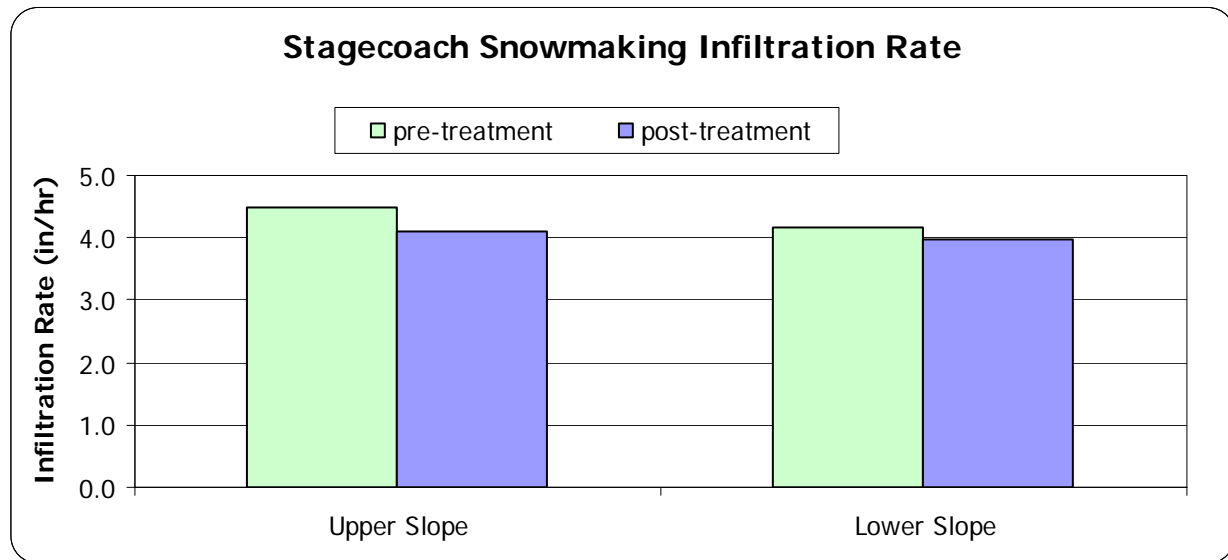
The post-treatment infiltration rate at the Stagecoach upper slope (4.1 in/hr) was similar to the pre-treatment infiltration rate (4.5 in/hr; Figure 162). The post-treatment infiltration rate at the Stagecoach lower slope (4.0 in/hr) was similar to the pre-treatment infiltration rate (4.2 in/hr). The success criterion, which states the post-treatment infiltration rate must be no more than 0.8 in/hr lower than the pre-treatment infiltration rate, was met at both plots.

Figure 162. Stagecoach Snowmaking Infiltration Rate. Infiltration rates were similar pre- and post-treatment. Post-treatment infiltration rates were above 4.0 in/hr.

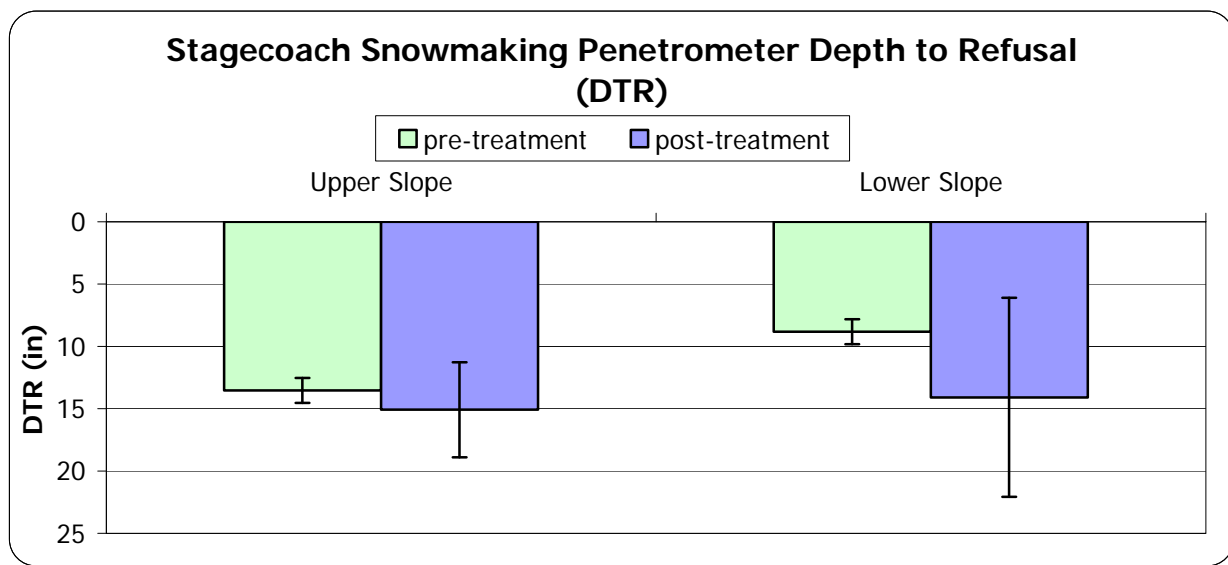
The post-treatment penetrometer DTR at the Stagecoach upper slope (15.1 inches) was 1.6 inches deeper than the pre-treatment DTR (13.5 inches; Figure 163). The post-treatment DTR at the Stagecoach lower slope (14.1 inches) was 5.3 inches deeper than the pre-treatment DTR (8.8 inches). At the lower slope, the penetrometer DTRs were inconsistent between skier's left and right of this slope, with skier's left having shallower penetrometer DTRs. This resulted in a high standard deviation (8 inches) for the penetrometer measurements and the large range of sediment yields among the three rainfall frames (Figure 161). The success criterion, which states that the post-treatment DTR cannot be more than 4.0 inches shallower than the pre-treatment DTR, was met for both plots. However, had the penetrometer DTR been measured separately at the skier's left area at the lower slope, the criterion would not have been met for skier's left.

Figure 163. Stagecoach Penetrometer Depth to Refusal (DTR). Penetrometer DTRs increased by 1.6 and 5.3 inches post-treatment. Error bars denote one standard deviation above and below the mean.

Although the penetrometer and sediment yield success criteria were met for the lower slope, consistently low penetrometer measurements (less than 2 inches) were recorded on the skier's left portion of the treatment area. The rainfall frame in this part of the treatment area produced the highest sediment yield, which was 58% higher than the average pre-treatment sediment yield. Further penetrometer monitoring is recommended on the skier's left portion of the slope and within the area of disturbance above the monitoring plot to determine the scope of the problem. If widespread compaction is found, further tilling may be necessary. Any additional management responses will be determined following the penetrometer monitoring.

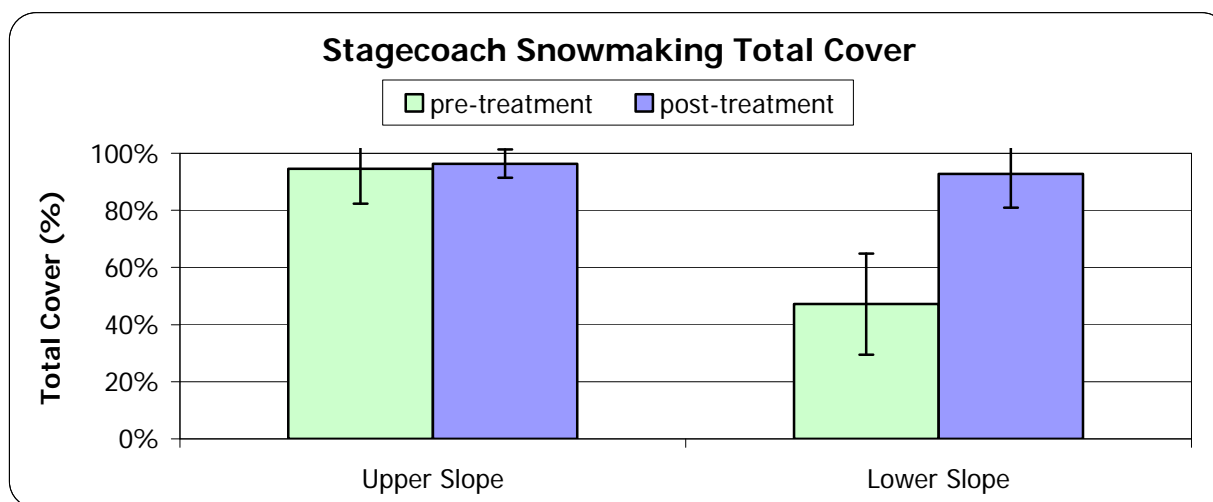
The post-treatment total cover at the Stagecoach upper slope (96%) was similar to the pre-treatment total cover (95%; Figure 164). The post-treatment total cover at the Stagecoach lower slope (93%) was nearly double the pre-treatment total cover (47%). The success criterion, which states that the post-treatment total cover must be greater than 70% post-treatment, was met for both plots.

Figure 164. Stagecoach Snowmaking Total Cover. Total cover was above 90% for both plots post-treatment. Error bars denote one standard deviation above and below the mean.

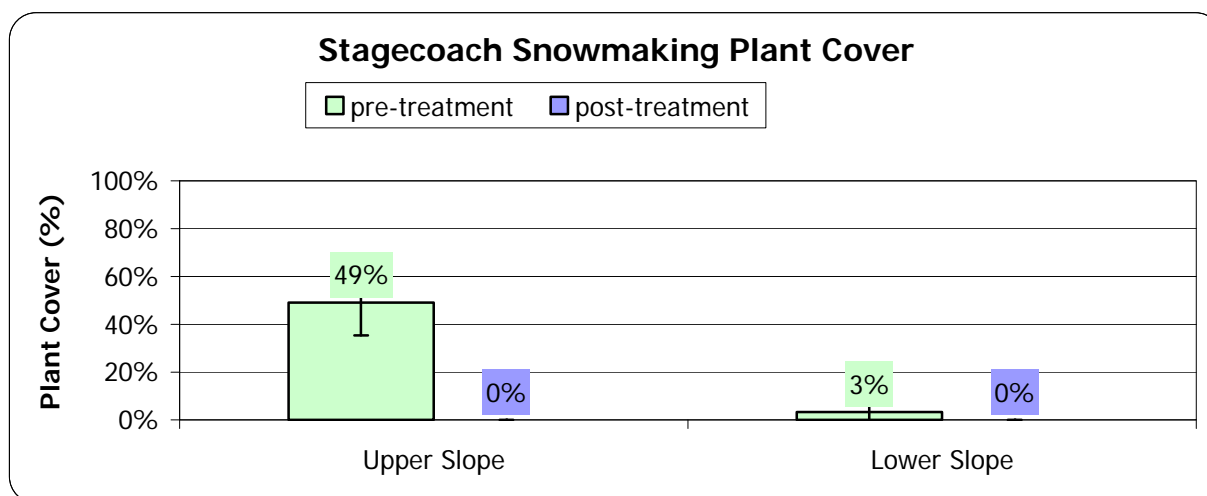
The plant cover at the Stagecoach upper slope decreased from 49% pre-treatment to zero post-treatment. The plant cover at the Stagecoach lower slope decreased from 3% to zero post-treatment. The success criterion, which states that the post-treatment plant must be 10% or greater, was not met for either plot.

Figure 165. Stagecoach Snowmaking Plant Cover. Plant cover decreased to zero at both plots post-treatment. The error bars denote one standard deviation above and below the mean.

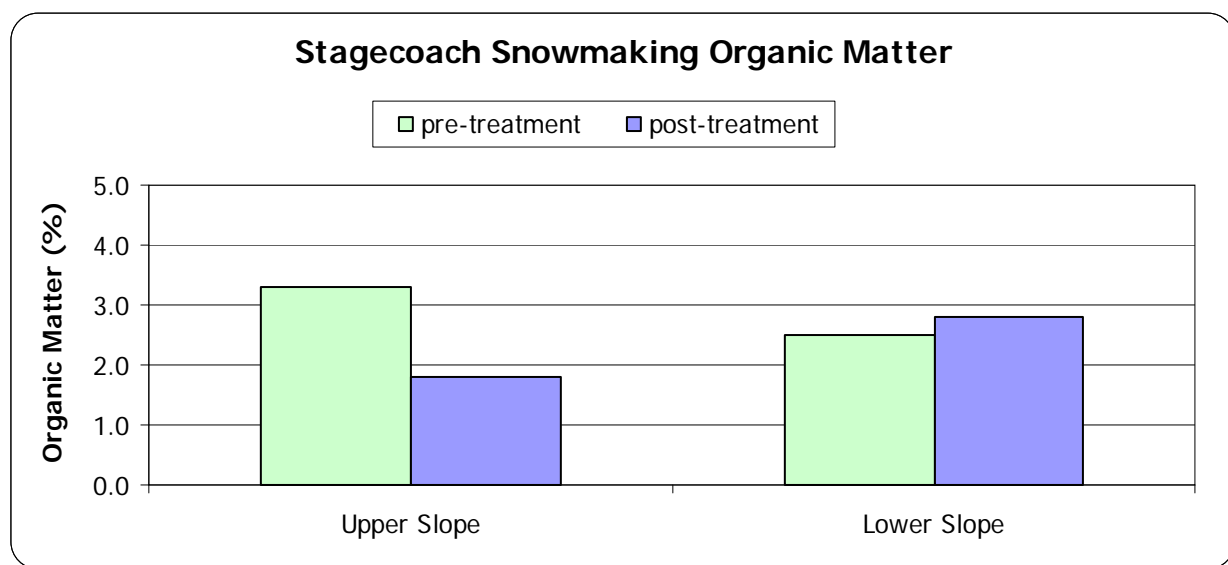
The post-treatment organic matter content at the Stagecoach upper slope (1.8%) was 46% or 1.5 percentage points lower than the pre-treatment organic matter content (3.3%; Figure 166). The post-treatment organic matter content at the Stagecoach lower slope (2.8%) was 12% higher than the pre-treatment organic matter content (2.5%). The success criterion, which states the post-treatment organic matter content must be no more than 1.5 percentage points lower than the pre-treatment organic matter content, was met for both the upper slope and the lower slope.

Figure 166. Stagecoach Organic Matter. Organic matter content declined by 46% at the upper slope, and increased by 12% at the lower slope.

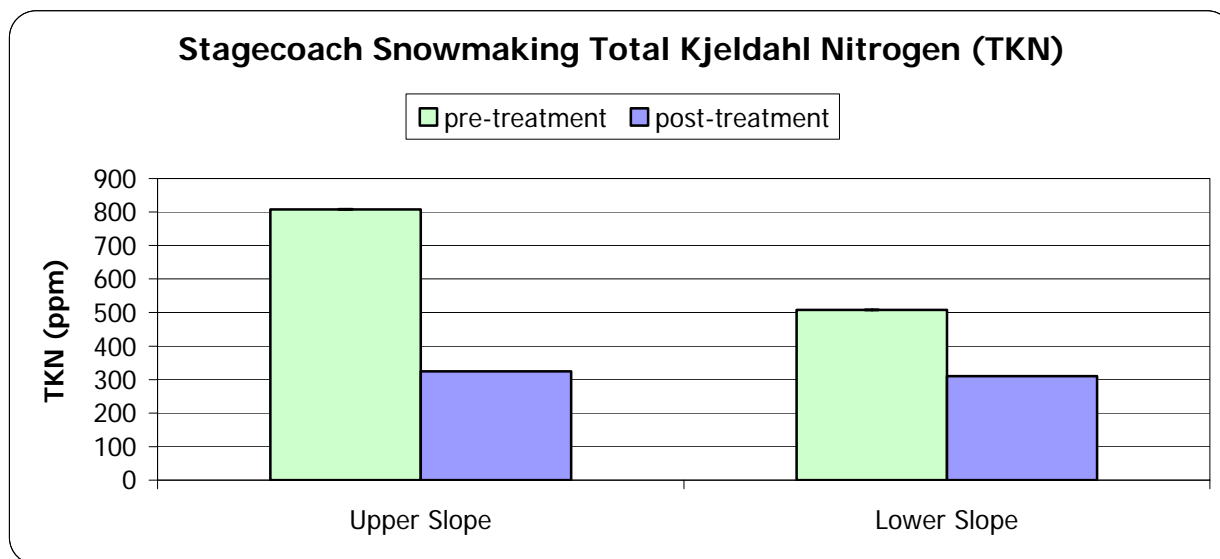
The post-treatment TKN at the Stagecoach upper slope (324 ppm) was 60% or 484 ppm lower than the pre-treatment TKN (808 ppm; Figure 167). The post-treatment TKN at the Stagecoach lower slope (310 ppm) was 39% or 198 ppm lower than the pre-treatment TKN (508 ppm). A success criterion for TKN was not used in 2009, as discussed in Appendix B.

Figure 167. Stagecoach Snowmaking Total Kjeldahl Nitrogen (TKN). The TKN decreased by 39% to 60% at the Stagecoach upper and lower plots.

deeply into the soil profile likely resulted in reduced nutrient concentration and, therefore, lower TKN measured in soil samples. In future projects where topsoil salvage and reuse is used, it is recommended that topsoil is mixed into the top 4-6 inches of soil after deeper loosening is completed. Additionally, since most of the organic matter and nutrients in high elevation decomposed granite soil are concentrated in a relatively thin and fragile topsoil/duff layer, some of which is often lost during removal/replacement, soil amendment additions are recommended to supplement the salvaged topsoil on similar projects in the future. Rather than recommending immediate treatment action to increase vegetation cover, another year of cover monitoring is recommended to better understand the long term trajectory for plant cover. If monitoring in 2010 indicates an increasing trend in plant cover, follow up treatments may not be necessary. However, if measurable plant cover is not present in 2010, treatment actions such as fertilizing, seeding and/or irrigation will be necessary to help achieve success criteria.

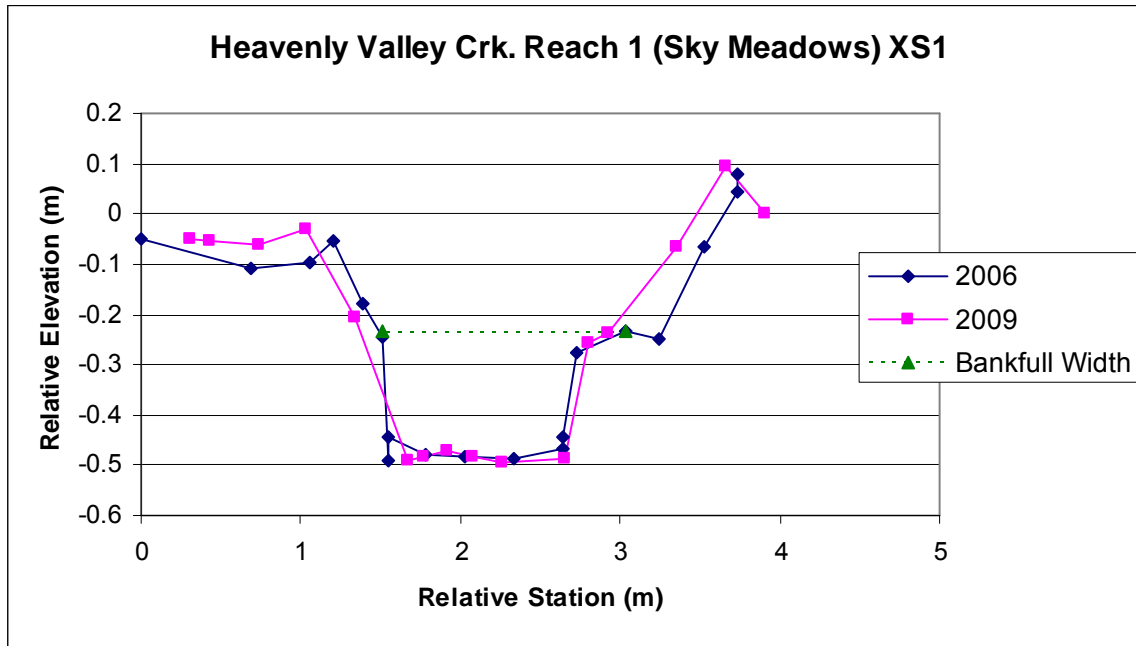
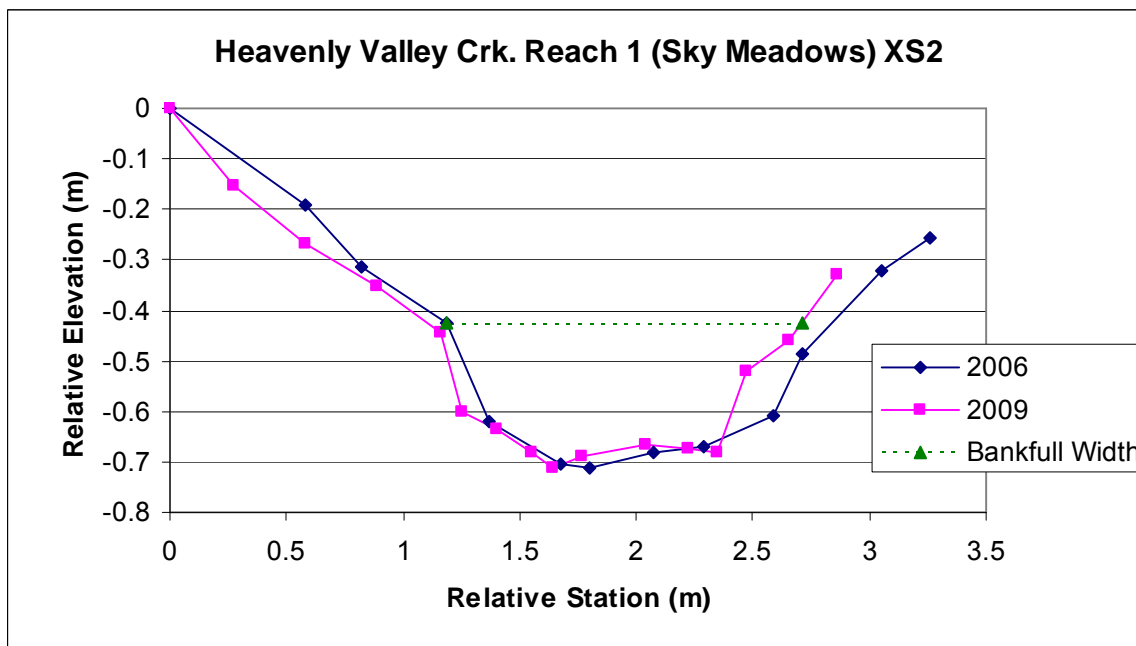
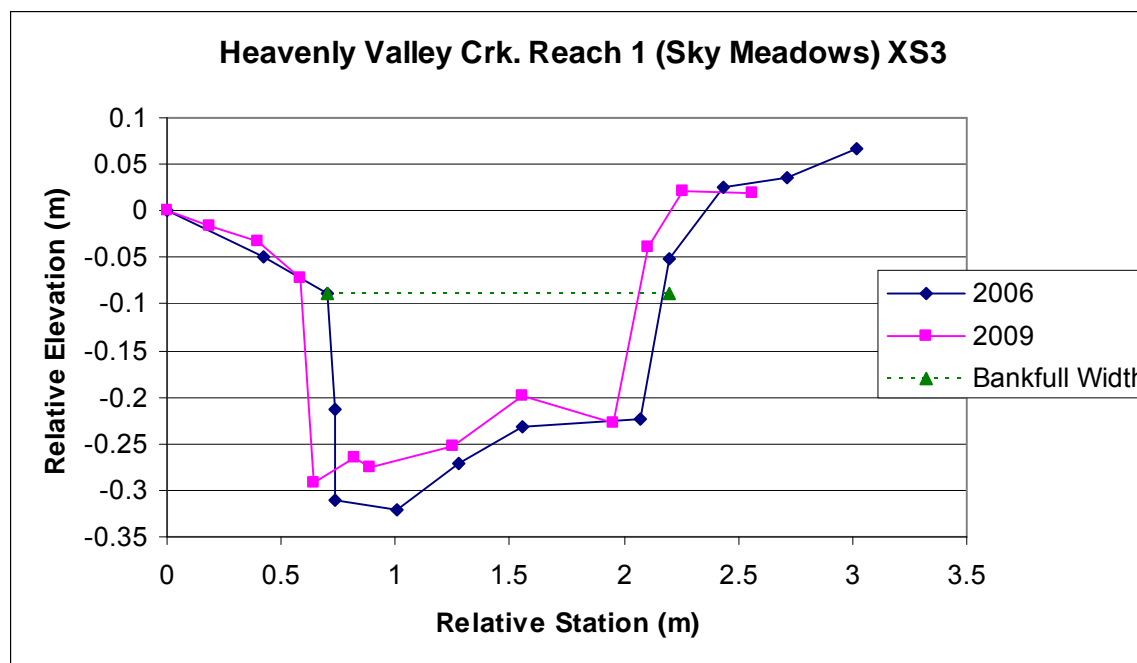
In general stream conditions have improved since 2006, with deepening pools, more stable banks, and less vulnerable banks. The amount of woody debris has also increased. The 2006 and 2009 cross section profiles for the three cross-sections (XS-1 through XS-3) situated within this reach are presented in Figures 5.3 – 5.5. There is very little change in the cross sections between 2006 and 2009. The right bank headpin at cross section one (XS-1) and both headpins at cross section three (XS-3) had been buried by fallen and decaying meadow vegetation and the left bank headpin at cross section two (XS-2) was buried by an eroding bank. These headpins were located using a metal detector prior to commencing the cross section surveys.

Figure 5.3. Permanent Cross Section number 1 (XS-1) HVC-1, Sky Meadows, along Heavenly Valley Creek.

Figure 5.4. Permanent Cross Section number 2 (XS-2) for HVC-1, Sky Meadows, along Heavenly Valley Creek.

Figure 5.5. Permanent Cross Section number 3 (XS-3) for HVC-1, Sky Meadows, along Heavenly Valley Creek.

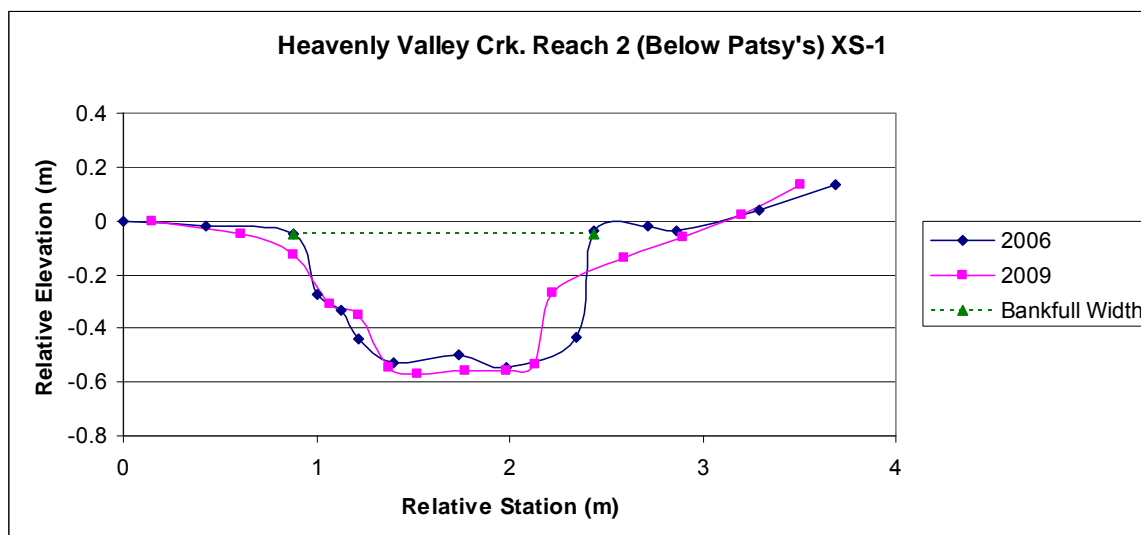
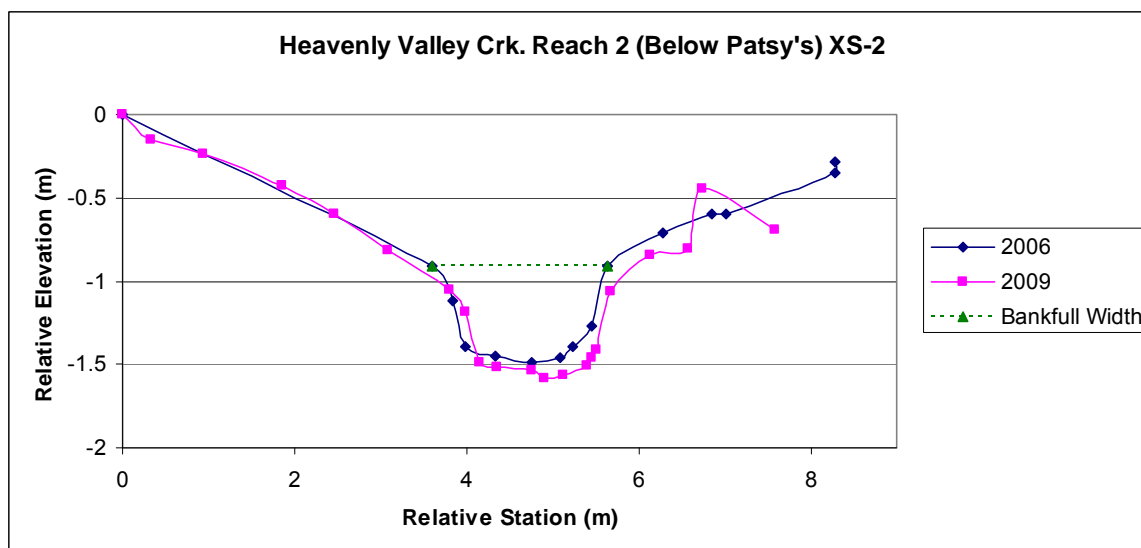
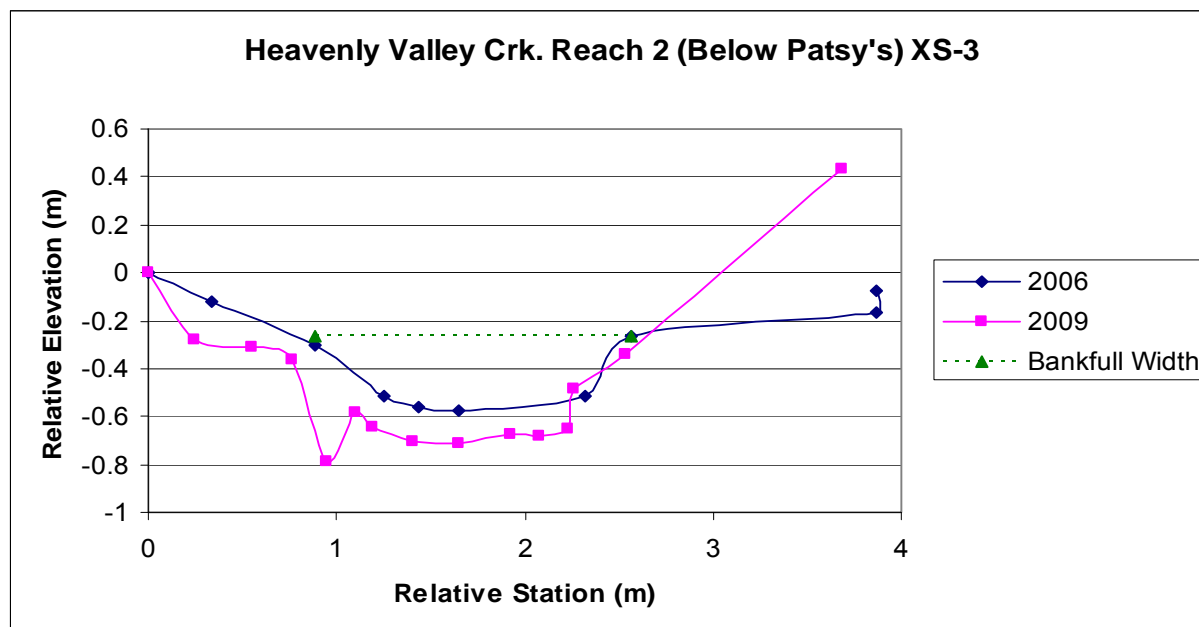
In general channel conditions have improved since 2006. Permanent cross-sections for Below Patsy's, HVC-2, are graphed in Figures 5.6 – 5.8. The cross sections show very little change between 2006 and 2009. These cross-sections are graphed and presented with the cross-sections surveyed in 2006. All cross-sections are graphed from rebar monuments. Elevation and station measurements are graphed relative to the left bank rebar stake. The base of the rebar stake on the left bank is the zero, zero point.

Figure 5.6. Permanent Cross Section number 1 (XS-1) for HVC-2, Below Patsy's, along Heavenly Valley Creek

Figure 5.7. Permanent Cross Section number 2 (XS-2) for HVC-2, Below Patsy's, along Heavenly Valley Creek

Figure 5.8. Permanent Cross Section number 3 (XS-3) for HVC-2, Below Patsy's, along Heavenly Valley Creek.

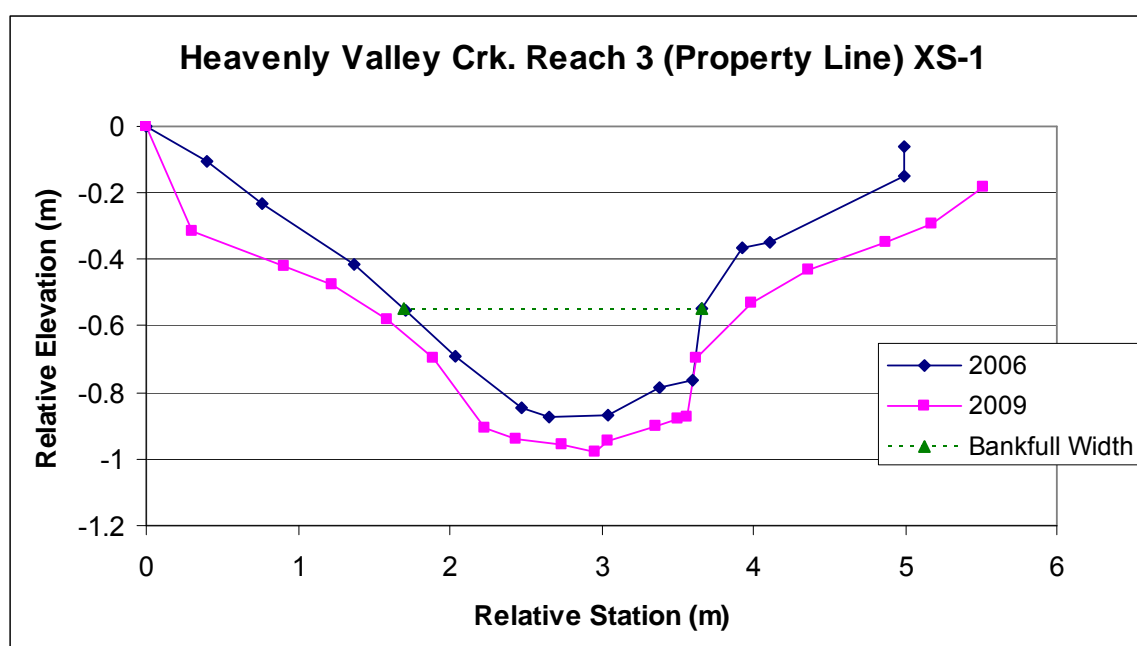
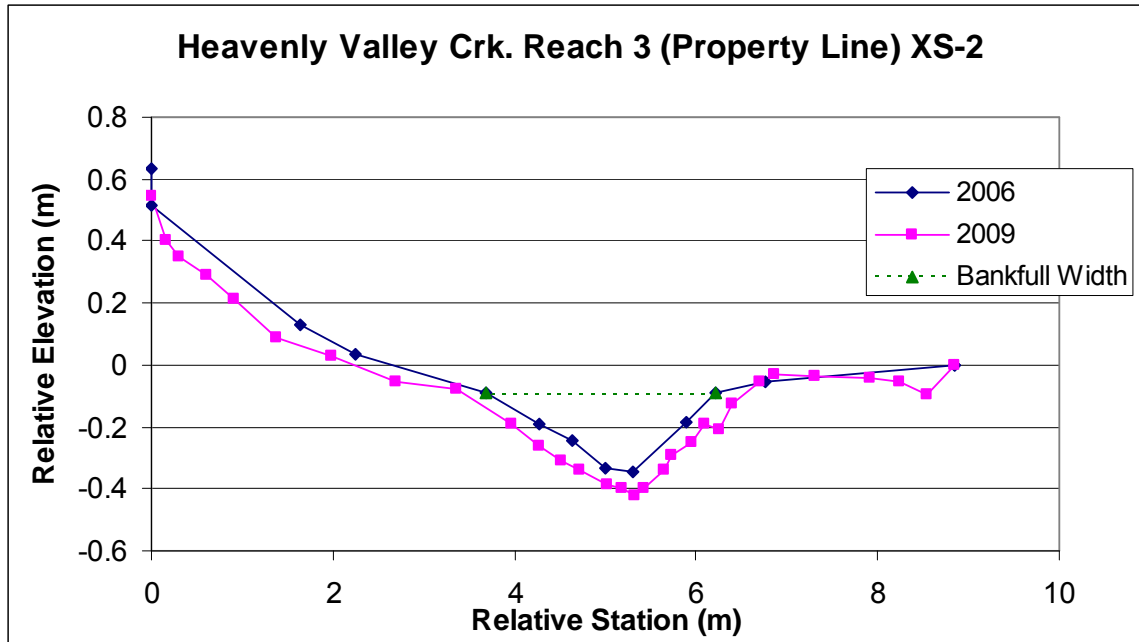
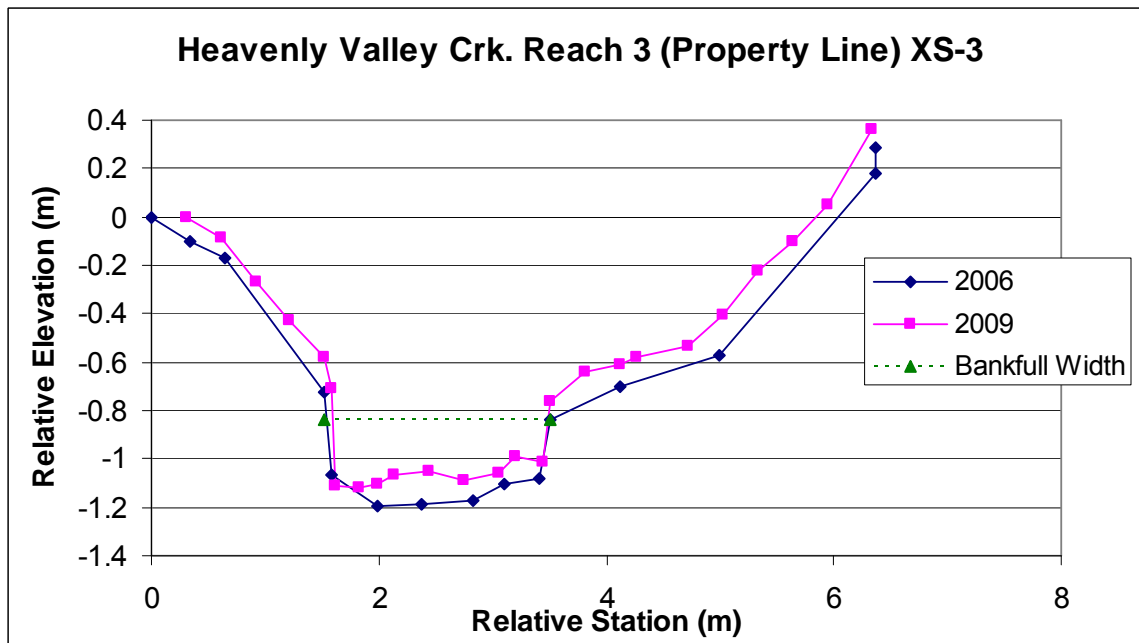
This location shows general improvement, although the percentage of fines in pools is greater in 2009 compared to 2006. Permanent cross sections for Heavenly Valley Creek's Property Line reach, HVC-3, are graphed and presented in Figure 5.9 – 5.11. The cross sections show very little change between 2006 and 2009. The cross sections are graphed and presented with the cross sections surveyed in 2006. All cross sections are graphed from rebar monuments. Elevation and station measurements are graphed relative to the left bank rebar stake. The base of the rebar stake on the left bank is the zero, zero point.

Figure 5.9. Permanent Cross Section number 1 (XS-1) for HVC-3, Property Line, along Heavenly Valley Creek.

Figure 5.10. Permanent Cross Section number 2 (XS-2) for HVC-3, Property Line, along Heavenly Valley Creek.

Figure 5.11. Permanent Cross Section number 3 (XS-3) for HVC-3, Property Line, along Heavenly Valley Creek.

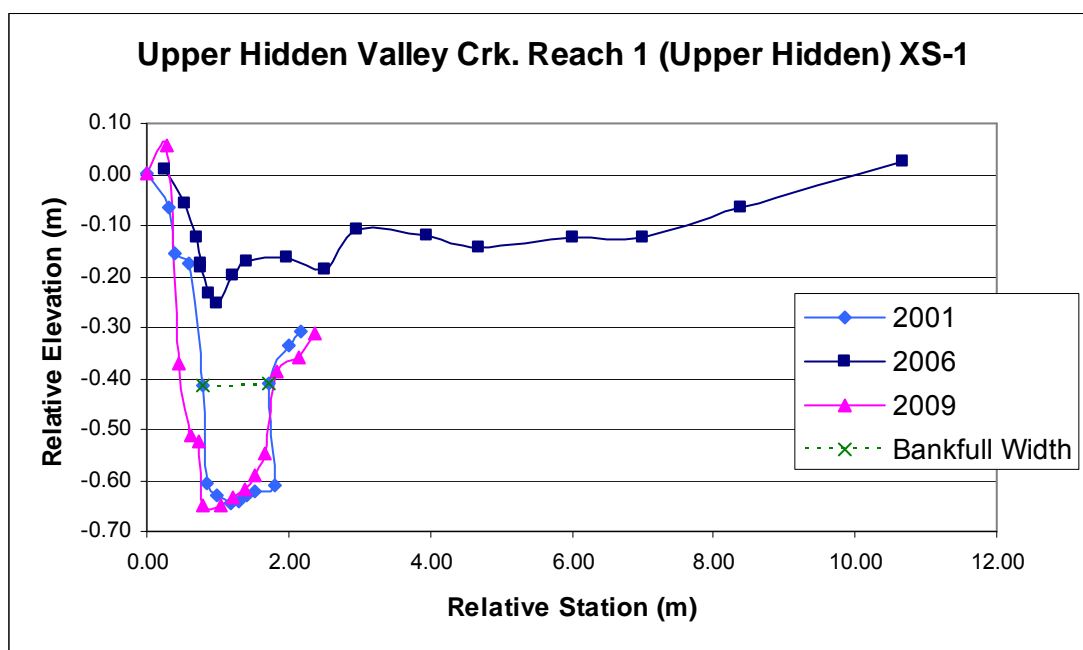
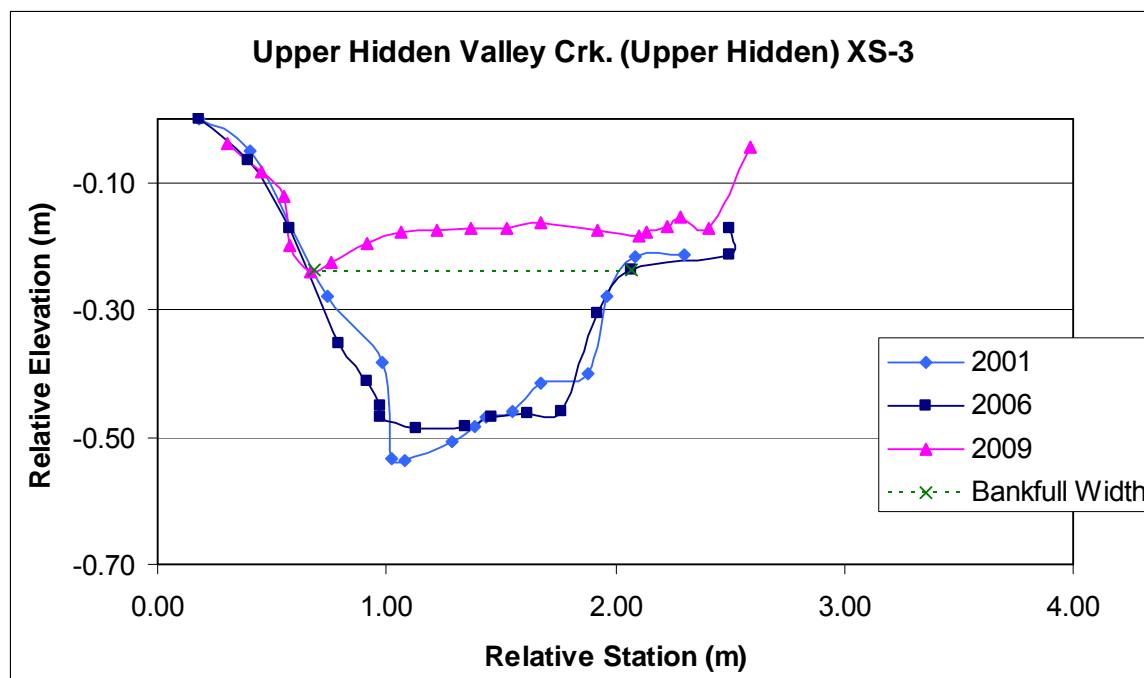
Cross sections for the reference reach, Upper Hidden (HDVC-1), are graphed in Figures 5.12 – 5.13. Like in 2006, only two of three cross-sections were located during the stream assessment in 2009 (cross sections one and three). Only the buried left bank rebar monument was located for cross section one (XS-1) in 2006. In 2009, both monuments were located for cross section one (XS-1). Cross section one (XS-1) in 2006 was aligned perpendicular to the current stream flow but, since the right bank monument was never found, the alignment is different from the 2001 and 2009 cross sectional graphs

Figure 5.12. Permanent Cross Section number 1 (XS-1) for HDVC-1, Upper Hidden, along Hidden Valley Creek.

Figure 5.13. Permanent Cross Section number 3 (XS-3) for HDVC-1, Upper Hidden, along Hidden Valley Creek.

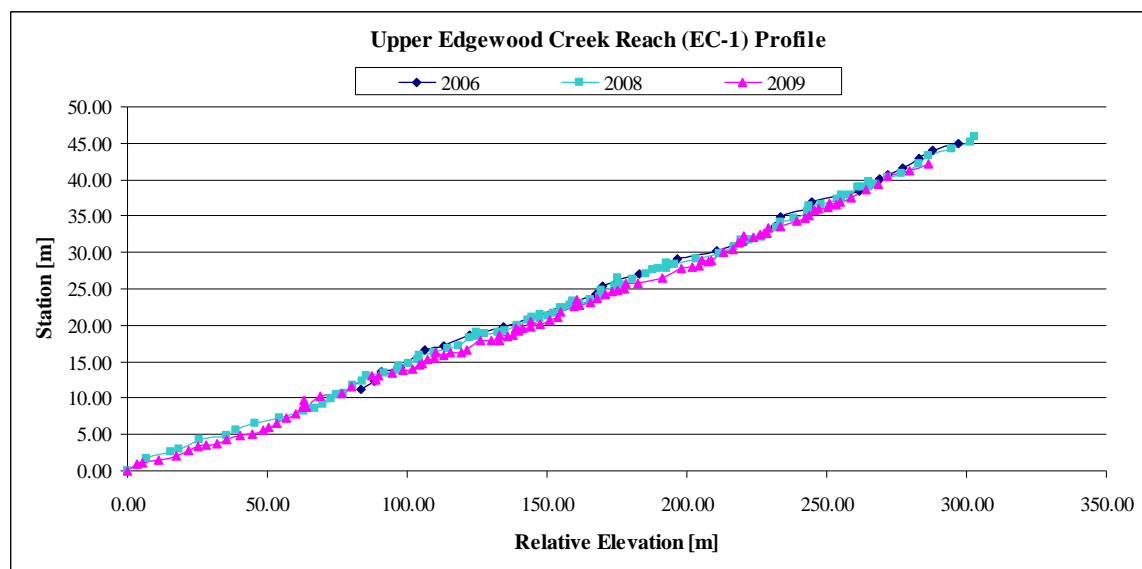
Figure 5.17. Bed profile of reach EC-1, Upper Edgewood, along Edgewood Creek.

Established in 2006, the profile was taken along the entire reach length along the dry bed. Elevation and station measurements are graphed relative to the downstream end of the reach. The downstream end of the reach is point zero, zero. The profile of the Upper Edgewood Reach shows a fairly uniform slope throughout the surveyed reach. The profile also indicates that there may have been some channel degradation since last surveyed in 2008. The survey conducted in 2009 shows the bed profile being slightly lower than in 2008.

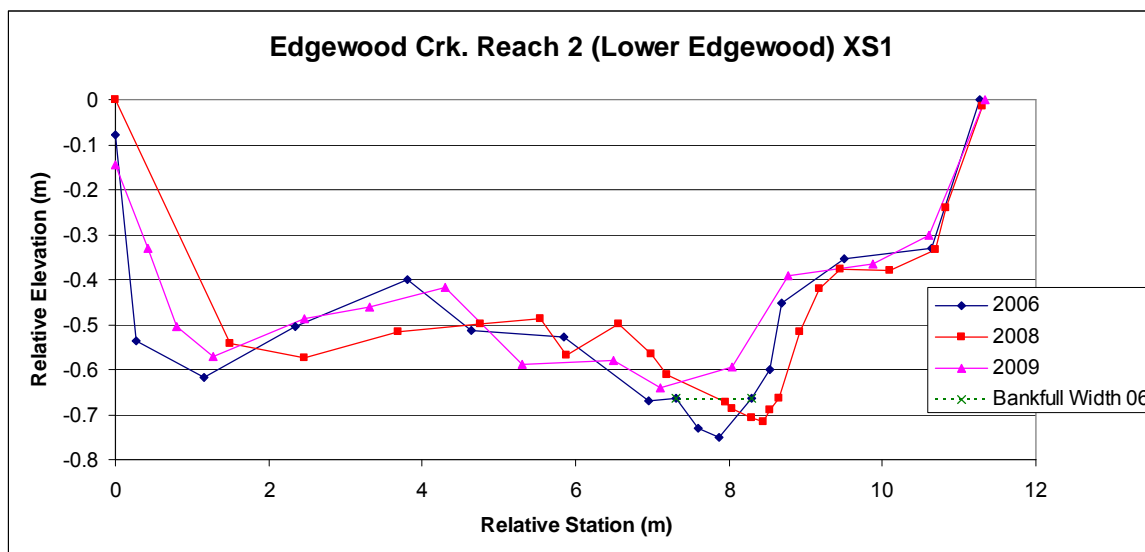
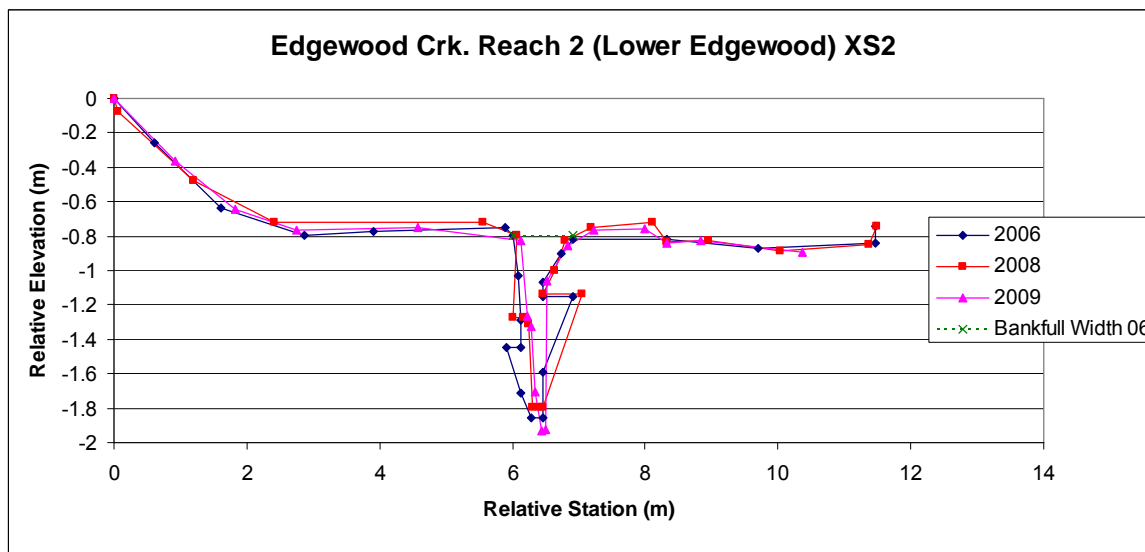
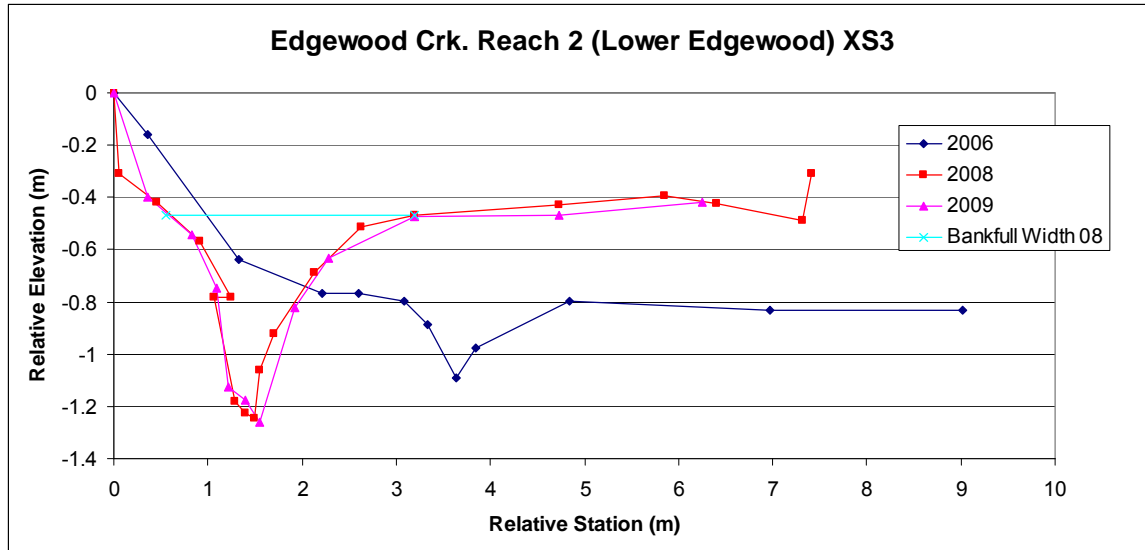
Permanent cross sections for Edgewood Creek's Lower Edgewood reach, EC-2, are graphed and presented in Figures 5.21 – 5.23. The most upstream cross section, (cross section three, XS-3), had to be re-located in 2008 due to restoration activities destroying the permanent monument. The new location is directly below the rock grade control structure constructed as part of the Lower Edgewood Restoration Project completed in 2007. Established in 2006 and 2008, all cross sections are graphed from rebar monuments. Elevation and station measurements are graphed relative to the left bank rebar stake. The top of the rebar stake on the left bank is the zero, zero point.

Figure 5.21. Permanent Cross Section number 1 (XS-1) for EC-2, Lower Edgewood, along Edgewood Creek.

Figure 5.22. Permanent Cross Section number 2 (XS-2) for EC-2, Lower Edgewood, along Edgewood Creek.

Figure 5.23. Permanent Cross Section number 3 (XS-3) for EC-2, Lower Edgewood, along Edgewood Creek.
