### 5.3.12 Scenic Resources

This section evaluates the effects of the General Plan revision and pier rebuild project on scenic and aesthetic resources, as defined by CEQA and the TRPA Regional Plan, Code of Ordinances, and Environmental Thresholds. The effects resulting from General Plan implementation under all of the alternatives described herein would be the same regardless of ownership of the Plaza parcels.

## Kings Beach State Recreation Area General Plan

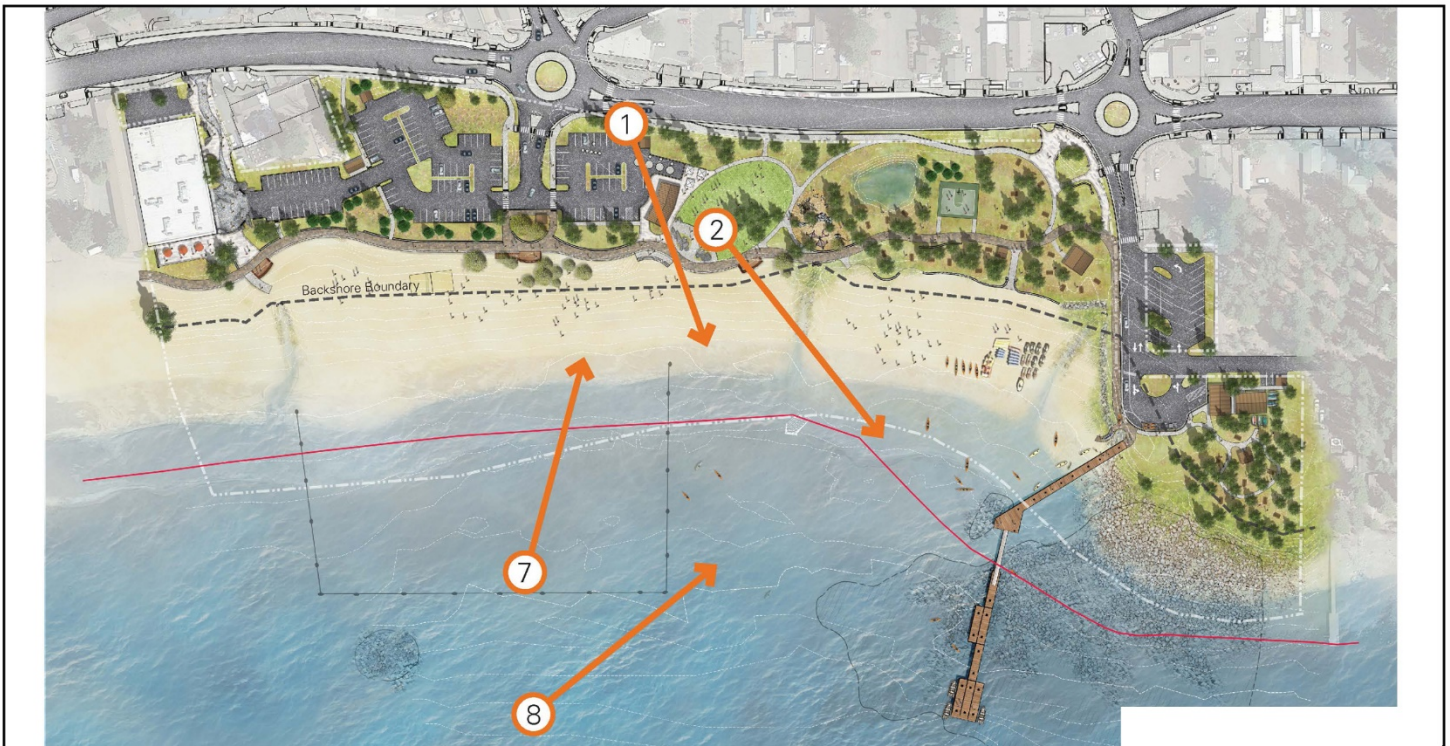
Alternative 2 Viewpoints

Viewpoints shown in Exhibit 5.3.12-1 reflect the views most likely to be degraded by changes in visual conditions under Alternative 2. Exhibit 5.3.12-4 shows the existing and future views from Viewpoint 1, from the south side of SR 28 just east of the Bear Street roundabout, facing southeast. This viewpoint reflects the view from SR 28 that has the highest probability of being degraded by Alternative 2 because it provides relatively open views to Lake Tahoe, which would be affected by new structures. As described in the roadway scenic resources discussion in Section 2.2.4 of this General Plan, TRPA-designated roadway Scenic Resource 20-5 is located along SR 28 just west of the Bear Street roundabout facing southeast across the KBSRA parking lot towards Lake Tahoe. However, only minimal changes would occur within the view from Scenic Resource 20-5, and changes that could occur (e.g., resurfacing and configuring the parking lot, would not block existing views). Therefore, the simulation was prepared for Viewpoint 1 because it is the view towards Lake Tahoe most likely to be affected by Alternative 2.

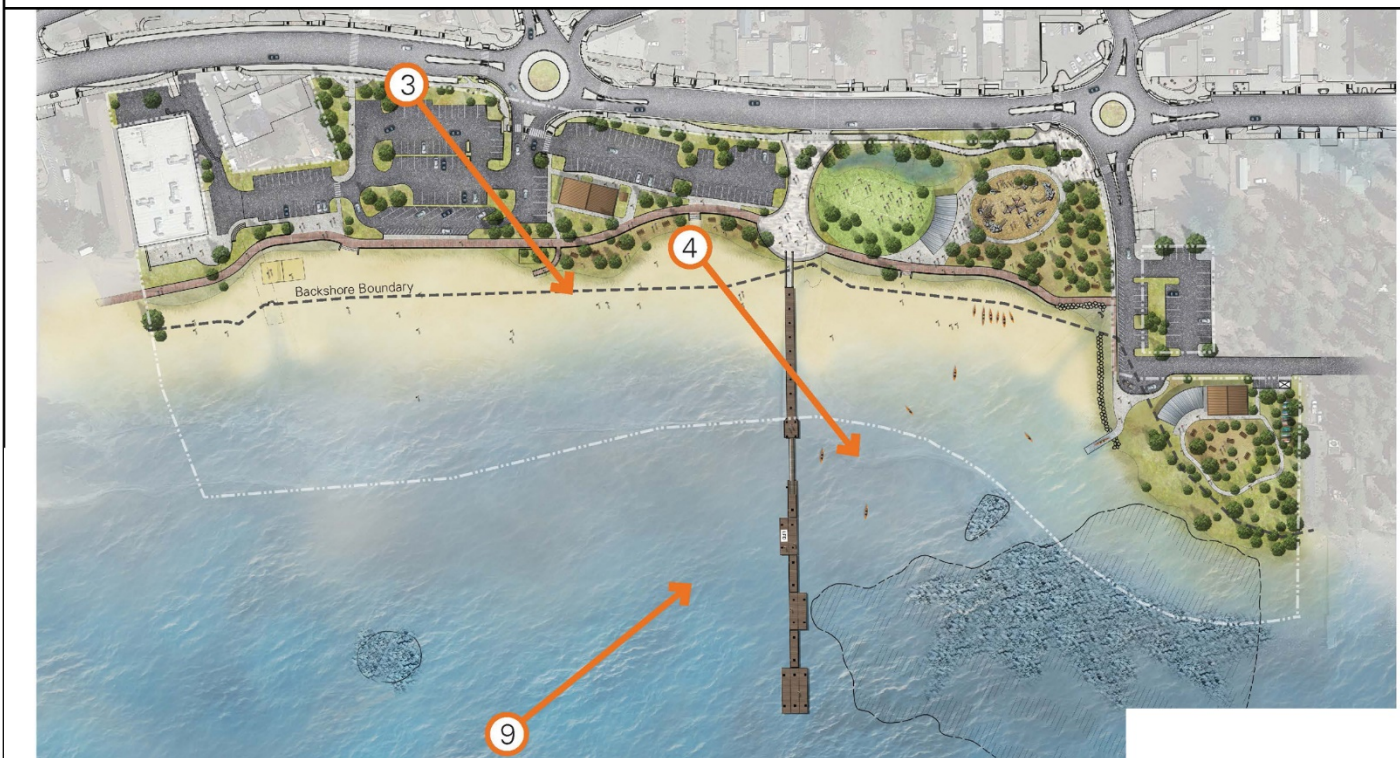
Alternative 3 Viewpoints

The viewpoints shown in Exhibit 5.3.12-2 reflect the views most likely to be degraded by changes in visual conditions under Alternative 3. Exhibit 5.3.12-6 shows the existing and futures views toward Lake Tahoe from Viewpoint 3, which is located at the TRPA-designated roadway Scenic Resource 20-5 along SR 28 just west of the Bear Street roundabout facing southeast. In addition to being a TRPA-designated scenic resource, this viewpoint reflects the view from SR 28 that has the highest probability of being degraded by Alternative 3 because it provides open views to Lake Tahoe, which could be affected by new structures.

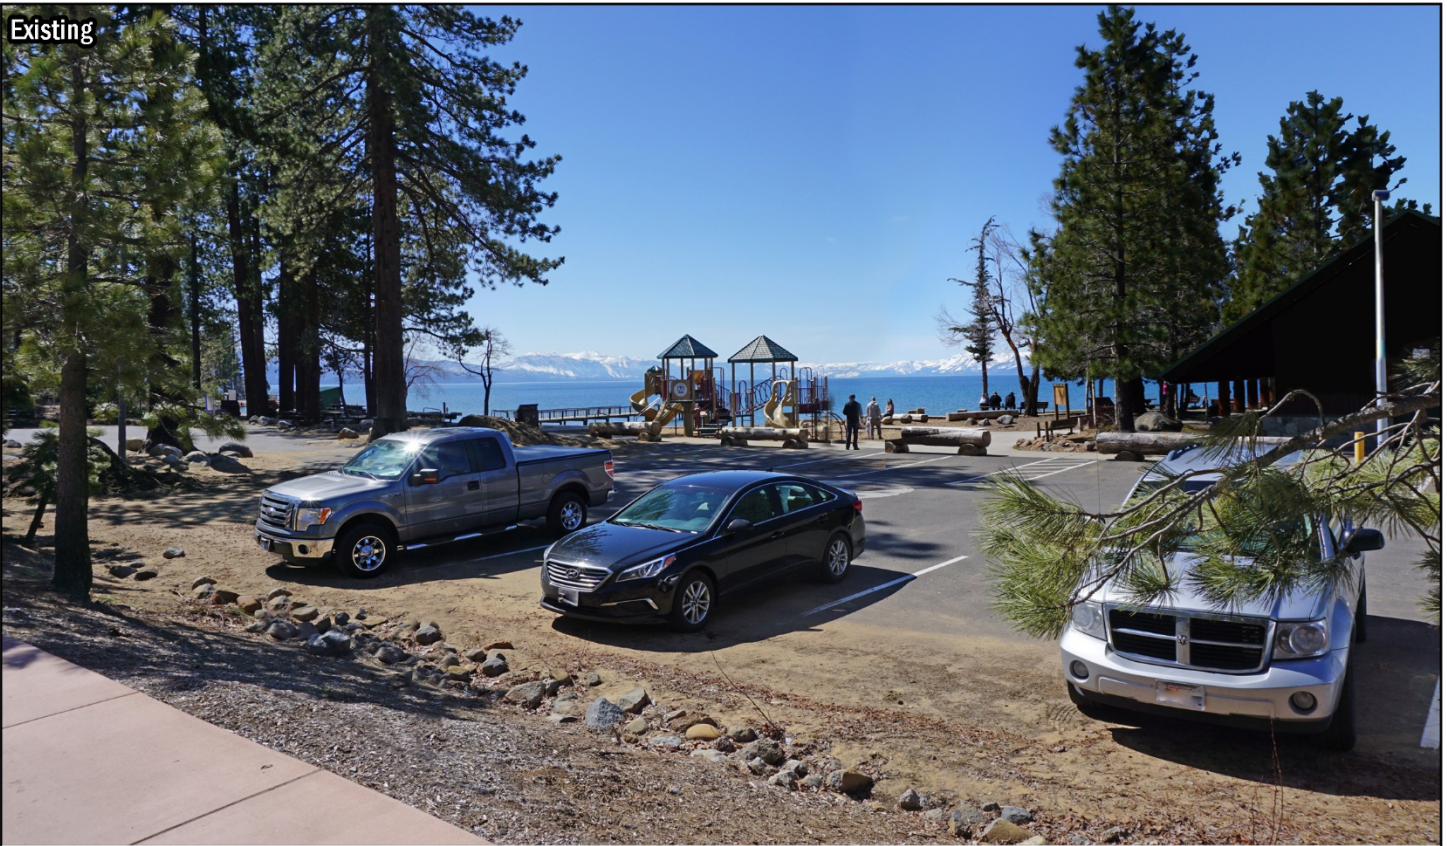
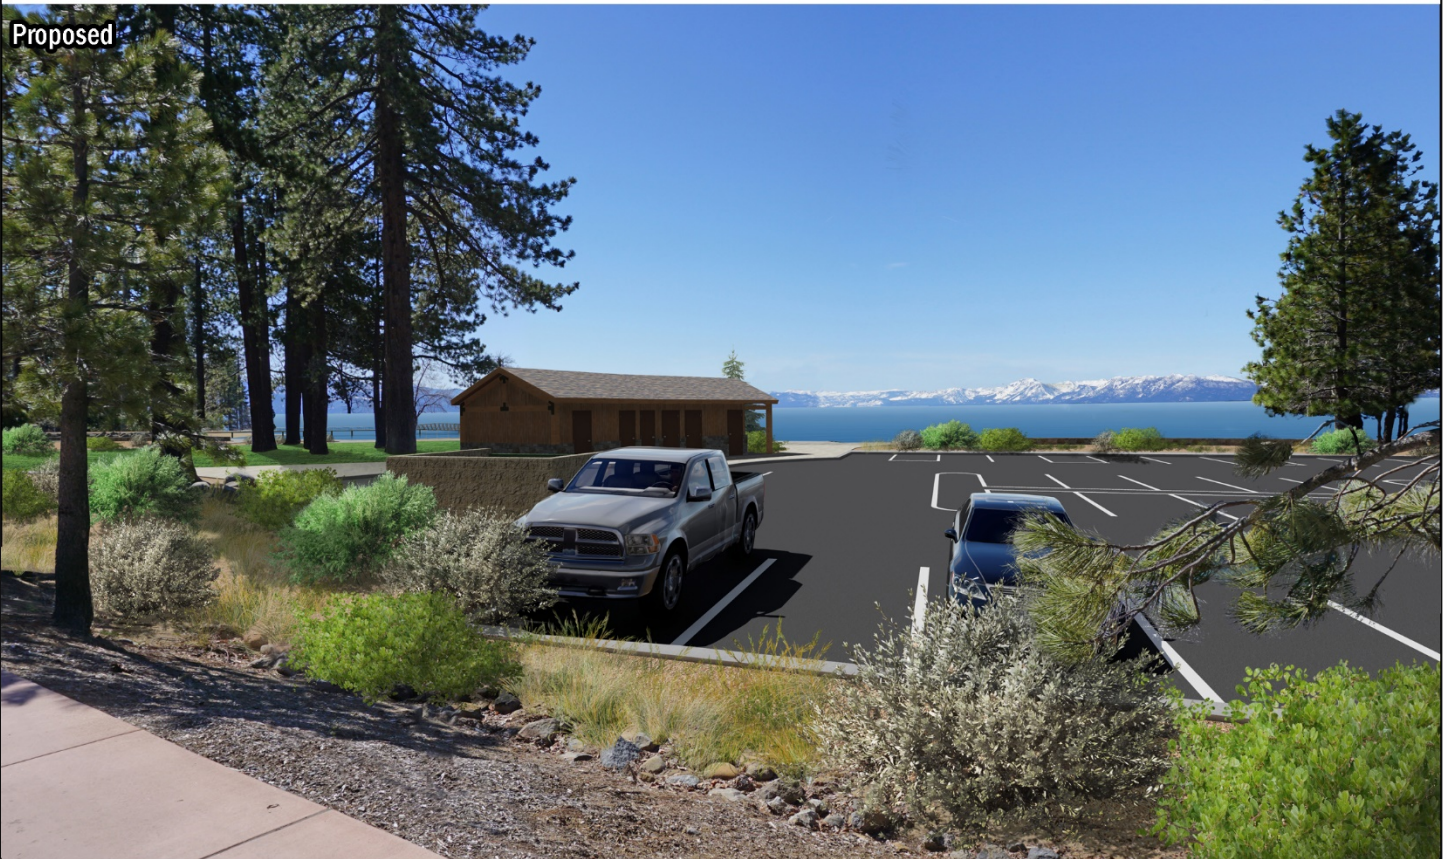
Existing

Proposed

In Alternative 2, the existing playground would be replaced with a nature-based play structure. However, this play structure would be located farther to the east, outside of the view from Viewpoint 1, and behind a clump of existing trees, such that the new structure would not block views of the lake. In Alternative 2, the existing restroom and several adjacent conifers would be removed to accommodate the reconfigured parking lot. The conifers that would be removed currently screen views of the restroom. However, with the restroom relocation, removal of these trees would not increase the visibility of human-made structures from the roadway or lake.

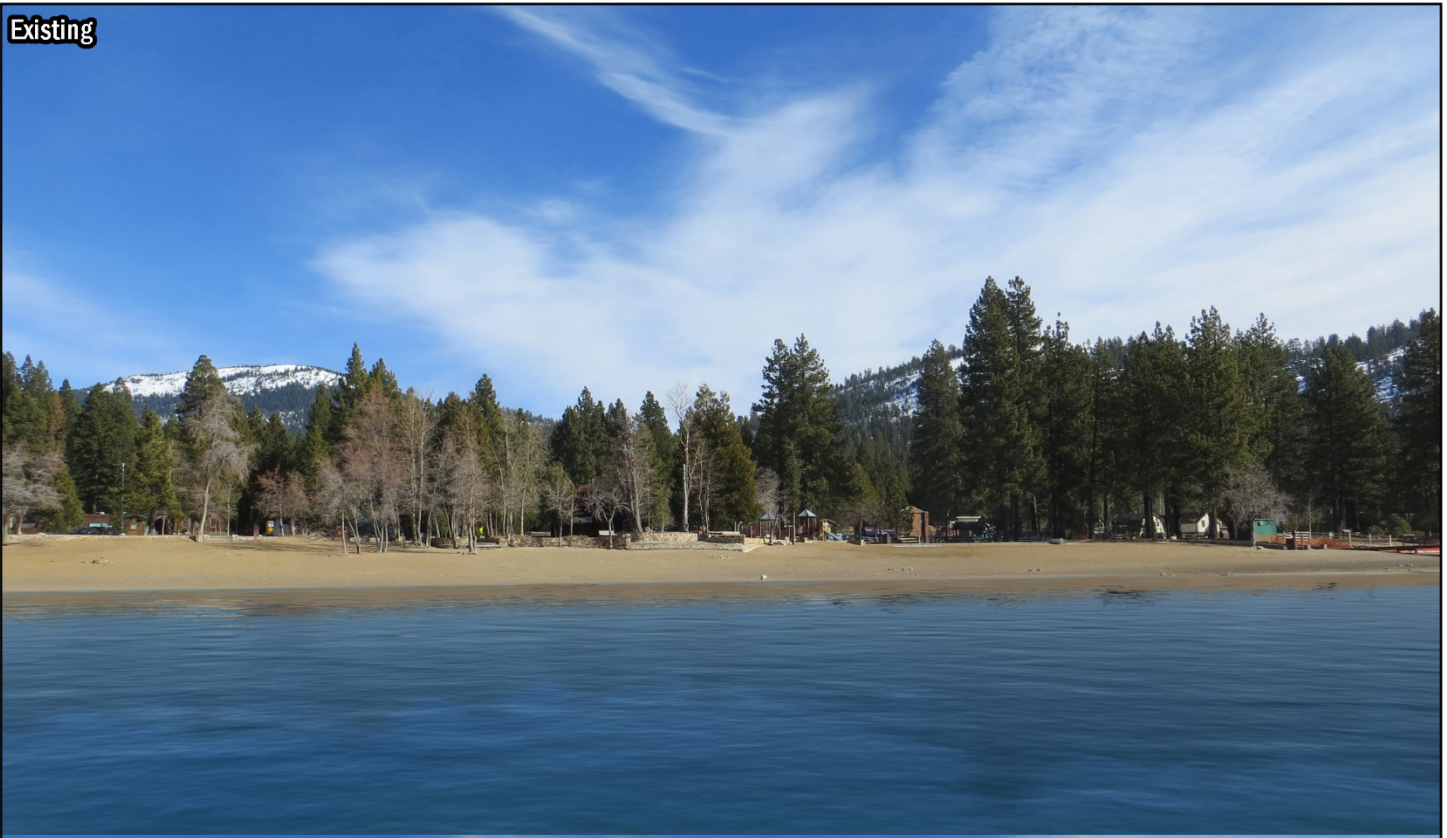
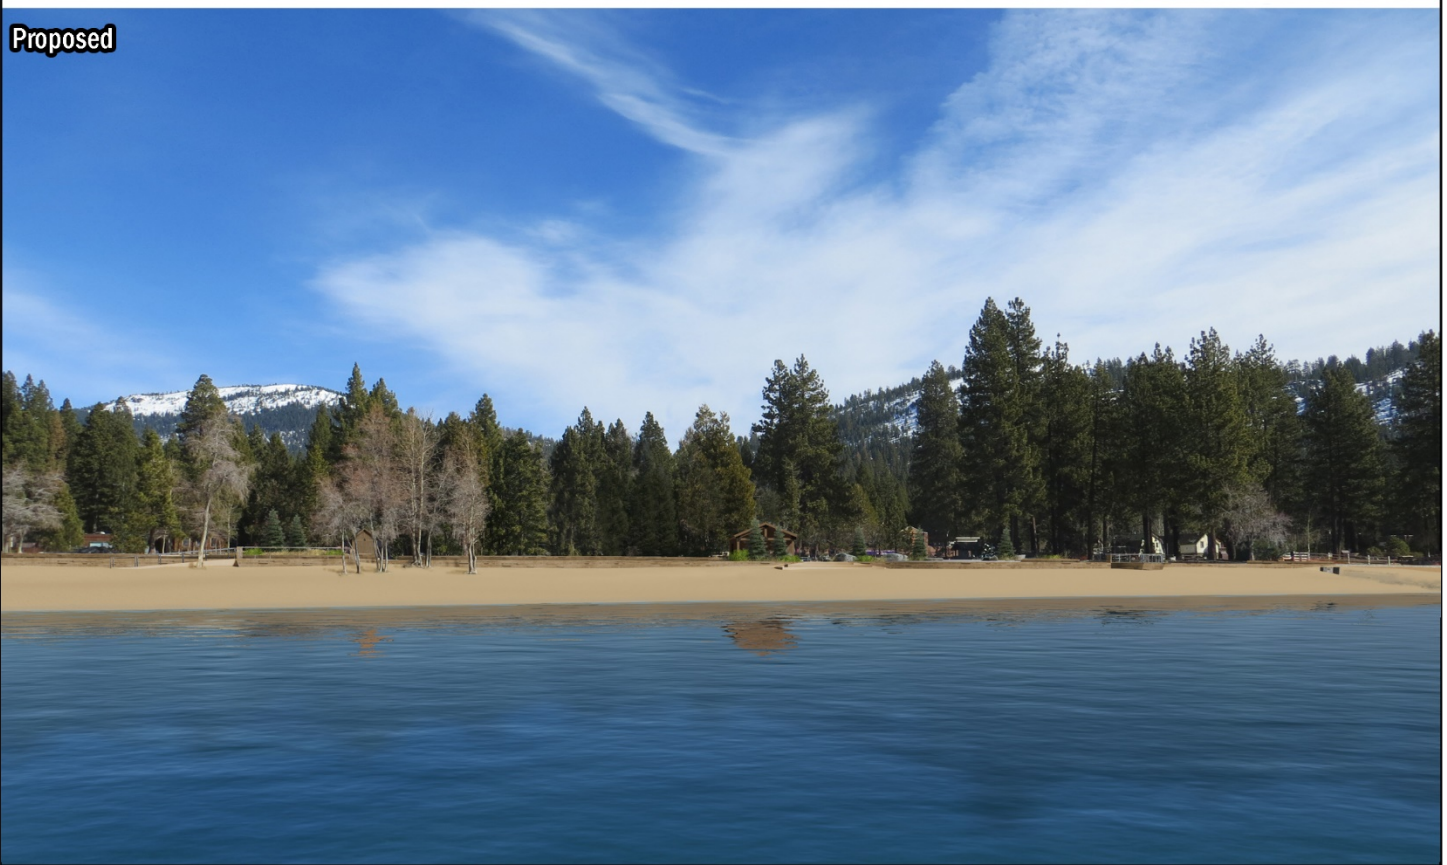
**Existing**

**Proposed**

Exhibit 5.3.12-10 shows the existing and future views from Viewpoint 7, on Lake Tahoe, approximately 300 feet from the high-water mark and facing north-northeast. This viewpoint reflects the view from Lake Tahoe that has the greatest chance of being degraded by Alternative 2 because it provides direct views of the structures that would be most visible, including the new restroom, promenade/sand wall, and visitor contact station. In the existing view, the shoreline is dominated by a mix of deciduous and conifer trees. The existing rock retaining walls are visible as tan walls near the center of the view, and the restroom is visible as a dark structure, partially obscured by trees directly behind the retaining wall. The playground is clearly visible just to the right of the retaining wall, and the green concessionaire building and the landside end of the pier are visible on the right side of the view. Several buildings north of KBSRA are also visible through the trees. These off-site buildings include the brown building in the left side of the view, and the brown and yellowish buildings between the playground and the concessionaire building. Overall, the quality of the existing view is good because of the predominance of trees along the shoreline, which screen most visible signs of development.

As described above, Alternative 2 would alter man-made features visible from Lake Tahoe, which is one of the three criteria used to determine shoreline travel unit threshold scores. Based on the simulation in Exhibit 5.3.12-10 and the visual magnitude calculations in Appendix B, these visual changes would not reduce the quality of views from Lake Tahoe or degrade the TRPA scenic quality ratings for the applicable shoreline travel units. Thus, the impact would be **less than significant**.

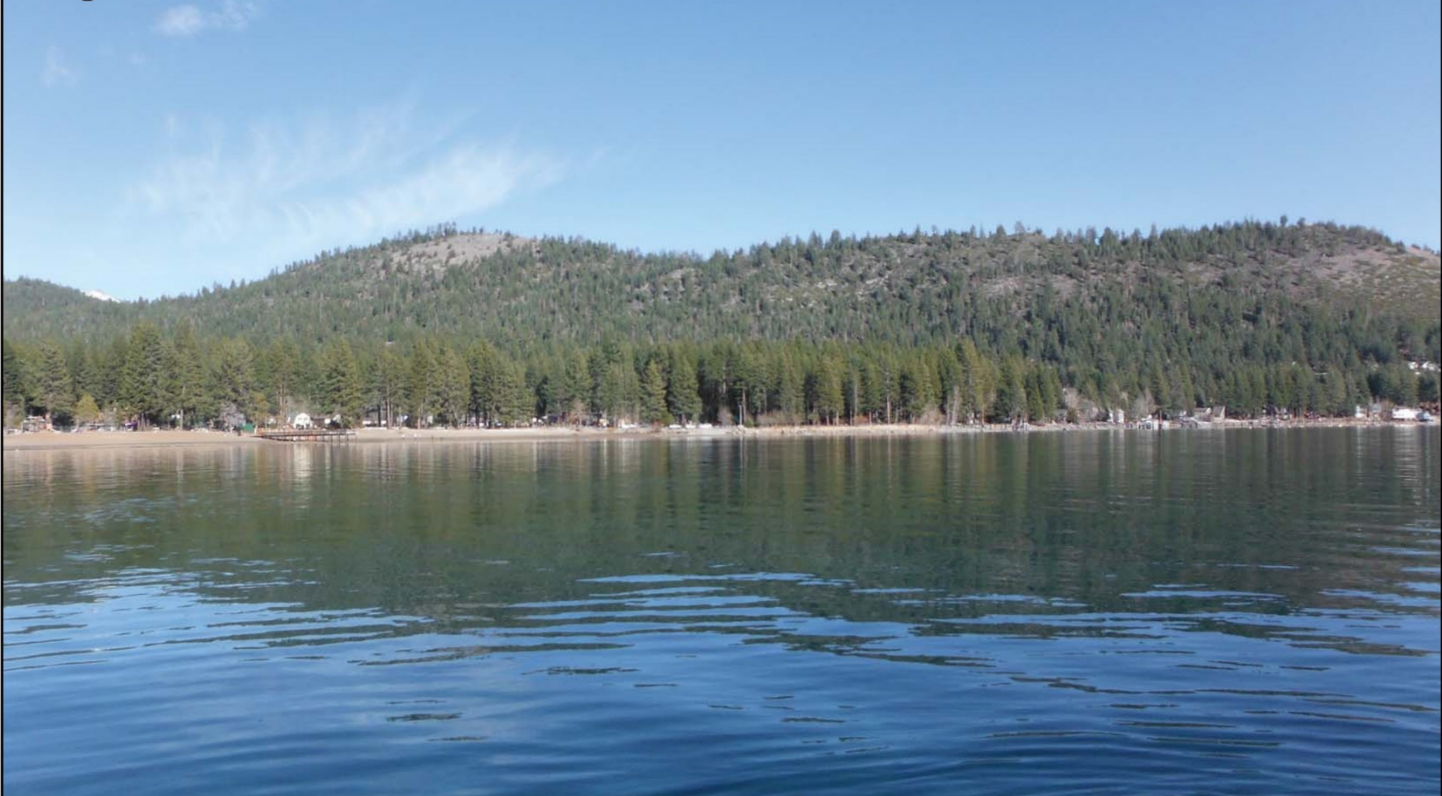
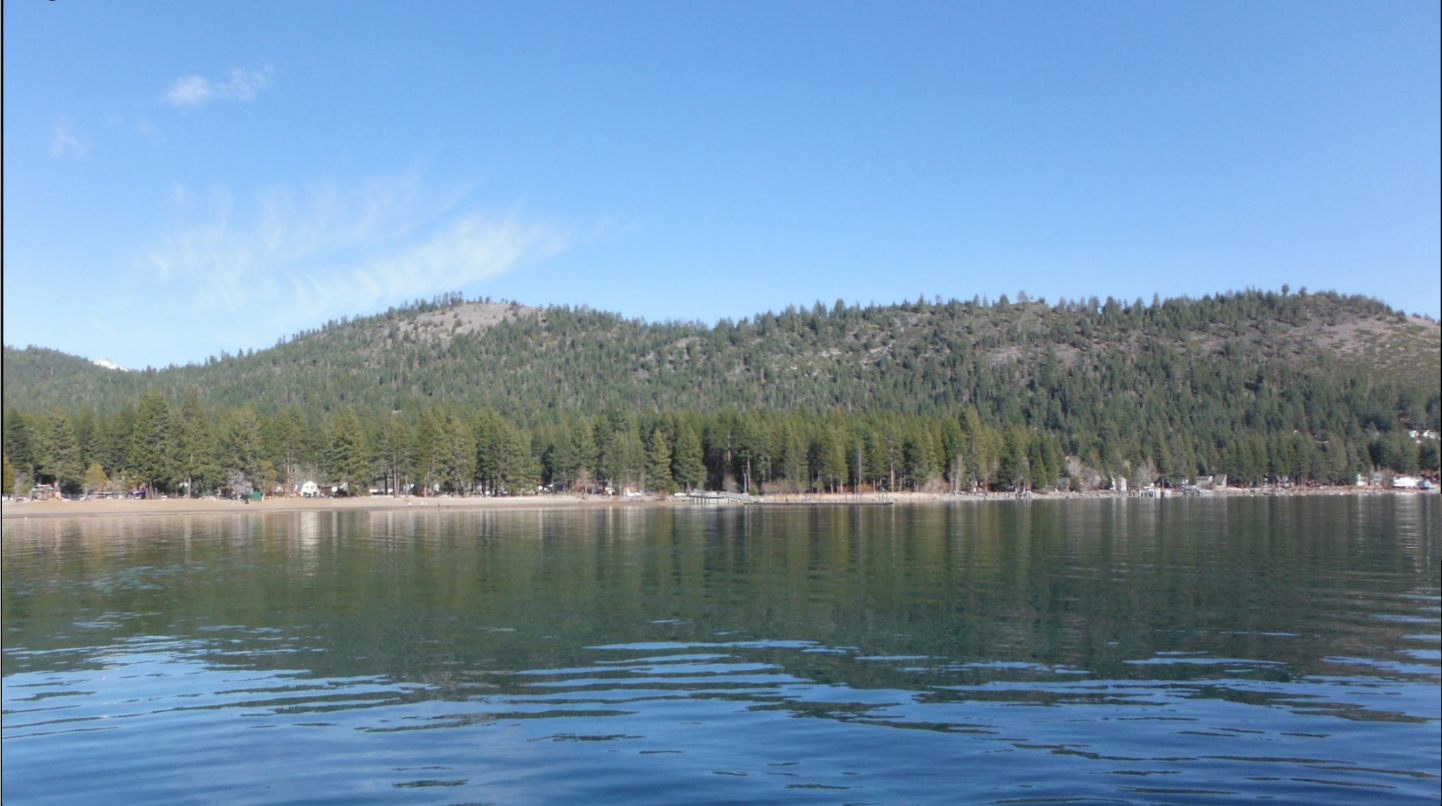
Exhibit 5.3.12-11 Existing View and Simulation of Alternative 2 from Viewpoint 8

**Existing**

**Proposed**

As shown in Exhibit 5.3.12-11, the proposed pier would be visible but would not dominate the view from this distance. The fixed portion of the pier and the gangway are the most visible elements of the pier because they block views of the sandy beach. The floating section of the pier, while longer and closer than the fixed portion, is substantially less prominent. The color and proximity of the floating section to the surface of the water cause it to blend into the water, while retaining unobstructed views of the sandy beach behind the pier. The design elements of the proposed pier are shown in greater detail in a rendering of the rebuilt pier included as Exhibit 5.3.12-12. Overall, Alternative 2 would result in the removal of an existing pier that blocks views of the sandy beach and replace it with a new pier that also blocks views of the sandy beach. The proposed pier would not change the character of the shoreline view, which already contains a mix of visible shoreline development and vegetation.
