EXISTING VISIBLE LAKE VIEW
ELEVATION (VIEW 1) = 446.5 total sf

1 VIEW 1-PHOTOGRAPH, 300' OFFSET FROM HW (39°14'7.64"N / 120° 1'35.00"W)

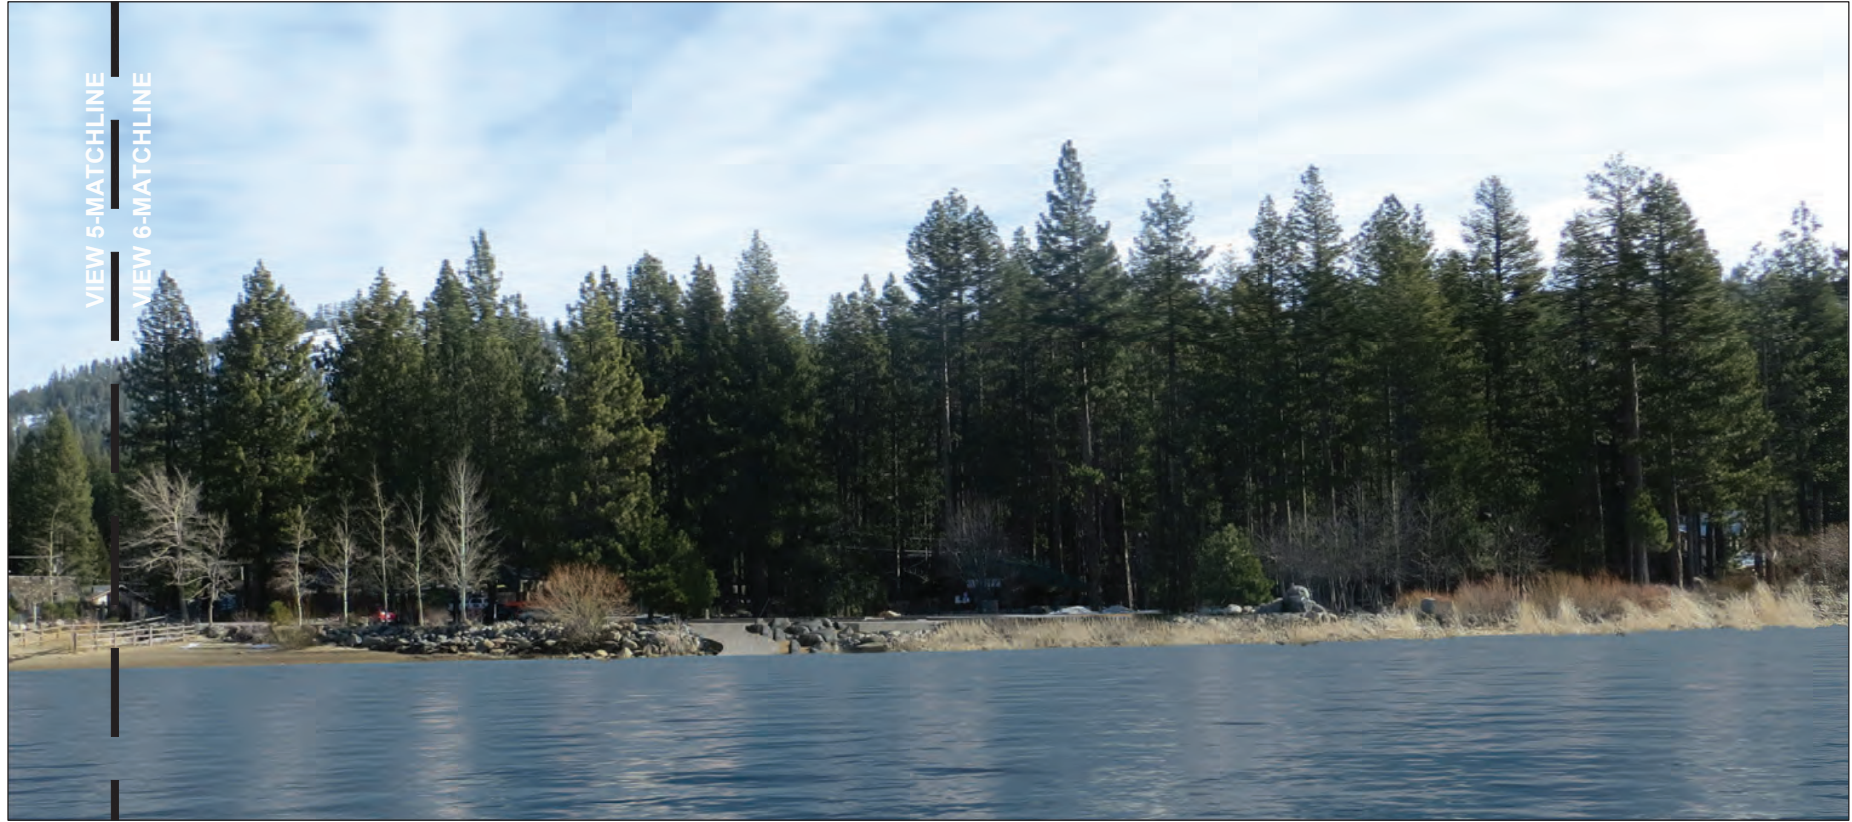
PROPOSED VISIBLE FEATURES
ELEVATION (VIEW 6) = 824.6 total sf

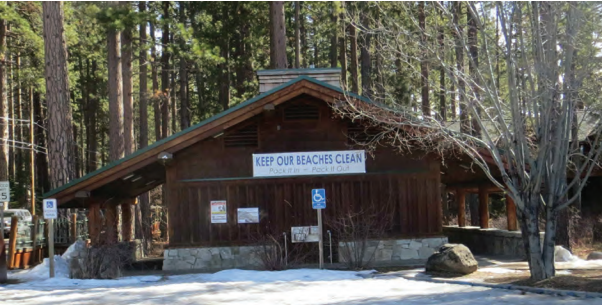
6 VIEW 6-SIMULATION, 300' OFFSET FROM HW (39°14'4.32"N / 120° 1'25.34"W)

EX. COMFORT STATION		
Drinking Fountain	= 5.0 sf	0.6%
Granite Veneer	= 48.3 sf	5.9%
Logs	= 15 sf	1.9%
Metal Roof Edge	= 15.7 sf	1.9%
Wood Fascia	= 50.4 sf	6.1%
B&B Siding	= 140 sf	16.9%
Shingle Siding (Plane-1)	= 97.5 sf	11.8%
Shingle Siding (Plane-2)	= 16 sf	1.9%
Vents	= 26.0 sf	3.2%

EXISTING COMFORT STATION
