ADVENTURE PEAK EPIC DISCOVERY ACTIVITES HEAVENLY MOUNTAIN RESORT EL DORADO COUNTY, CALIFORNIA APN 030-030-01 DOUGLAS COUNTY, NEVADA APN 1318-00-002-010

EAST PEAK LAKE BASIN EPIC DISCOVERY ACTIVITIES HEAVENLY MOUNTAIN RESORT EL DORADO COUNTY, CALIFORNIA APN 030-030-01 DOUGLAS COUNTY, NEVADA APN 1318-00-002-010

SKY MEADOWS BASIN EPIC DISCOVERY ACTIVITES HEAVENLY MOUNTAIN RESORT EL DORADO COUNTY, CALIFORNIA APN 030-020-01 DOUGLAS COUNTY, NEVADA APN 1318-00-002-010

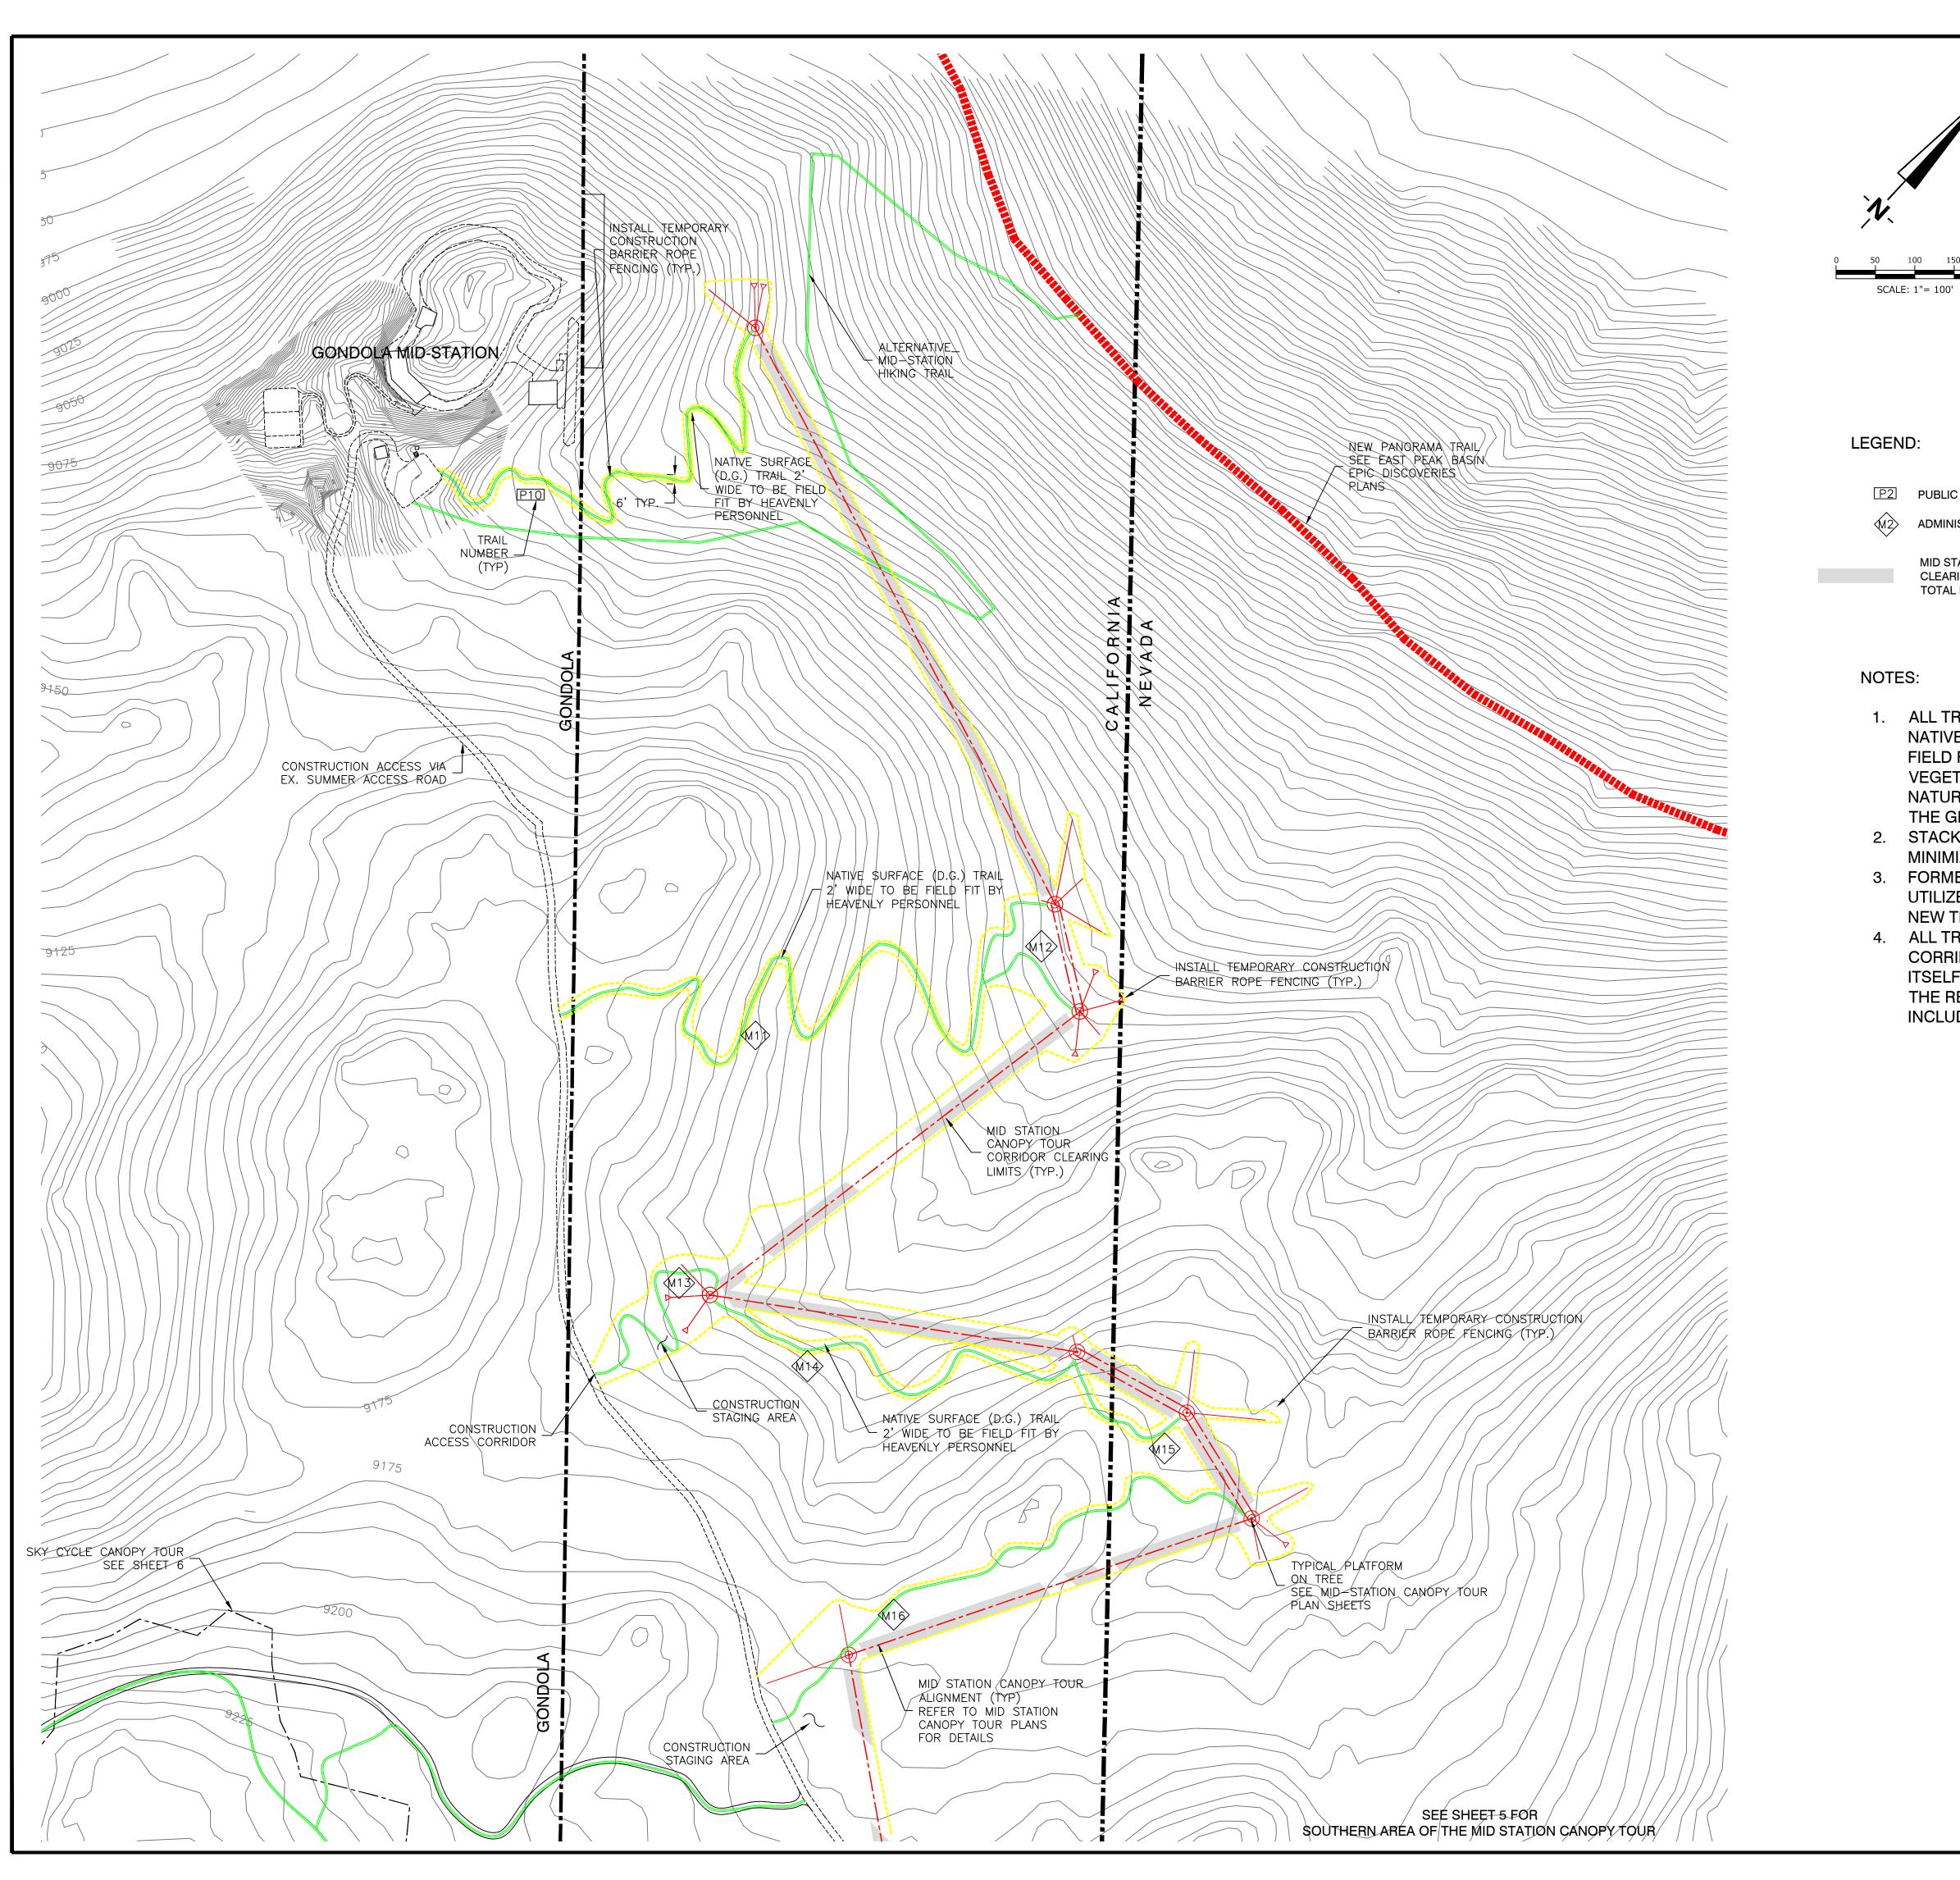
P2 PUBLIC HIKING TRAILS ADMINISTRATIVE MAINTENANCE TRAILS

> MID STATION CANOPY TOUR CORRIDOR CLEARING LIMITS (TYP) TOTAL ESTIMATED CLEARING: 1.4 ACRES

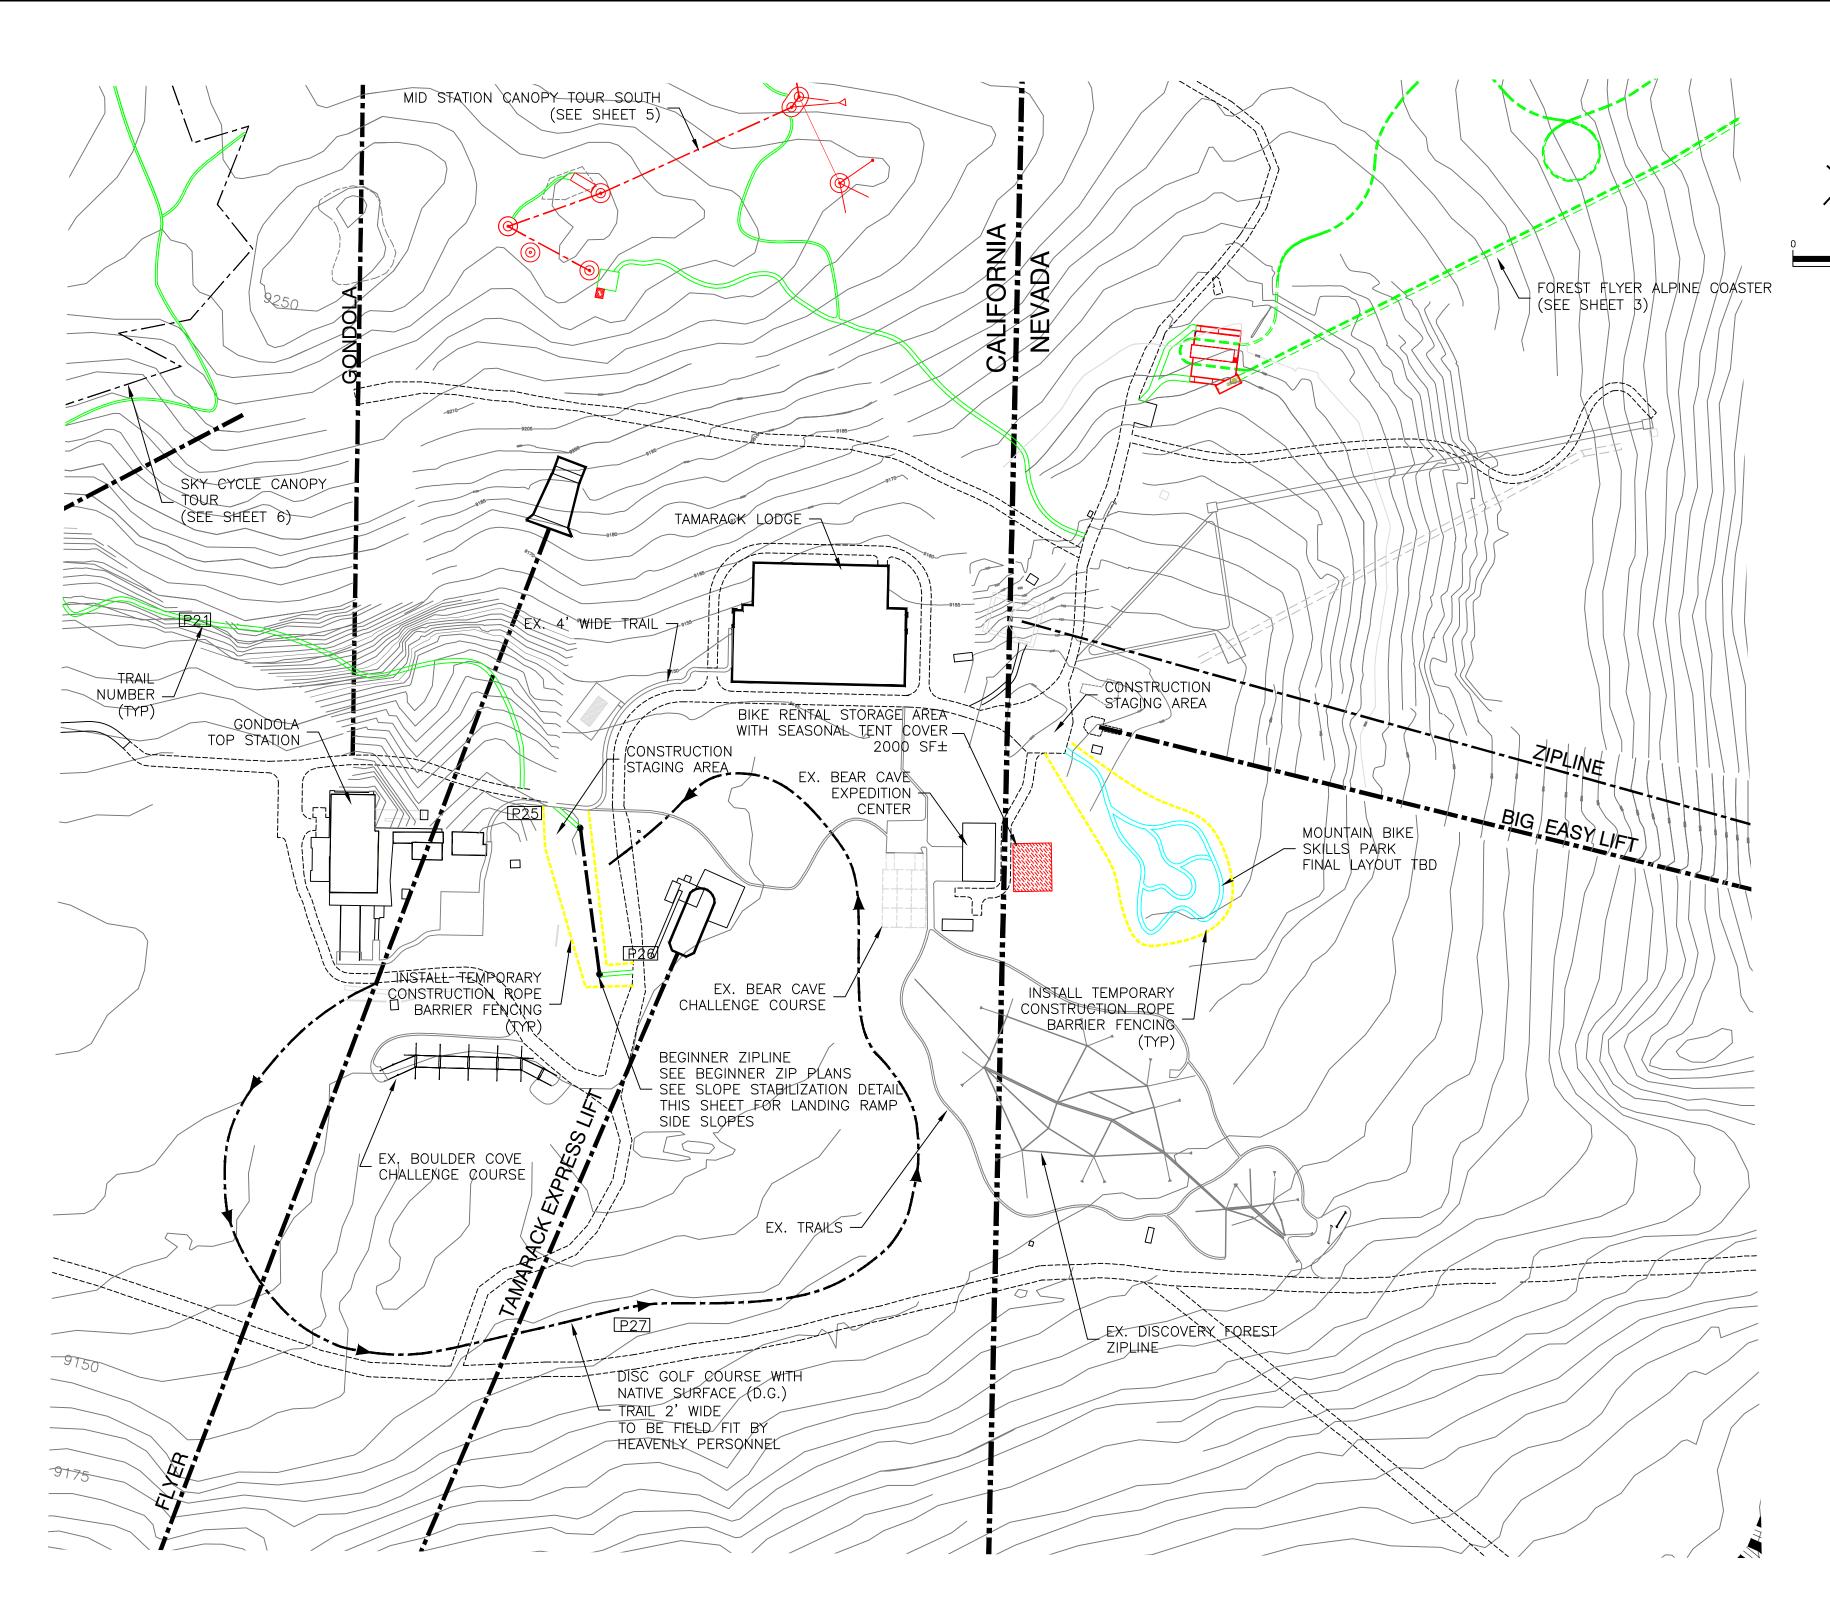
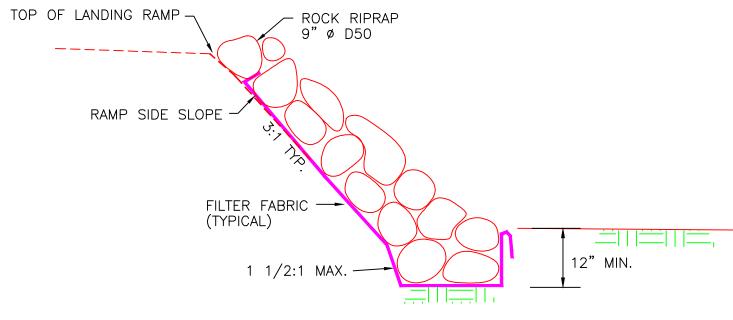
SLOPE STABILIZATION KIDDIE ZIP LANDING RAMP SIDE SLOPES NOT TO SCALE

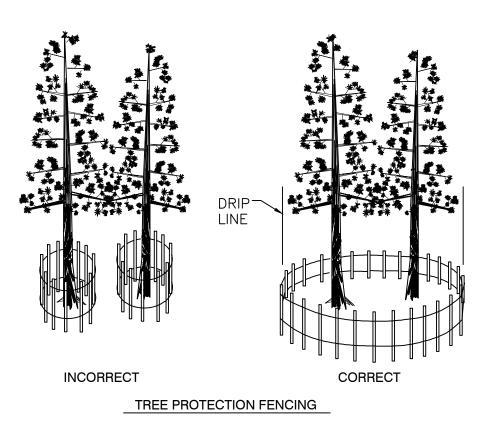
1. TEMPORARY FENCING TO BE A MINIMUM OF 4' HIGH.

2. POSTS TO BE SET AT A MINIMUM OF 6' ON

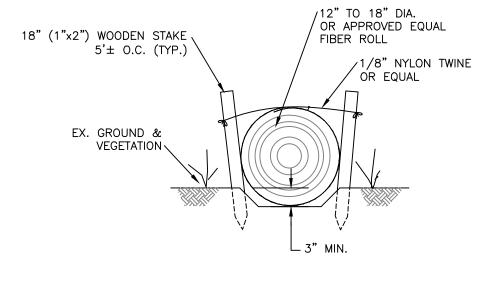
TEMPORARY SEDIMENT BARRIER FIBER ROLLS NO SCALE

- 1. FIBER ROLL INSTALLATION REQUIRES THE PLACEMENT AND SECURE STAKING OF THE ROLL IN A TRENCH, 3" TO 6" DEEP, DUG ON CONTOUR. RUNOFF MUST NOT BE ALLOWED TO RUN UNDER OR AROUND ROLL.
- 2. INSTALL IN ACCORDANCE WITH MANUFACTURER'S RECOMMENDATIONS.
- 3. FIBER MATERIAL SHALL BE BIODEGRADABLE WEED-FREE STRAW, JUTE, COIR, OR EXCELSIOR. MATERIALS REQUIRE TRPA AND U.S. FOREST SERVICE APPROVAL PRIOR TO INSTALLATION.

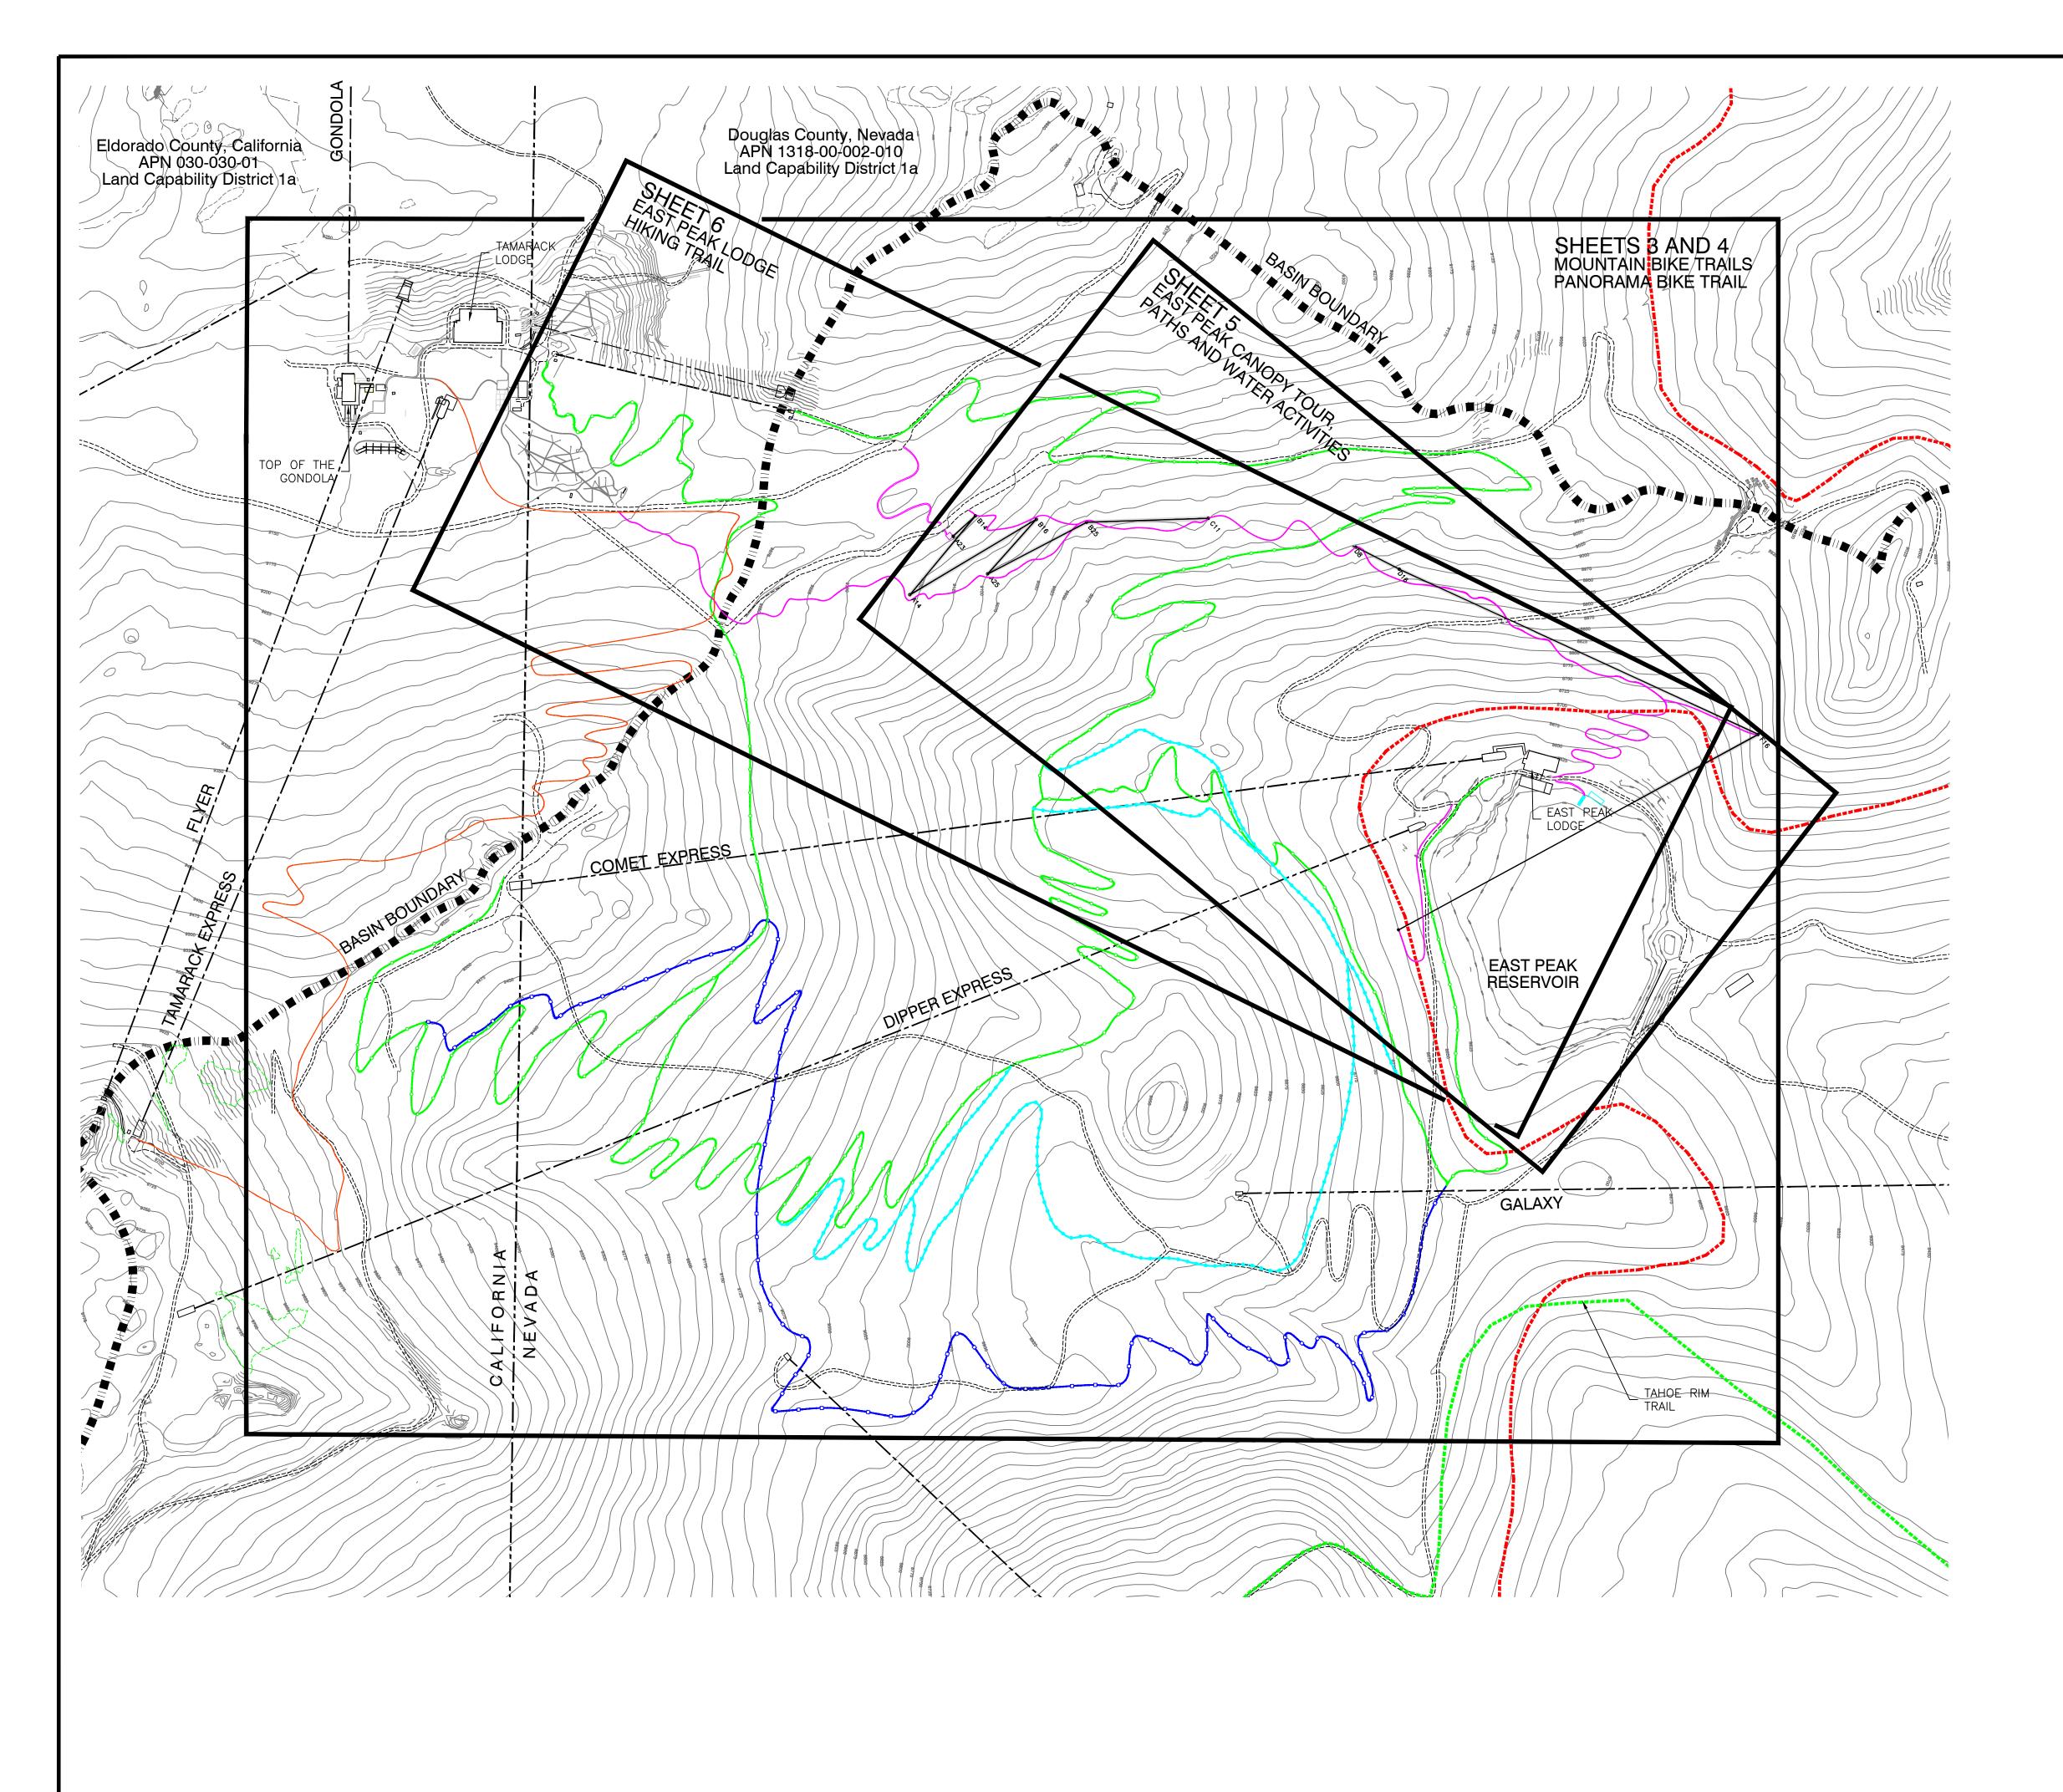
- MOUNTAIN BIKE BEGINNER TRAIL
- MOUNTAIN BIKE INTERMEDIATE TRAIL
- MOUNTAIN BIKE ADVANCED TRAIL

- NEW HIKING TRAILS

PANORAMA BIKE TRAIL

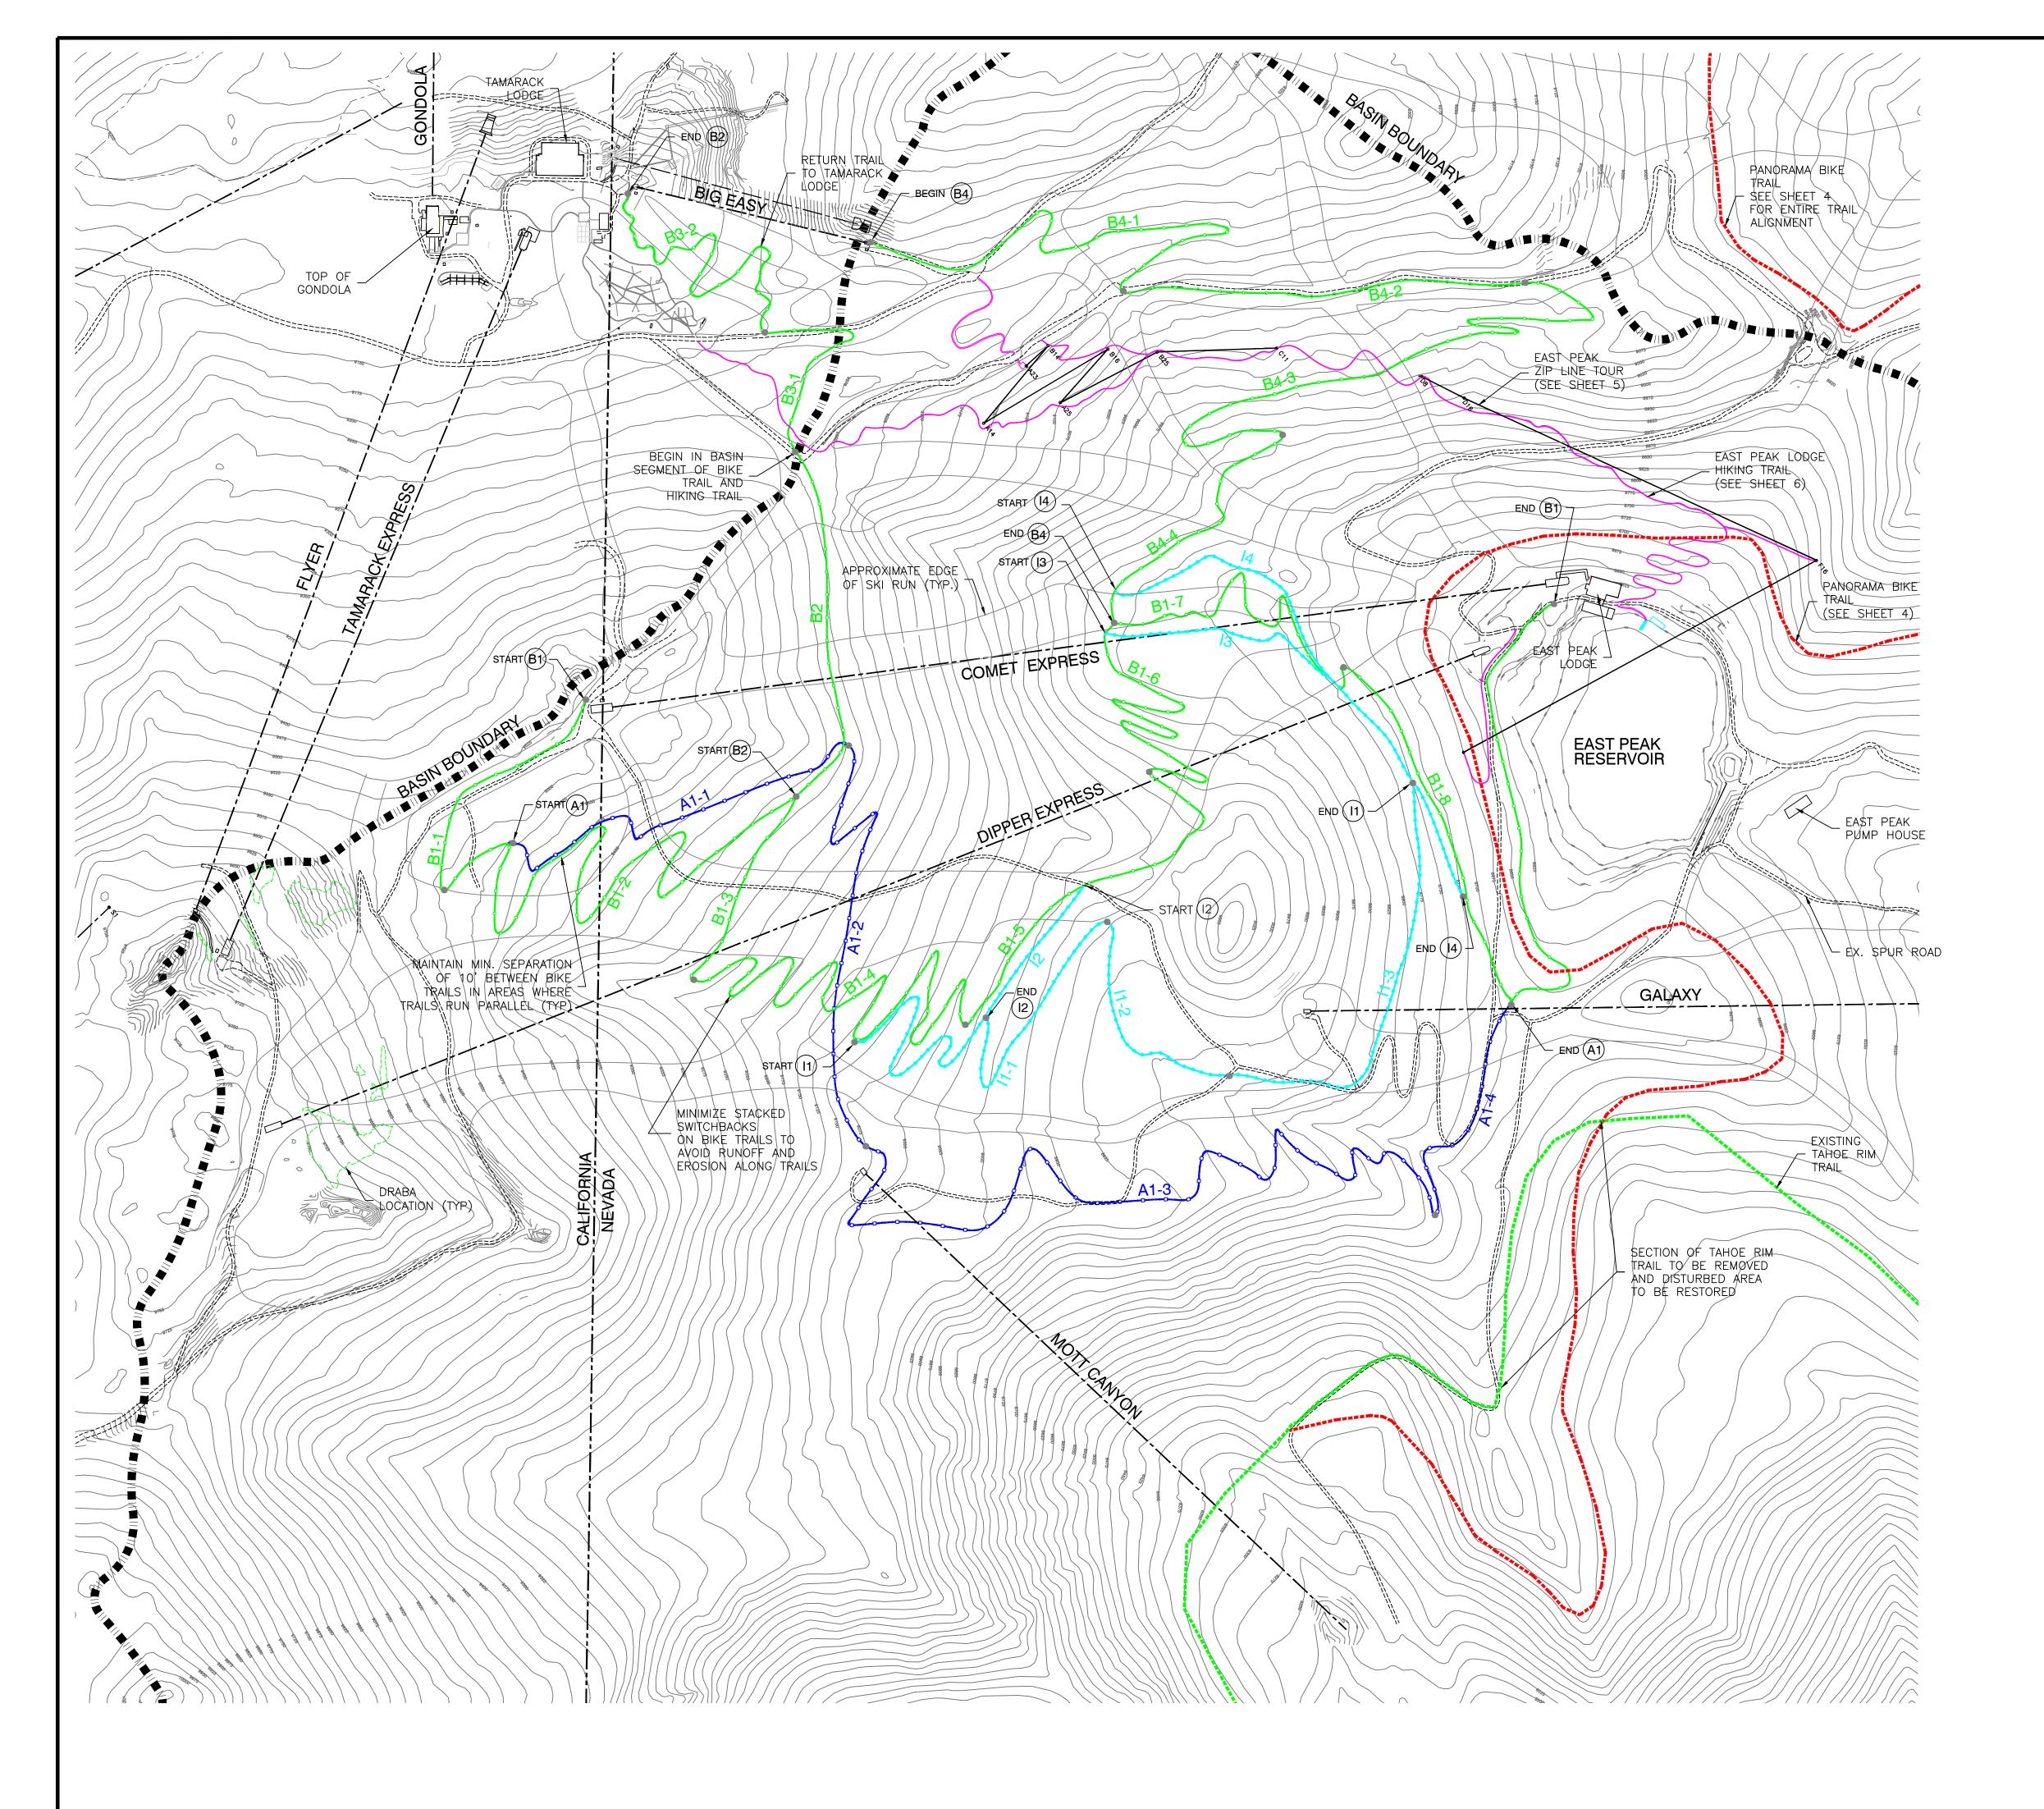
- oo	MOUNTAIN BIKE BEGINNER TRAIL
••••	MOUNTAIN BIKE INTERMEDIATE TRAIL
. 	MOUNTAIN BIKE ADVANCED TRAIL
	PANORAMA BIKE TRAIL
	NEW HIKING TRAILS
B1-1 (B1)	MOUNTAIN BIKE TRAIL SEGMENT DESIGNATION
٠	MOUNTAIN BIKE TRAIL SEGMENT START / STOP
	EXISTING ROADS
	EXISTING TRAILS
	APPROXIMATE EDGE OF SKI RUN

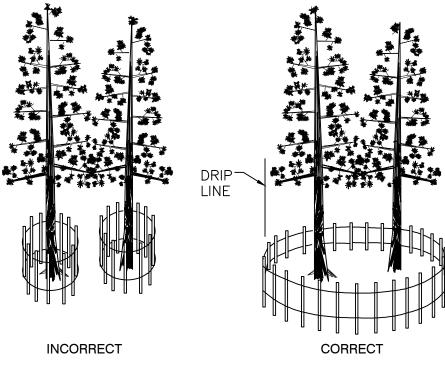
TREE PROTECTION FENCING

2. POSTS TO BE SET AT A MINIMUM OF 6' ON

1. TEMPORARY FENCING TO BE A MINIMUM OF 4' HIGH.

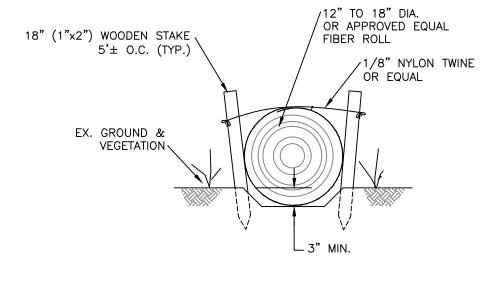
1. FIBER ROLL INSTALLATION REQUIRES THE PLACEMENT AND SECURE STAKING OF THE ROLL IN A TRENCH, 3" TO 6" DEEP, DUG ON CONTOUR. RUNOFF MUST NOT BE ALLOWED TO RUN UNDER OR AROUND ROLL

. INSTALL IN ACCORDANCE WITH MANUFACTURER'S RECOMMENDATIONS

FIBER MATERIAL SHALL BE BIODEGRADABLE WEED-FREE STRAW, JUTE, COIR, OF EXCELSIOR. MATERIALS REQUIRE TRPA AND U.S. FOREST SERVICE APPROVAL PRIOR TO INSTALLATION

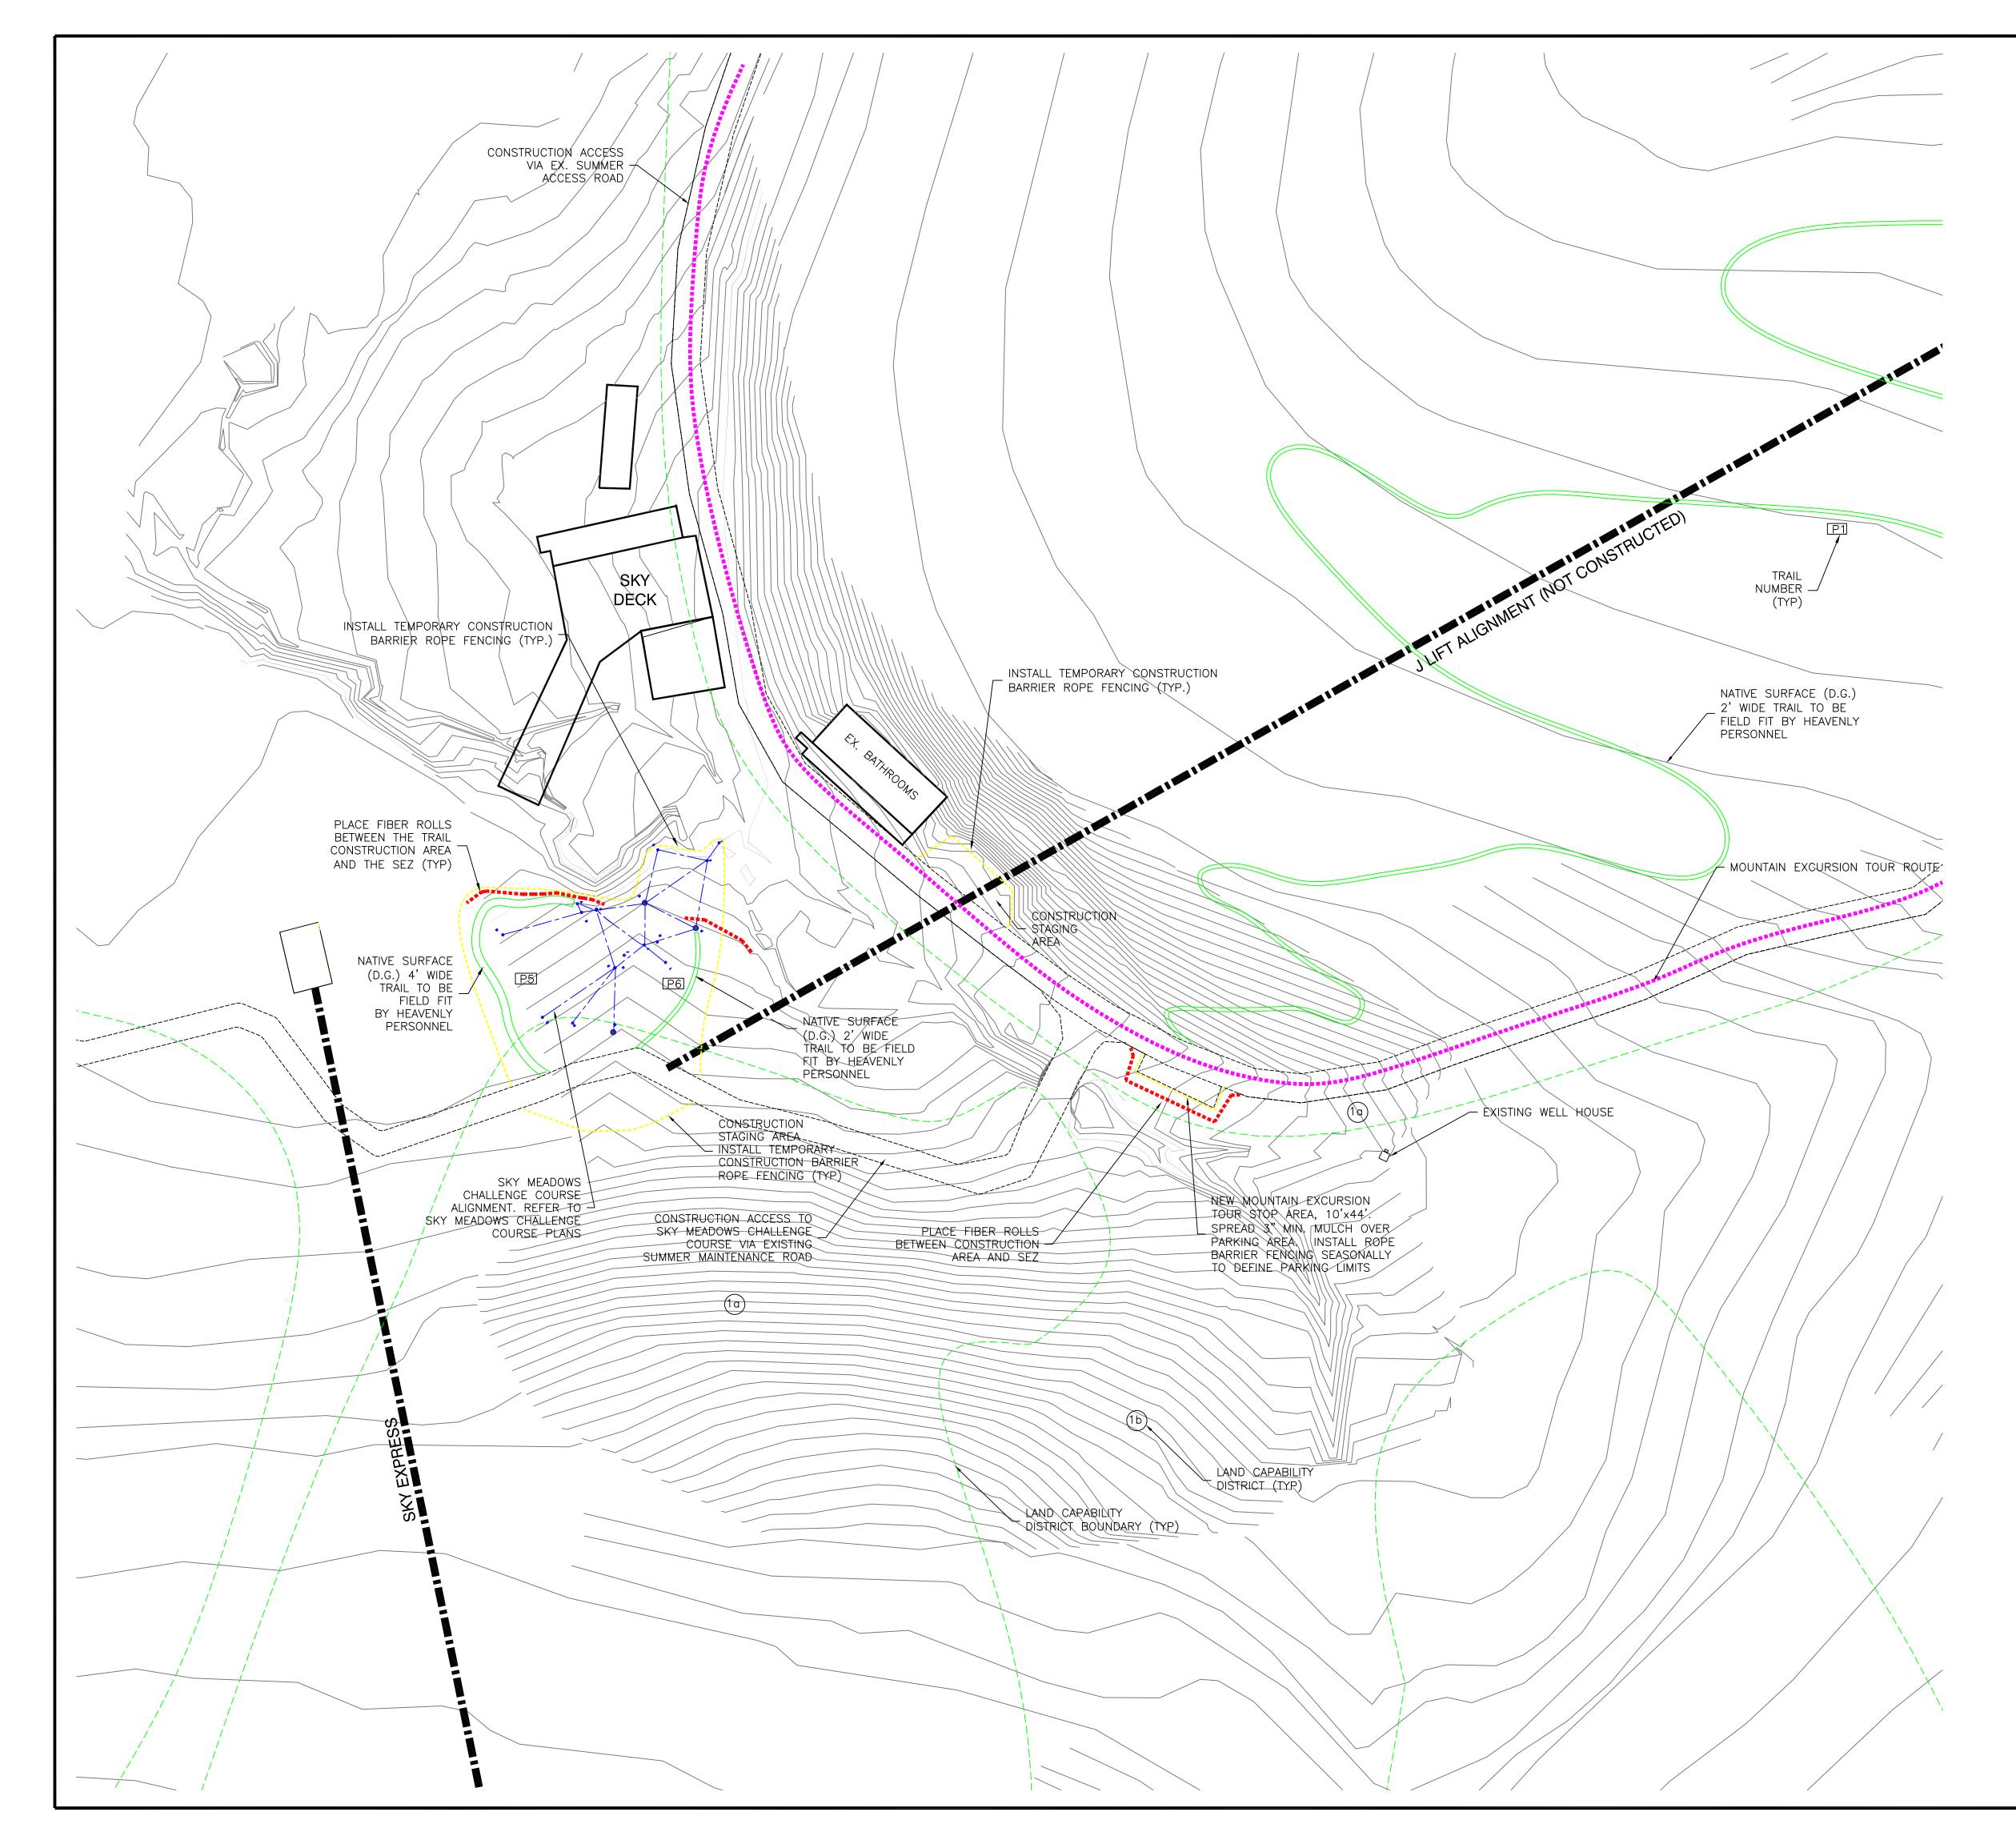
- P2 PUBLIC HIKING TRAILS
- M2 ADMINISTRATIVE MAINTENANCE TRAILS

- 1. ALL TRAILS SHALL BE AT GRADE, NATIVE MATERIAL TRAILS THAT ARE FIELD FIT TO MINIMIZE REMOVAL OF VEGETATION AND UTILIZE THE NATURAL TOPOGRAPHY TO MINIMIZE GRADES.
- 2. STACKED SWITCHBACKS SHALL BE MINIMIZED TO THE EXTENT POSSIBLE.
- 3. FORMER ROADWAY PRISMS SHALL BE UTILIZED WHERE PRACTICABLE FOR NEW TRAIL ALIGNMENTS.
- 4. ALL TRAIL CONSTRUCTION CORRIDORS OUTSIDE OF THE TRAIL ITSELF SHALL BE REVEGETATED PER THE REVEGETATION SPECIFICATIONS INCLUDED IN THESE PLANS.
