ADVENTURE PEAK EPIC DISCOVERY ACTIVITES HEAVENLY MOUNTAIN RESORT EL DORADO COUNTY, CALIFORNIA APN 030-030-01 DOUGLAS COUNTY, NEVADA APN 1318-00-002-010

EAST PEAK LAKE BASIN EPIC DISCOVERY ACTIVITIES HEAVENLY MOUNTAIN RESORT EL DORADO COUNTY, CALIFORNIA APN 030-030-01 DOUGLAS COUNTY, NEVADA APN 1318-00-002-010

SKY MEADOWS BASIN EPIC DISCOVERY ACTIVITES HEAVENLY MOUNTAIN RESORT EL DORADO COUNTY, CALIFORNIA APN 030-020-01 DOUGLAS COUNTY, NEVADA APN 1318-00-002-010

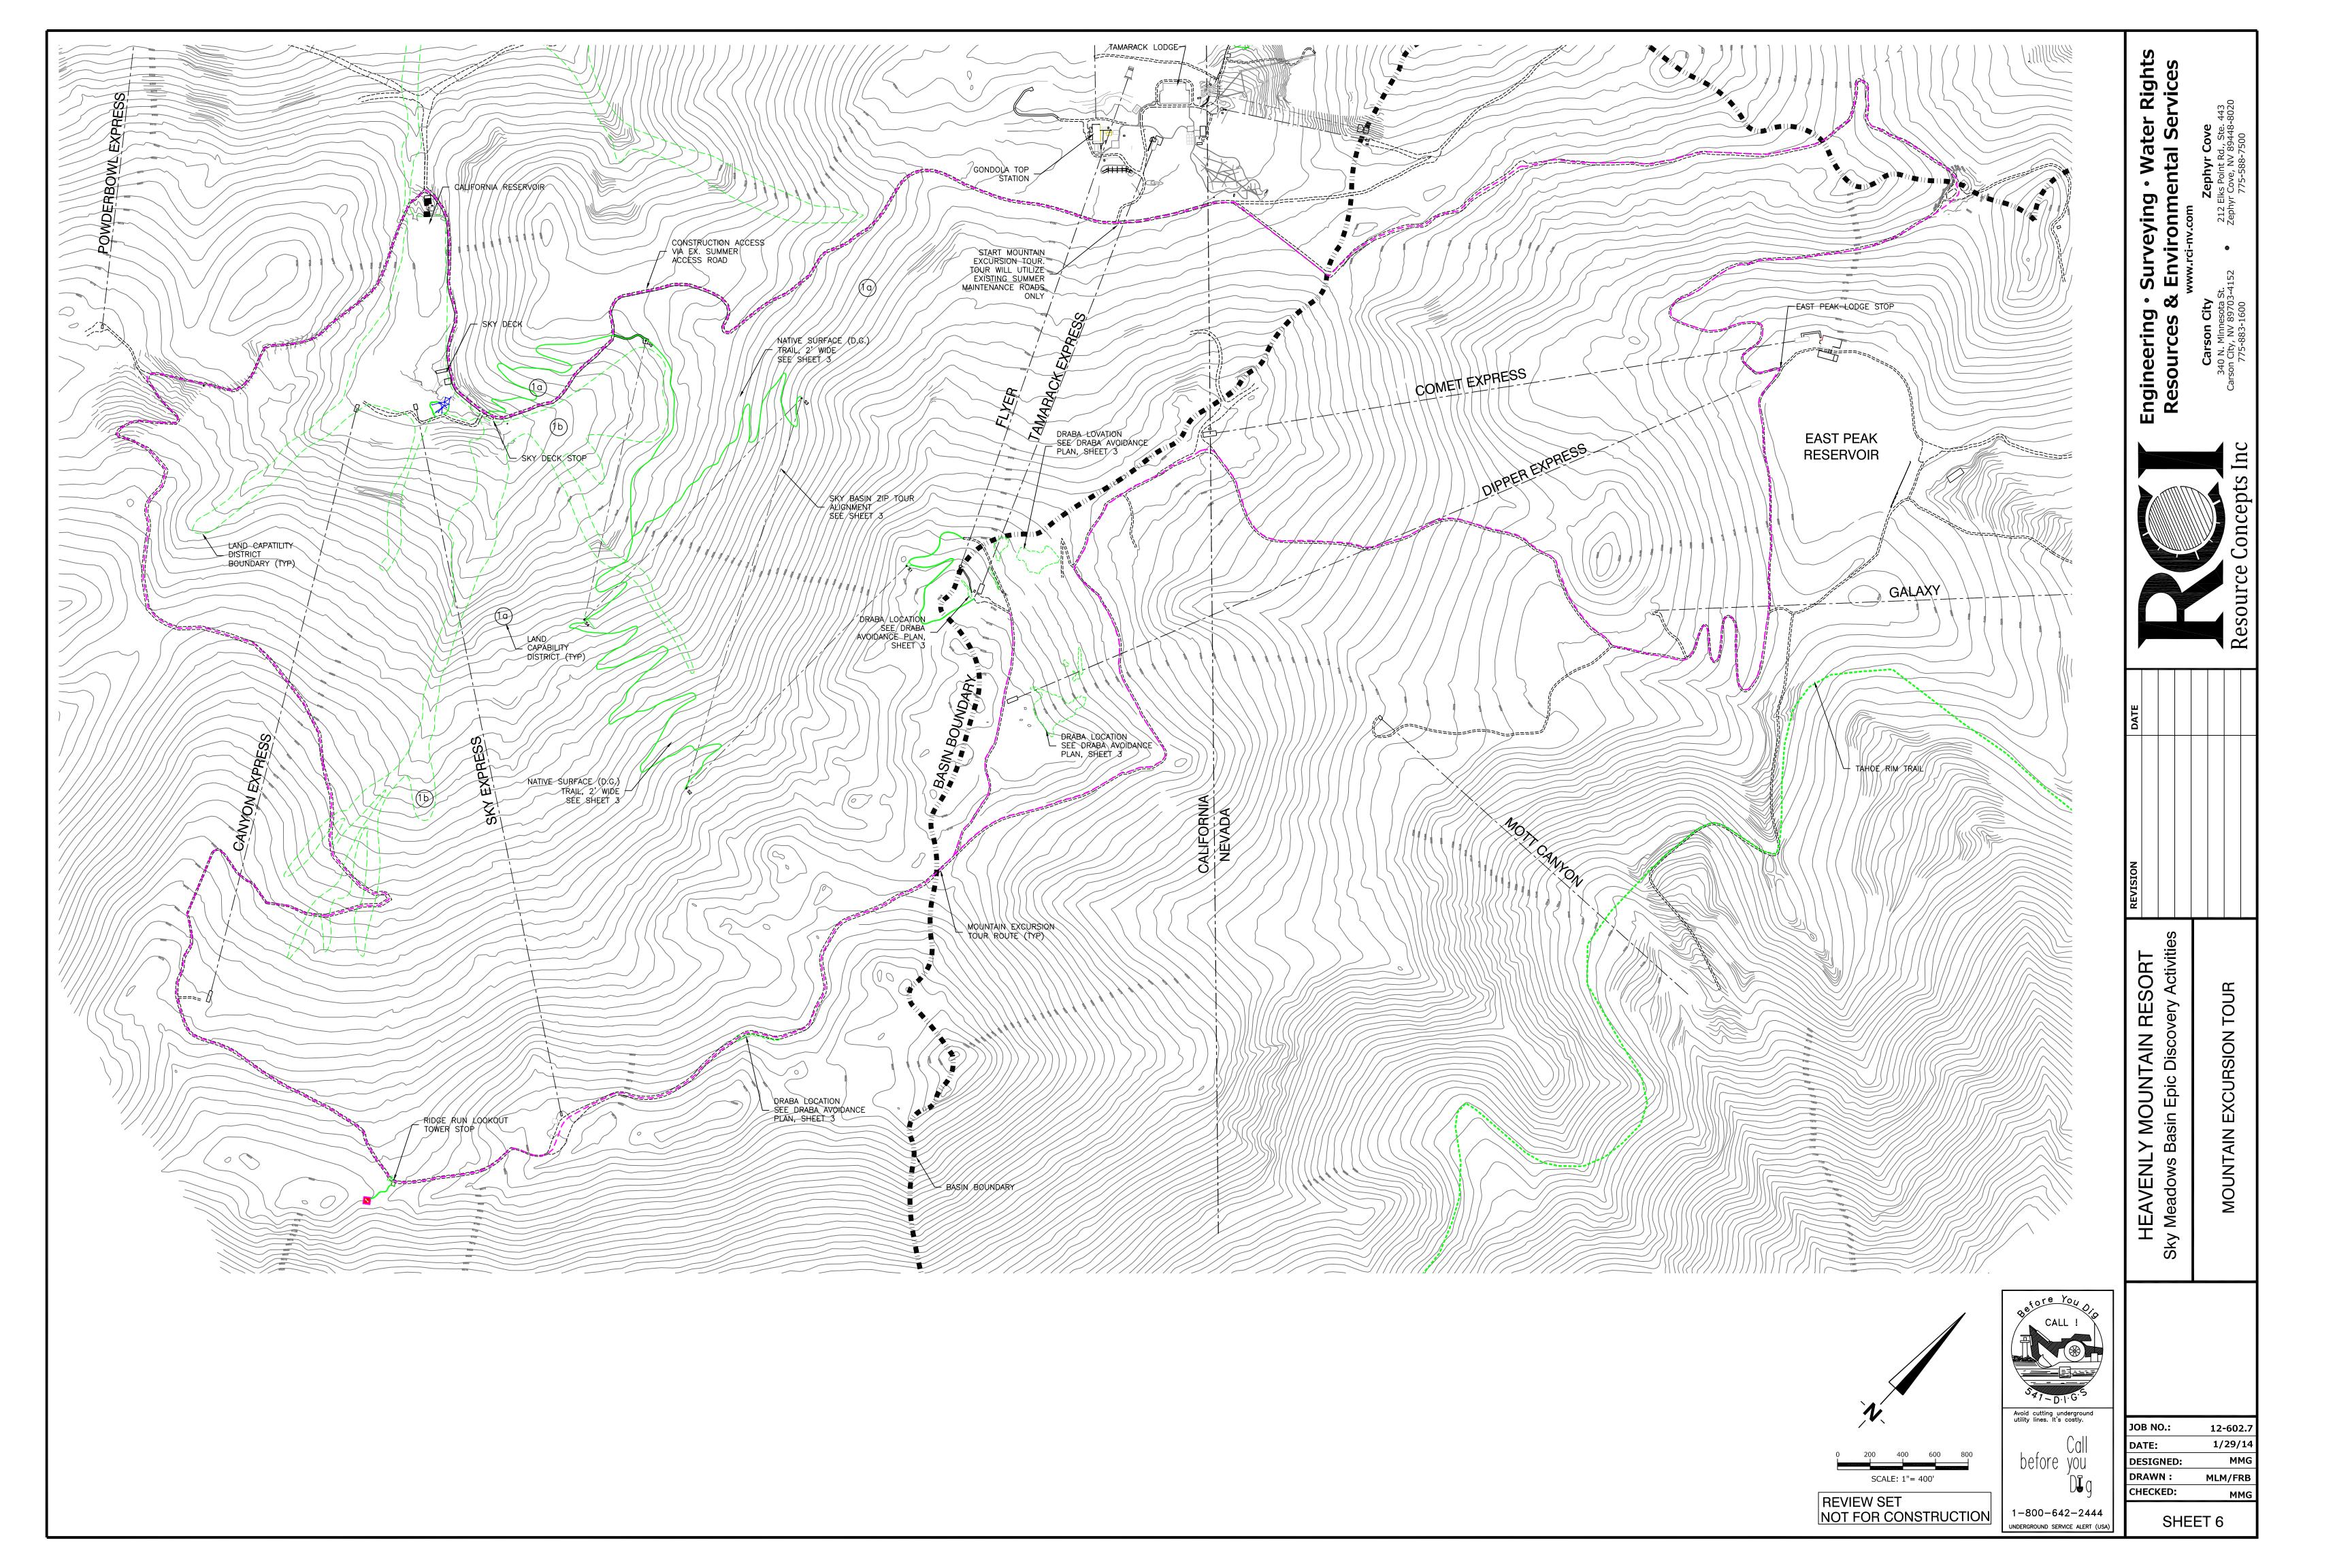
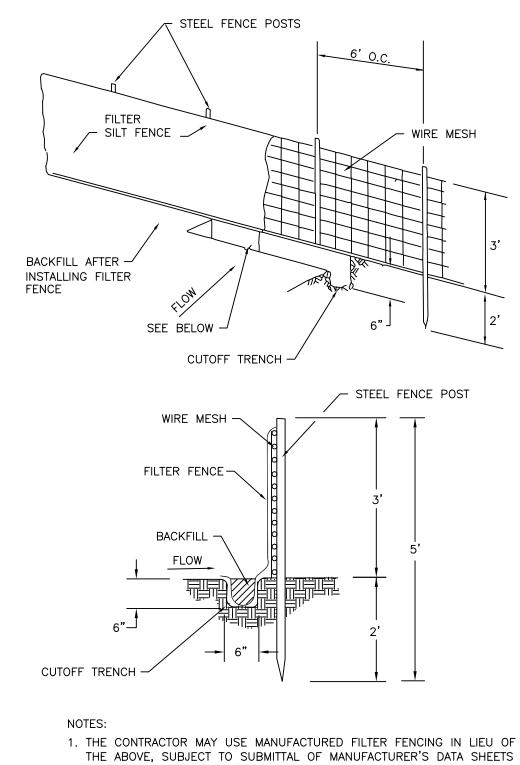
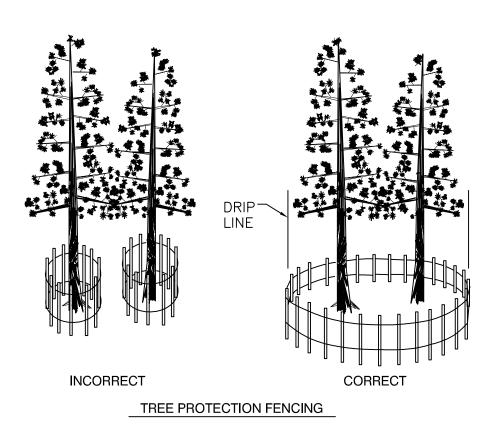
- 1. TEMPORARY FENCING TO BE A MINIMUM OF 4' HIGH.
- 2. POSTS TO BE SET AT A MINIMUM OF 6 CENTERLINE FROM EACH OTHER.
- 3. FENCING MATERIALS TO BE APPROVED BY THE ENGINEER.

- TO THE ENGINEER FOR APPROVAL. 2. WIRE MESH CAN BE DELETED IF POST SPACING IS REDUCED TO
- 4-FOOT OC.
- 3. ENDS OF RUN OF FILTER FENCE SHALL BE TURNED UPHILL TO FORM A
