STAFF REPORT

Subject Globetrotter Properties LLC Land Capability Challenge, 176 Highway 50, Douglas County, NV APN: 1318-22-001-013, TRPA File No: LCAP2023-0144

Hearings Officer review and approval of the proposed Land Capability Challenge.

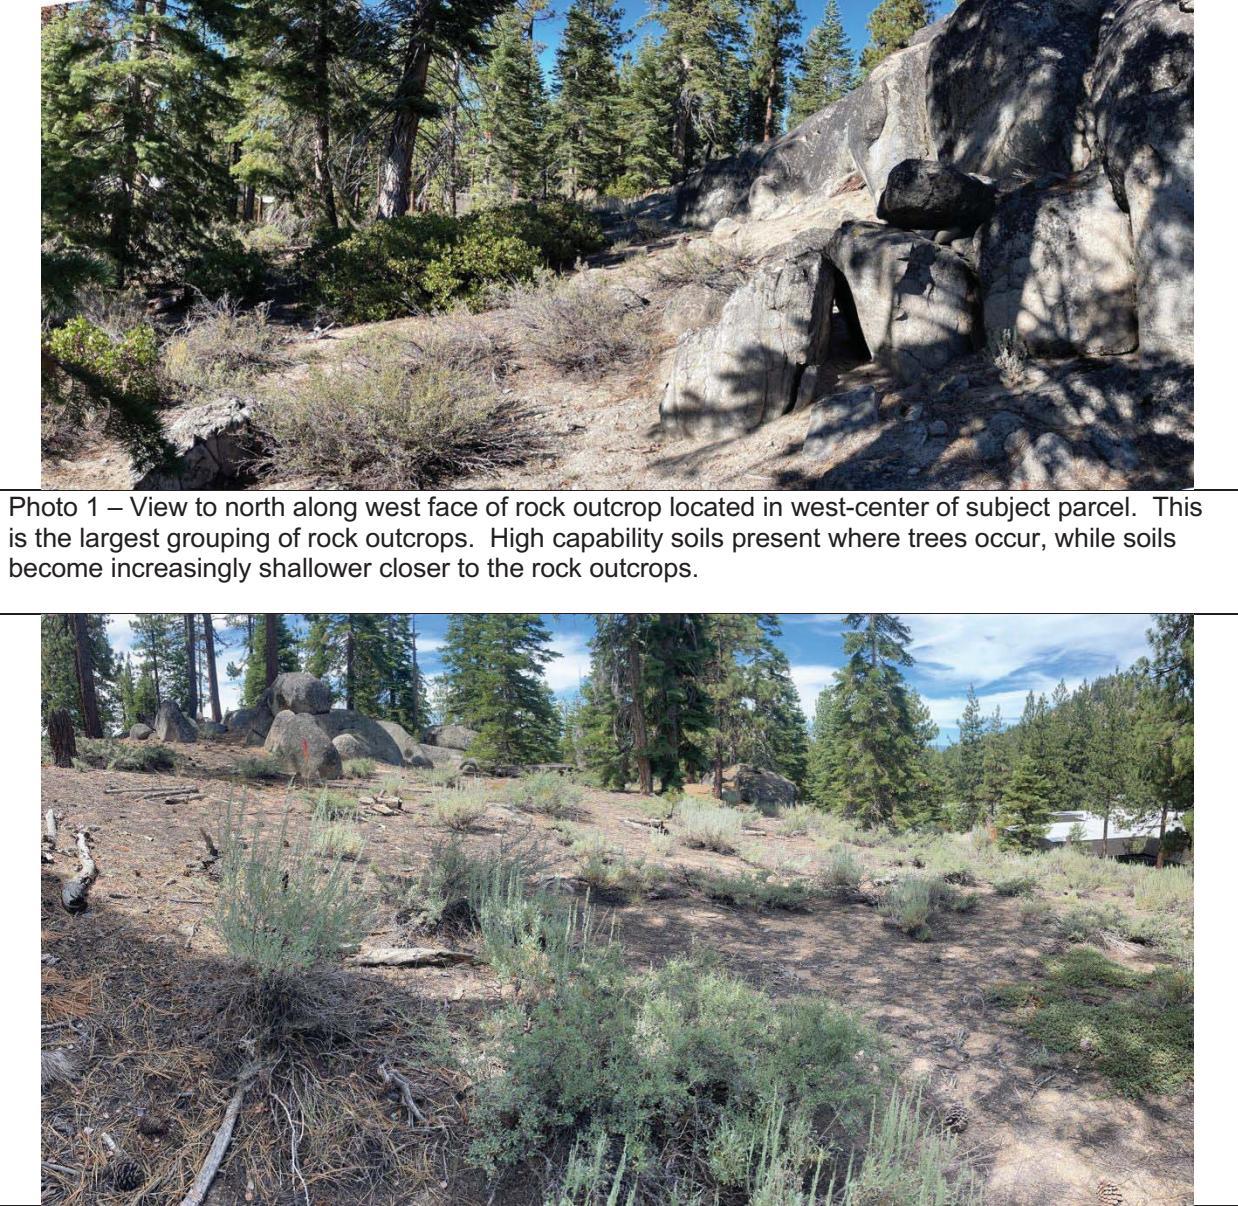
Photo 2 – View to west from northeast corner. Such area slopes to the north (office buildings at far right). The slopes are mostly 17 to 25%, but the upper right portion of photo has slopes between 30 and 35%. Surface stones and boulders amount to 5% ground cover. The deep soils documented in the soil pits qualifies this vicinity for Class 4.

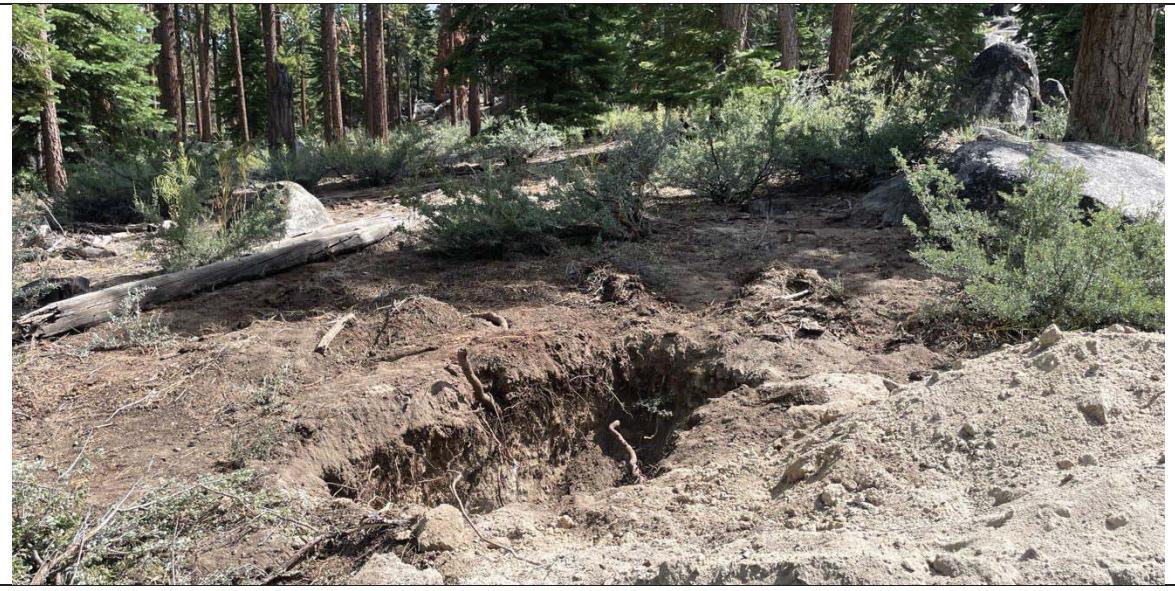
Photo 3 – View to northeast at Soil pit no. 1. This soil has minimal soil formation with an 18-inch topsoil atop several feet of highly weathered bedrock (C horizon). Soil textures are loamy coarse sand to coarse sand with 15 to 40% gravels and cobbles in the subsoil horizons.

- Oi 1-0 inches,
- A1 1 8 inches, brown (10YR 5/3) and dark brown (10YR 3/3) moist; gravelly loamy coarse sand; weak fine granular structure; soft, loose, nonsticky and nonplastic; many fine common and medium roots; many very fine and fine interstitial pores; fifteen percent gravel, clear smooth boundary.

- A2 8 18 inches, light yellowish brown (10YR 6/4) and dark yellowish brown (10YR 4/4) moist; gravelly loamy coarse sand; weak fine granular structure; soft, loose, nonsticky and nonplastic; many fine medium and few coarse roots; many very fine and fine interstitial pores; gradual wavy boundary.

- C1 18 24 inches, light yellowish brown (10YR 6/4) and dark yellowish brown (10YR 4/4) moist; gravelly loamy coarse sand; single grain; soft, loose, nonsticky and nonplastic; common fine and few medium roots; many very fine and fine interstitial pores; thirty percent gravel; gradual wavy boundary.

- C2 24 48 inches, light yellowish brown (2.5Y 6/4) and light olive brown (2.5Y 5/4) moist; very gravelly coarse sand; single grain; soft, loose, nonsticky and nonplastic; common fine and few medium roots; many very fine and fine interstitial pores; seventy-five percent gravel; gradual irregular boundary.

- C3 48+ inches, pale brown (2.5Y 7/4) and light yellowish brown (2.5Y 6/4) moist; very gravelly loamy coarse sand; single grain; slightly hard, very friable, nonsticky and nonplastic; common medium and few fine roots; many very fine and fine interstitial pores; sixty-five percent gravel.

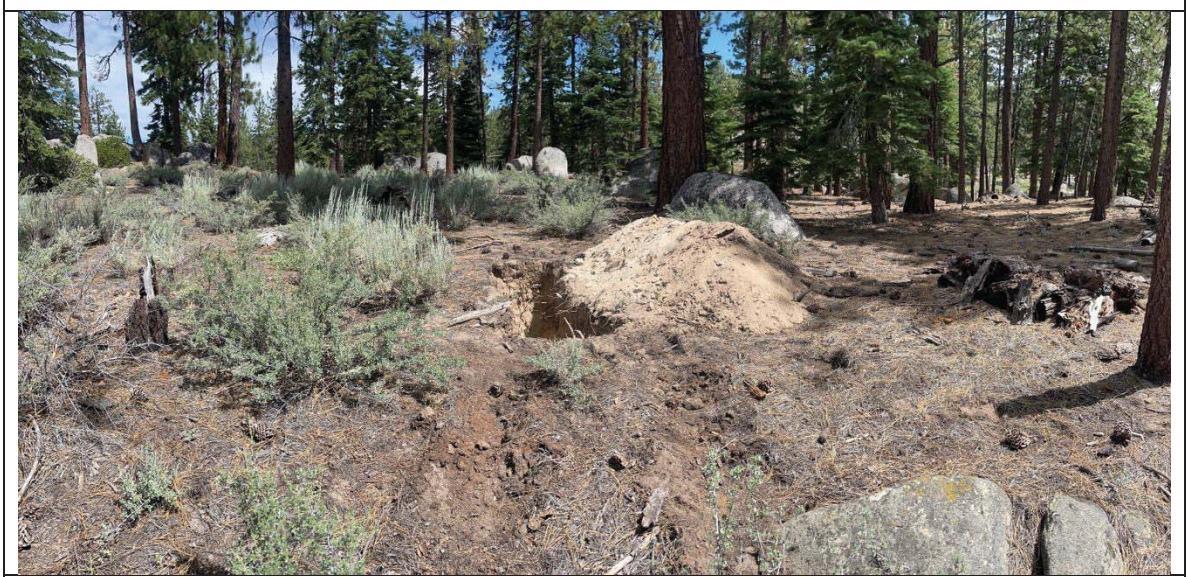
Photo 4 – View to northeast at Soil pit no. 3, located in the north-center of the subject parcel. This soil qualifies as Class 6, as per Land-Capability Classification of the Lake Tahoe Basin, California-Nevada (Bailey, 1974). This location has 4 to 10% slopes that dip to the south. The upland forest is dominated by Jeffrey pine and lesser amounts of white fir and incense cedar. The understory vegetation consists of sagebrush, bitterbrush, greenleaf manzanita, and scattered grasses/forbs. While variable, the vegetated ground cover in this vicinity is 30 to 40% and duff cover is 60 to 70%.

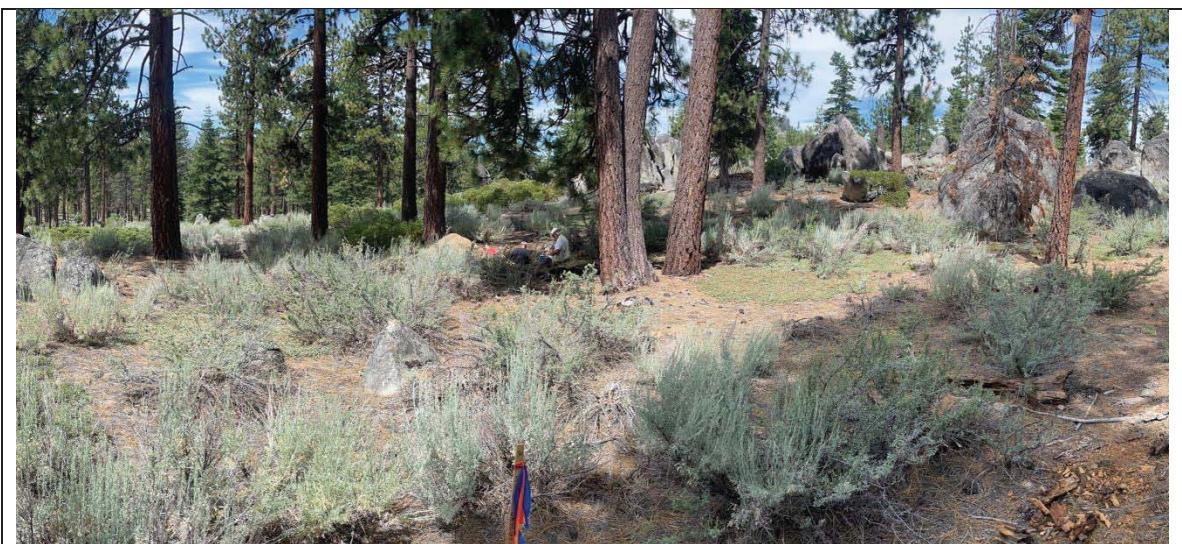
Photo 5 – View to northwest toward Soil pit no. 3, situated in a broad area east of the rock outcrops shown in Photo 1. The slopes in foreground are 10 to 15%, which drain to the south by southwest. All of the soil pit locations have undisturbed soils, but trees have been harvested and/or thinned over several decades (no recent cutting evident). Visible rocks in foreground and far left are large boulders but not attached to bedrock.

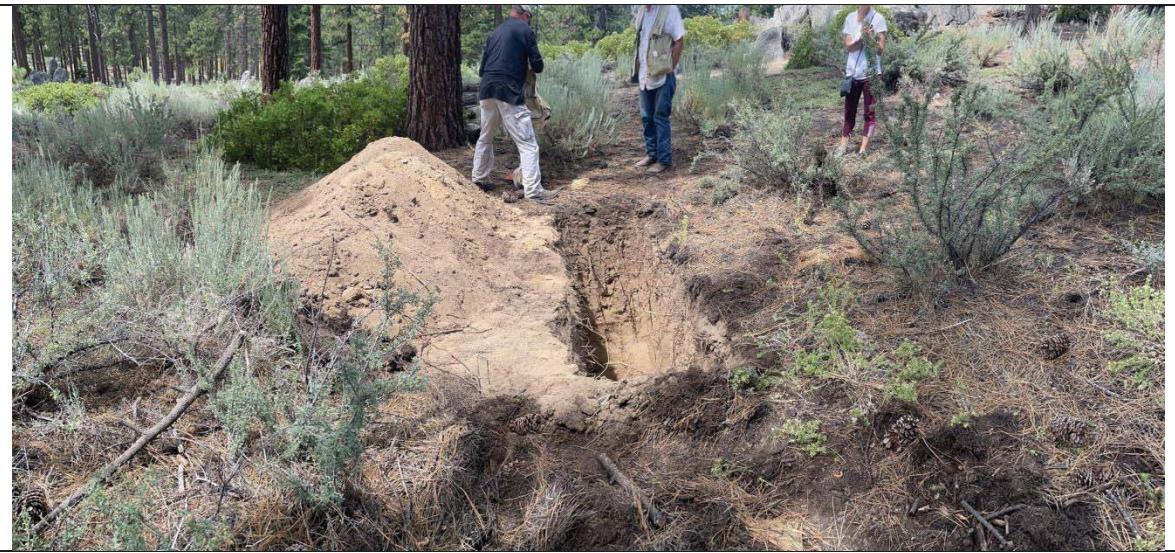
Photo 6 – View to west at Soil pit no. 2. This location has a gentle slope with rock outcrops to the east, south and west. The observed soil profile has 2 inches of conifer needles and duff, then 14 inches of a dark grayish brown to dark brown topsoil (A horizon). The underlying subsoil (cambic Bw horizon) is a dark yellowish brown loamy coarse sand having 15 to 25% gravels, plus a few cobbles and stones. At 48 inches, the soil material becomes highly decayed bedrock (C horizon) having very gravelly coarse sand textures. The observed soil does not match the Cagwin series, which was mapped as such in the 1974 Soil Survey of Lake Tahoe Basin. These soils are significantly deeper, somewhat excessively drained and have rapid permeability in the subsoil.

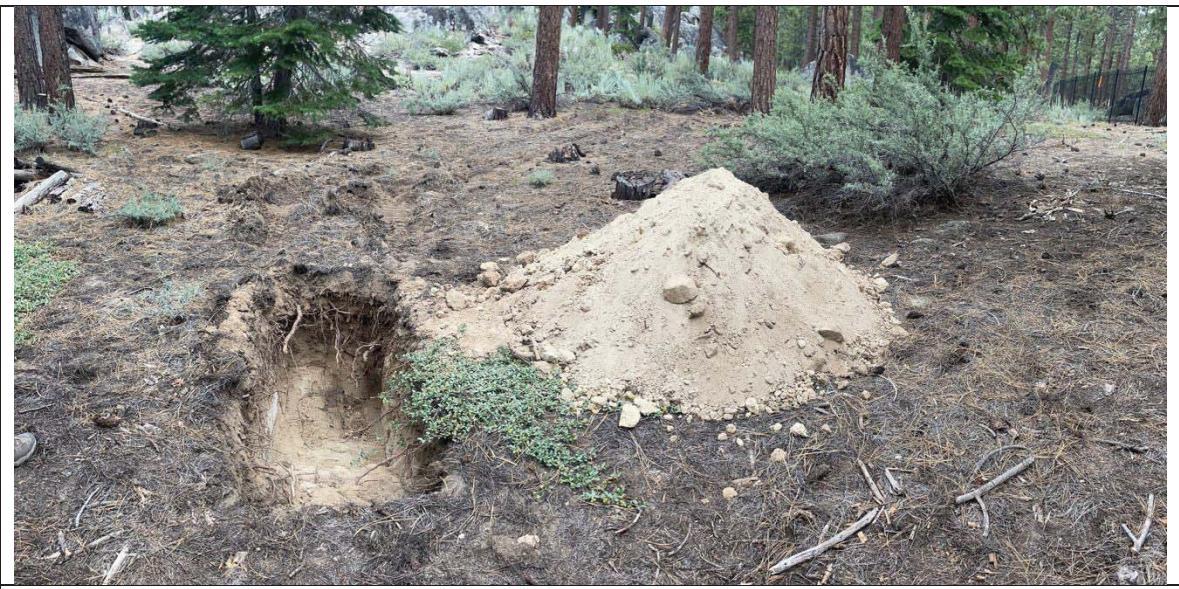
Photo 7 – View to northeast at Soil pit no. 4, located near the south corner of the property. Slopes in this area are 8 to 12%, dipping to the southwest. While the duff layer is only 1 inch thick here, the soils are sufficiently sandy and have granular to subangular blocky structure that effectively transmits rain and snowmelt through the profile. Such conditions are consistent with Hydrologic Soil Group A (no subsurface water and no limitations for root penetration). Soil erosion within parcel is very low and regeneration after disturbance is relatively quick.

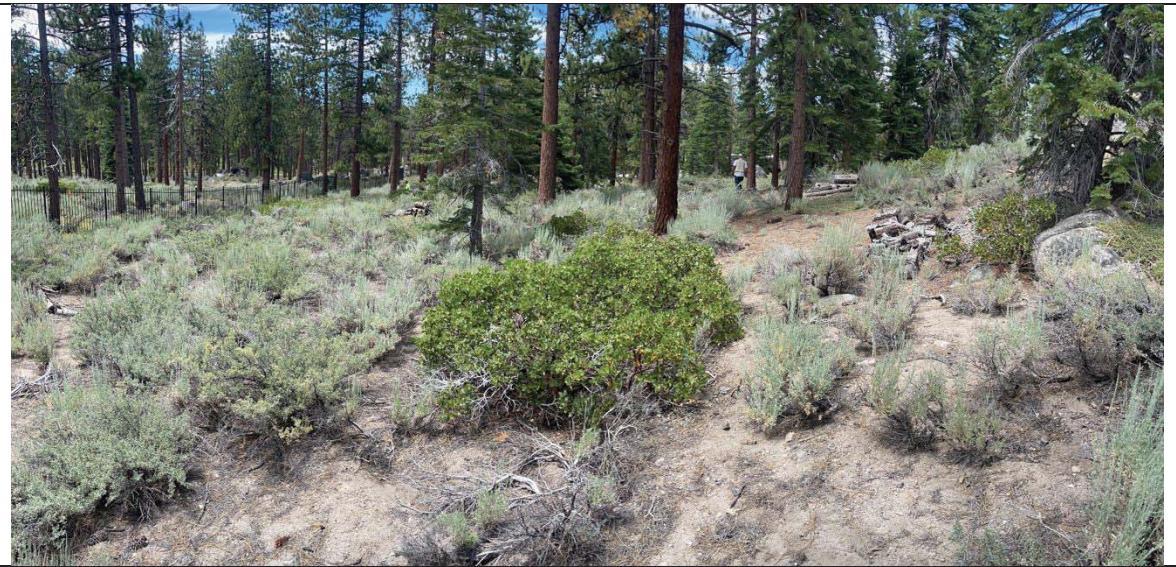
Photo 8 – View to west along south property line (metal fence at far left). Except for rock outcrops, this vacant parcel has similar vegetation and ground cover conditions throughout. The slope in center-foreground is 20 to 25% (right), that becomes 10 to 15% at left. These unnamed, deep soils (labeled XXX by TRPA) have 3 slope classes, namely 0 to 16% (Class 6), 16 to 30% (Class 4), and 30 to 50% (Class 2). Boulders and small outcrops included in this map unit.

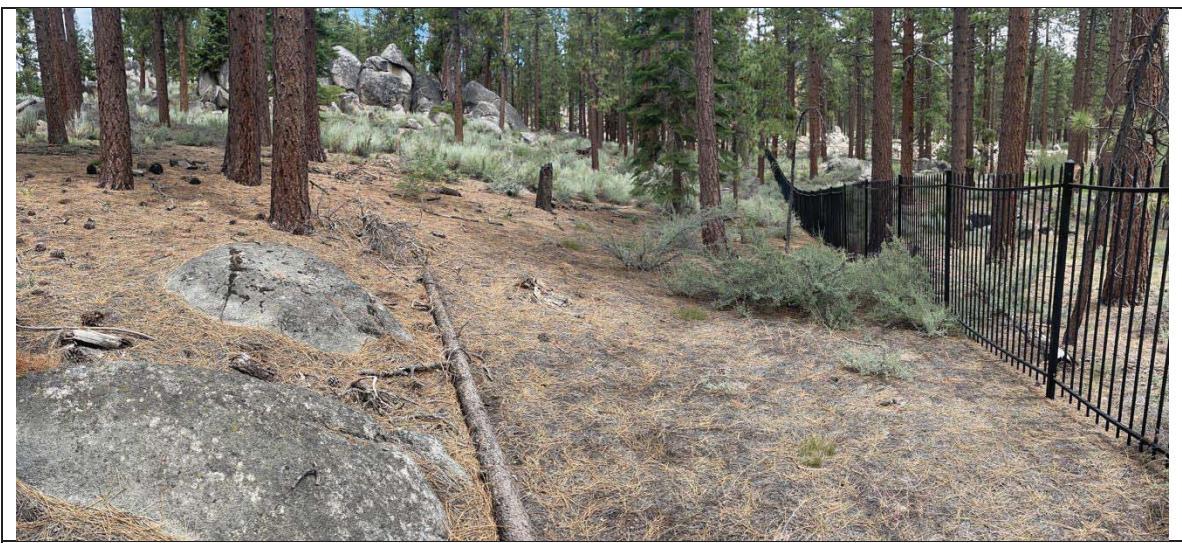
Photo 9 – View to east along south property line (east of Soil pit no. 4). The exposed bedrock typically has smooth, rounded edges because this location was formerly wave-washed when Lake Tahoe was naturally higher. The resultant soils have subsoil layers composed of highly decayed granodiorite bedrock that is naturally buried by soil materials eroded from higher elevations (colluvium).

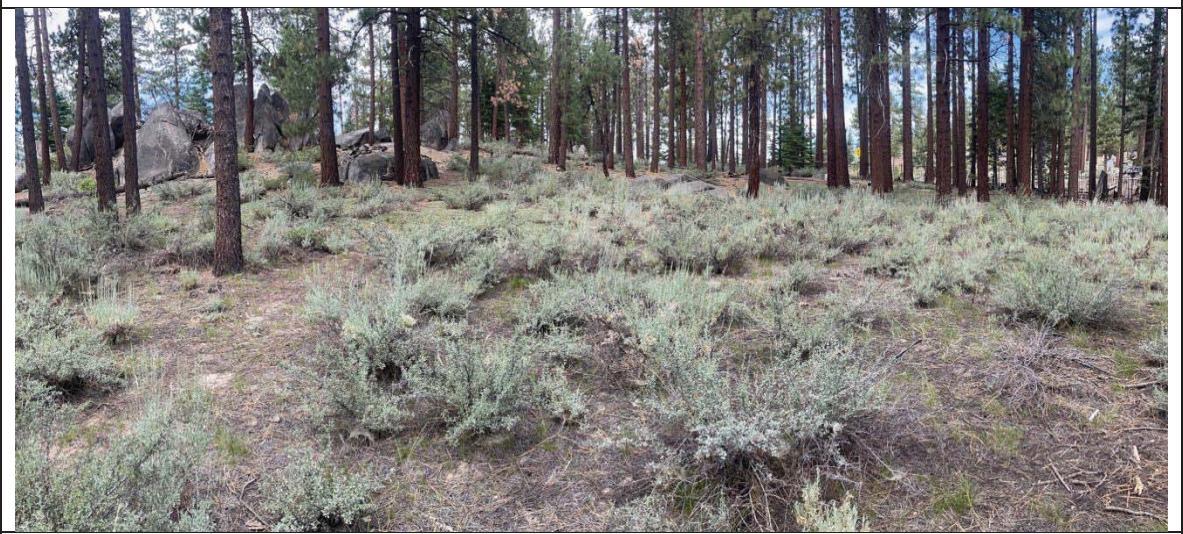
Photo 10 – View to north and parallel to Highway 50 (east edge of parcel). This east-facing slope has slightly greater tree cover (Jeffrey pine, white fir). Foreground vegetation is predominantly bitterbrush and sagebrush. Other shrub species present on this parcel include currant, prostrate ceanothus, greenleaf manzanita and snowberry. Non-native plant composition is very low due harsh winter climate and relatively low ground disturbance (adjacent to U.S.F.S. land).

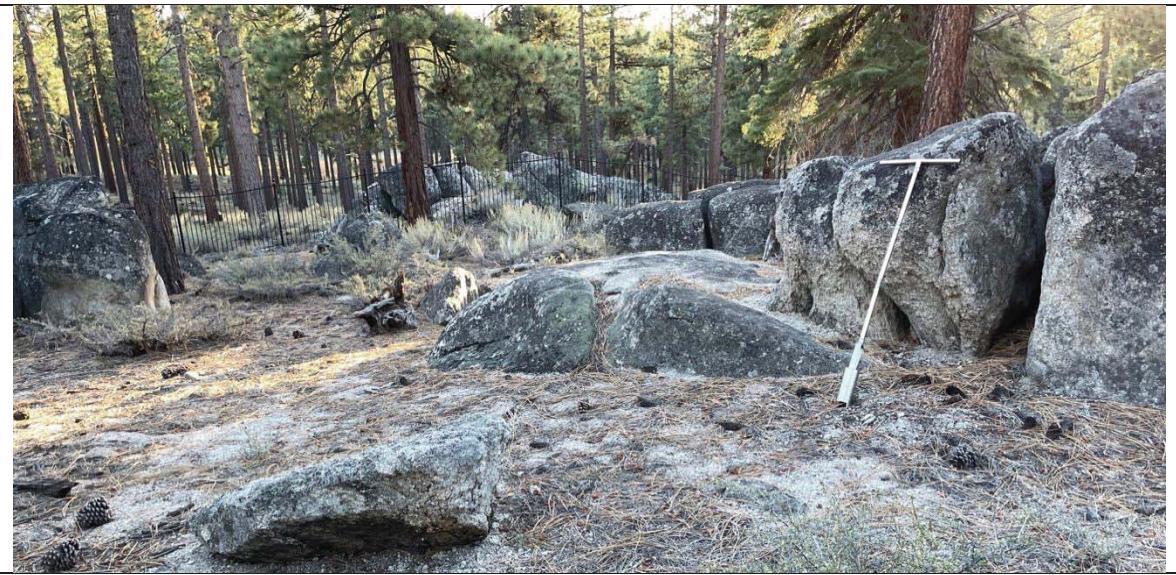
Photo 11 – View to southwest at Auger hole no. 1, located in the western extent of the property. This vicinity is has a small grouping of rock outcrops with separated by shallow soils. The soil near the center of the photo is about 14 inches deep, then the underlying material is too hard to cut with the auger blades. This soil is consistent with the Cagwin series described in the 1974 soil survey. The Cagwin-Rock outcrop, 5 to 15% slopes map unit includes rock outcrops that amount to approximate 15% of the soil delineation. This soil qualifies as Class 4.

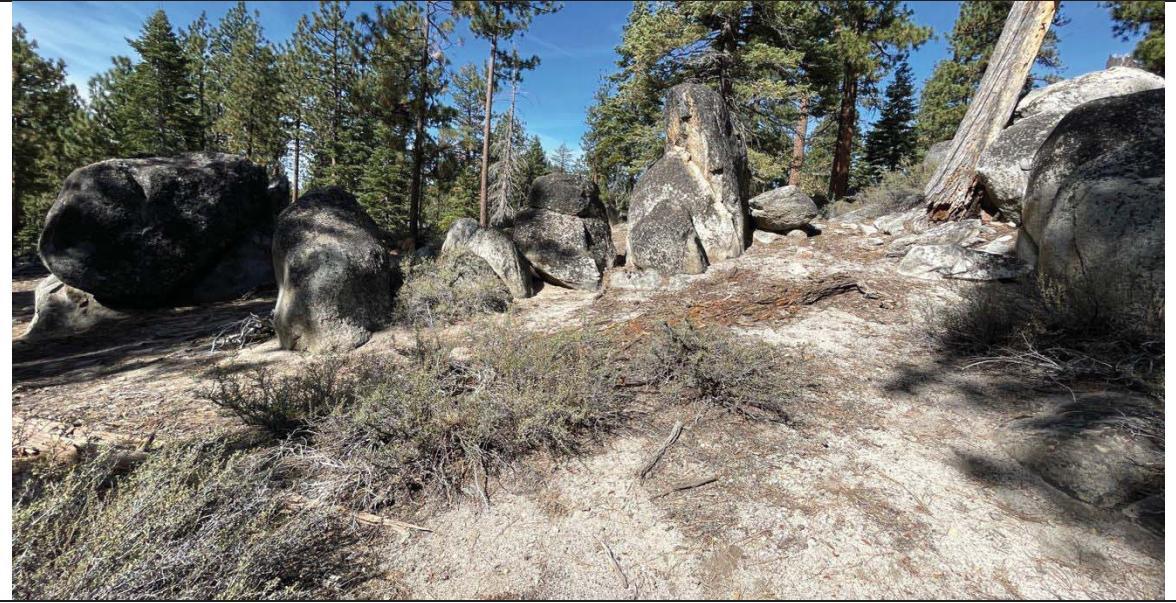
Photo 12 – View to northwest at eastside of rock outcrop near Auger hole no. 5. Shallow soils around the rock outcrops typically have few or no trees, stunted or sparse shrubs, and exposed mineral soil surface (due to lack of natural duff layer). For Auger hole no. 5, the topsoil is 11 inches thick that is underlain by 8 inches of subsoil (C horizon). At 19-inch depth, the hand auger could no longer cut through the decayed bedrock. This soil qualifies as Class 4.

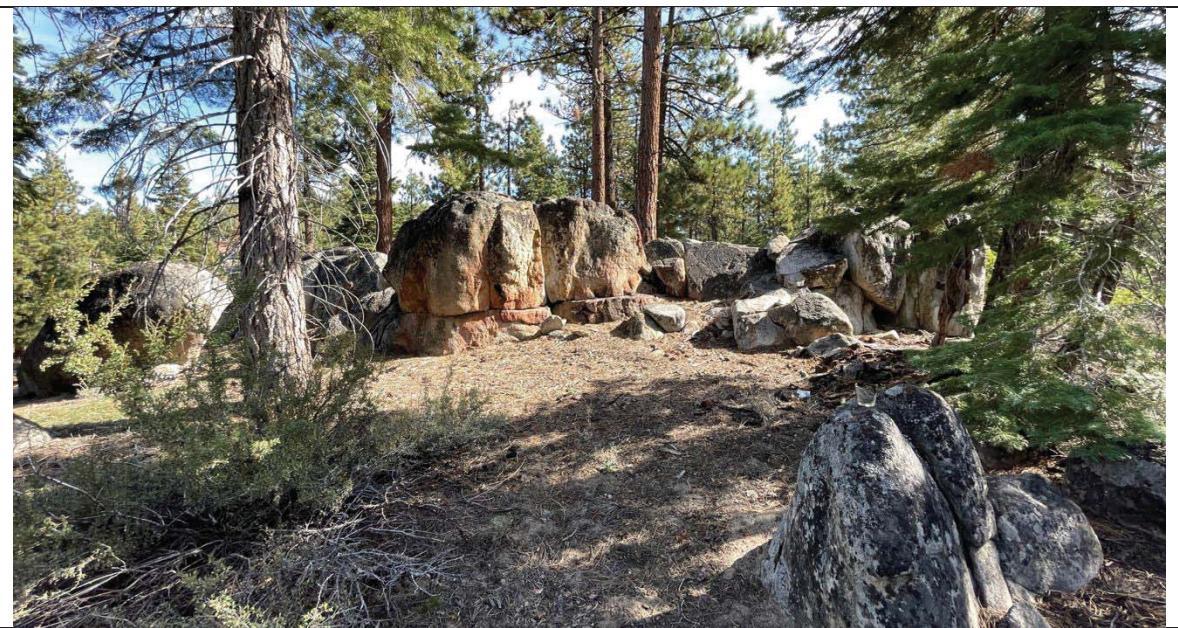
Photo 13 – View to east at rock outcrop located at highest elevation of property. Such location is situated north of Soil pit no. 3. The presence of larger trees in this vicinity indicates that presence of shallow soils around bedrock is not uniform. The mapping of rock outcrops was based on hand-augering depth, ground cover, proximity to exposed bedrock, and thin or absent duff layer. Thus, presence of several large trees alone did not disqualify the mapping of shallow soils.

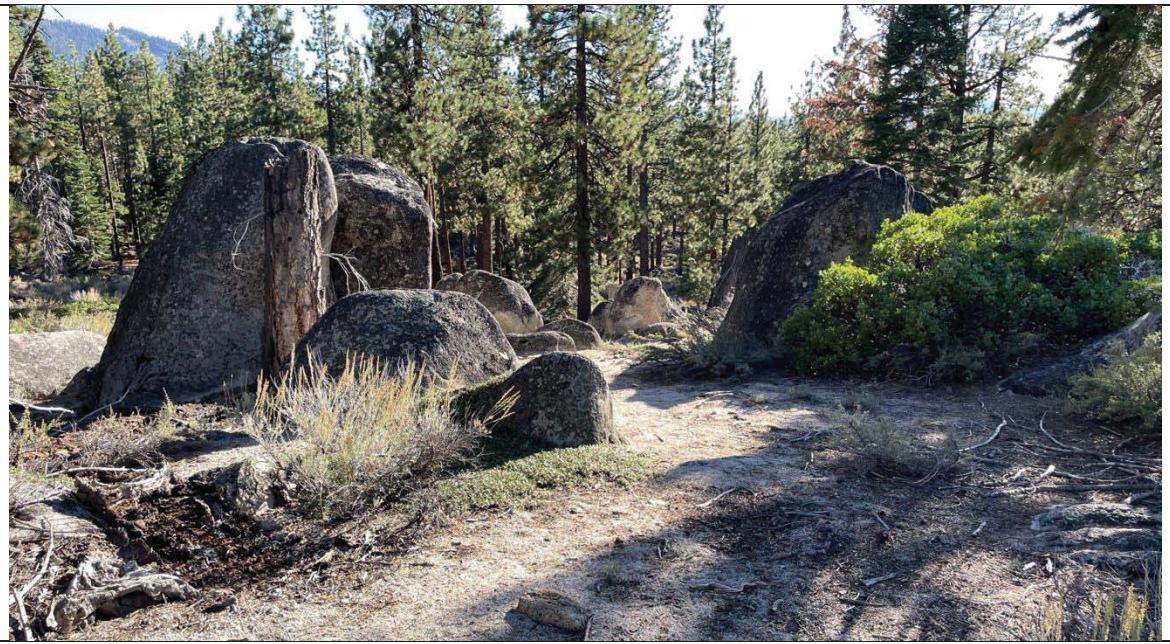
Photo 14 – View to southeast from Auger hole no. 2 (west-center of property). The soil at this location was 17 inches deep before augering could no longer cut into the weathered bedrock. To assure that subsurface rocks were not mistaken as bedrock, the TRPA contractor augered 2 to 4 more holes in this vicinity. The profile documented was the deepest of the holes augered.

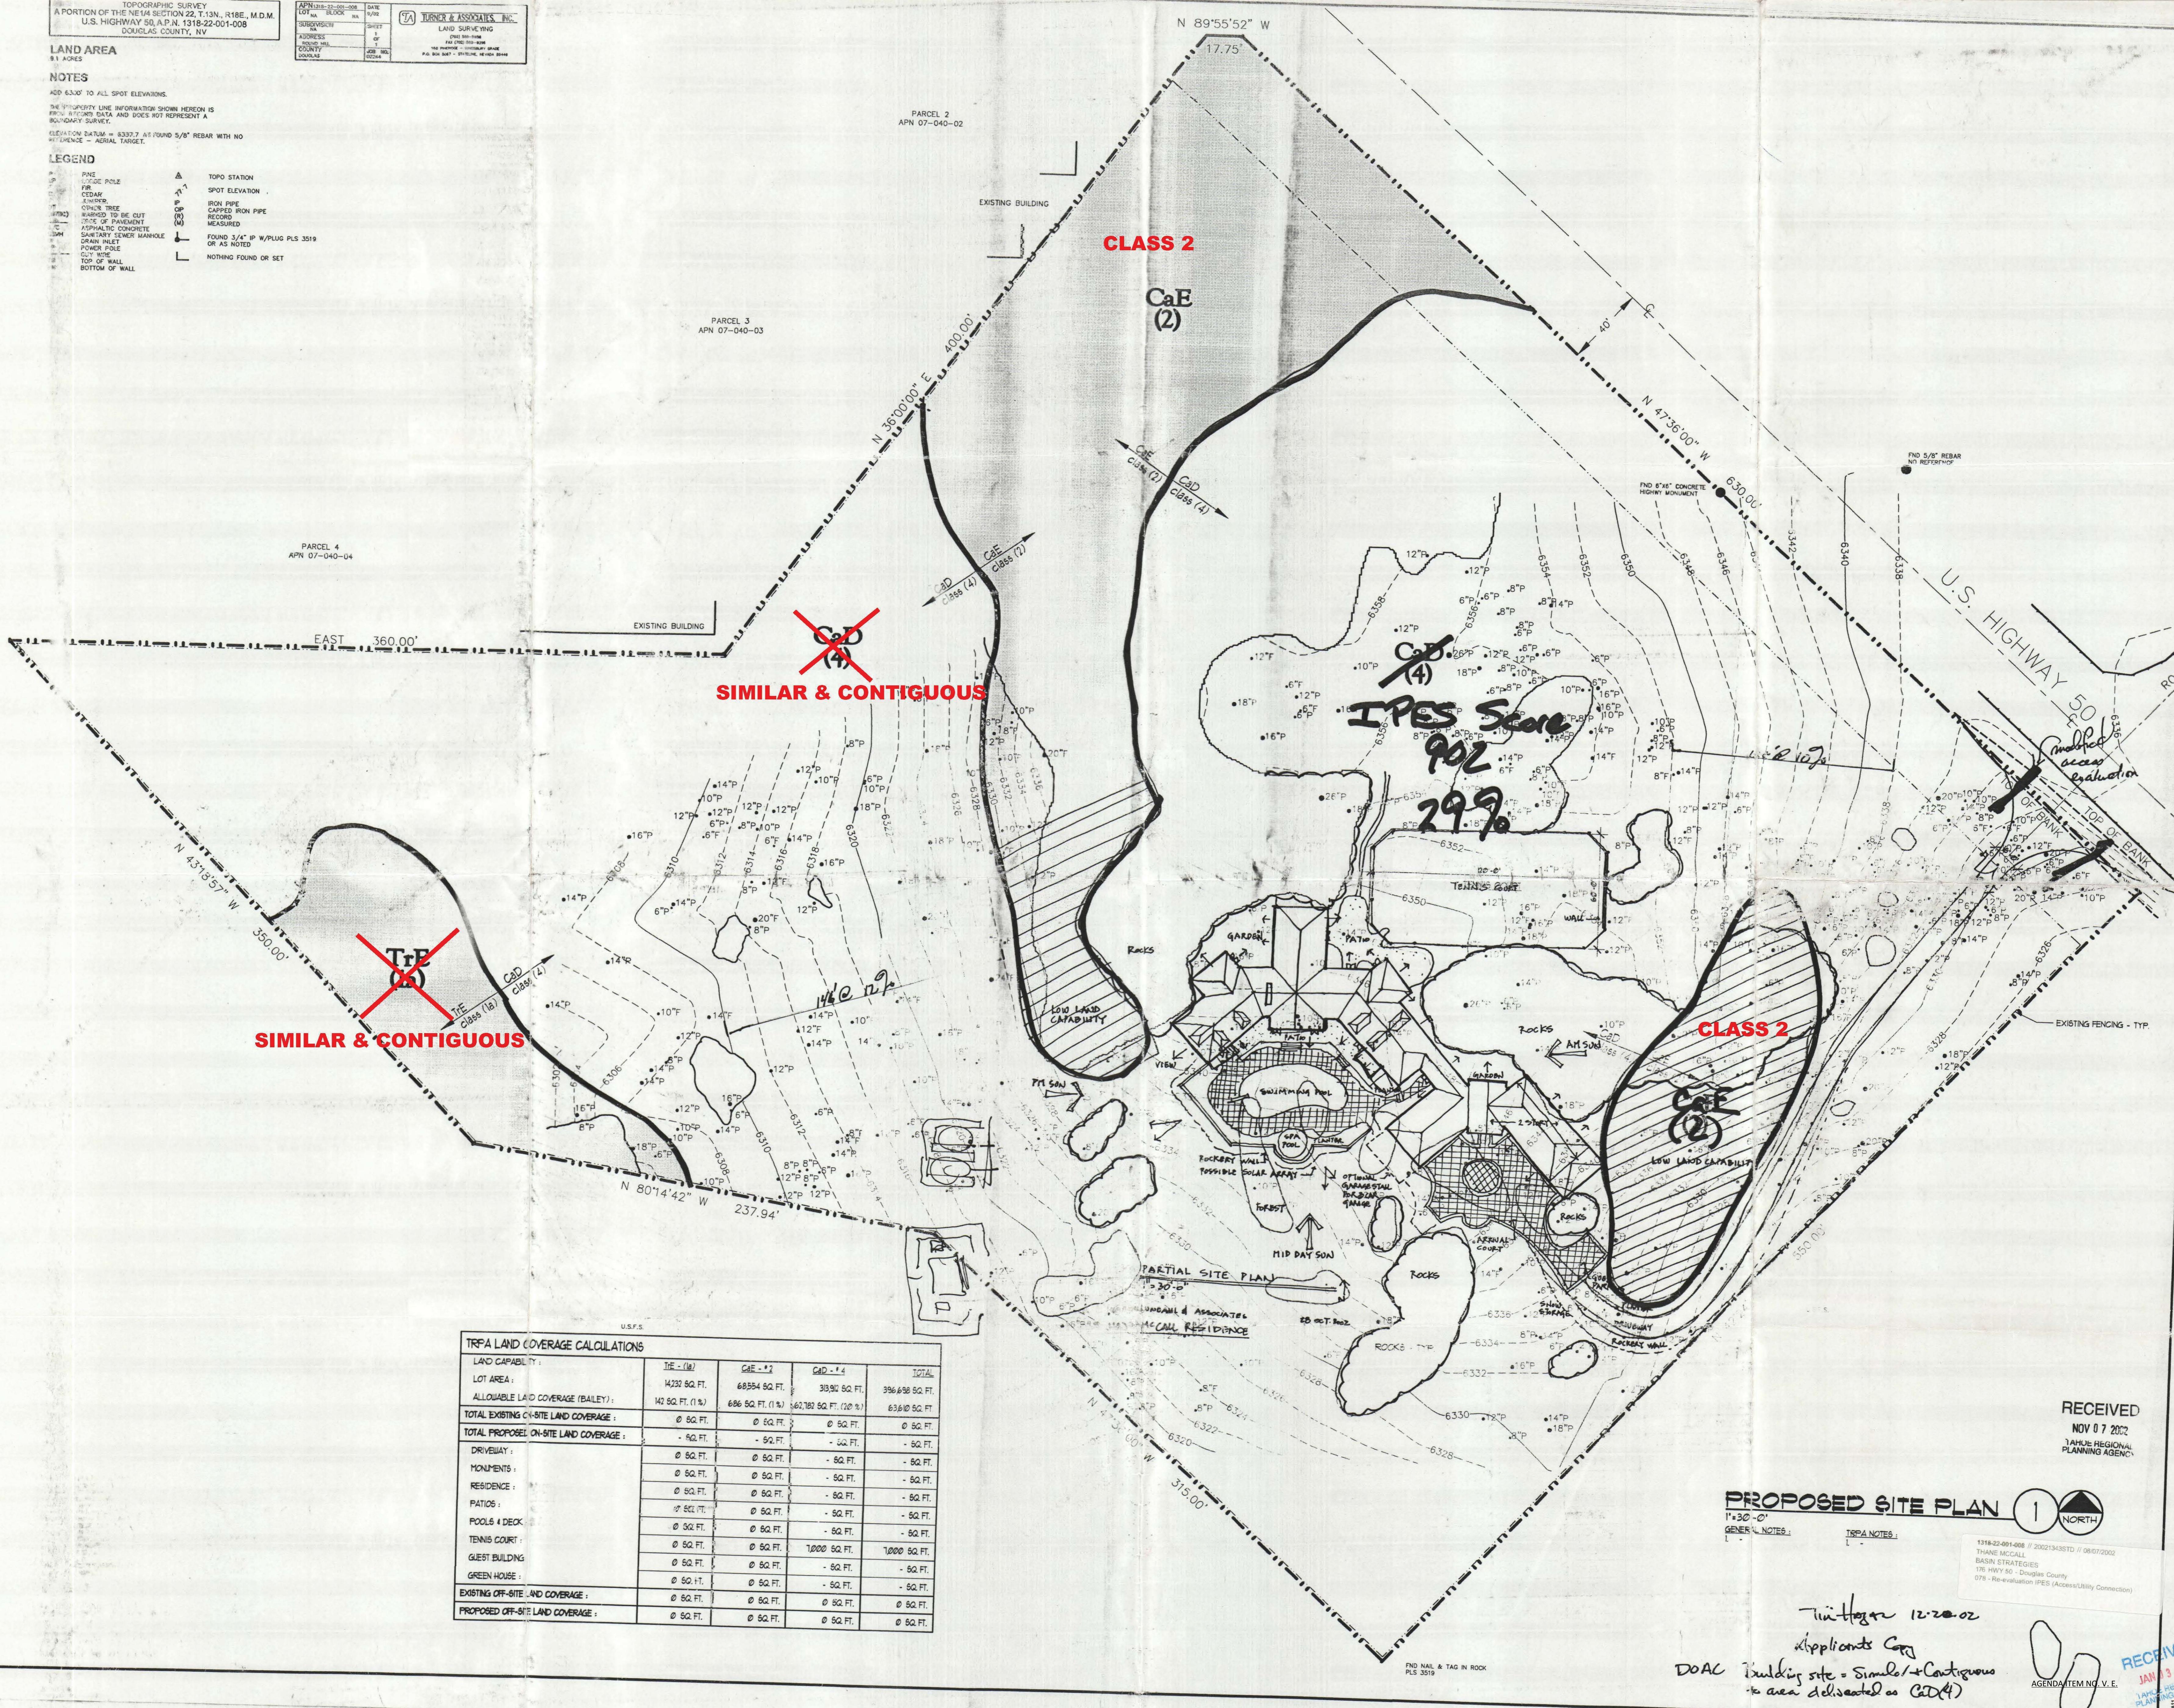
Attachment C December 24, 2002, TRPA Land Capability Verification and October 2022 land capability challenge recommendation map.

Auger Holes -- 5 holes were hand-augered and examined by TRPA Contractor (Phil Scoles, soil scientist). Auger holes were positioned to document areas of shallow soils associated with groupings of rock outcrops. The auger hole depths ranged from 13 to 22 inches. These shallow soils are very droughty and considered Hydrologic Soil Group C. Soil textures are predominately loamy coarse sand throughout profile. Gravel content ranges from 5 to 15% and cobbles-stones content is 5 to 10%. Roots extend to the grus layer (black and white partially weathered bedrock). The observed soils in the auger holes generally match the mapped Cagwin-Rock outcrop map unit, because they have bedrock between 20 and 40 inches. In accordance with Land-Capability Classification of the Lake Tahoe Basin. Californiaslopes 15 to 30% (or greater).

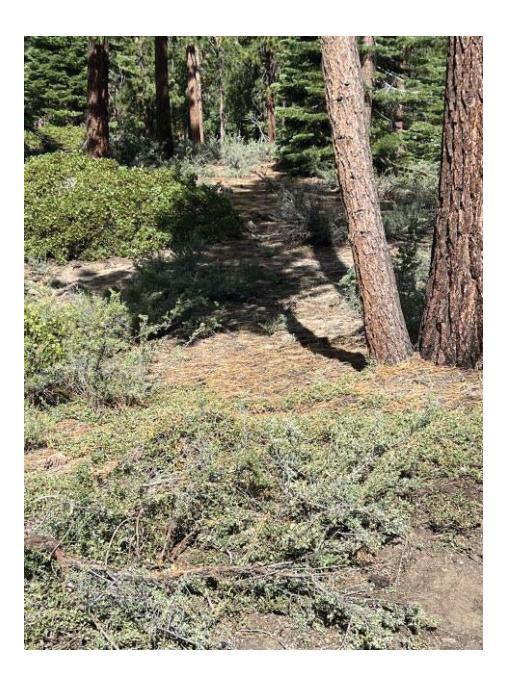
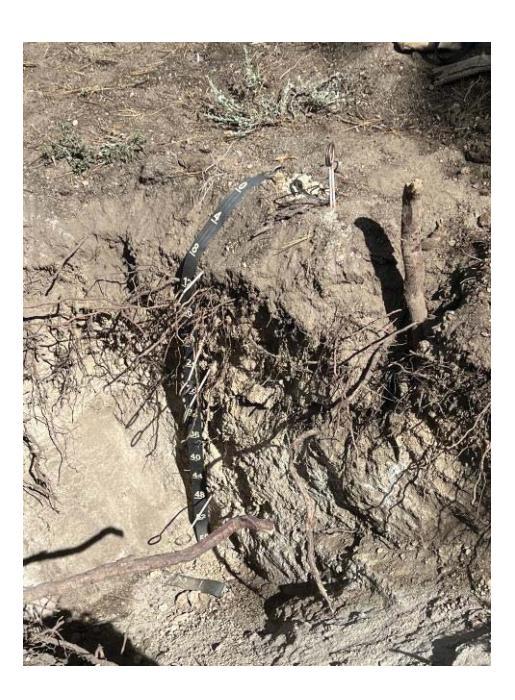
Figure 1. Pit 1 landscape.

Figure 2. Pit 1 profile.

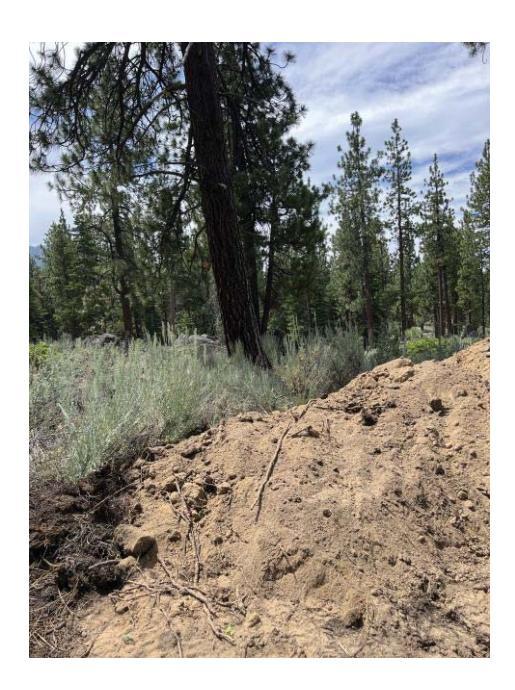
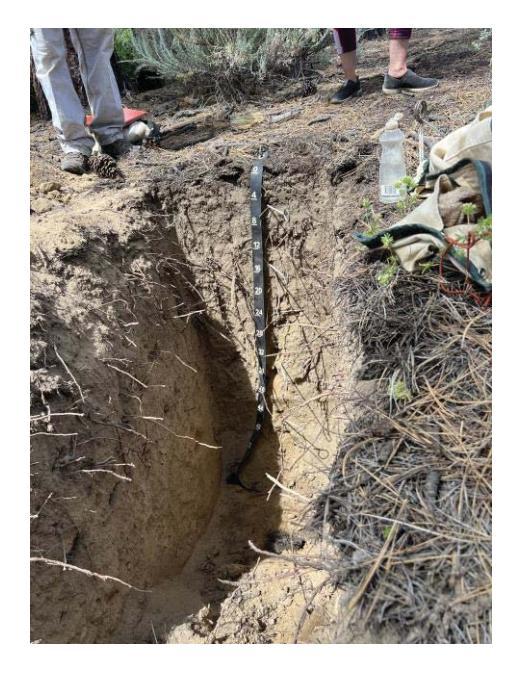
Figure 3. Pit 2 landscape.

Figure 4, Pit 2 profile.

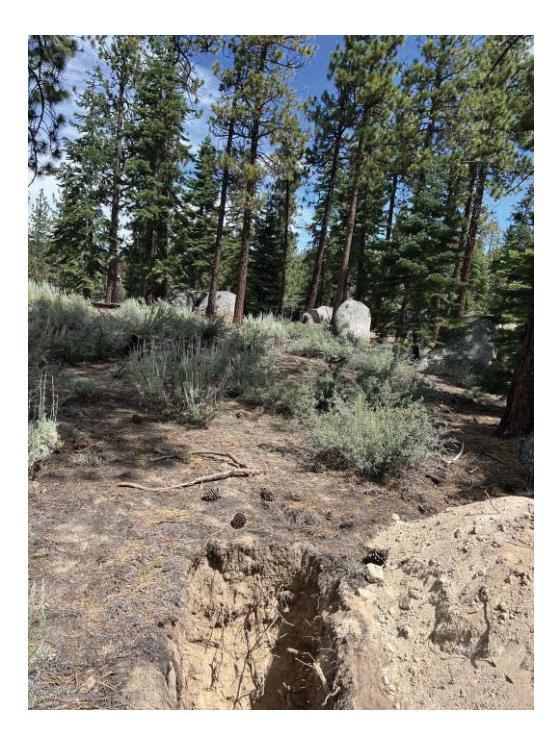
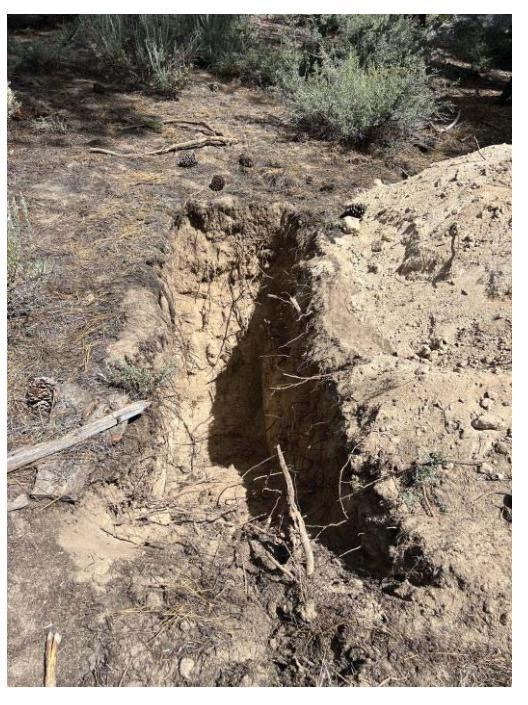
Figure 5. Pit 3 landscape.

Figure 6. Pit 3 profile.

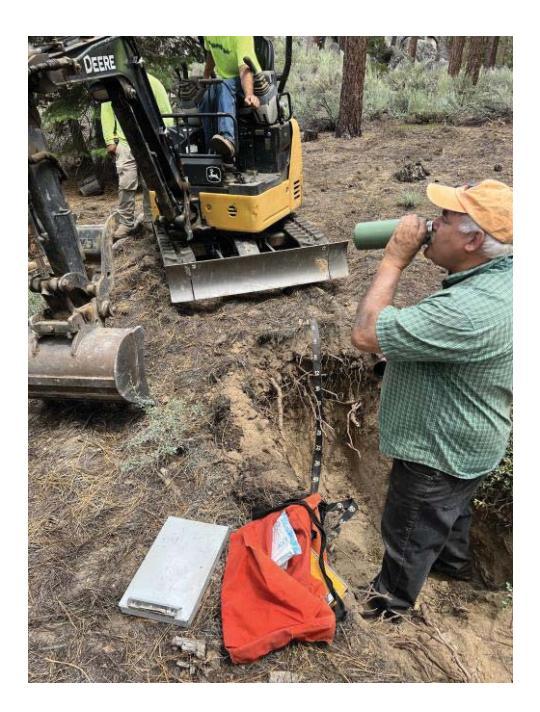
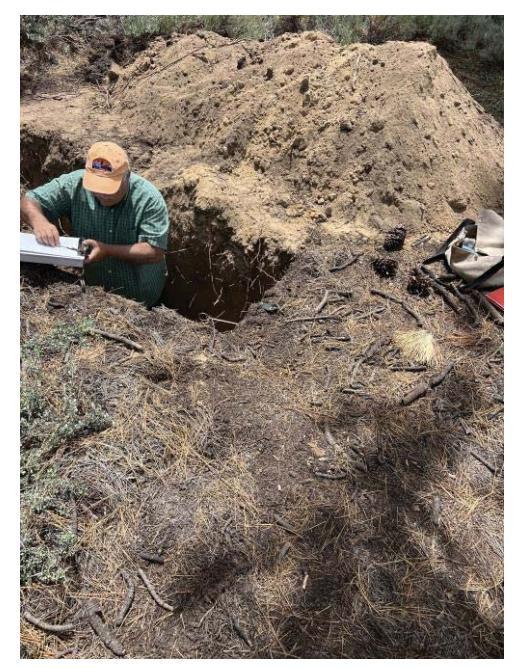
Figure 7. Pit 4 profile.

Figure 8. Pit 4 landscape.

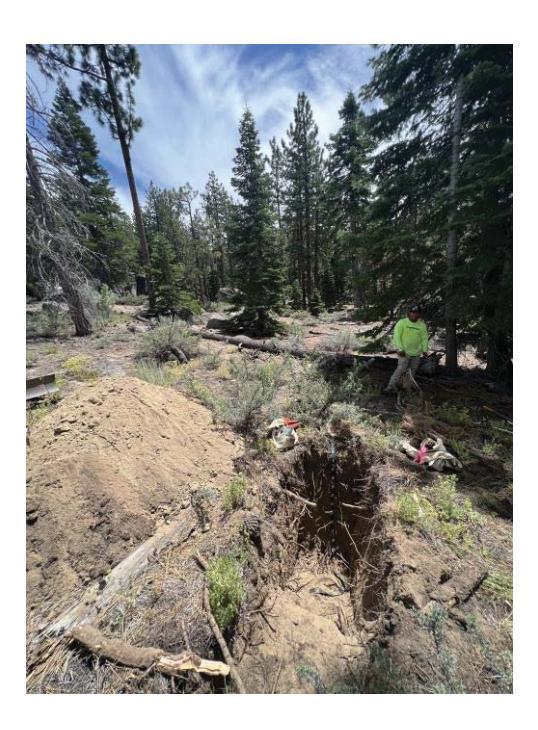
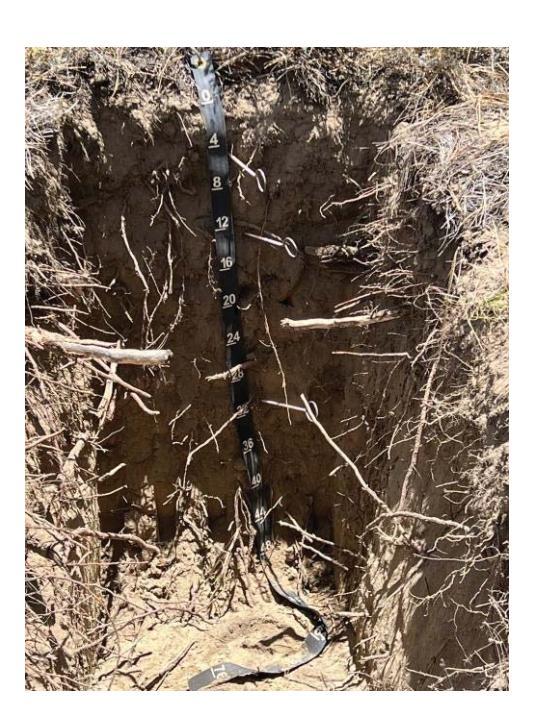
Figure 9. Pit 5 landscape.

Figure 10. Pit 5 profile.
