Heavenly Mountain Resort

Mitigation and Monitoring Plan Annual Report (October 2014 – September 2015)

Prepared for Tahoe Regional Planning Agency

May 2, 2016 (Revised August 2016)

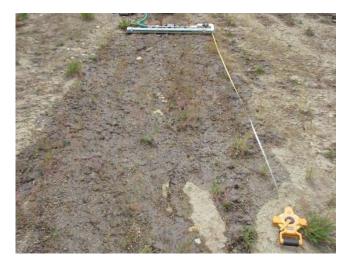
Figure 13. Runoff simulation before treatment with surface runoff and wide wetting front.

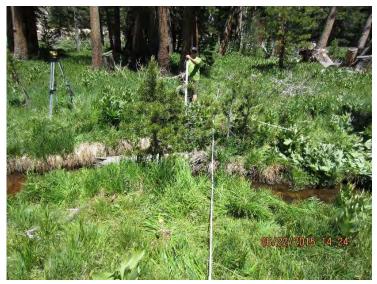
Strong Slope Break (Sky Meadows)

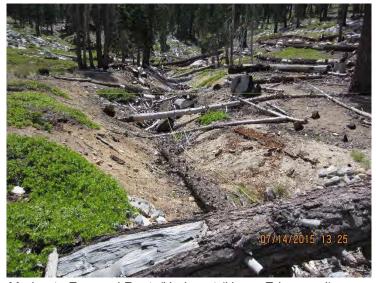
Moderate Exposed Roots/Undercut (Upper Edgewood)

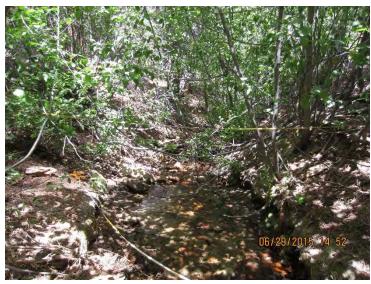
Strong/Moderate Lichen/Moss Types (Property Line)

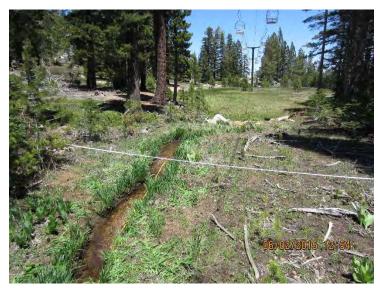
Moderate/Weak Deposits (Lower Daggett)

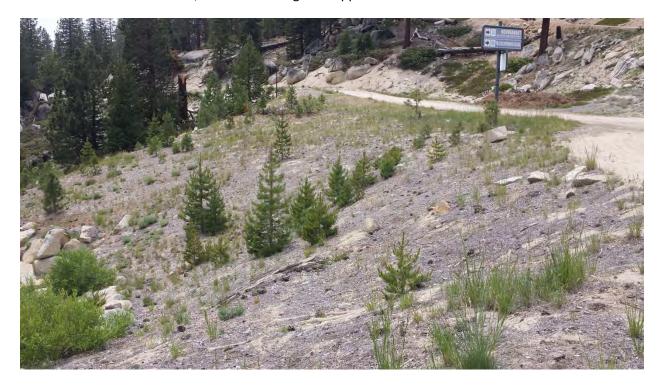
Powder bowl Treatment area, 6-26-15: No Irrigation applied or needed in 2015

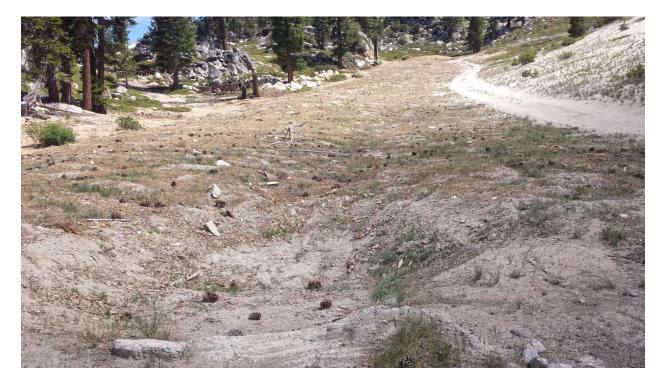
Pioneer-Poma Restoration area 6-27-14, Vegetation is visible and growing:

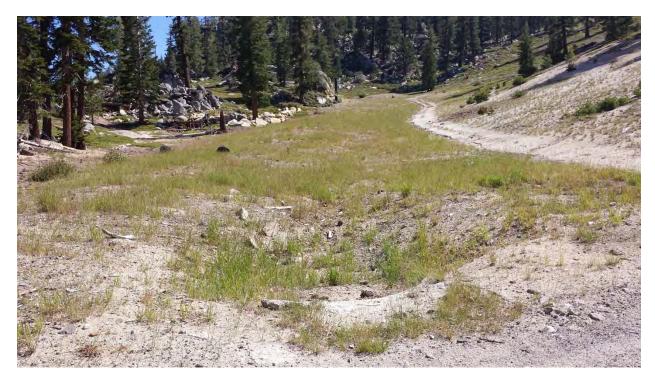
Pioneer-Poma Restoration area 7-29-15, Vegetation is flourishing. June/July rains are helping to reduce any need for irrigation in 2015. Vegetation is well established now over 18 months after project started.

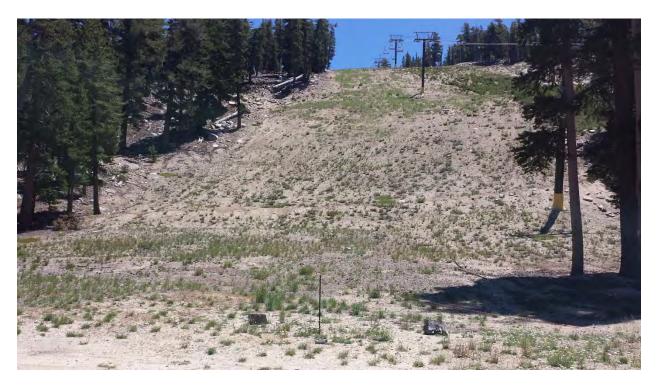
Double Down Lower Run before Treatment 7-29-15:

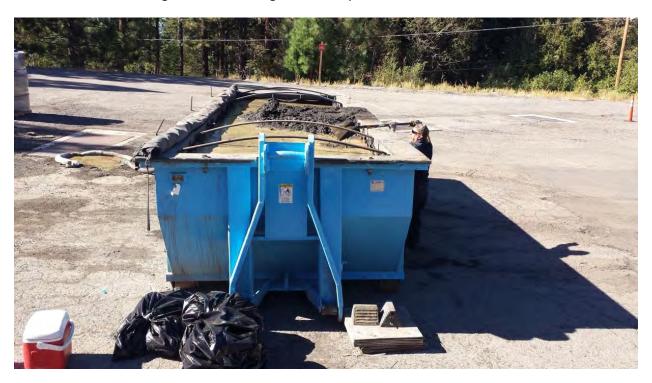
Clean Harbors DI Cleaning California Parking Lot, Late September 2015:

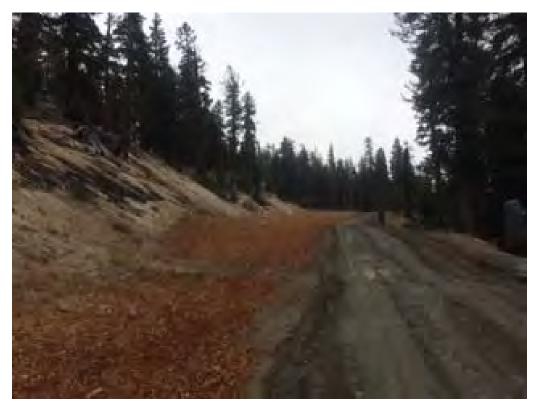
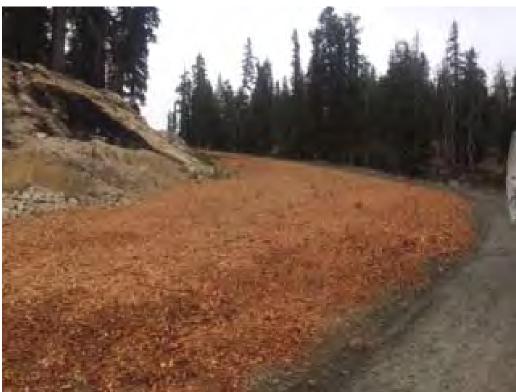
Finished Wood Chip Mulch on Maggies Shoulders Sept. 30th, 2015:

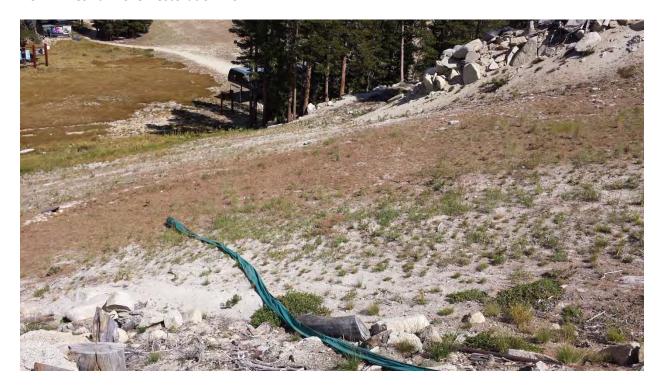
Hellwinkles Fall 2015 Restoration work:

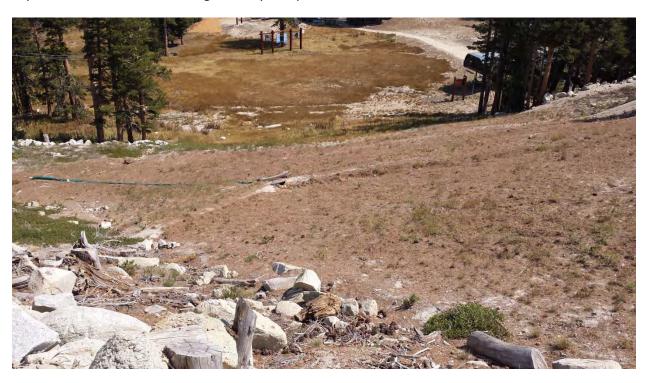
Sky Meadows Restorations of High Priority Hotspots:

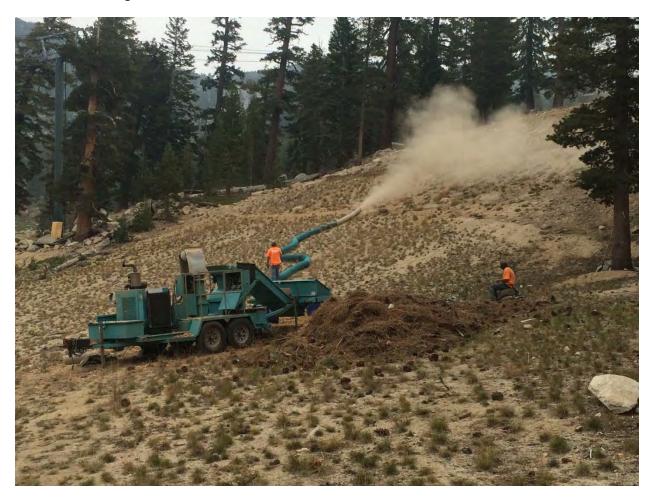
Lower Liz's Full Hogan restoration with Shred Vac from IERS. We rented this unit for 2 week in 2015:

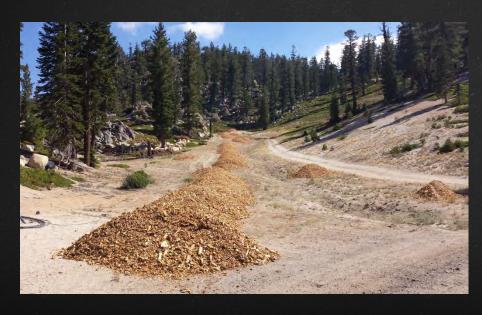
Pioneer/Poma prior to treatment

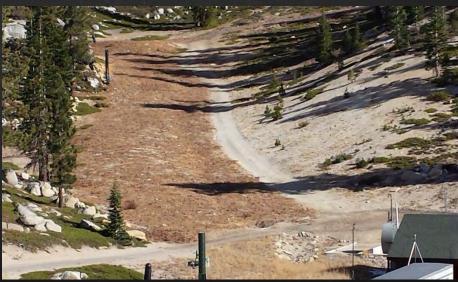
Pioneer/Poma after treatment

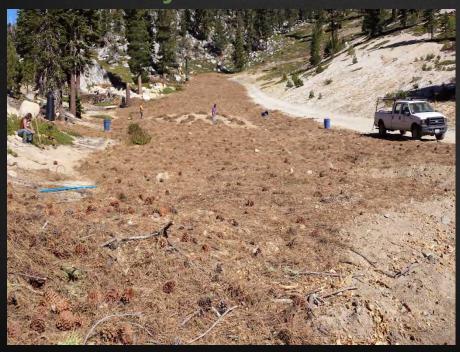
Nearing completion of this nearly 34 acre site 2013

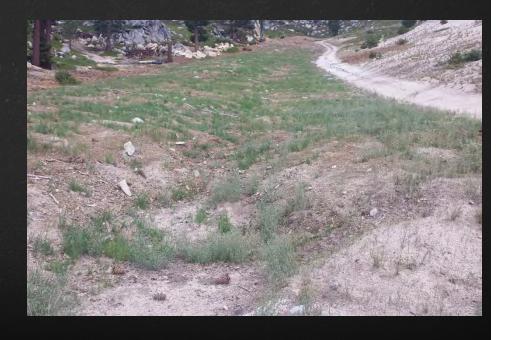
Finished Project Grasses growing in summer 2014

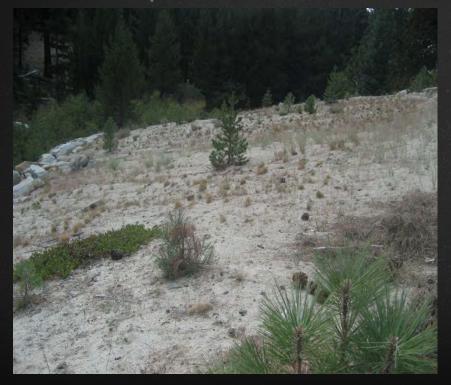
Powderbowl Restoration Site-

In 2012 prior to treatment

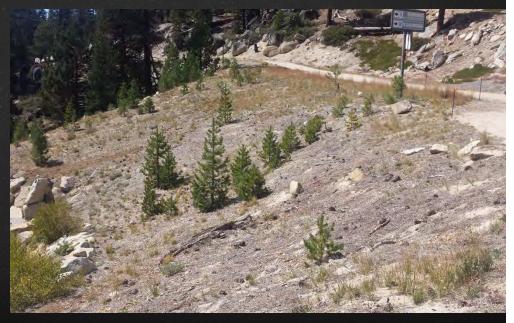
In late 2014 after treatment

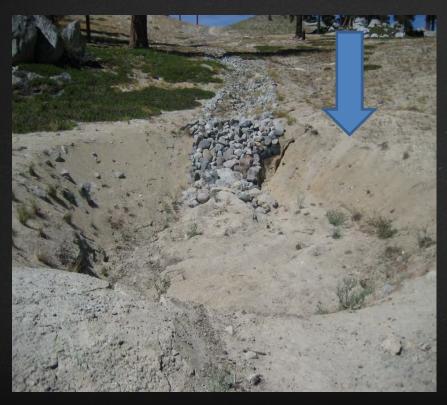
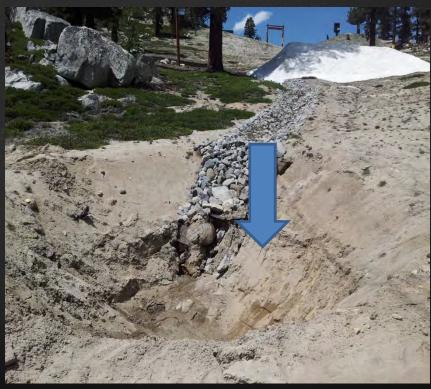
On Mt BMP's ongoing Maintenance Infiltration basin 2012 Infiltration basin 2013

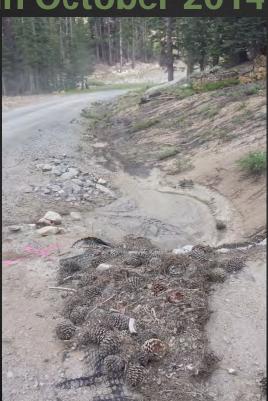
Maggies Pits Vacuumed out in October 2014

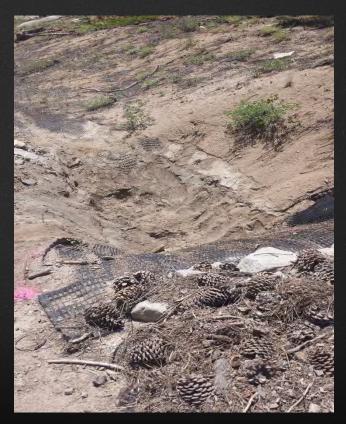
After picture highlights the improvement in sediment capacity

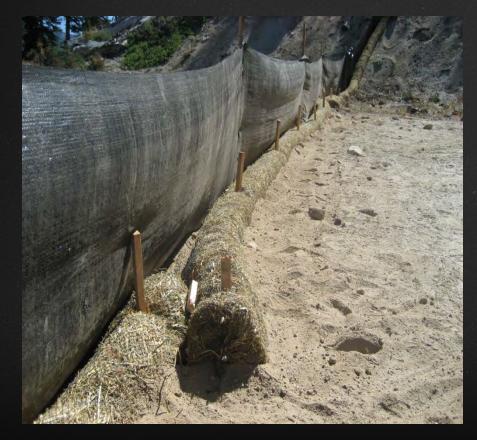
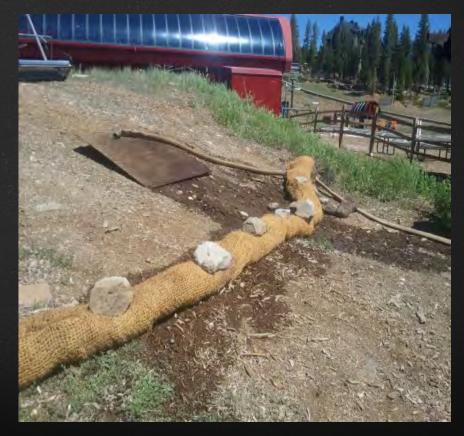
Wattles
Straw wattle with silt fence Pine Needle Wattle

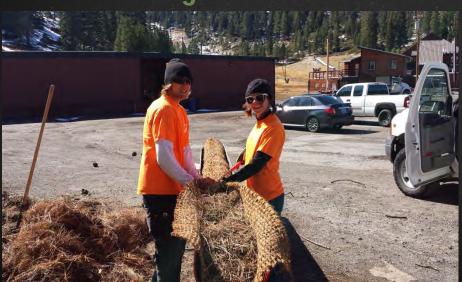
On mountain use for erosion control, in 2014 over 600 Ft built

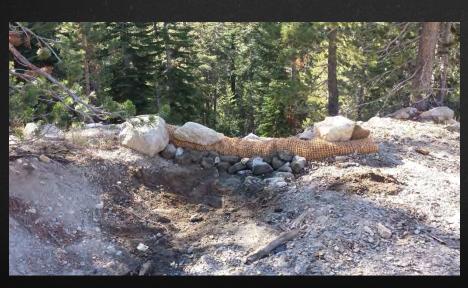
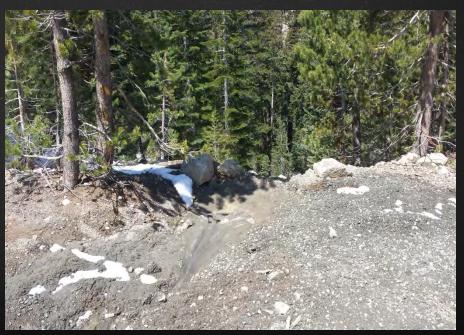
Pine Needle Wattles installed near Heavenly Valley Creek Fall 2013

Pine needle wattles a success in 2014, after large precipitation events
