Mitigation and Monitoring Plan Annual
Report (October 2014 – September 2015)

Heavenly Mountain Resort BMP Effectiveness Monitoring

2015 Annual Report & Construction Season Summary

April 27, 2016

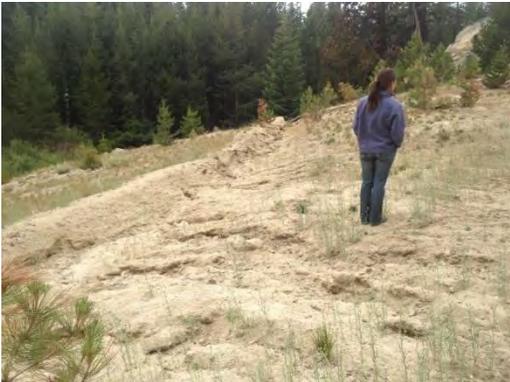
2

<p data-bbox="467 1291 708 1318">Water bar and erosion</p>

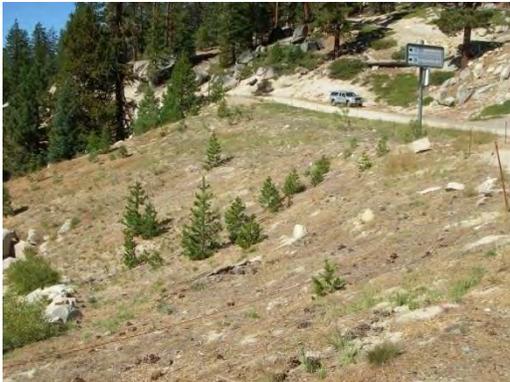
<p data-bbox="954 1291 1357 1318">1 year after full restoration treatment</p>
3

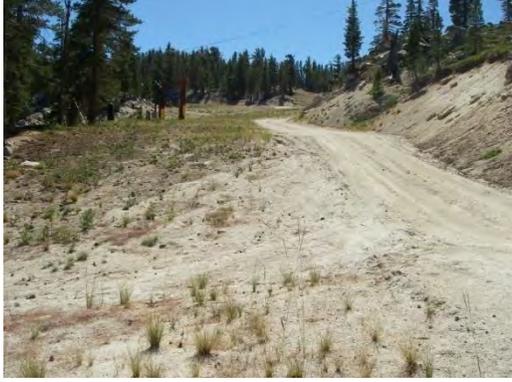
<p>13</p>

<p>Treated in 2015 – photo needed</p>

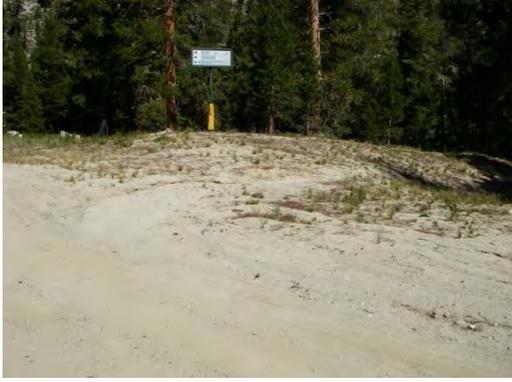
<p>Treated in 2015 – photo needed</p>

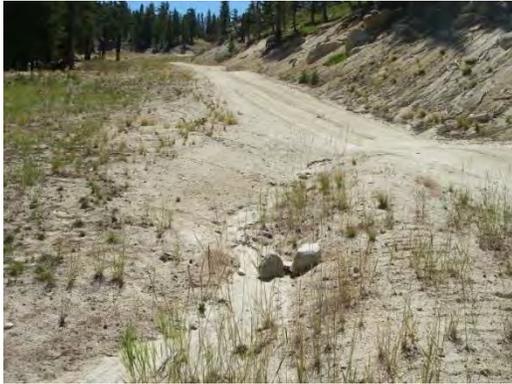
<p>14</p>

<p>Before - eroding water bar</p>

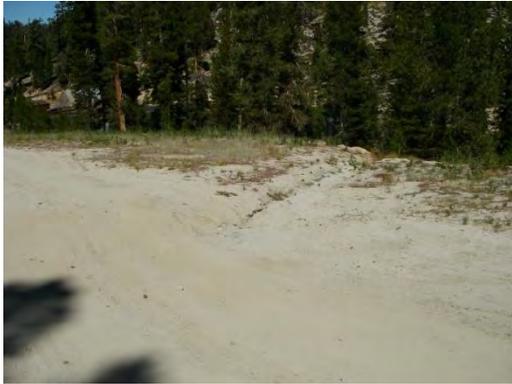
<p>Before - eroding water bar</p>

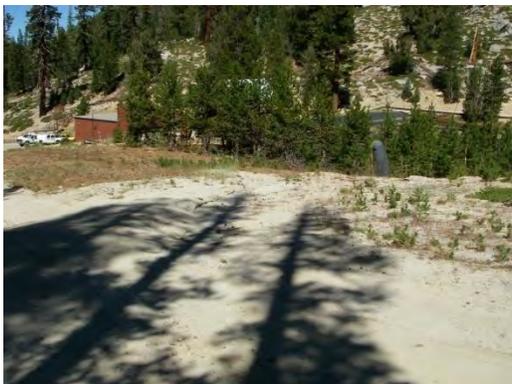
<p>Before - eroding water bar</p>

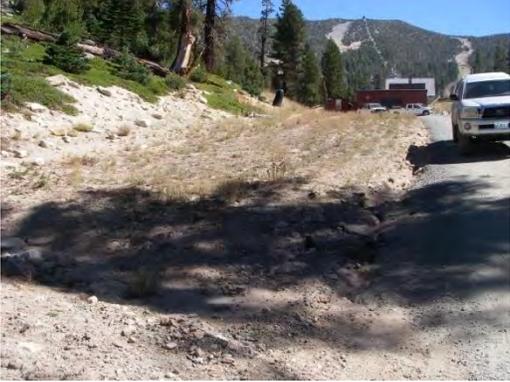
<p>17</p>

<p>Before – bare, rilled surface</p>

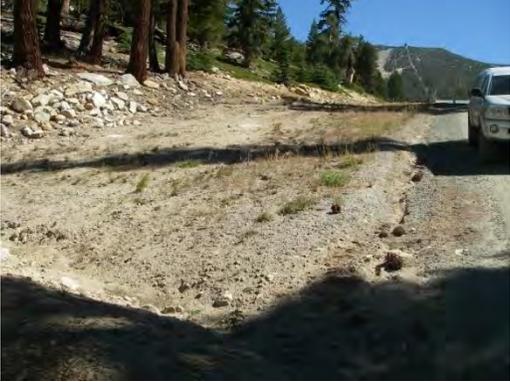
<p>Before treatment</p>

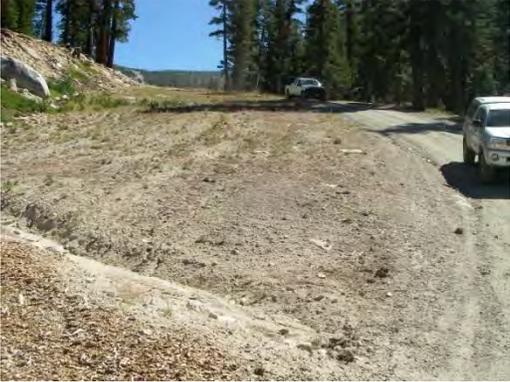
<p>Before treatment</p>

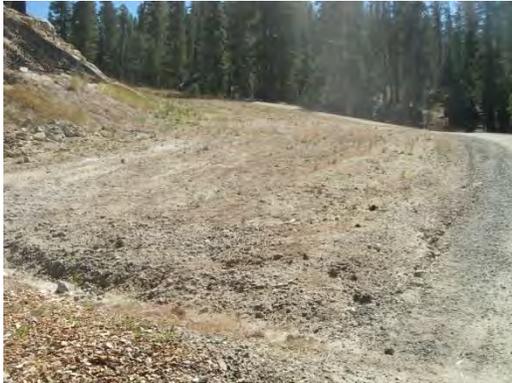
<p>20</p>

<p>Before treatment</p>

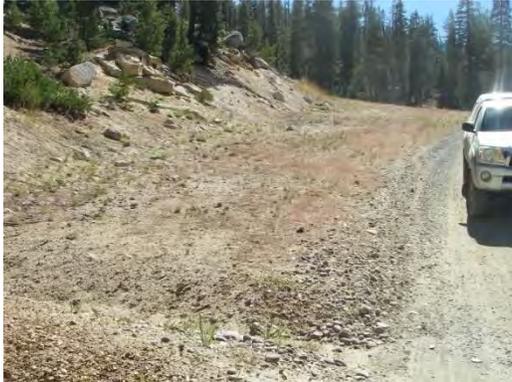
<p>Wood chip mulch added in 2015</p>
<p>21</p>

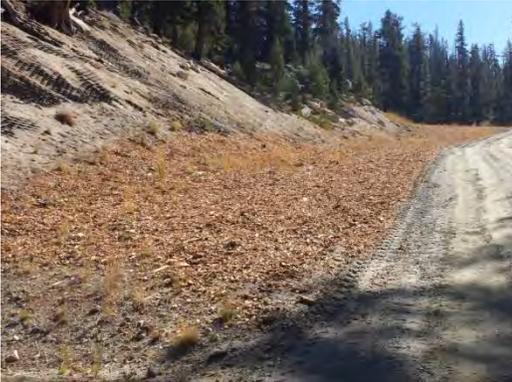
<p>Before treatment</p>

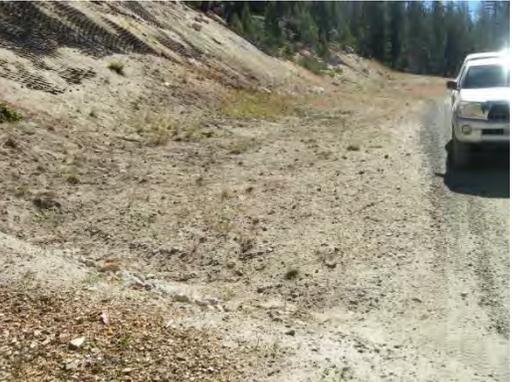
<p>Maggie's shoulders mulched in 2015</p>
<p>22</p>

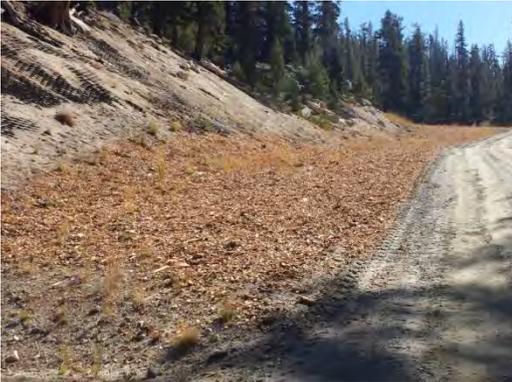
<p>Before treatment</p>

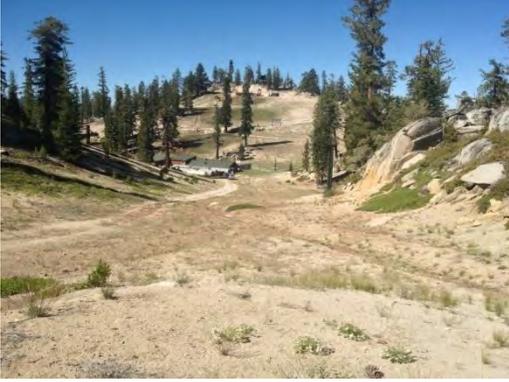
<p>Maggie's shoulders mulched in 2015</p>

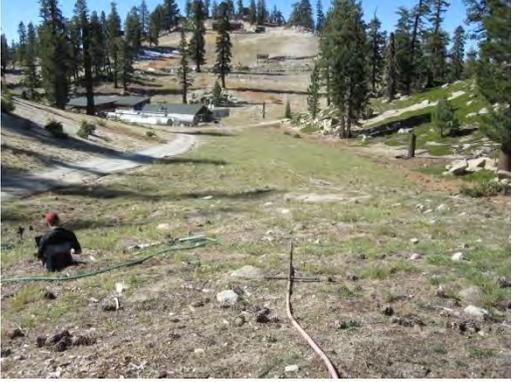
<p>Before</p>

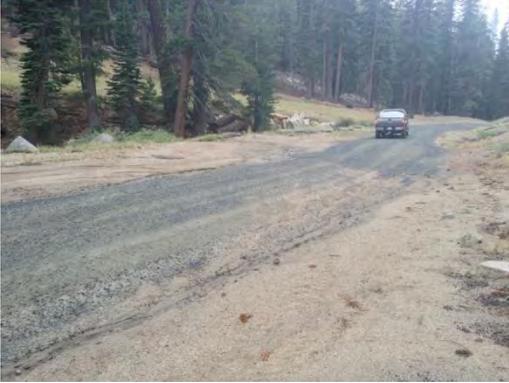
<p>Full Hogan treatment in 2013</p>
<p>24</p>

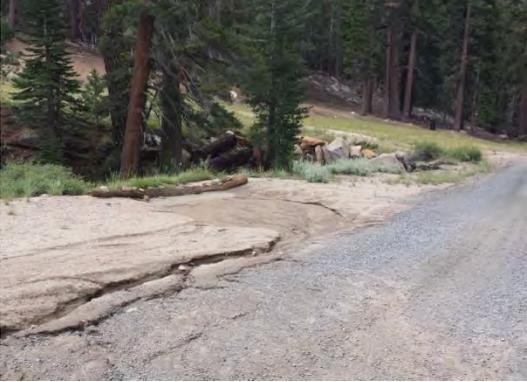
<p>Before - water bar drainage from summer road</p>

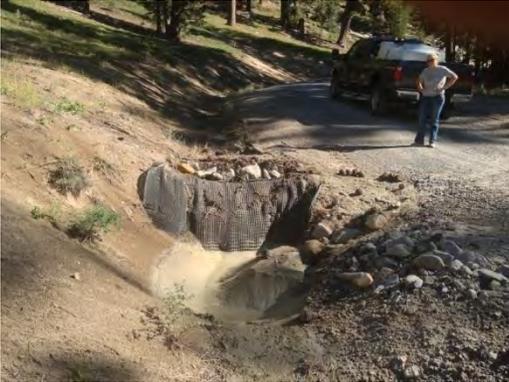
<p>After - pine needle wattle installed to capture sediment upslope of creek</p>
<p>25</p>

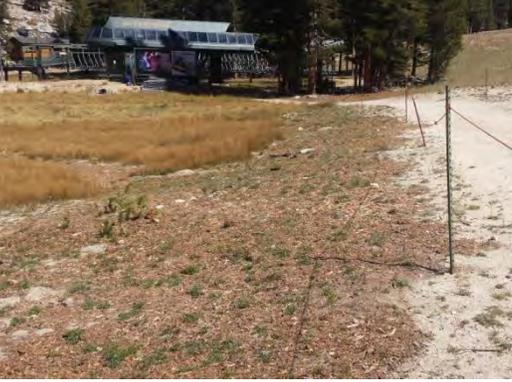
<p>Mulch applied on shoulders above Sky Meadows</p>

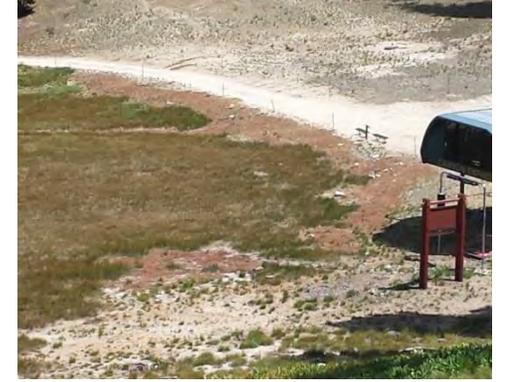
<p>Mulch applied on shoulders above Sky Meadows</p>
<p>32</p>

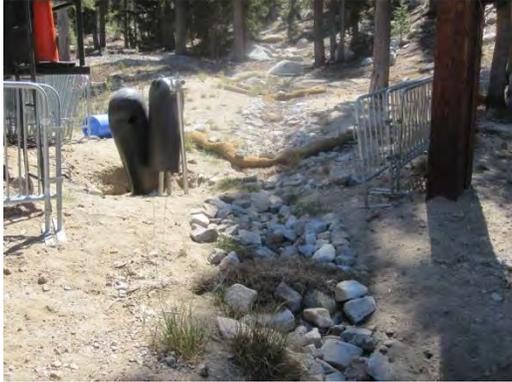
<p>Pine needle filter berms added to channel</p>

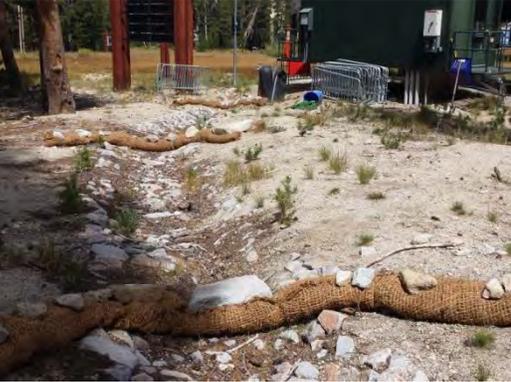
<p>Pine needle filter berms added to channel</p>

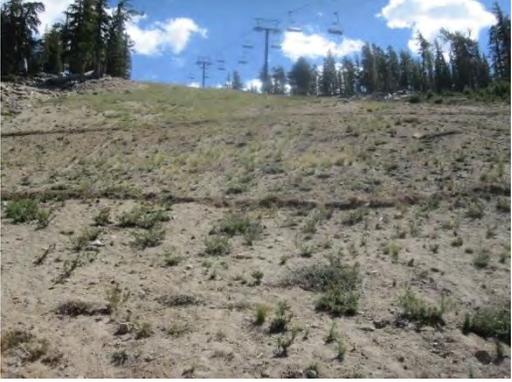
<p>Pine needle mulch filter berms added on Lower Double Down ski run</p>

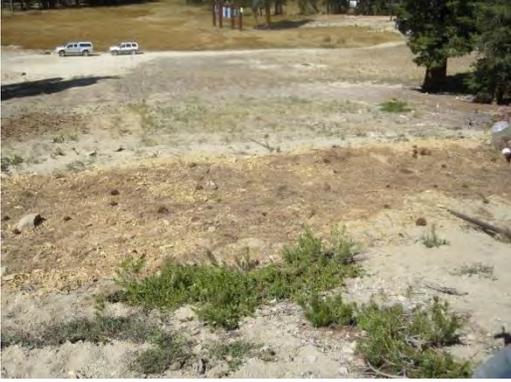
<p>Water bar to infiltration swale conversion complete on Lower Double Down ski run</p>
<p>34</p>

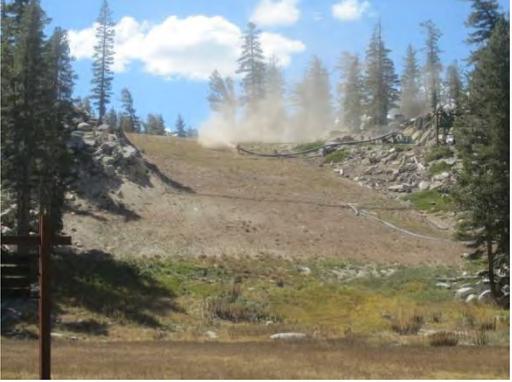
<p>Mulching steep, eroding ski run with Shred-Vac + adding mulch berms across Sky Chute</p>

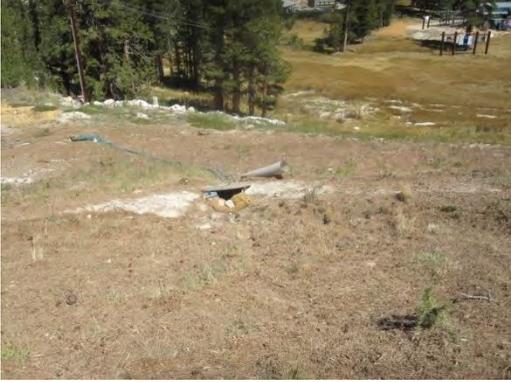
<p>Close up of mulch applied on ski run and extra thick mulch at water bar on Sky Chute</p>
<p>35</p>

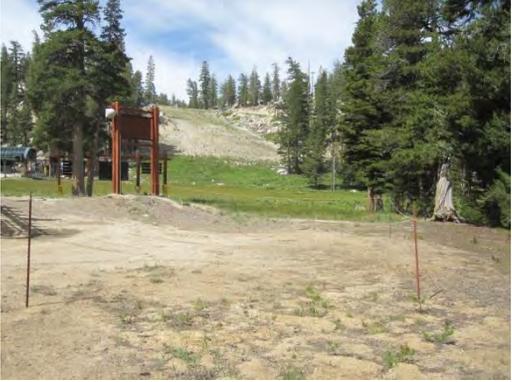
<p>Before – bare soil near creek</p>

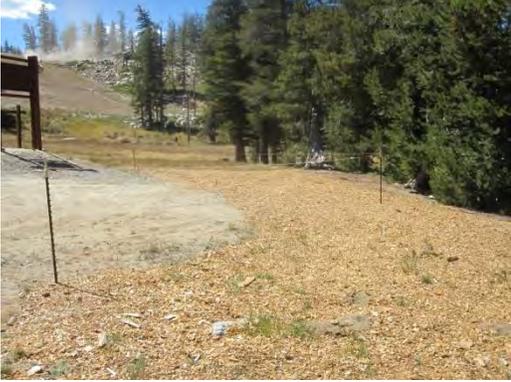
<p>After – thick mulch cover</p>

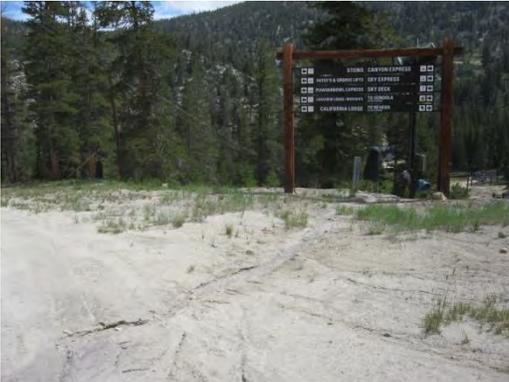
<p>Before - erosion and down-cutting</p>

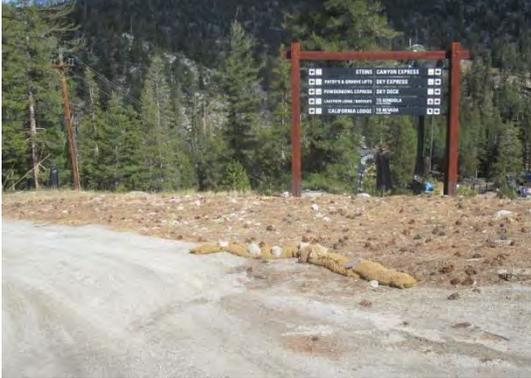
<p>After - shallow swale with amended/loosened soil, seed and surface mulch</p>
<p>37</p>

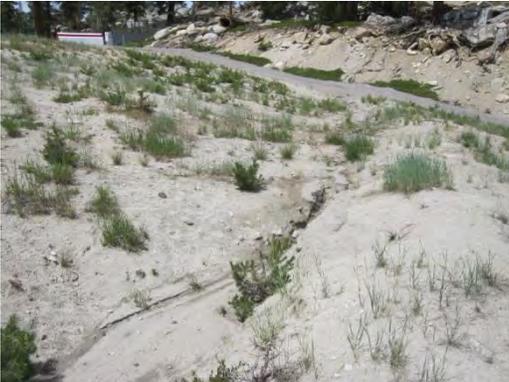
<p>Before - erosion and down-cutting</p>

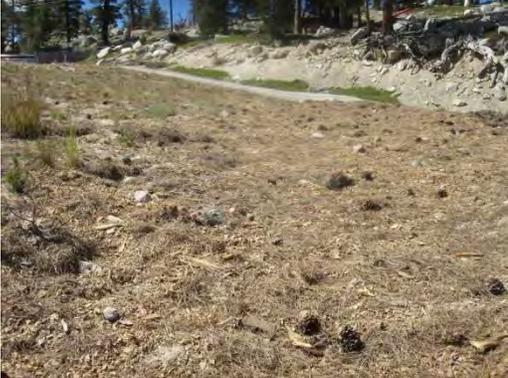
<p>After - shallow swale with amended/loosened soil, seed and surface mulch</p>
<p>38</p>

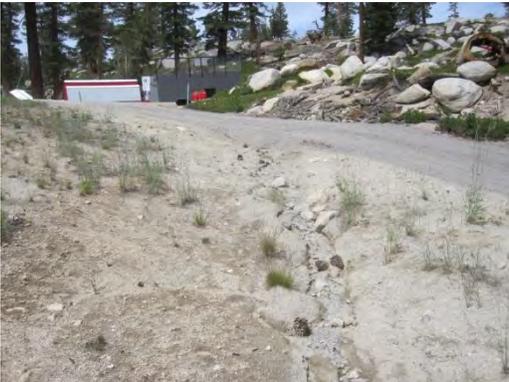
<p>Before - erosion and down-cutting</p>

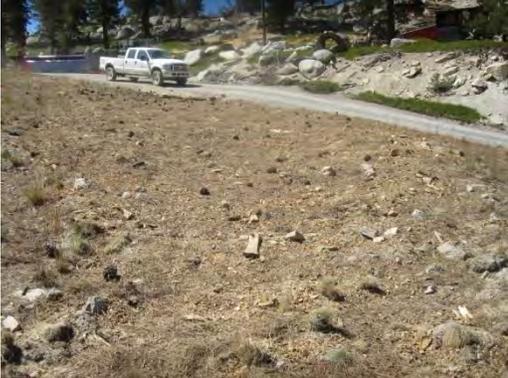
<p>After - shallow swale with amended/loosened soil, seed and surface mulch</p>

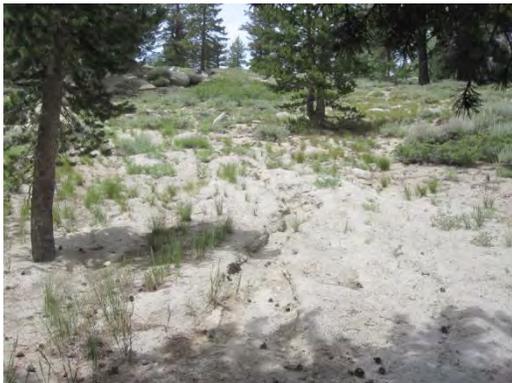
<p>Erosion/rilling below Hellwinkles road drainage</p>

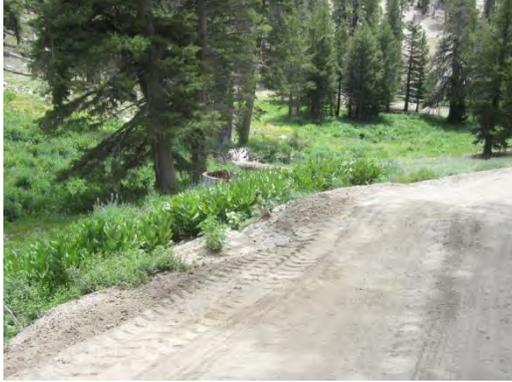
<p>Lower water bar on Hellwinkles drains direct to SEZ, causing erosion and rilling downslope</p>

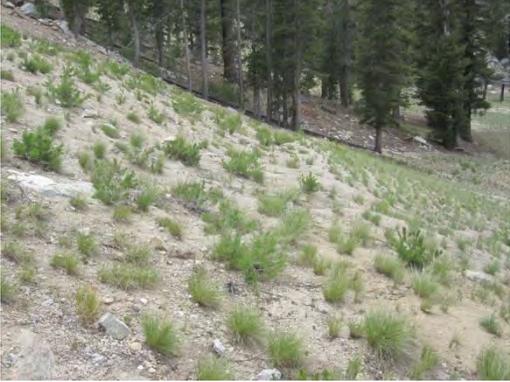
<p>Eroding water bar across Lower Liz's ski run</p>

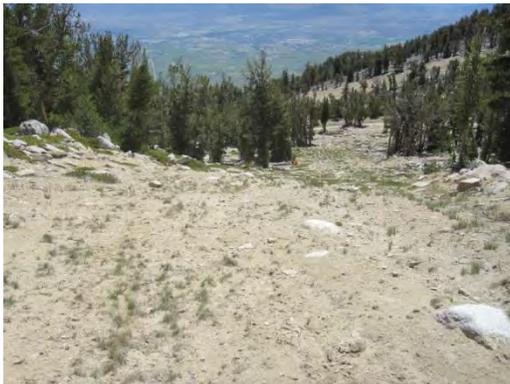
<p>5</p>

5	ski run/road	Y	M	Y	Y	L	M	H	compacted ski run/old road below Comet lift top terminal sheds water onto Aries ski run, contributing to ski run erosion issues (linked to HS #4)	create infiltration/spreading area at top of Aries ski run (before ski run steepens)
6	rill/gully	Y	M	Y	Y	L	M	H	~4 distinct large rills on ski run at proposed trail crossing	soil restoration treatment to stabilize rilling area below rocks
7	water bar	Y	H	Y	Y	L	M	H	proposed trail crossing at water bar with erosion, which collects runoff from at least 150ft of dirt road	design stable drainage crossing for trail
8	proposed trail	Y	L	N	N	L	H	H	proposed trail switchback very near dipper drainage; lots of bare soil but no visible erosion	shift trail alignment so it doesn't drain to dipper drainage
9	water	Y	M	Y	Y	L	M	H	proposed trail switchback at end of water bar (major depositional area)	shift trail alignment away from water bar depositional area

<p>Before - compacted area above Aries ski run</p>

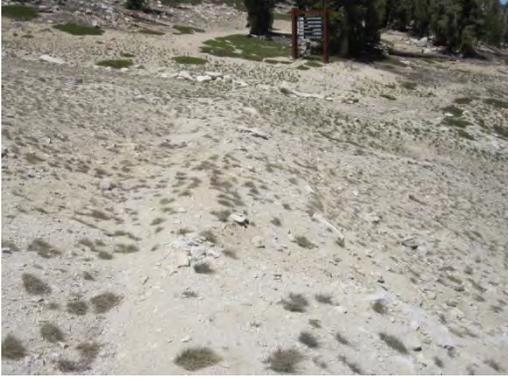
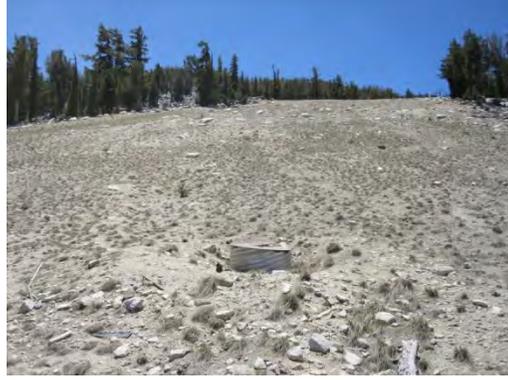
<p>13</p>

14	water bar	N	H	Y	Y	L	H	M	several blown out water bars on Big Dipper ski run; mitigation opportunity - not in proposed trail alignment	rebuild water bars and create infiltration capacity on the upslope sides through soil restoration treatment; rake out rills downslope; construct mulch berms or infiltration strips on ski run to prevent further erosion by slowing/dispersing flow
15	depositional area	N	H	Y	Y	L	M	M	depositional area at lower end of dipper drainage	address erosion through source control upslope
16	drainage	Y	M	Y	Y	L	M	H	proposed trail alignment crosses defined drainage	shift proposed trail alignment (location of switchback) to avoid crossing drainage
17	road	N	M	Y	Y	L	M	L	old road to avalanche gun - mitigation opportunity	Road to avi gun decommissioned in 2015
18	road	N	L	N	N	L	L	L	short loop/turnaround road - mitigation opportunity	Turnaround decommissioned in 2015
19	road-drainage crossing	N	H	Y	Y	M	M	M	lower end of dipper drainage crosses summer road; know to carry moderate flow during spring runoff	Pine needle mulch berms installed across channels that drain to road; still need to create infiltration/spreading area below

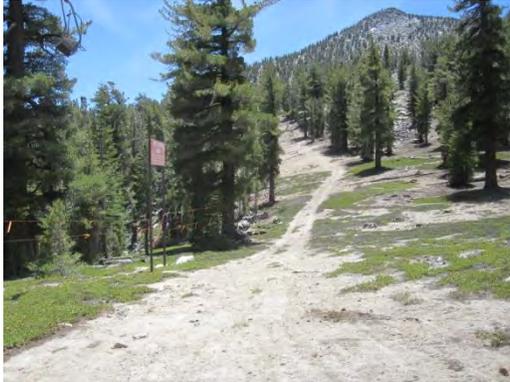
<p>Mott Road – before treatment</p>

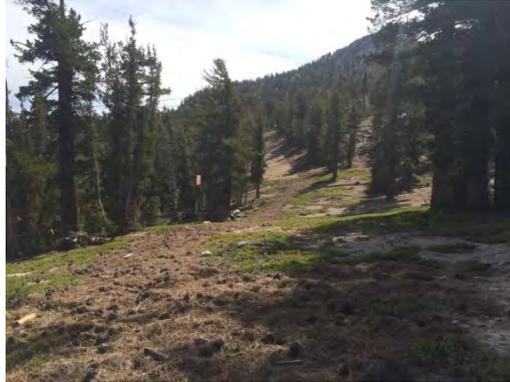
<p>Mott Road – after full decommissioning treatment in 2015</p>

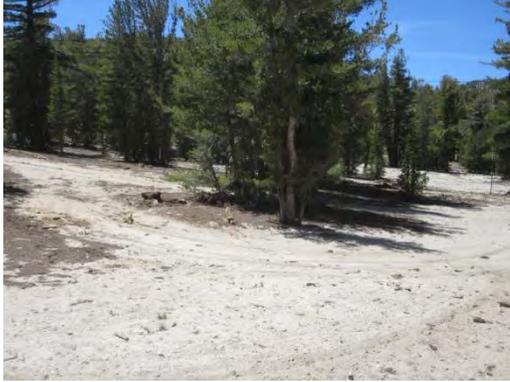
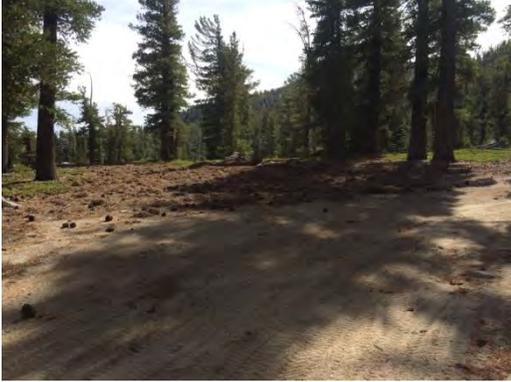
<p>Before - summer road turnaround</p>	<p>After – turnaround decommissioned in 2015</p>
<p>19</p>

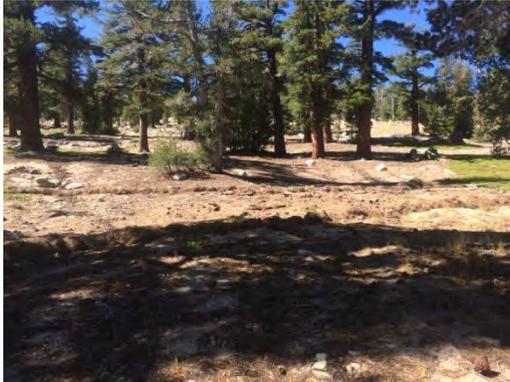
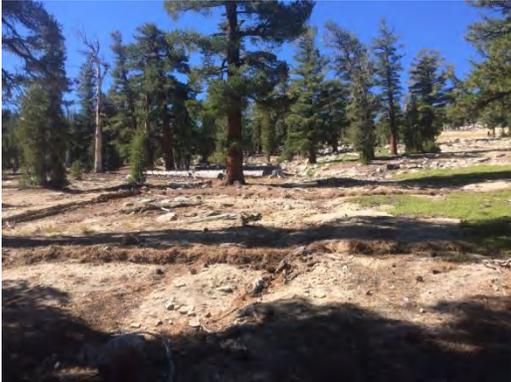
<p>Pine needle filter berms installed across surface drainages – Lower Dipper</p>	<p>Pine needle filter berms installed across surface drainages – Lower Dipper</p>
<p>20</p>

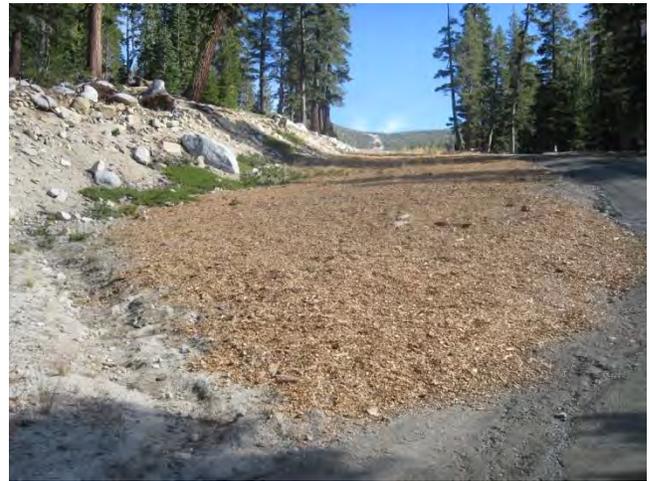
The road shoulders along Maggie's are referred to as "plots", which are delineated by the water bars at the base of each plot (Hot Spots 17-22). The upper three plots drain directly to Heavenly Valley Creek, and were deemed the highest treatment priorities. Plot 1 was mulched with wood chips in 2014. Plots 2 and 3 were mulched with wood chips in 2015. Some of these plots are intended to receive full treatment (soil loosening, seeding, etc) in future years, but applying several inches of mulch is expected to provide immediate sediment reductions with less initial effort. The photos below show Plot 2 before and after mulch application.

Figure 11. Photo of Maggie's Plot 2 after applying wood chips in 2015.

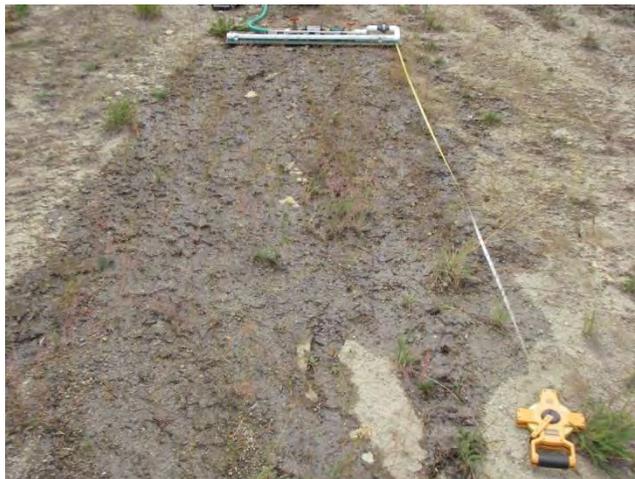
Figure 13. Runoff simulation before treatment with surface runoff and wide wetting front.

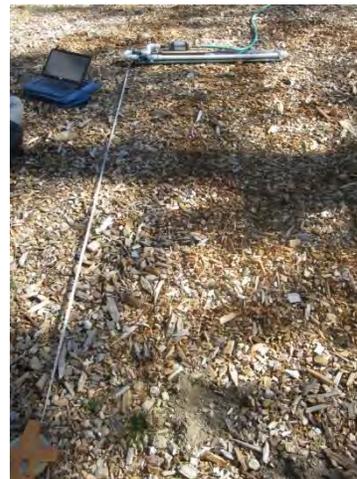
Figure 14. Runoff simulation after mulch application. Runoff is dispersed and slowed by the wood chips.

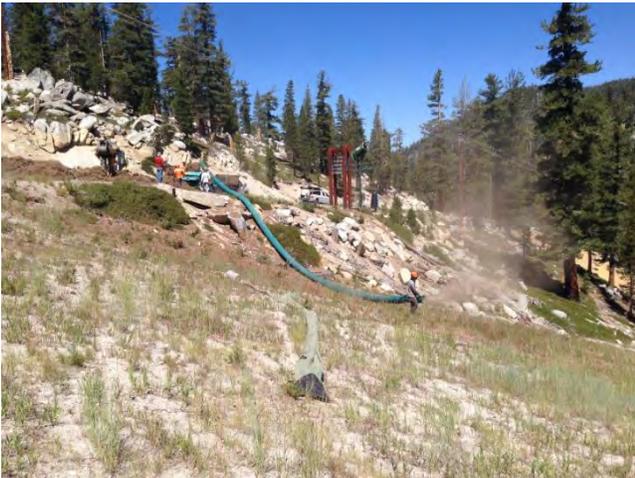
Figure 15. Shred-Vac blowing pine needles through a long canvas hose.

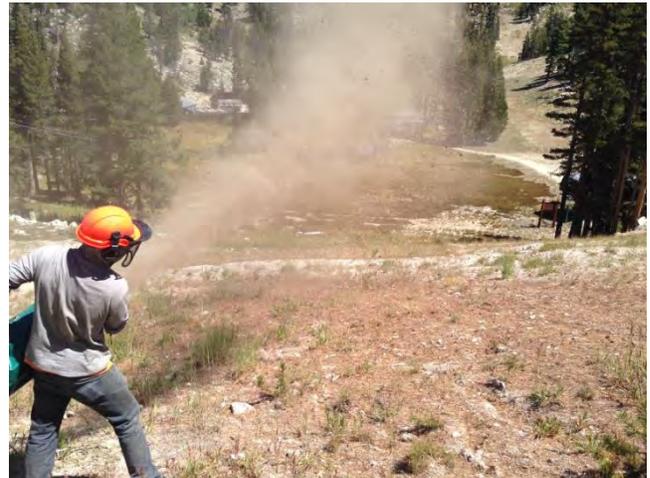
Figure 16. Heavenly staff applying mulch to the Sky Chute ski run using the Shred-Vac.

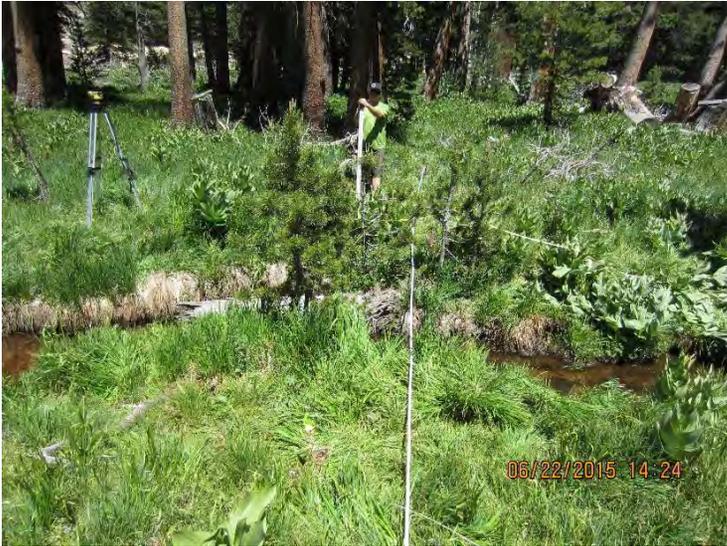
Strong Slope Break (Sky Meadows)

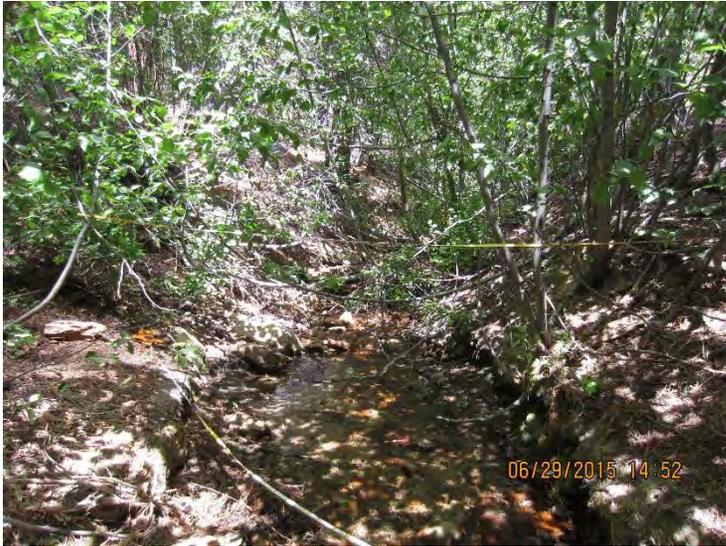
Strong/Moderate Lichen/Moss Types (Property Line)

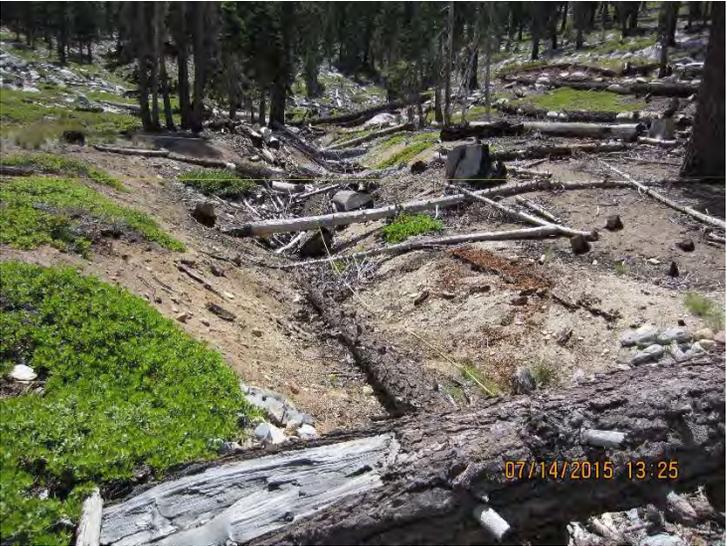
Moderate Exposed Roots/Undercut (Upper Edgewood)

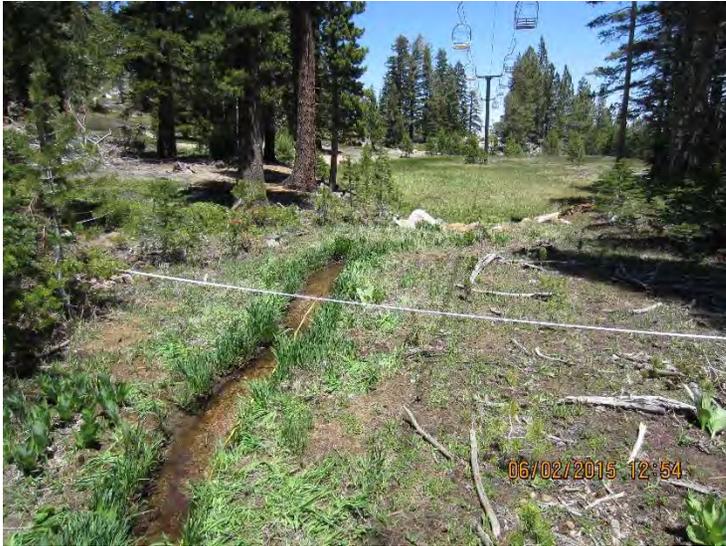
Moderate/Weak Deposits (Lower Daggett)

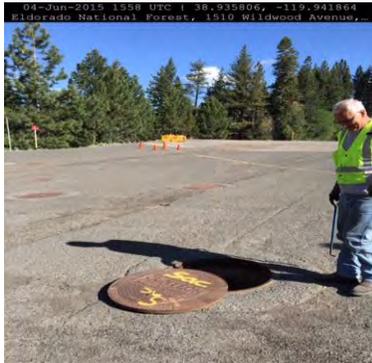
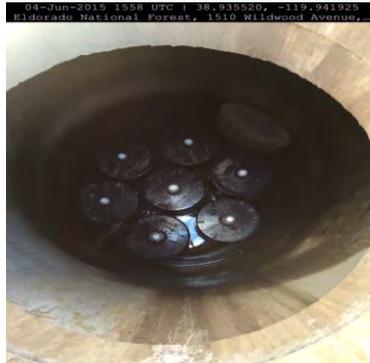
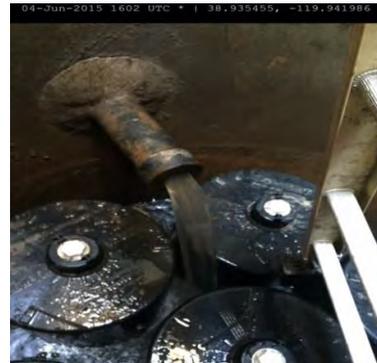
Unit #3 - 7 Phosphorous Cart MH

6" Sediment/21" water

Maintenance recommended due to high water level

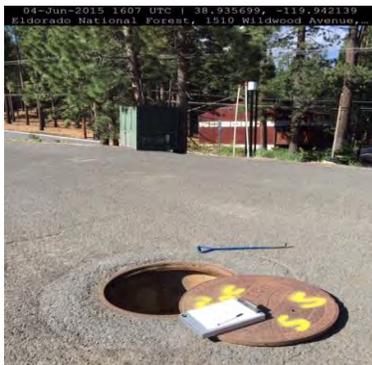
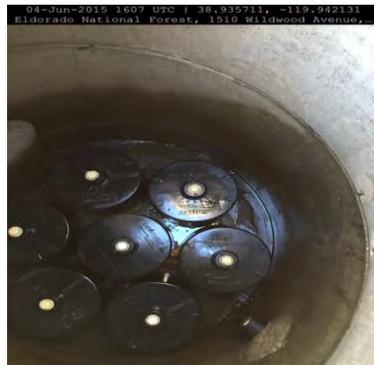
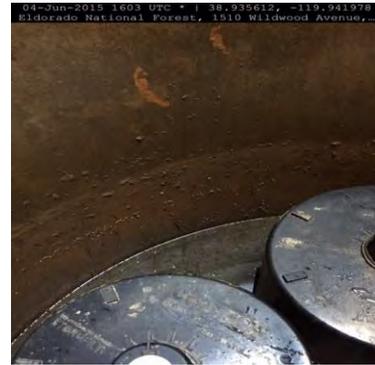
Unit #9 - 7 Phosphorous Cart MH

4" Sediment/Impacted media

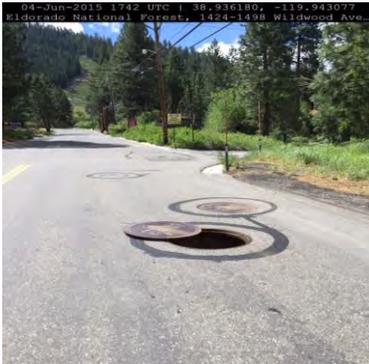
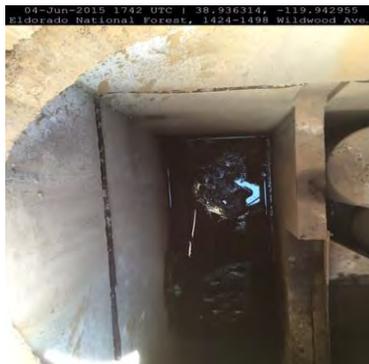
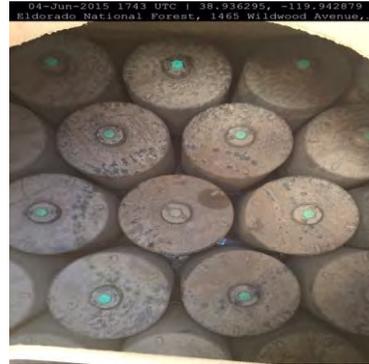
Wildwood Ave Unit - 42 ZPG Cart vault

12" Sediment/Carts spent

Maintenance recommended

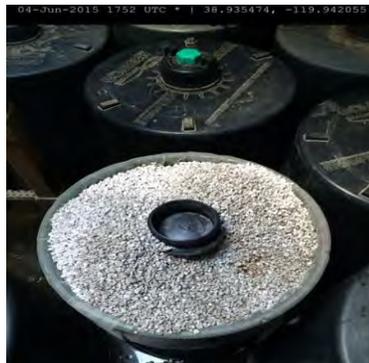
#4 unit - 114 ZPG cartridge vault

Maintenance not recommended

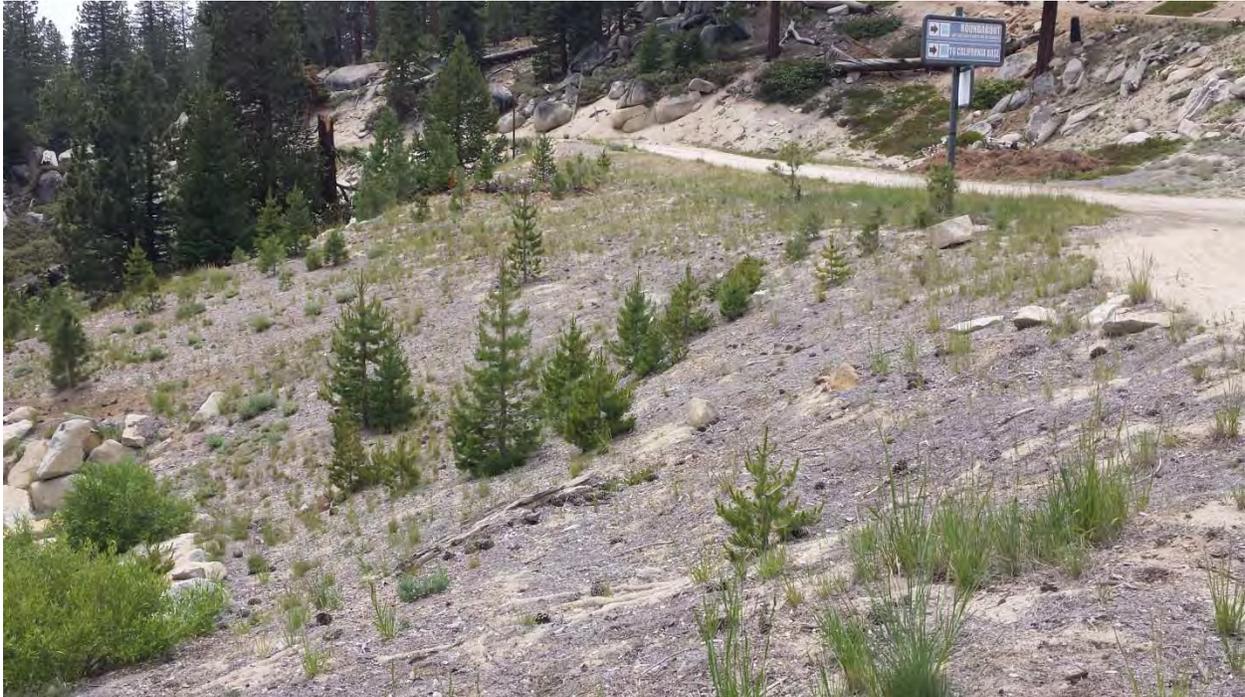
Powder bowl Treatment area, 6-26-15: No Irrigation applied or needed in 2015

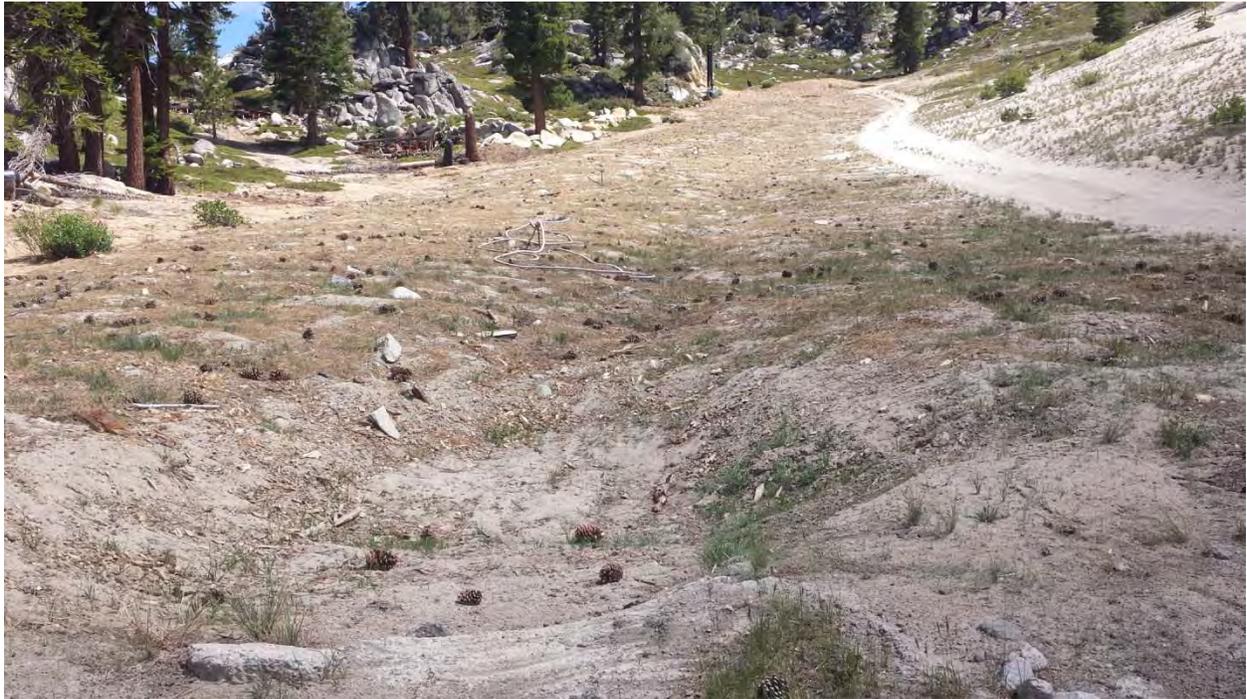
Pioneer-Poma Restoration area 6-27-14, Vegetation is visible and growing:

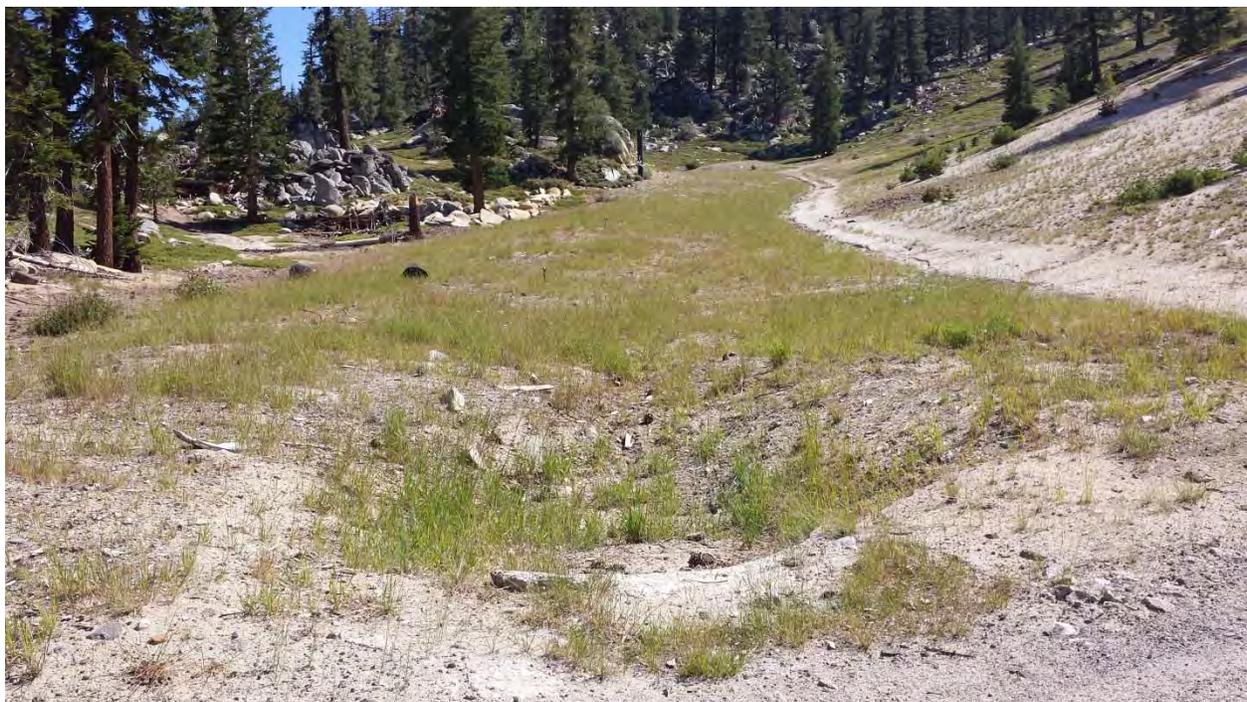
Pioneer-Poma Restoration area 7-29-15, Vegetation is flourishing. June/July rains are helping to reduce any need for irrigation in 2015. Vegetation is well established now over 18 months after project started.

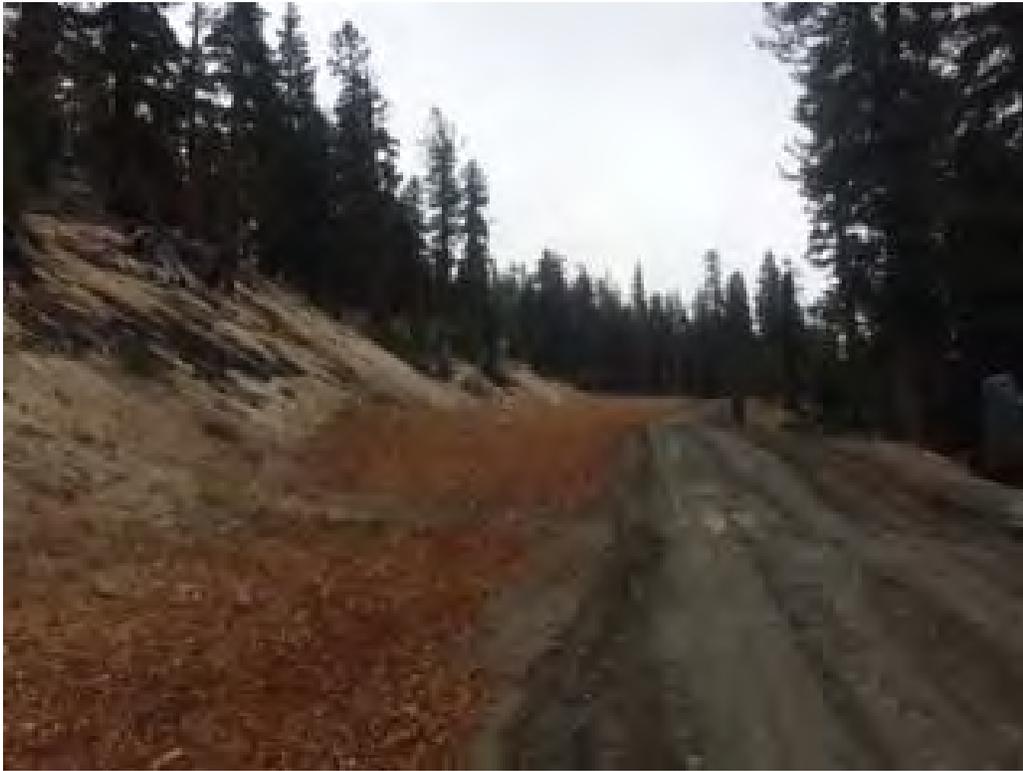
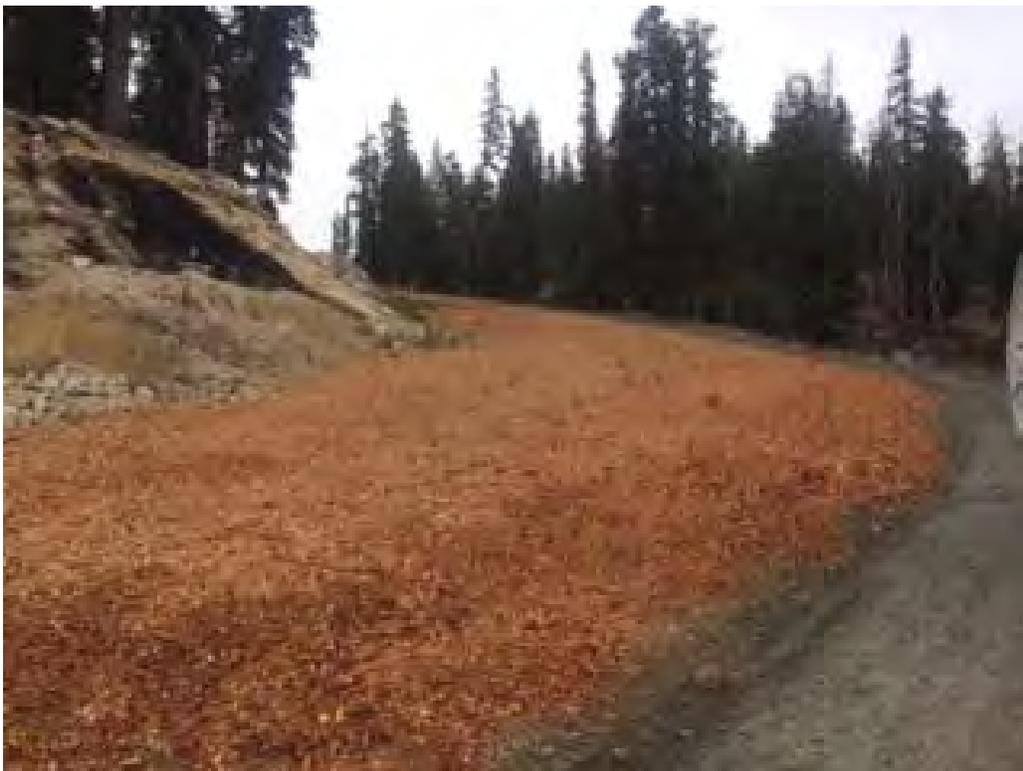
Finished Wood Chip Mulch on Maggie's Shoulders Sept. 30th, 2015:

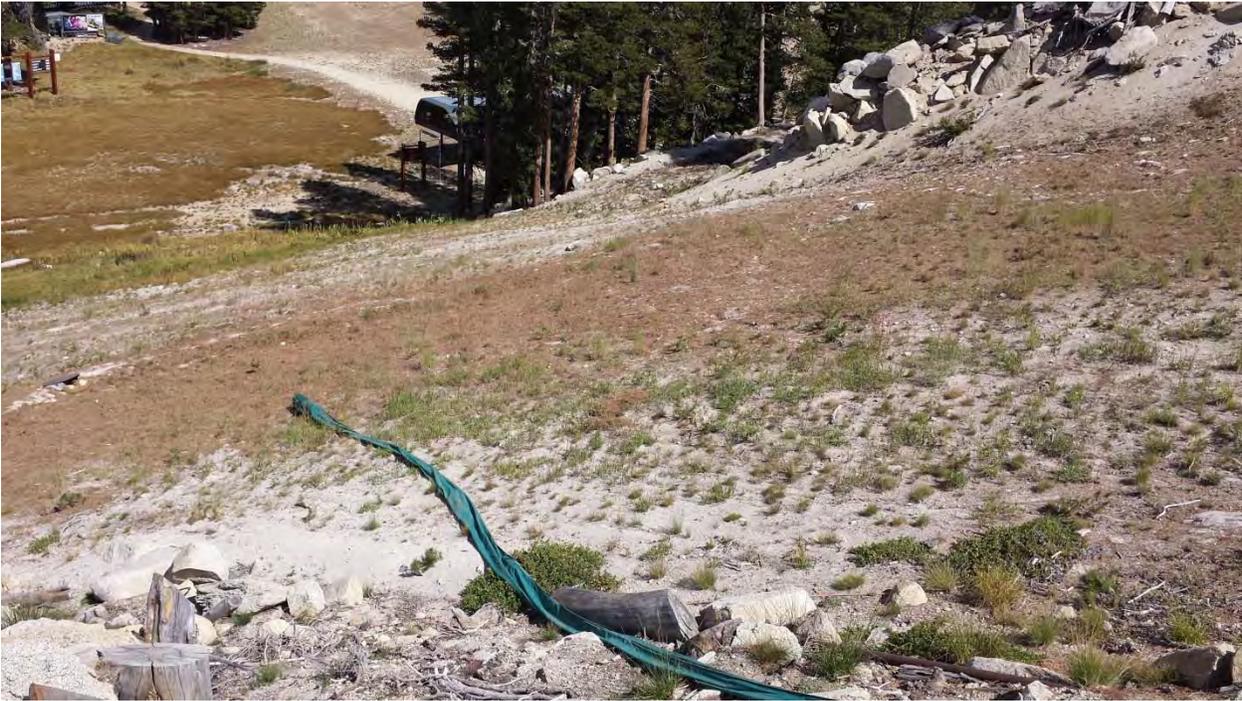
Hellwinkles Fall 2015 Restoration work:

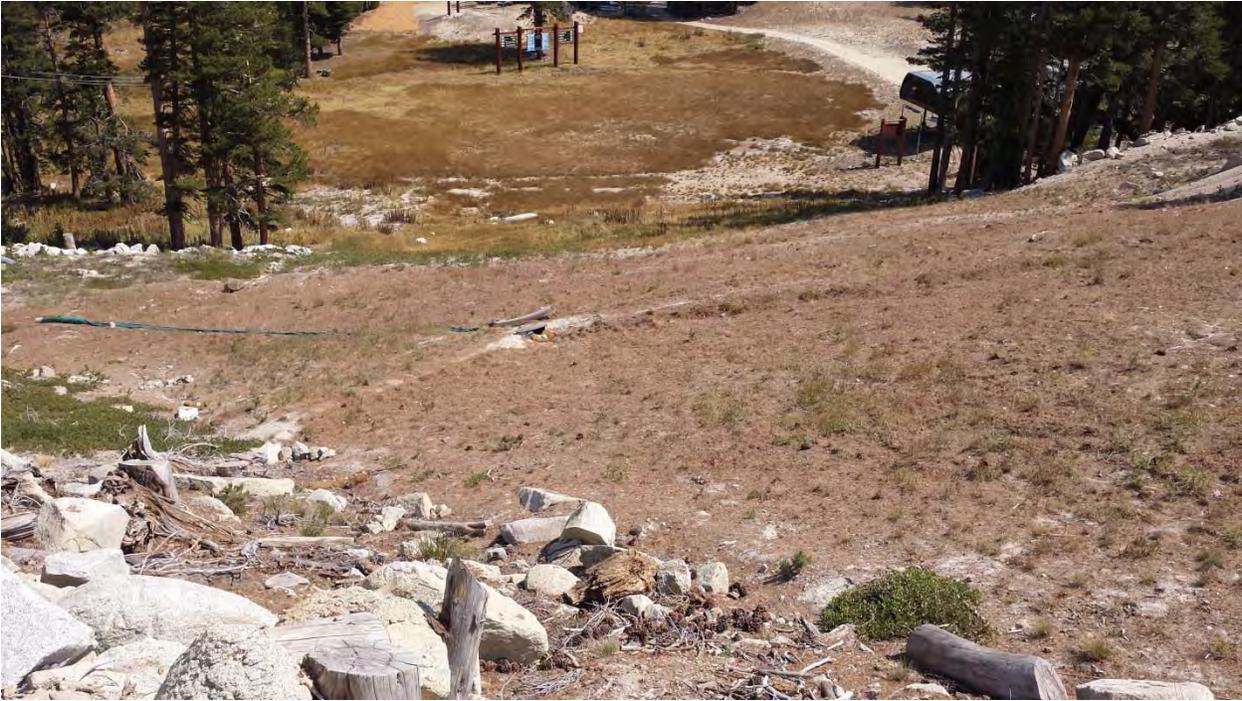
Sky Meadows Restorations of High Priority Hotspots:

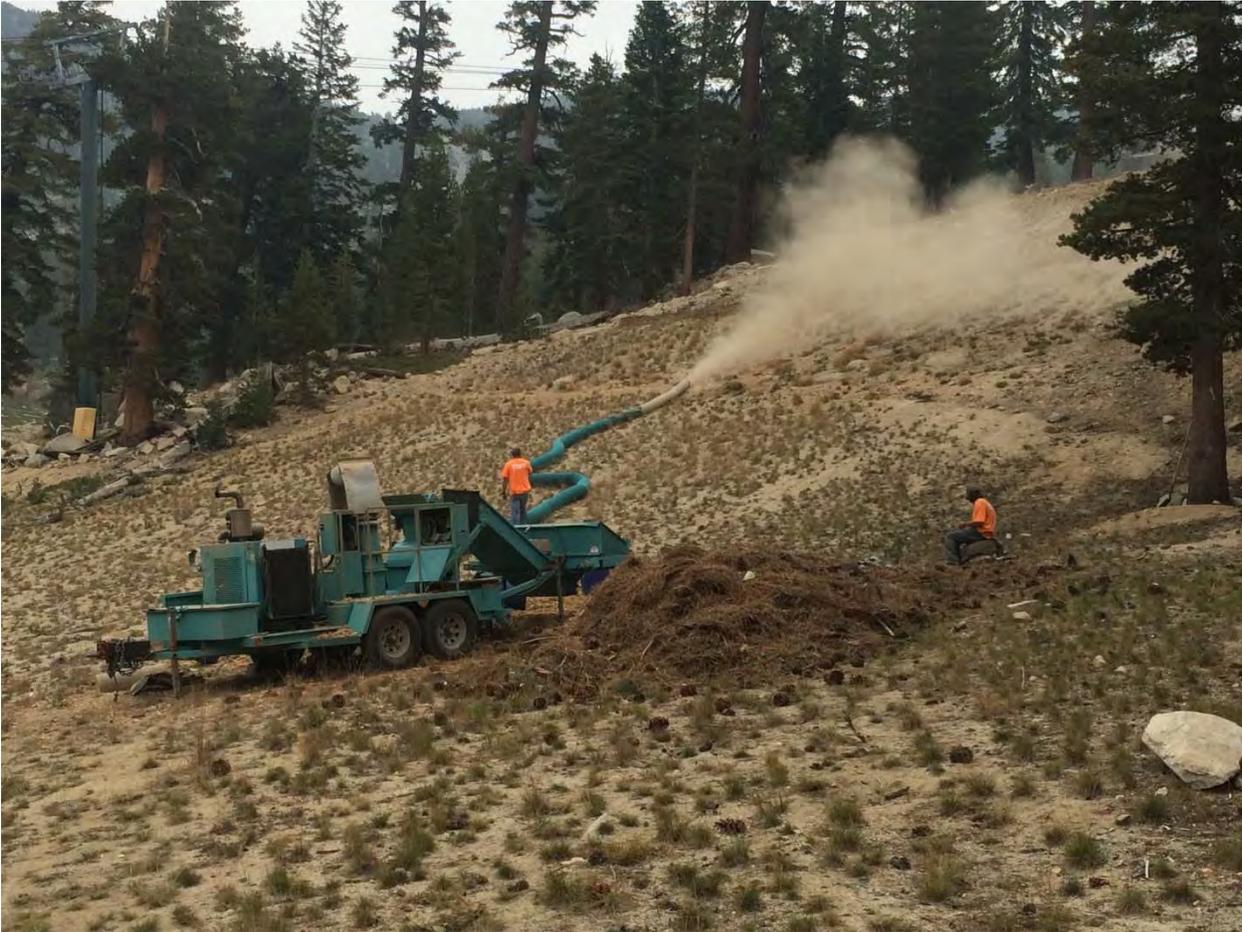
Lower Liz's Full Hogan restoration with Shred Vac from IERS. We rented this unit for 2 week in 2015:

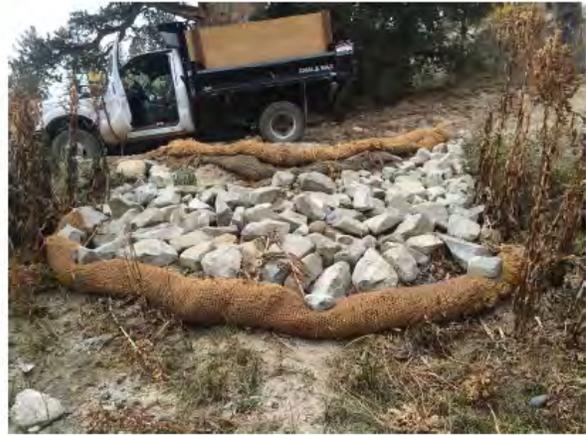
Riprap armoring below waterbar outlet

Additional pine needle wattle protection below riprap
