Mitigation and Monitoring Plan Annual
Report (October 2014 – September 2015)

Heavenly Mountain Resort BMP Effectiveness Monitoring

2015 Annual Report & Construction Season Summary

April 27, 2016

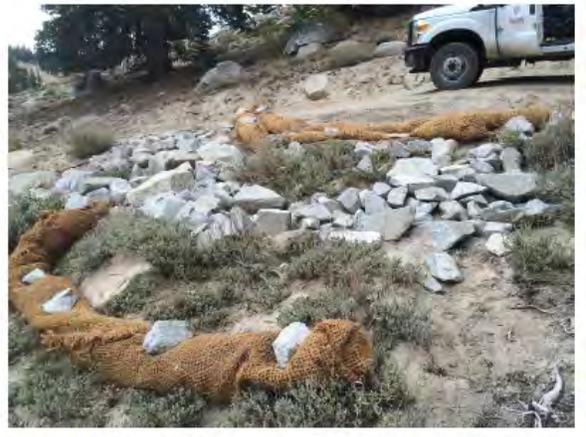
Pine needle wattle and riprap below waterbar outlet

Second layer of wattle protection below riprap outlet

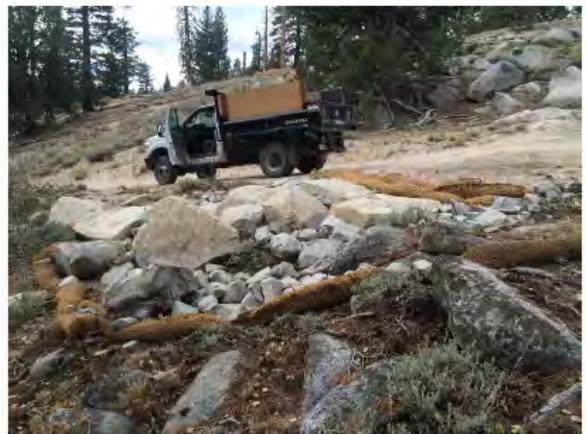
Pine needle wattles, added riprap below waterbar outlet

Additional pine needle wattle added below riprap

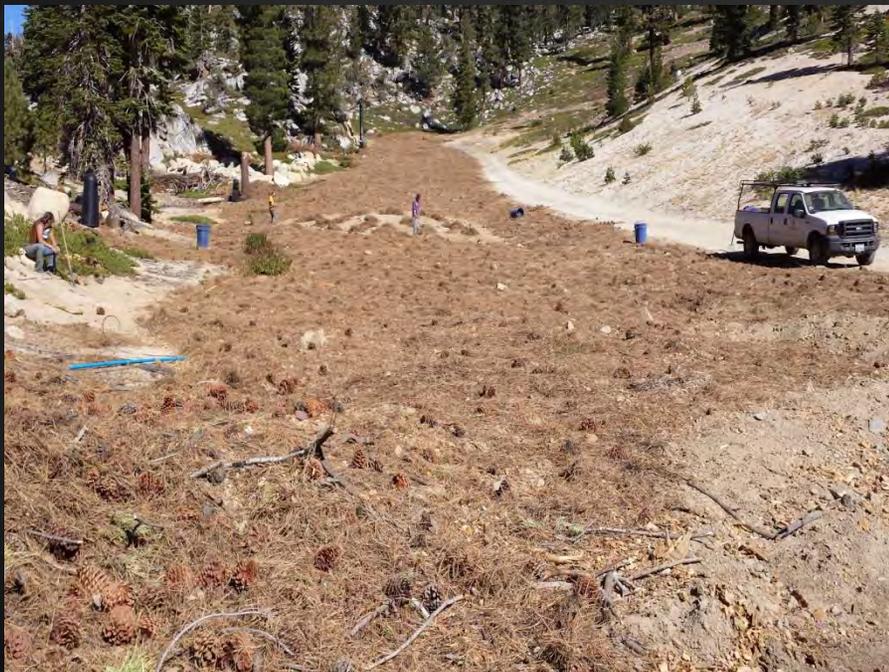
Nearing completion of this nearly $\frac{3}{4}$ acre site 2013

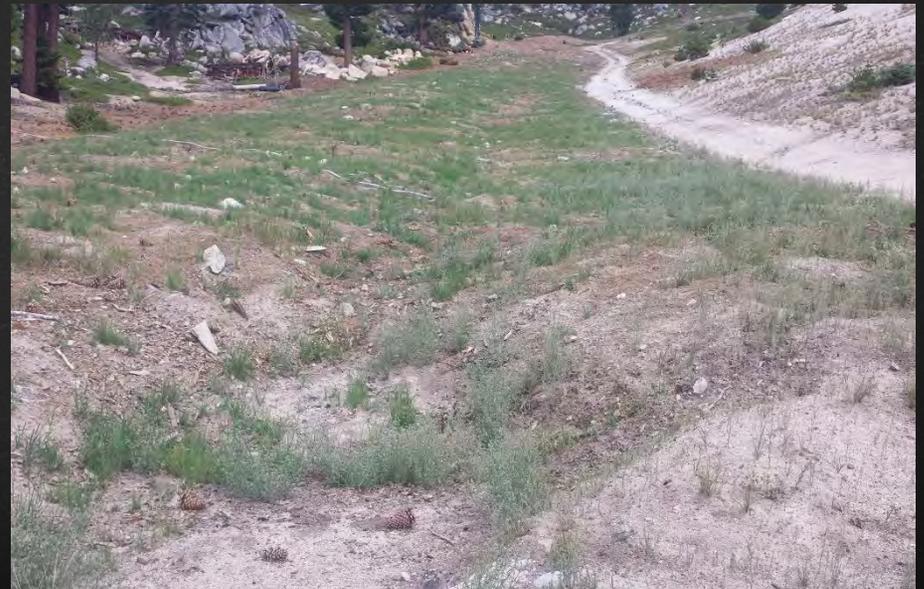
Finished Project Grasses growing in summer 2014

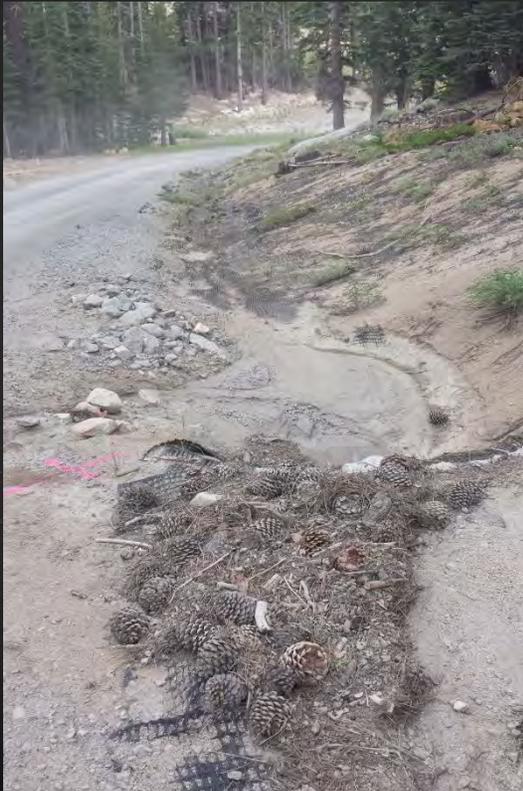
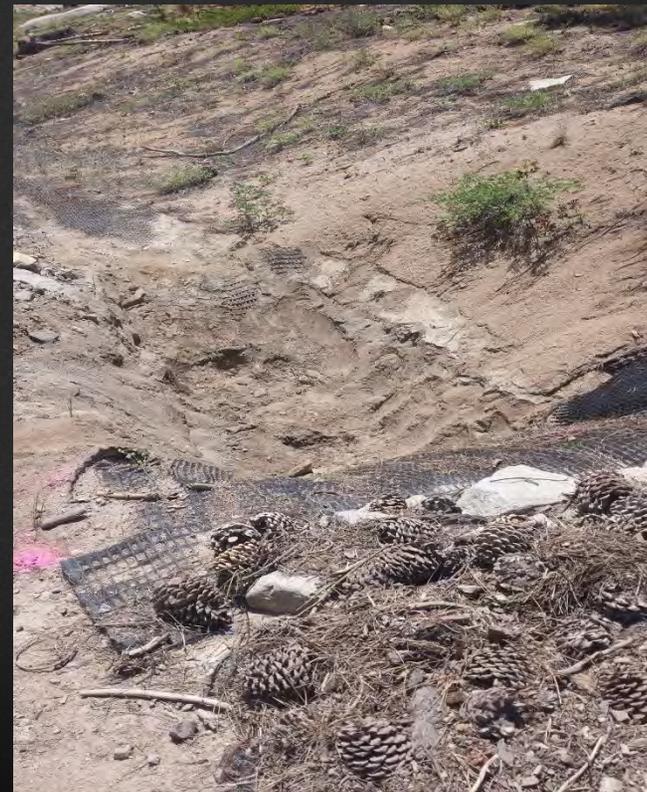
Maggies Pits Vacuumed out in October 2014

After picture highlights the improvement in sediment capacity

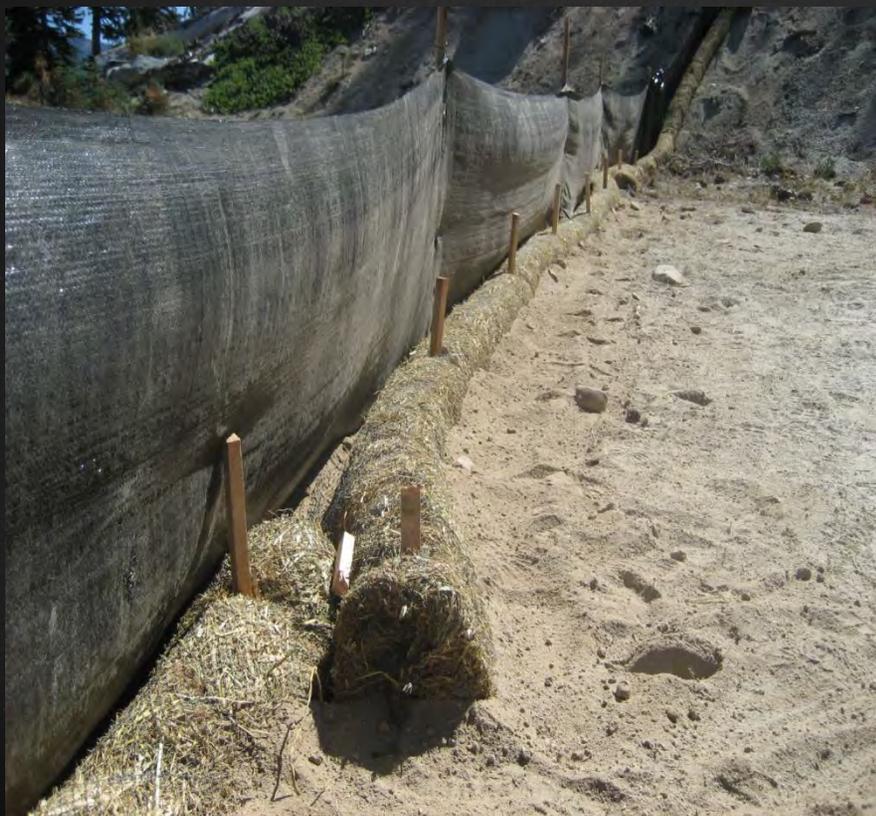
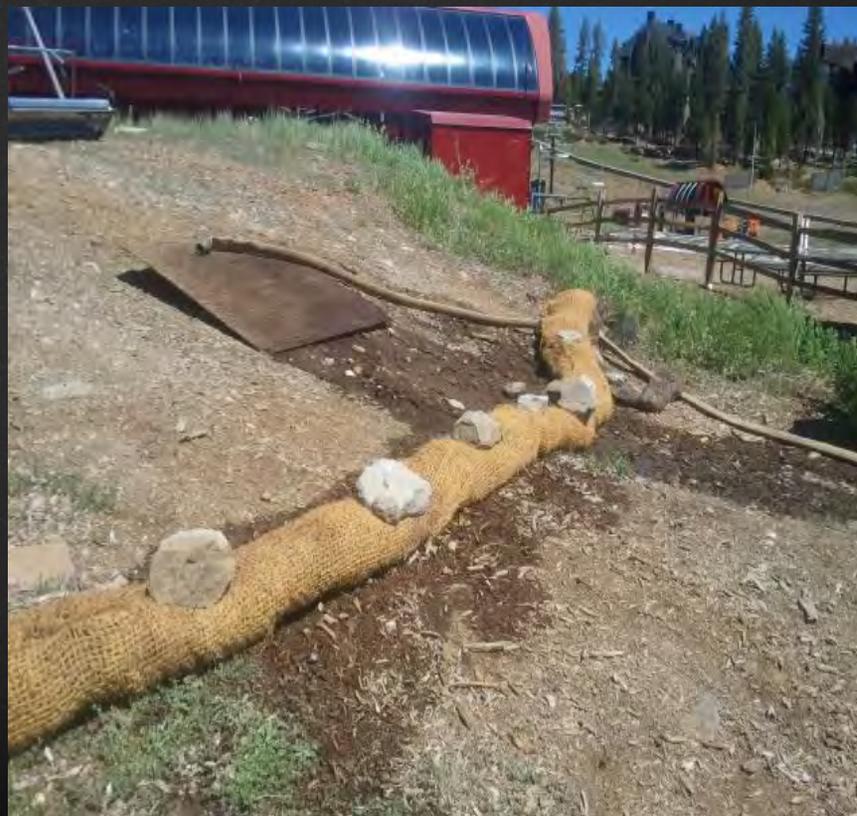
Wattles

Straw wattle with silt fence

Pine Needle Wattle

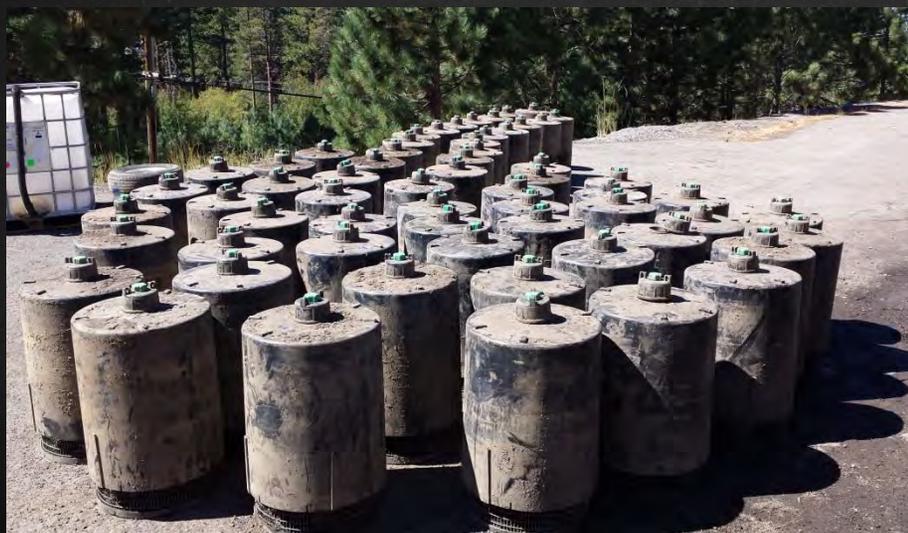
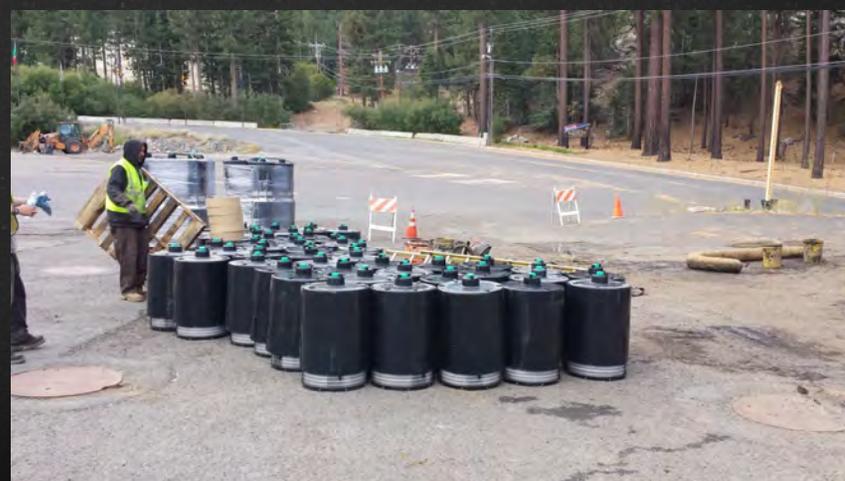
CML Storm Filters

Over 200 filters replaced in
2014

Full cartridge replacement of
all 456 filter since installation
in 2008, completed in 2014

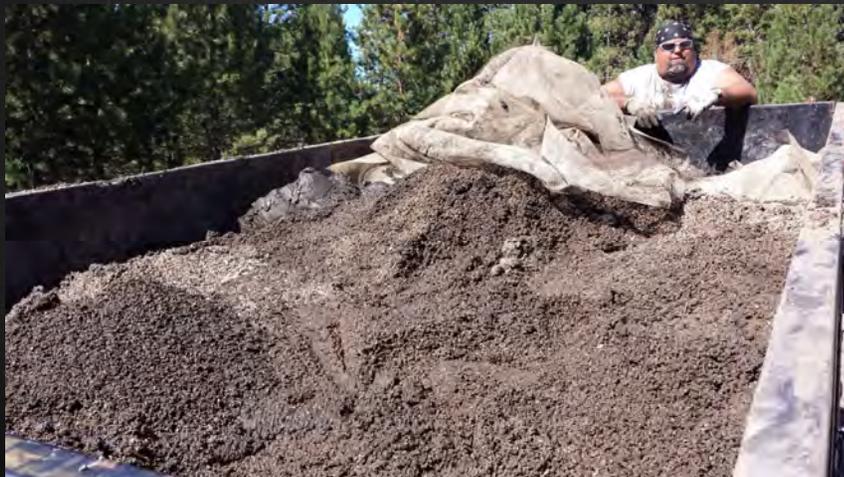
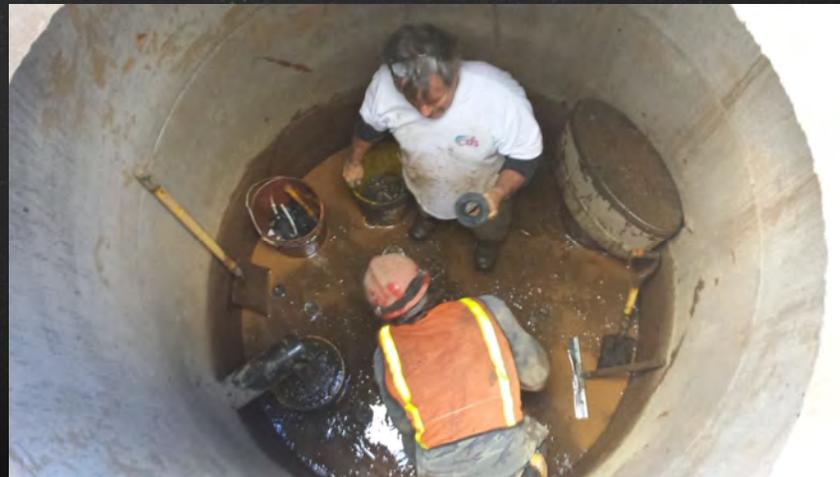
CML Storm Filters continued

Dozens of cubic yards of spend filter media and sediment removed in 2014

Sacrificial filters before being replaced with 14 new phosphorus filter media, which is showing positive improvements in WQ

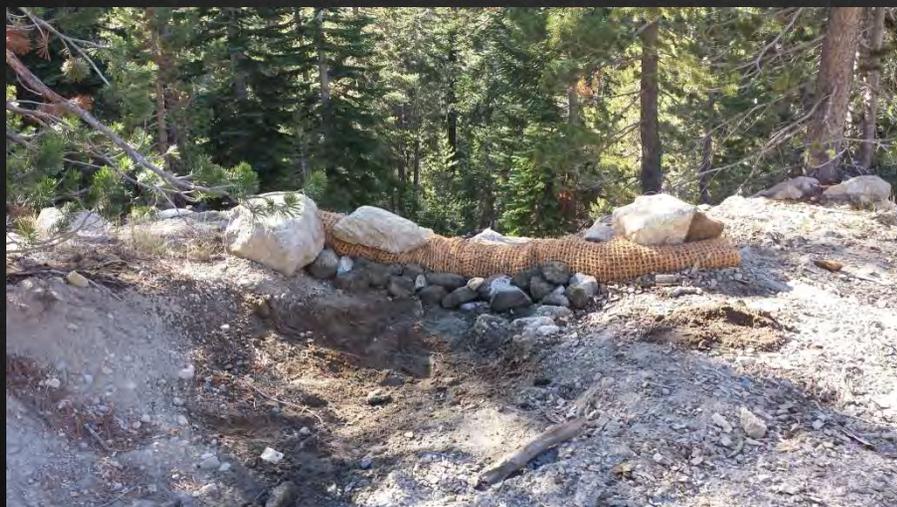
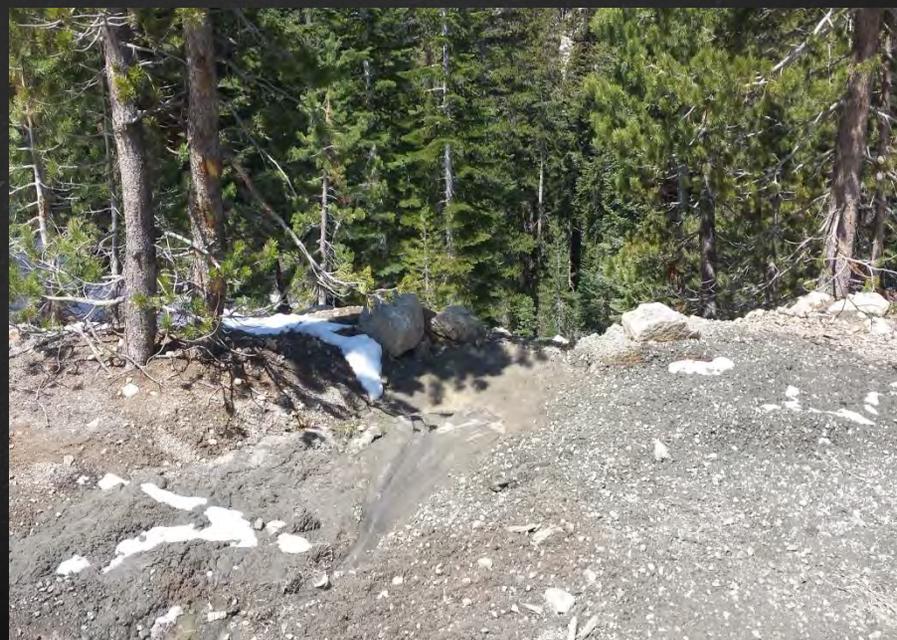
Pine Needle Wattles installed near
Heavenly Valley Creek Fall 2013

Pine needle wattles a success in
2014, after large precipitation
events

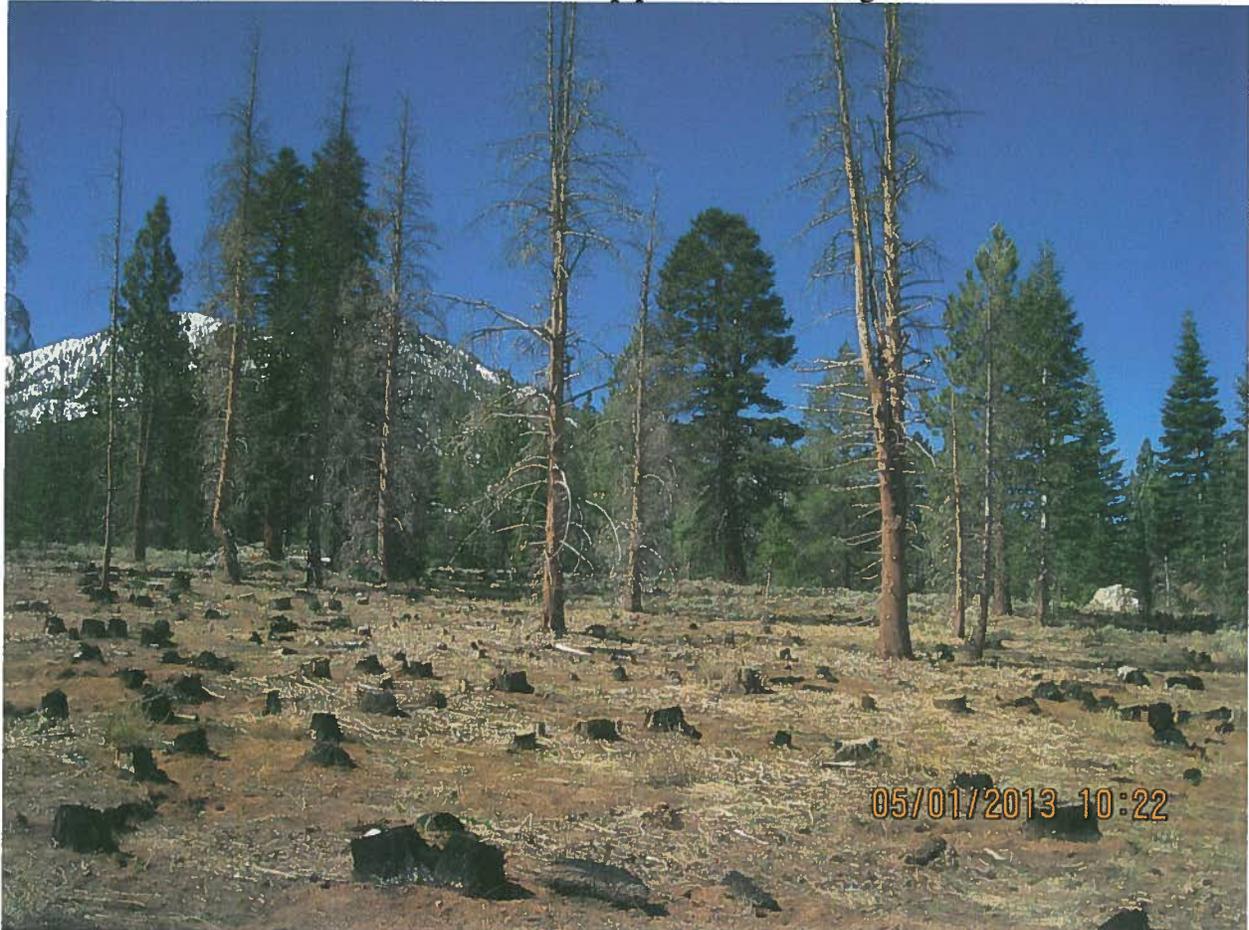
The result of the site visit to monitor the completion of these objectives proved satisfactory. The high levels of lodgepole mortality (from Mountain Pine Beetle) were cut, piled and burned, reducing the risk of stand replacing fire. The understory in the older portions of the stand was thinned to levels that would effectively improve resiliency for the long-term. There was evidence of adequate stocking of naturally regenerating seedlings throughout the treated area of the stand.

Photo 1: Reduction of fuel hazard and follow-up prescribed burning

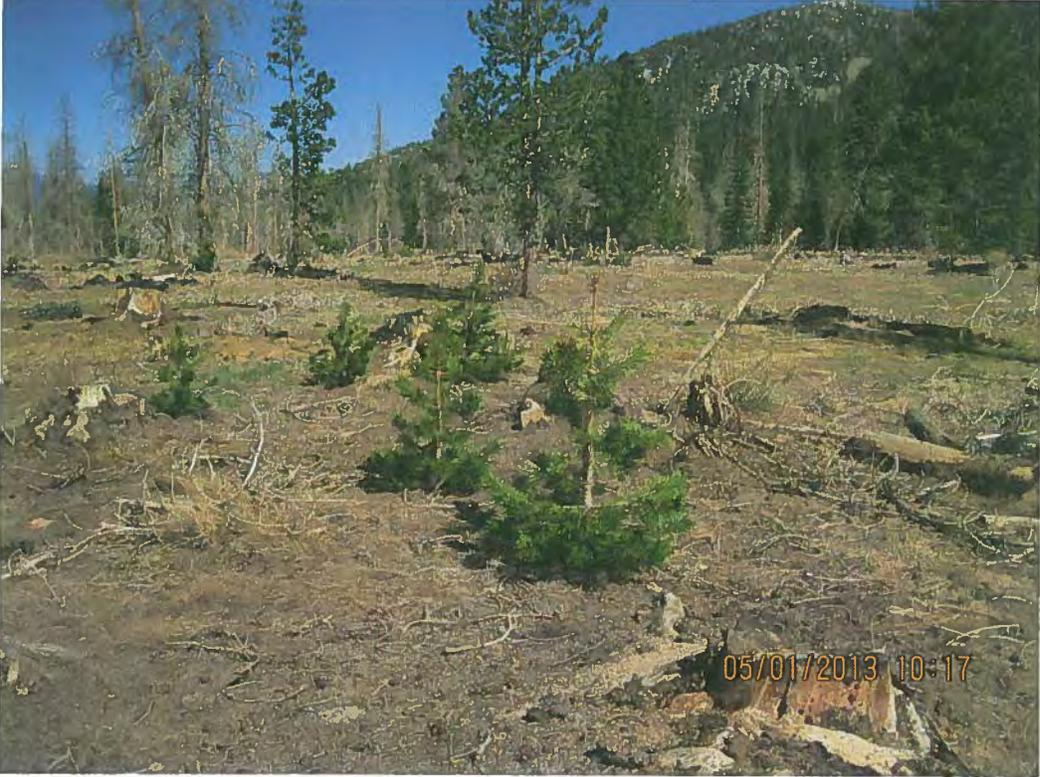
Photo 2: Natural regeneration occurring within the stand.

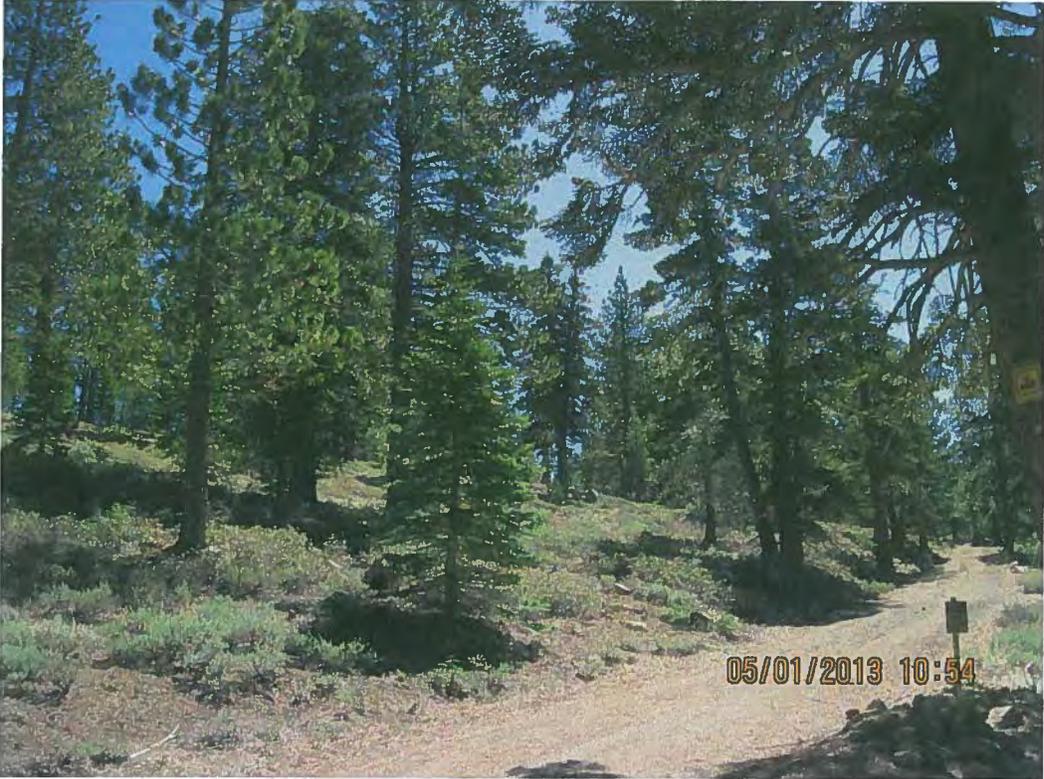
Photo 3: Enhancement of older forest portion of the stand.

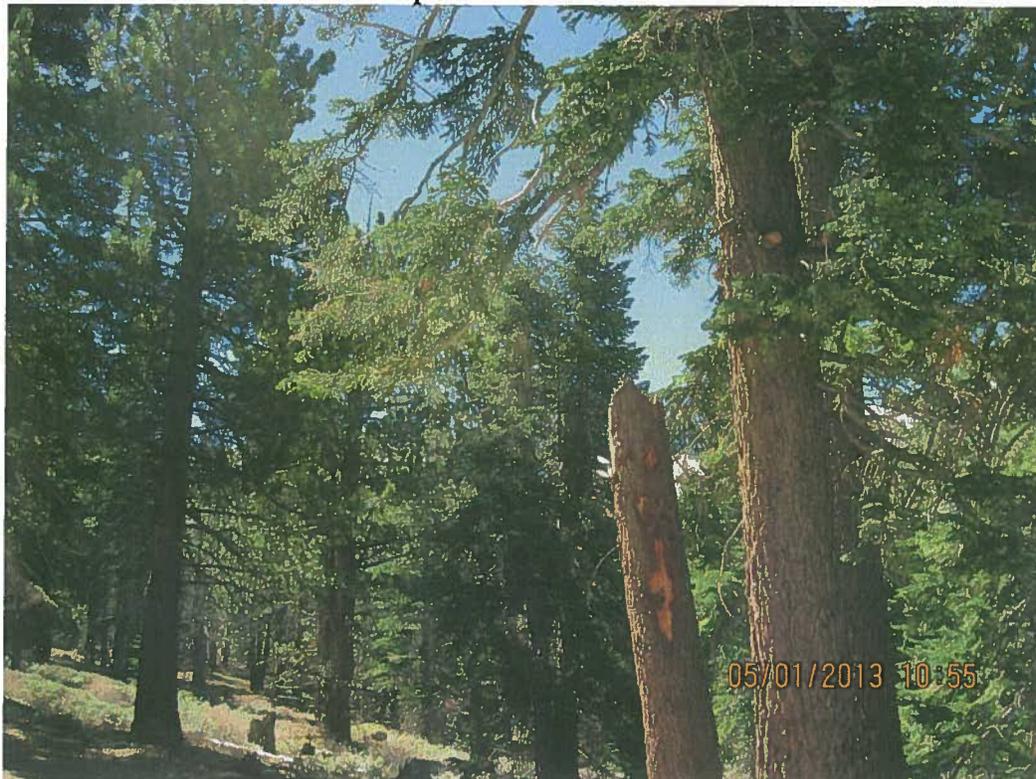
Photo 4: Enhancement of older portion of the stand.
