Heavenly Mountain Resort

Mitigation and Monitoring Plan
Annual Report (October 2016 –
September 2017)

Prepared for
Tahoe Regional Planning Agency

May 1, 2018

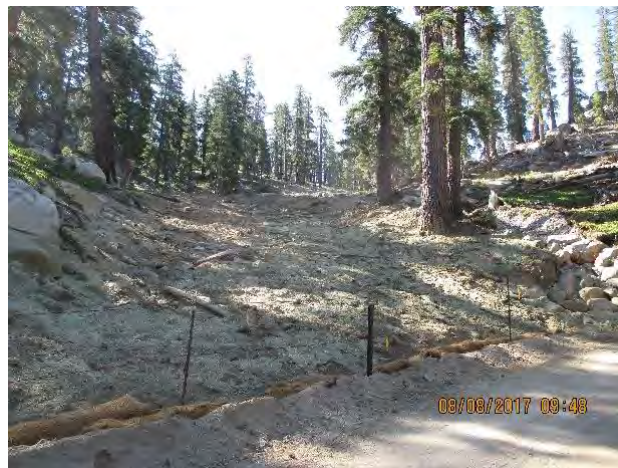
Hand Grenade Chute After: erosion resistance significantly improved on steep slope and toe of slope protection provided by cutoff ditch and pine needle wattle

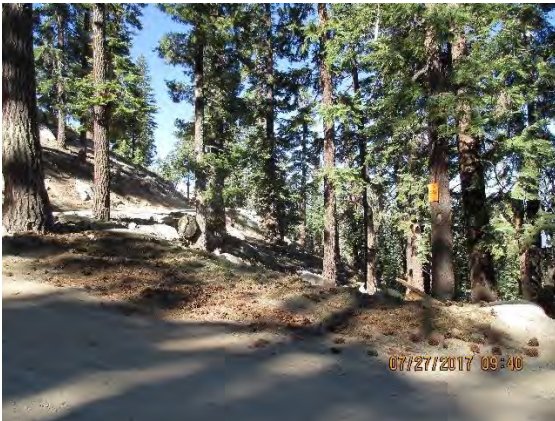
Hand Grenade Chute After: erosion resistance significantly improved on lower road shoulder with pine needle mulch and seed

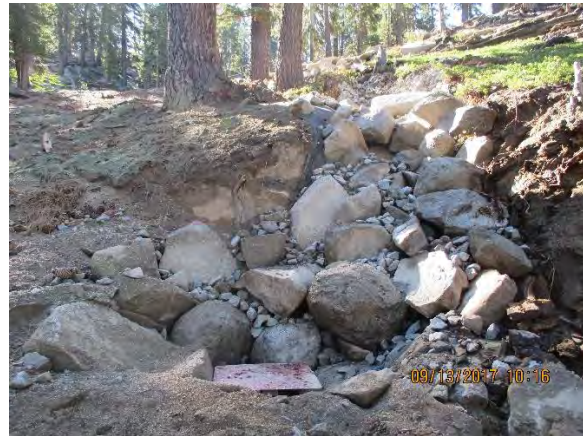
Hand Grenade Chute After: rock riprap protection on gully with geotextile and covered culvert inlet to pass flows across roadway

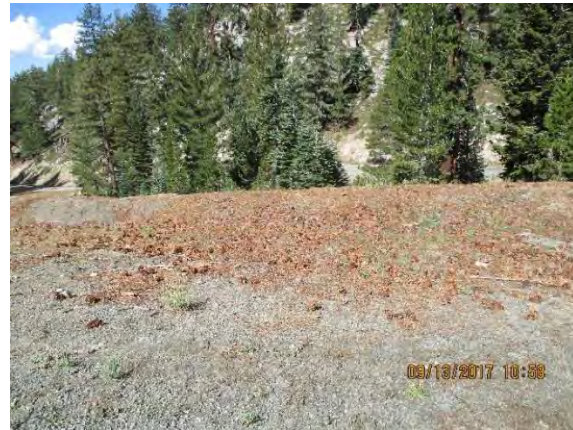
Maggie's Run After: erosion resistance significantly improved with pine needle mulch and regrading of water bar acting as a basin

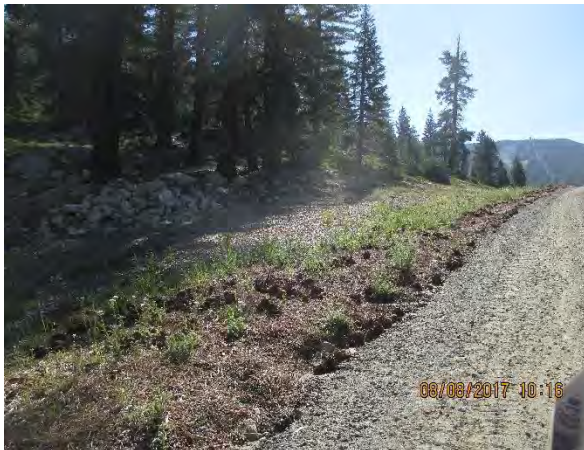
Maggie's Run After: gully formed alongside road improved with pine needle mulch

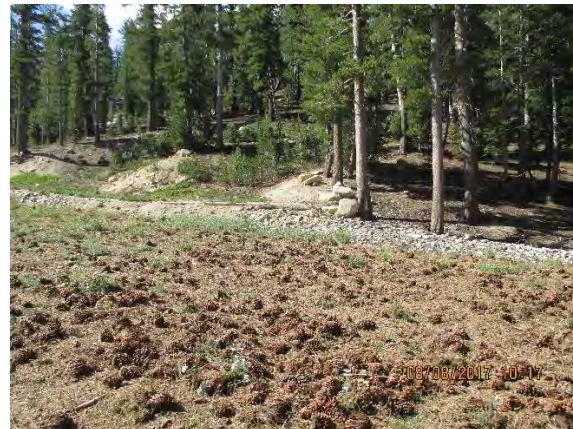
Maggie's Run After: erosion resistance significantly improved with pine needle mulch

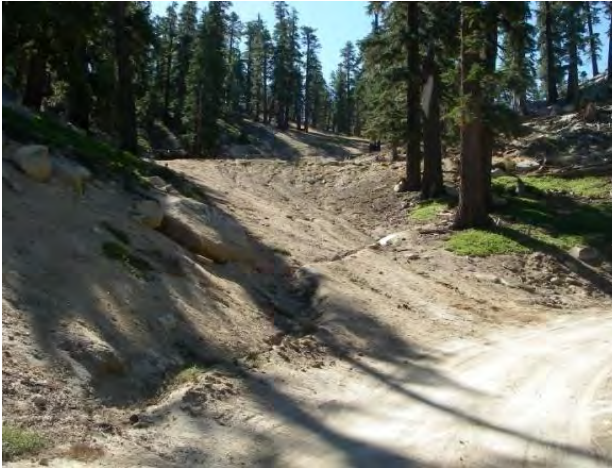
Hot Spot 1

Before: Bare ski slope impacted by drainage from switchback above & drainage flowing across roadway.

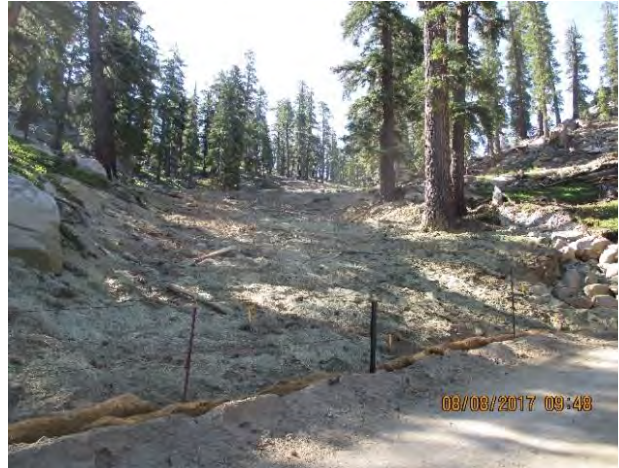
After: Area hydroseeded, tilled and mulched. Riprap channel directing flows to culvert under road.

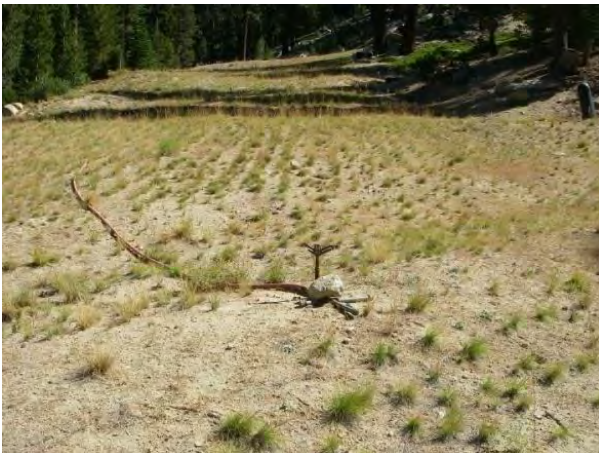
Hot Spot 3

Before: Existing vegetation requiring irrigation with little erosion resistance.

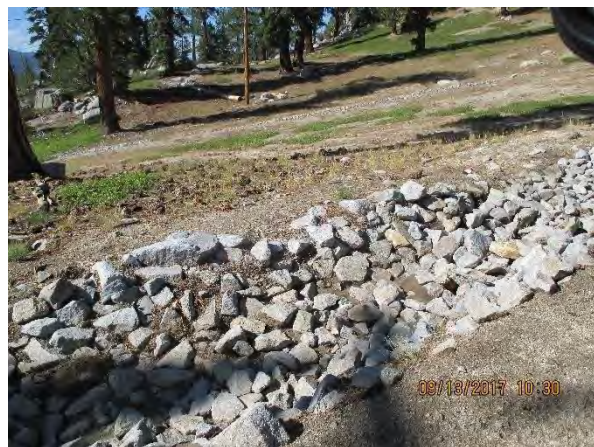
After: Stabilized bare soil areas with full restoration treatment and mulch filter berm. Sediment removed from rock lined channel below sediment plume area.

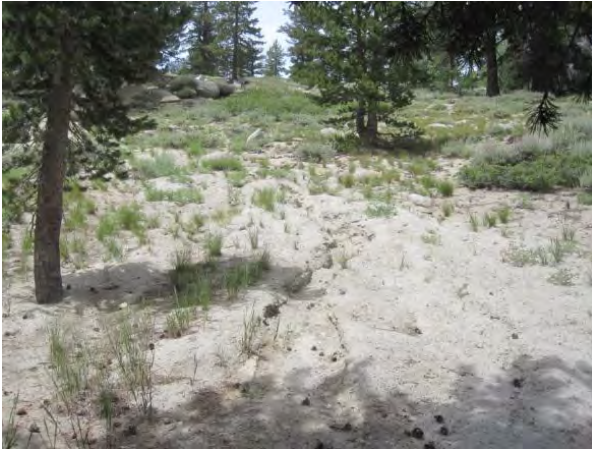
Hot Spot 45

Before: very steep section of road (Hellwinkel's) delivering sediment downslope near SEZ channel above Sky Meadows culvert. Rills and gullies formed on hillside below road and above channel.

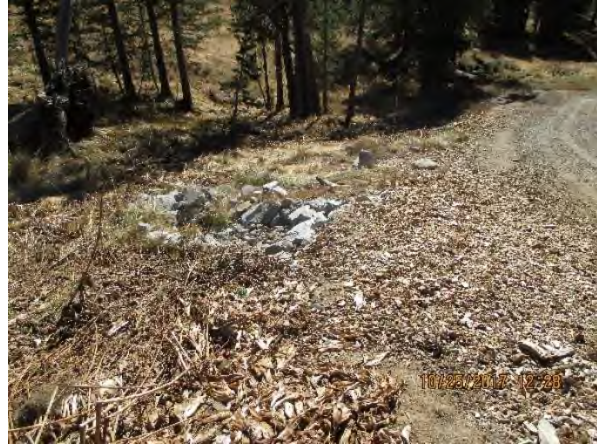
After: Road treated with surface stabilizing agent in 2016. French mattress drain installed to prevent spring from daylighting on road. Both water bar outlets have multiple wattles and rock riprap to protect minimize erosion and sediment transport to meadow/creek. Annual maintenance of treatments.

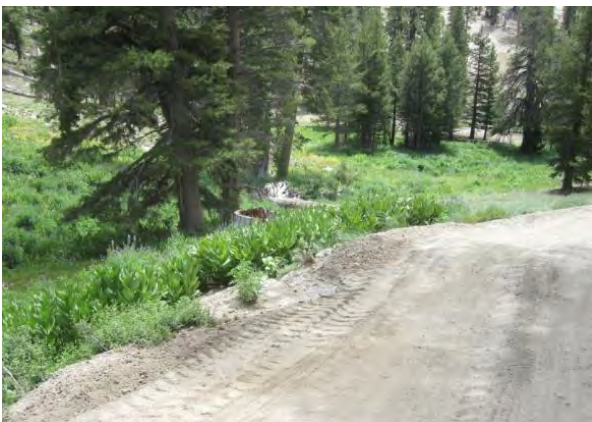
Hot Spot 46

Before: very steep section of road (Hellwinkel's) delivering sediment downslope near SEZ channel above Sky Meadows culvert. Rills and gullies formed on hillside below road and above channel.

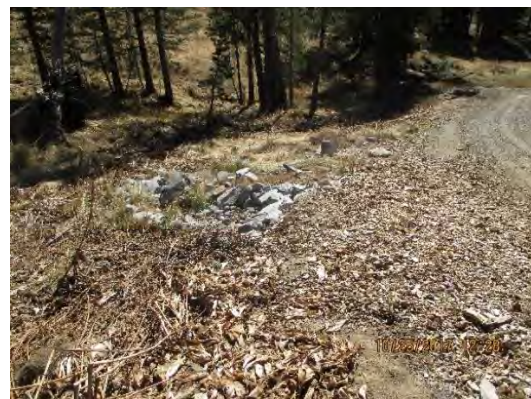
After: Road treated with surface stabilizing agent in 2016. French mattress drain installed to prevent spring from daylighting on road. Both water bar outlets have multiple wattles and rock riprap to protect minimize erosion and sediment transport to meadow/creek. Annual maintenance of treatments.

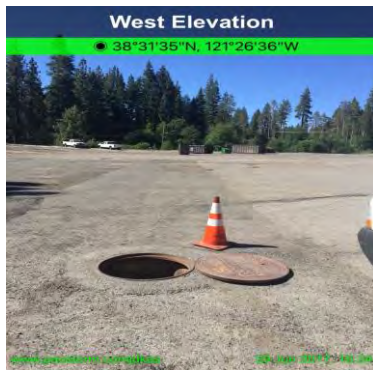
Unit #3 - 7 Phosphorous Cart MH

Cartridges submerged

Maintenance recommended due to high water level

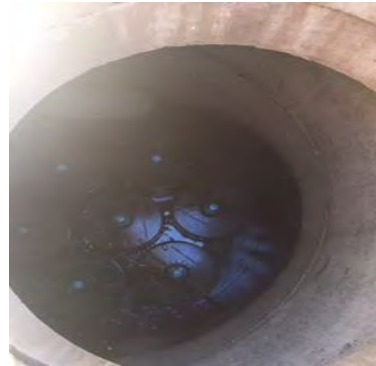
Partially submerged filters

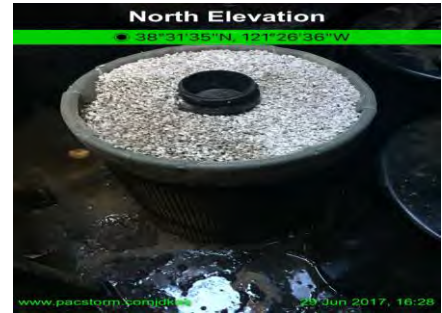
Cartridge bay

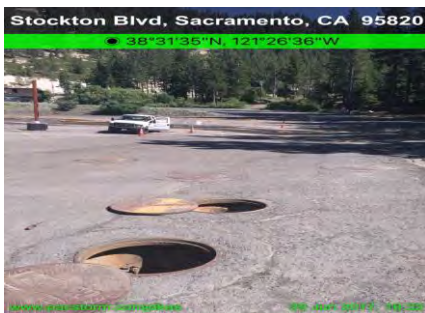
Loose clean media

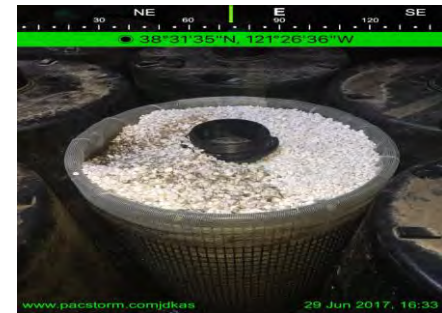
Cartridge bay

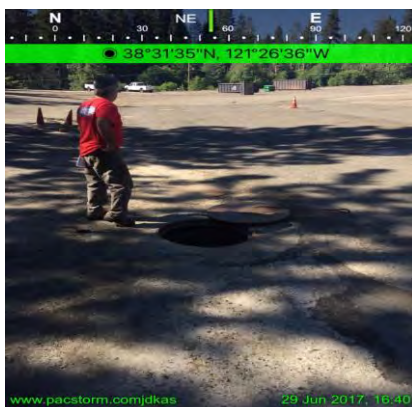
Loose clean media

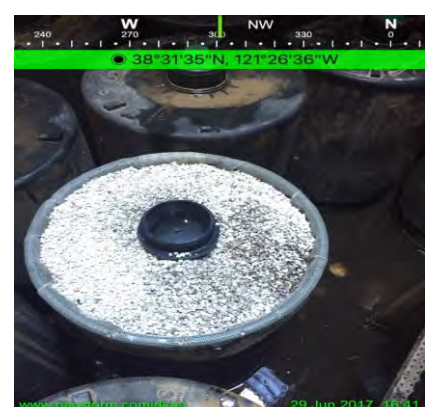
Inlet bay sediment

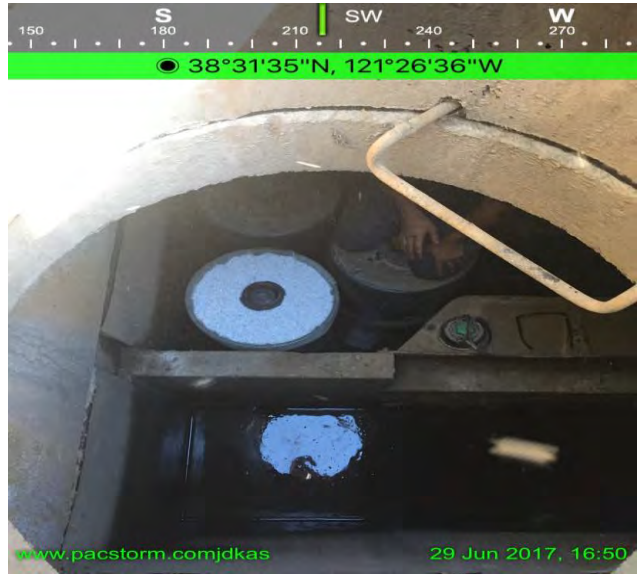
Loose clean media/minimal
sediment

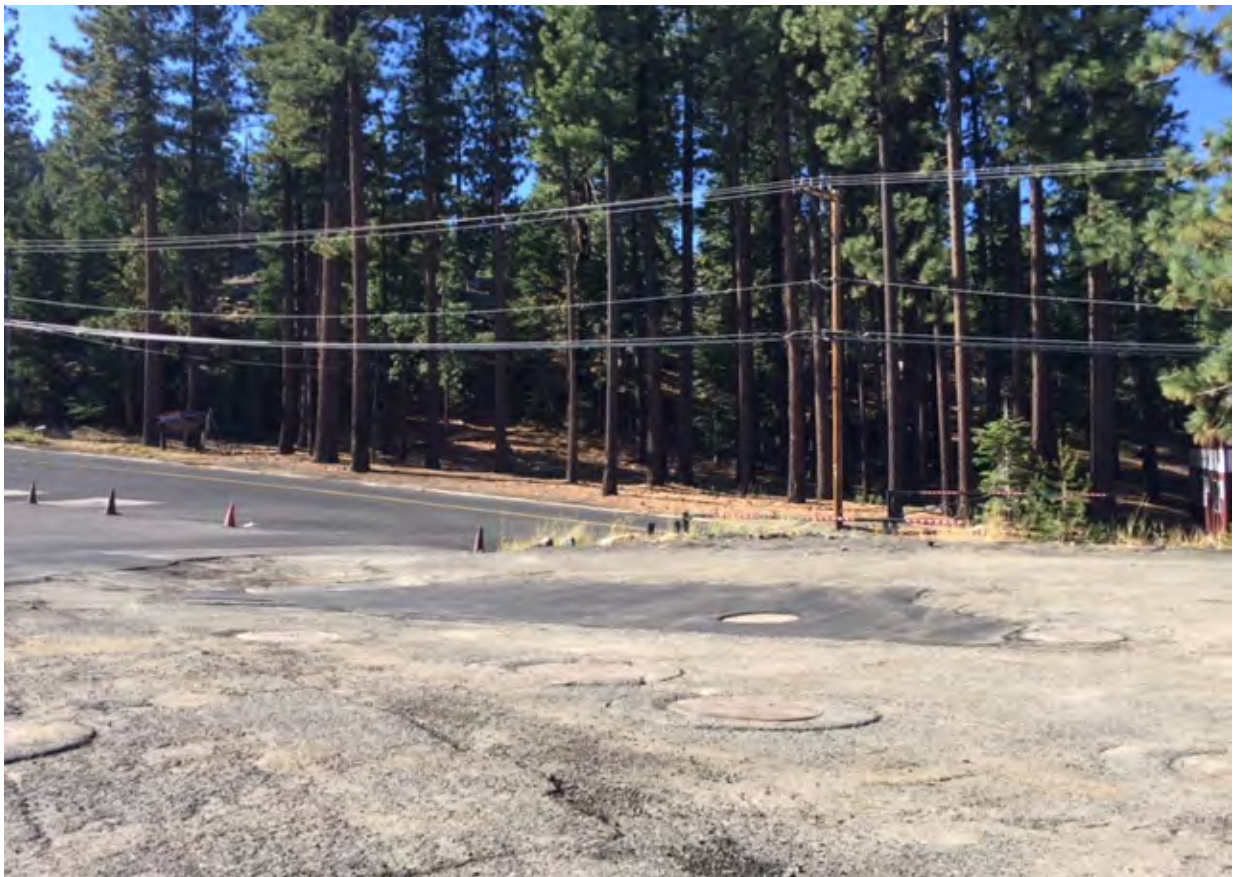
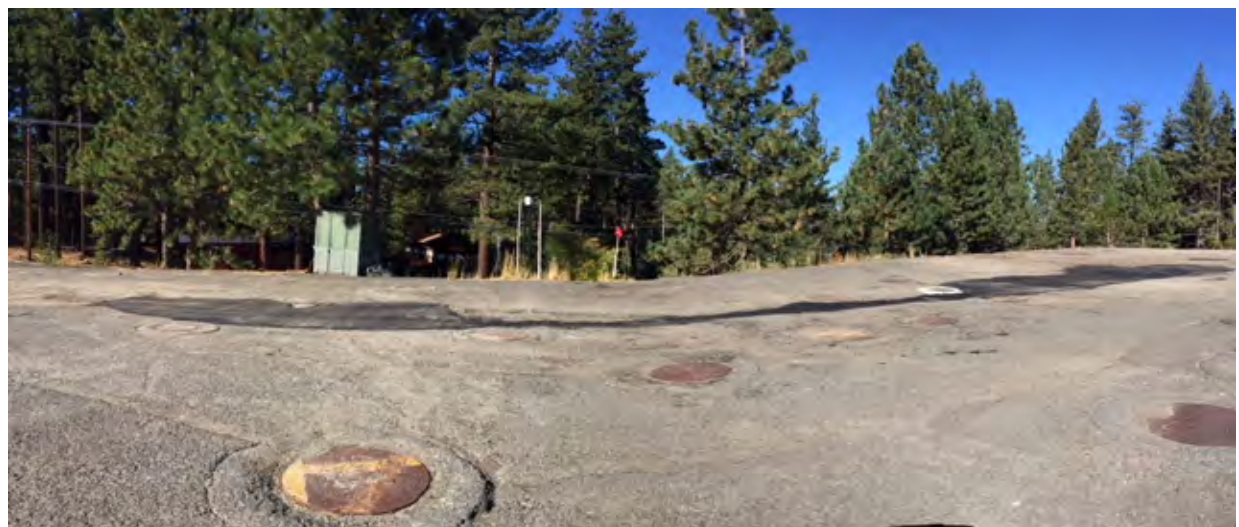
Pavement was patched and repaired above the vaults in the lower lot on 9/29

SEE PHOTOS ON NEXT PAGE OF CA PARKING LOT ASPHALT REPLACEMENT/IMPROVEMENTS NEAR THE STORMWATER TREATMENT VAULTS ON 9/29/17.

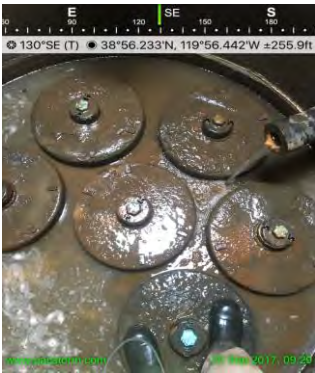
During maintenance

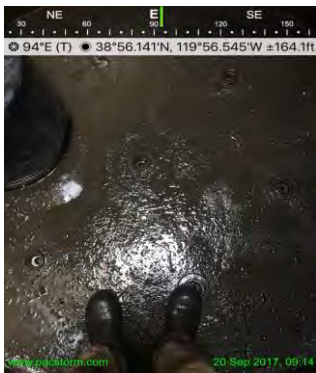
Maintenance completed

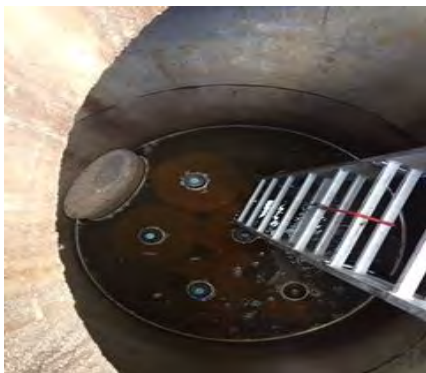
During Maintenance

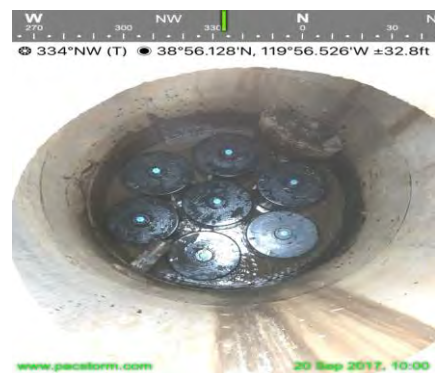
Maintenance completed

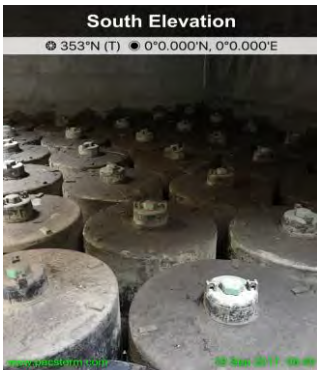
During maintenance

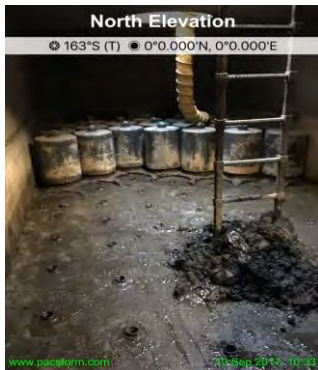
Maintenance completed

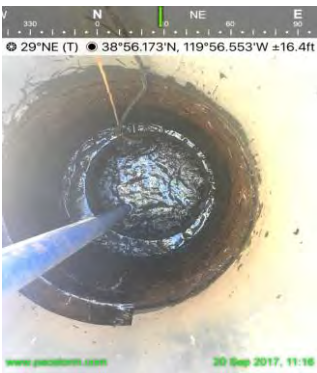
During maintenance

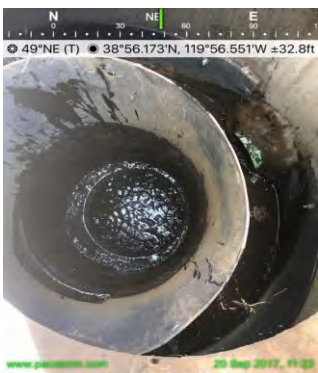
Maintenance completed

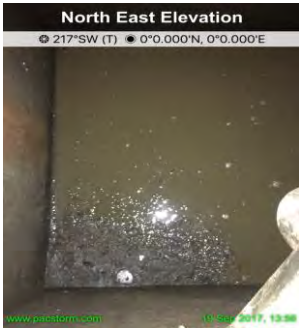
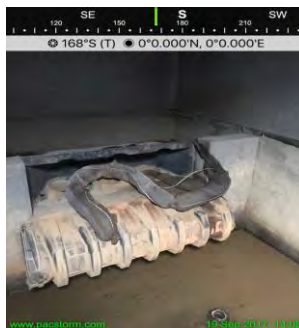
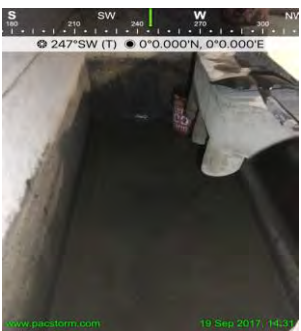
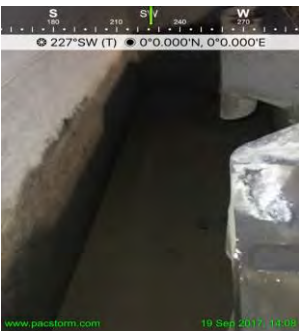
Inlet bay cleanings

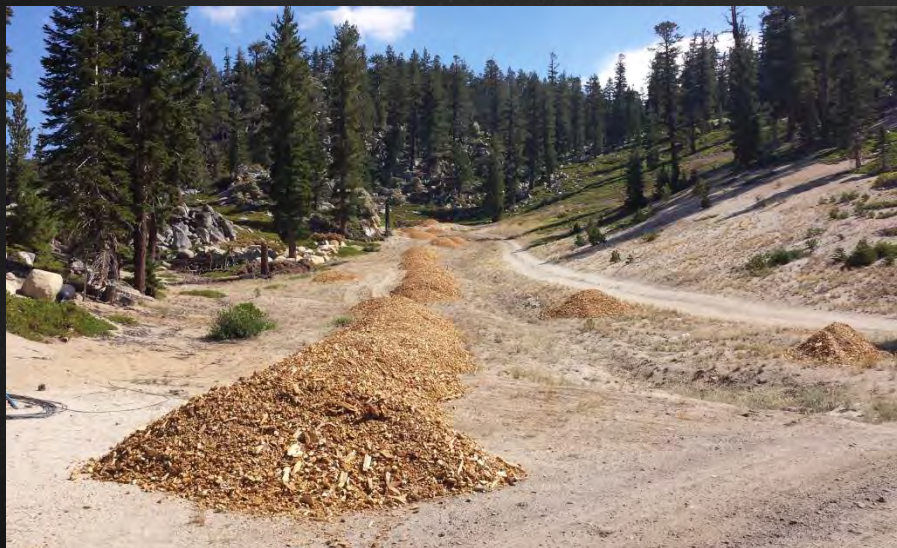
Pioneer/Poma prior to treatment

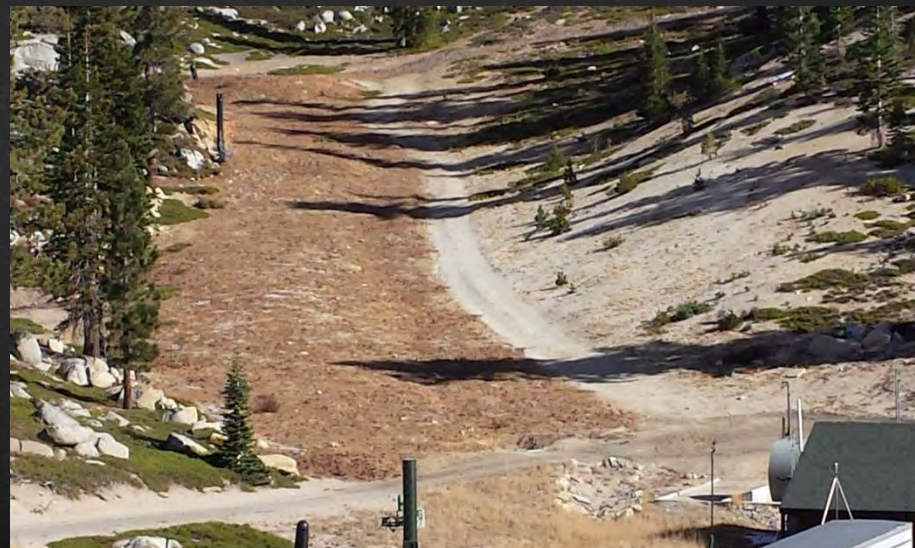
Pioneer/Poma after treatment

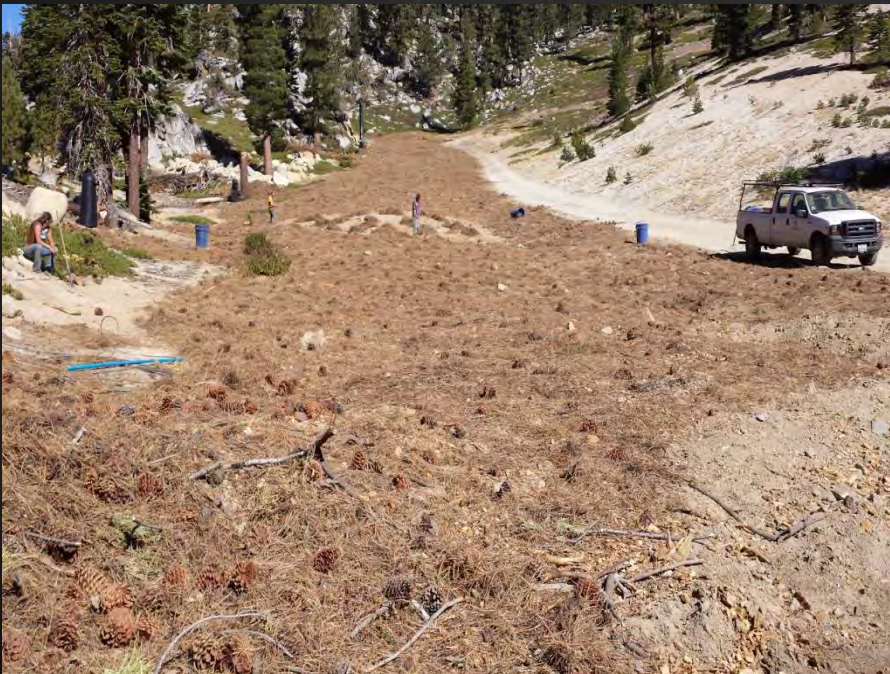
Nearing completion of this
nearly $\frac{3}{4}$ acre site 2013

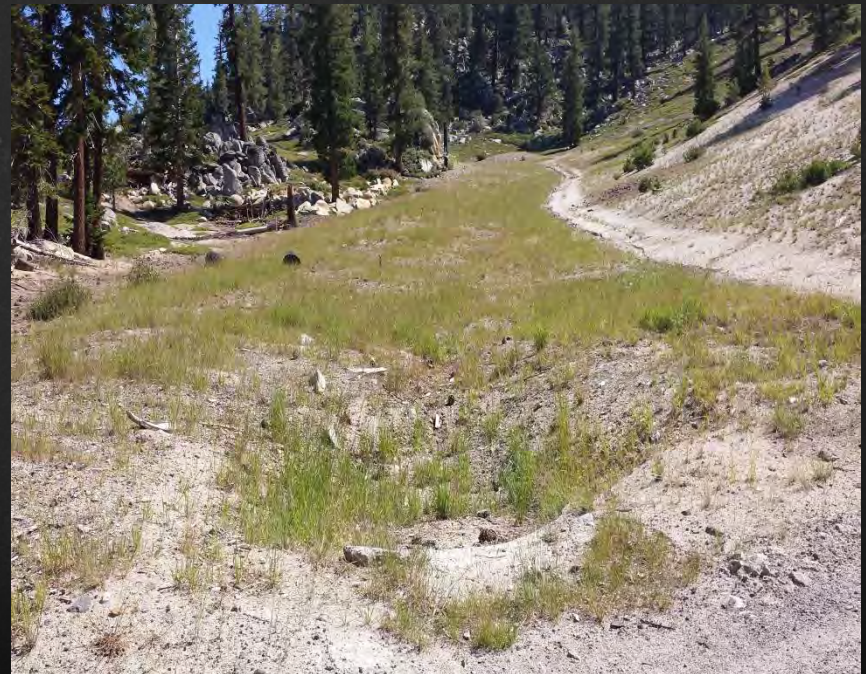
Finished Project Grasses
growing in July 2015

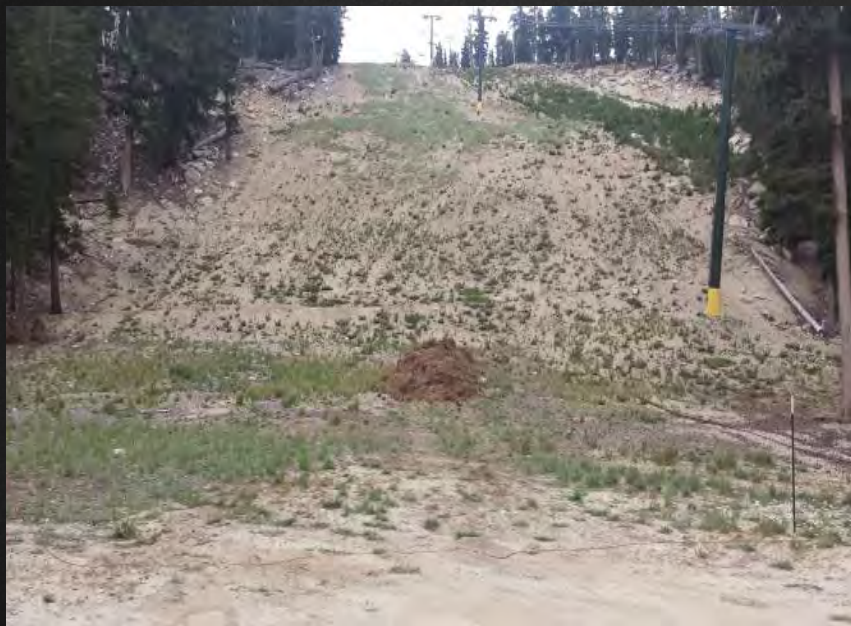
In 2015 prior to treatment

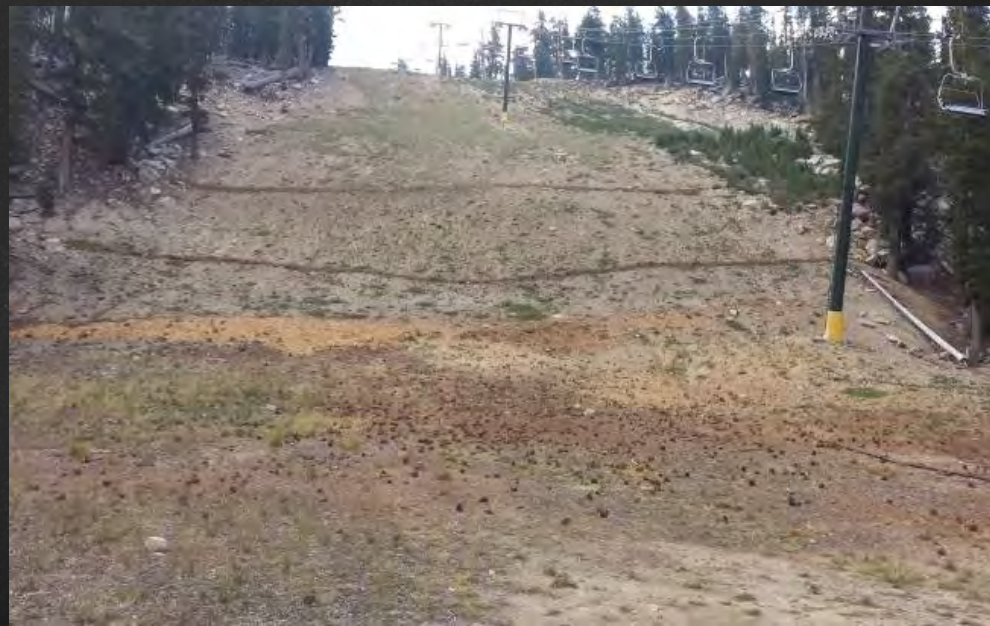
In late 2015 after treatment

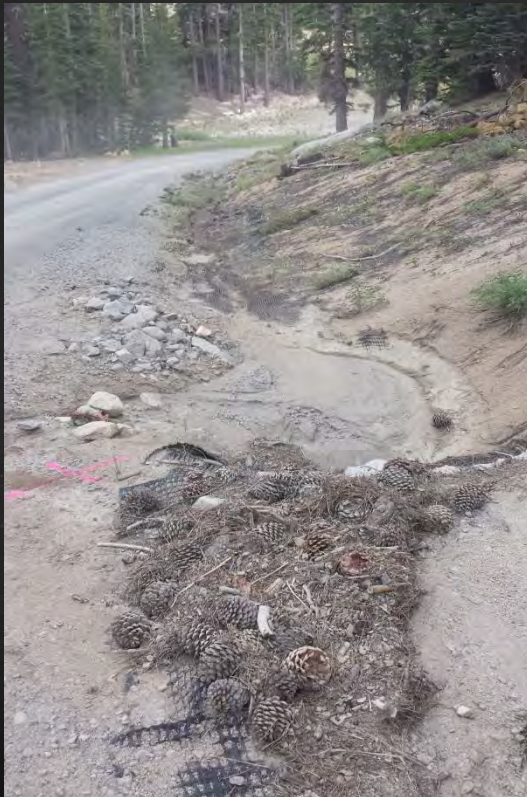
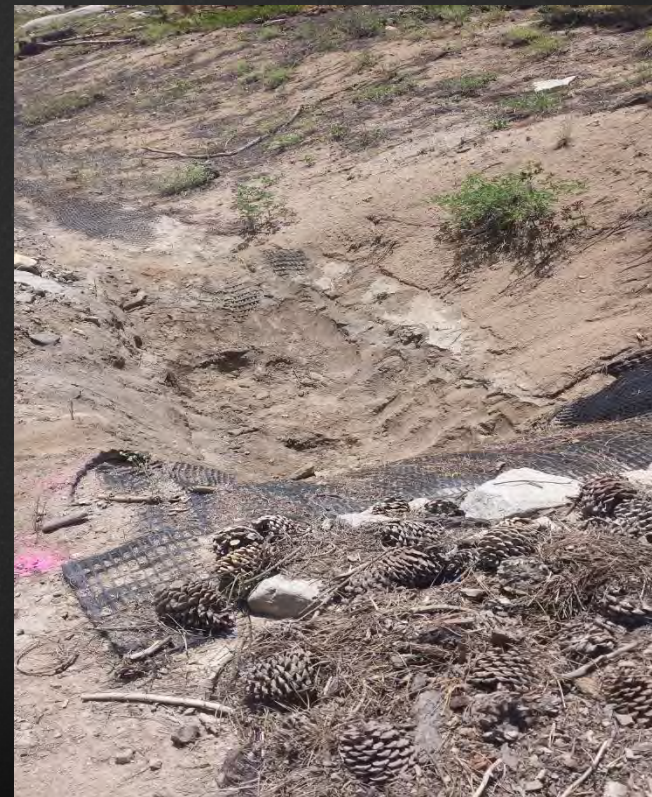
Maggie's Pits Vacuumed out in October 2014

After picture highlights the improvement in sediment capacity

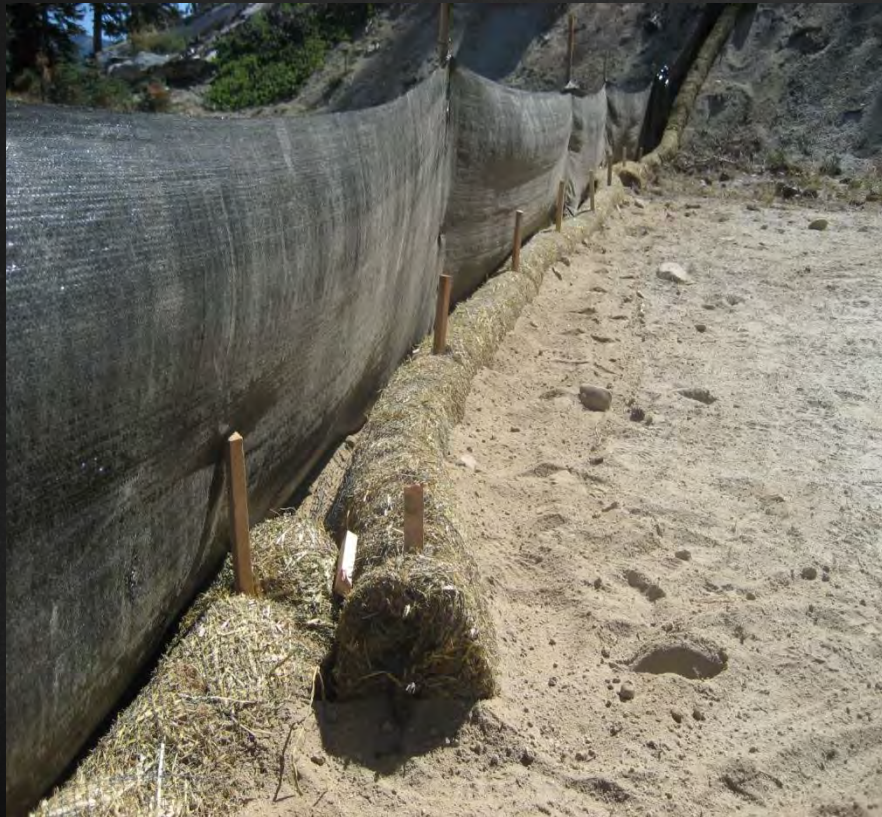
Straw wattle with silt fence

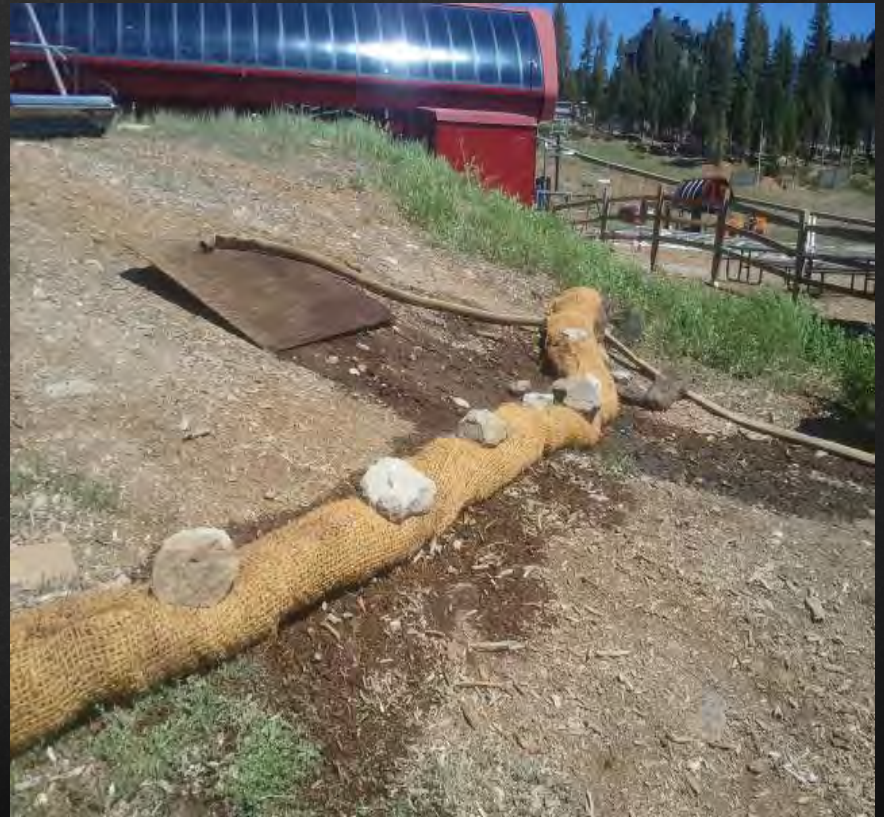
Pine Needle Wattle

Pine Needle Wattles installed near Heavenly Valley Creek Fall 2013, replaced annually.

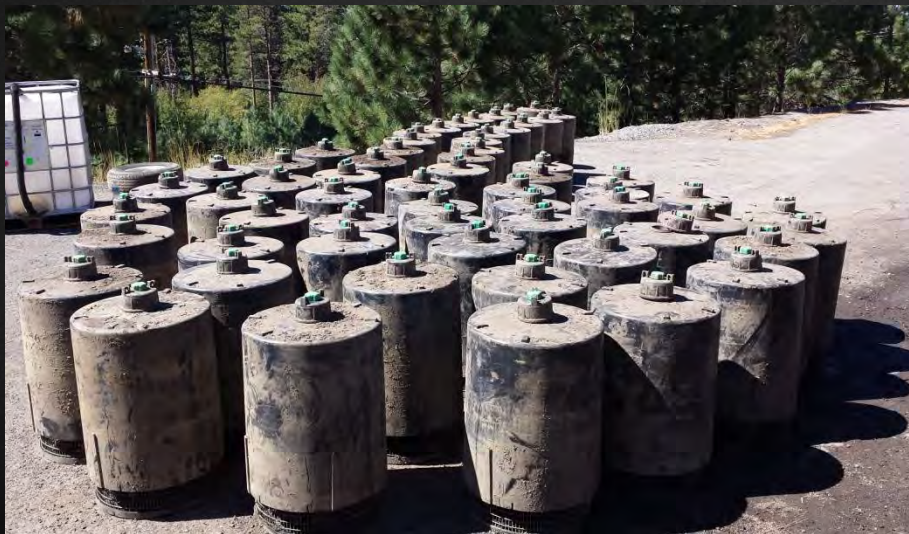
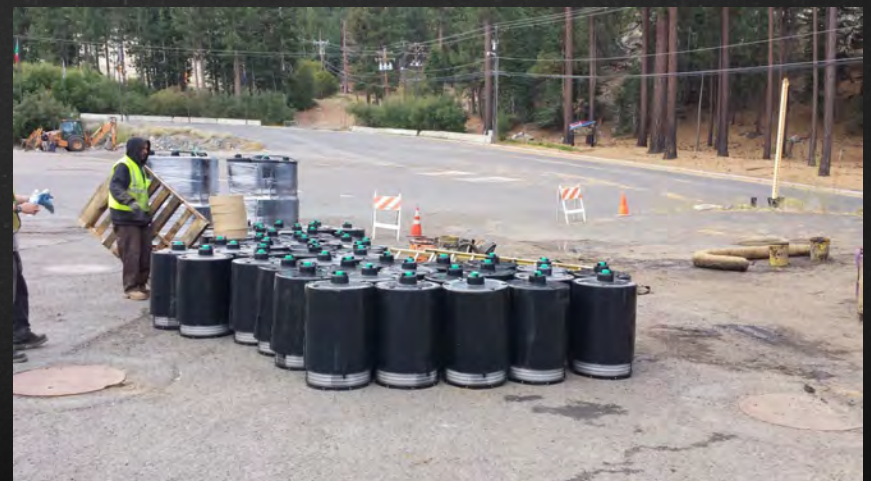
134 filters replaced in Fall
2016

Full cartridge replacement of
all 456 filter since installation
in 2008, completed in 2014

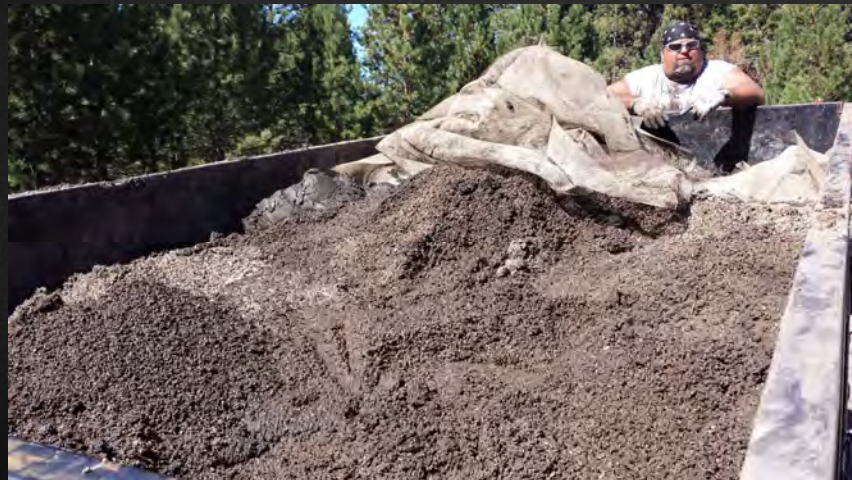
~10+ cubic yards of spend filter media and sediment removed in October 2016

Sacrificial filters before being replaced with 14 new phosphorus filter media, which is showing some positive improvements in WQ, year 4 of use.

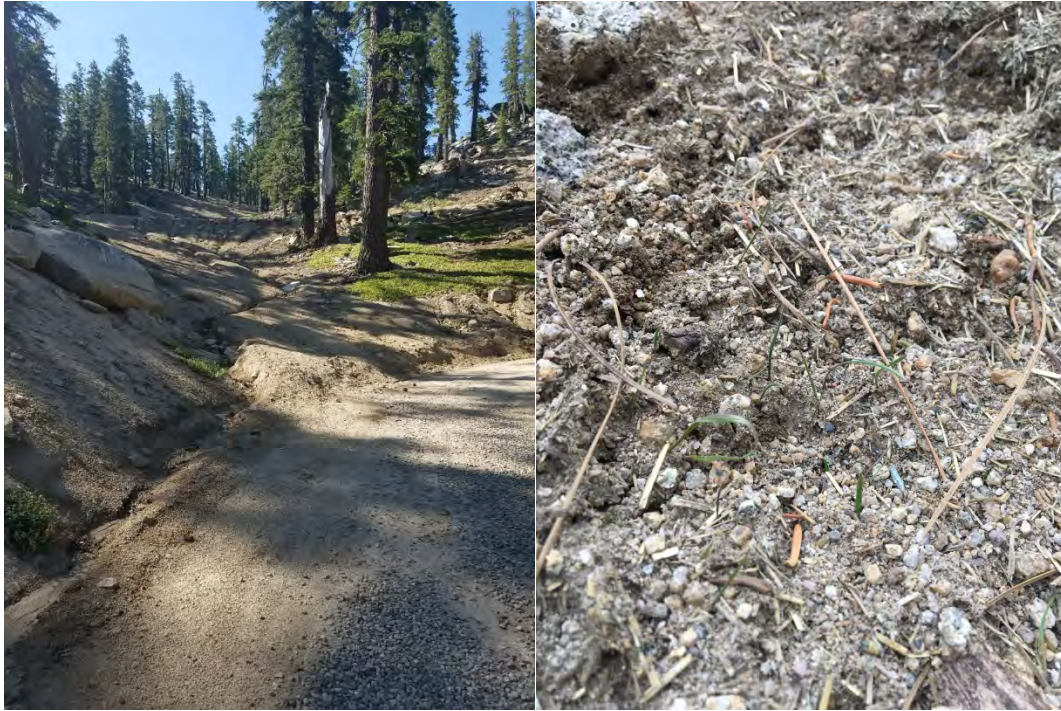
Hand Grenade/Roundabout before restoration treatment 7-07-17:

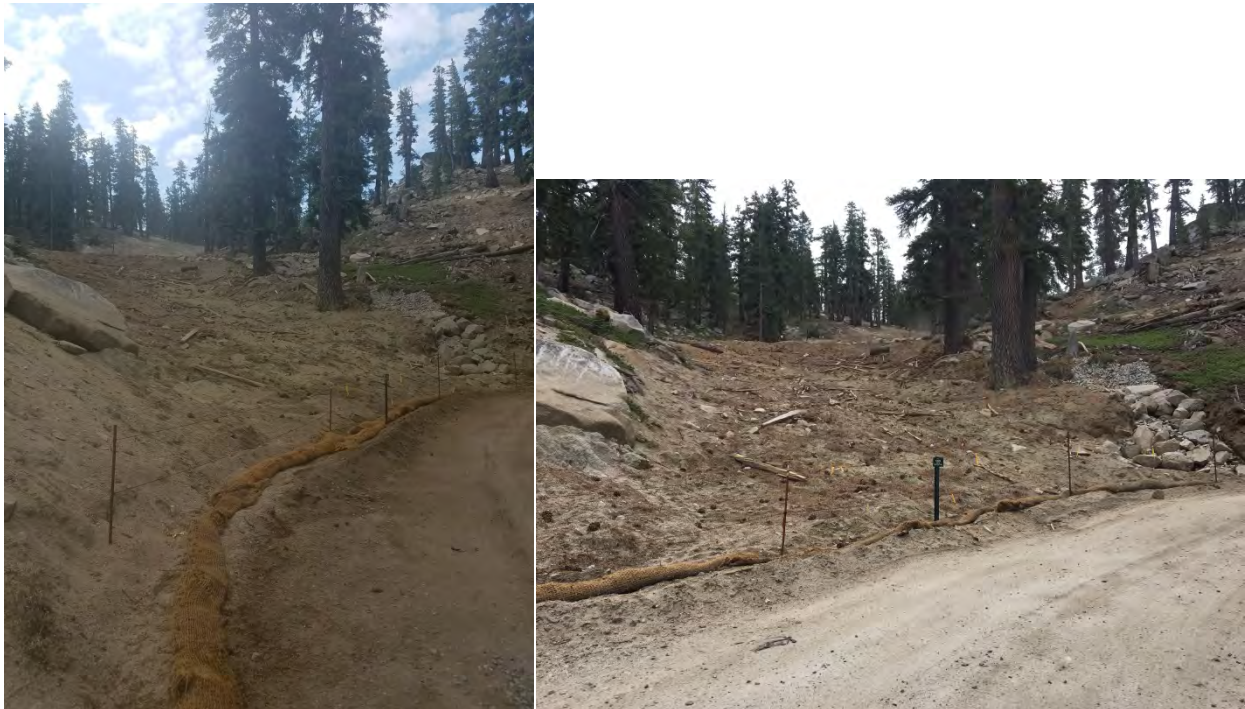
Hand Grenade/Roundabout on 8-11-17, site is stable, and some vegetation was growing (above right) as of Oct. 2017

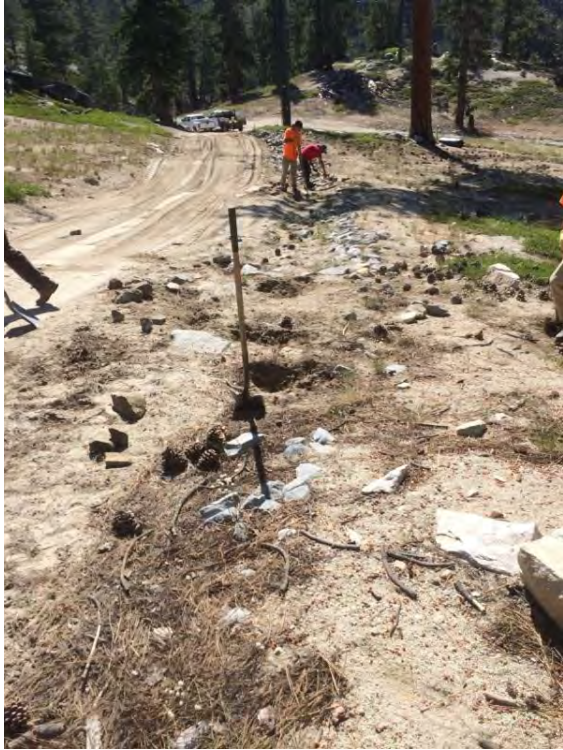
Trail Crew restored the groove rock line ditch photo taken 8-11-17:

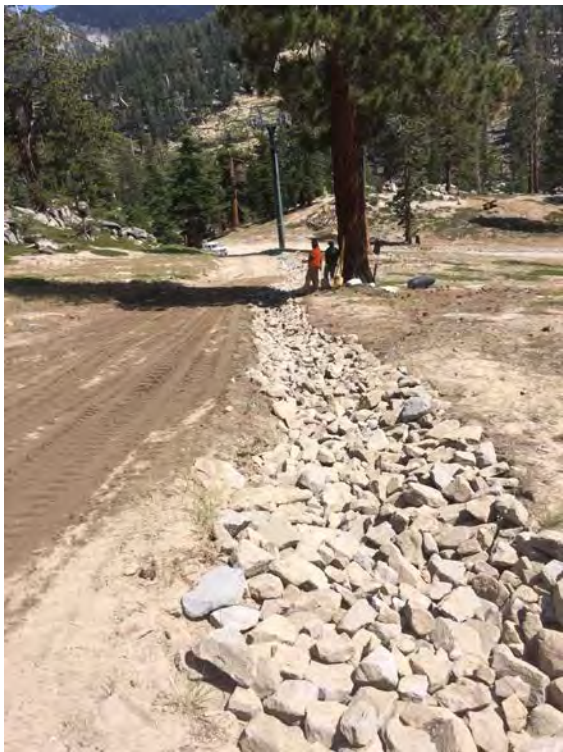
Trails crew after restoring the groove rock lined ditch

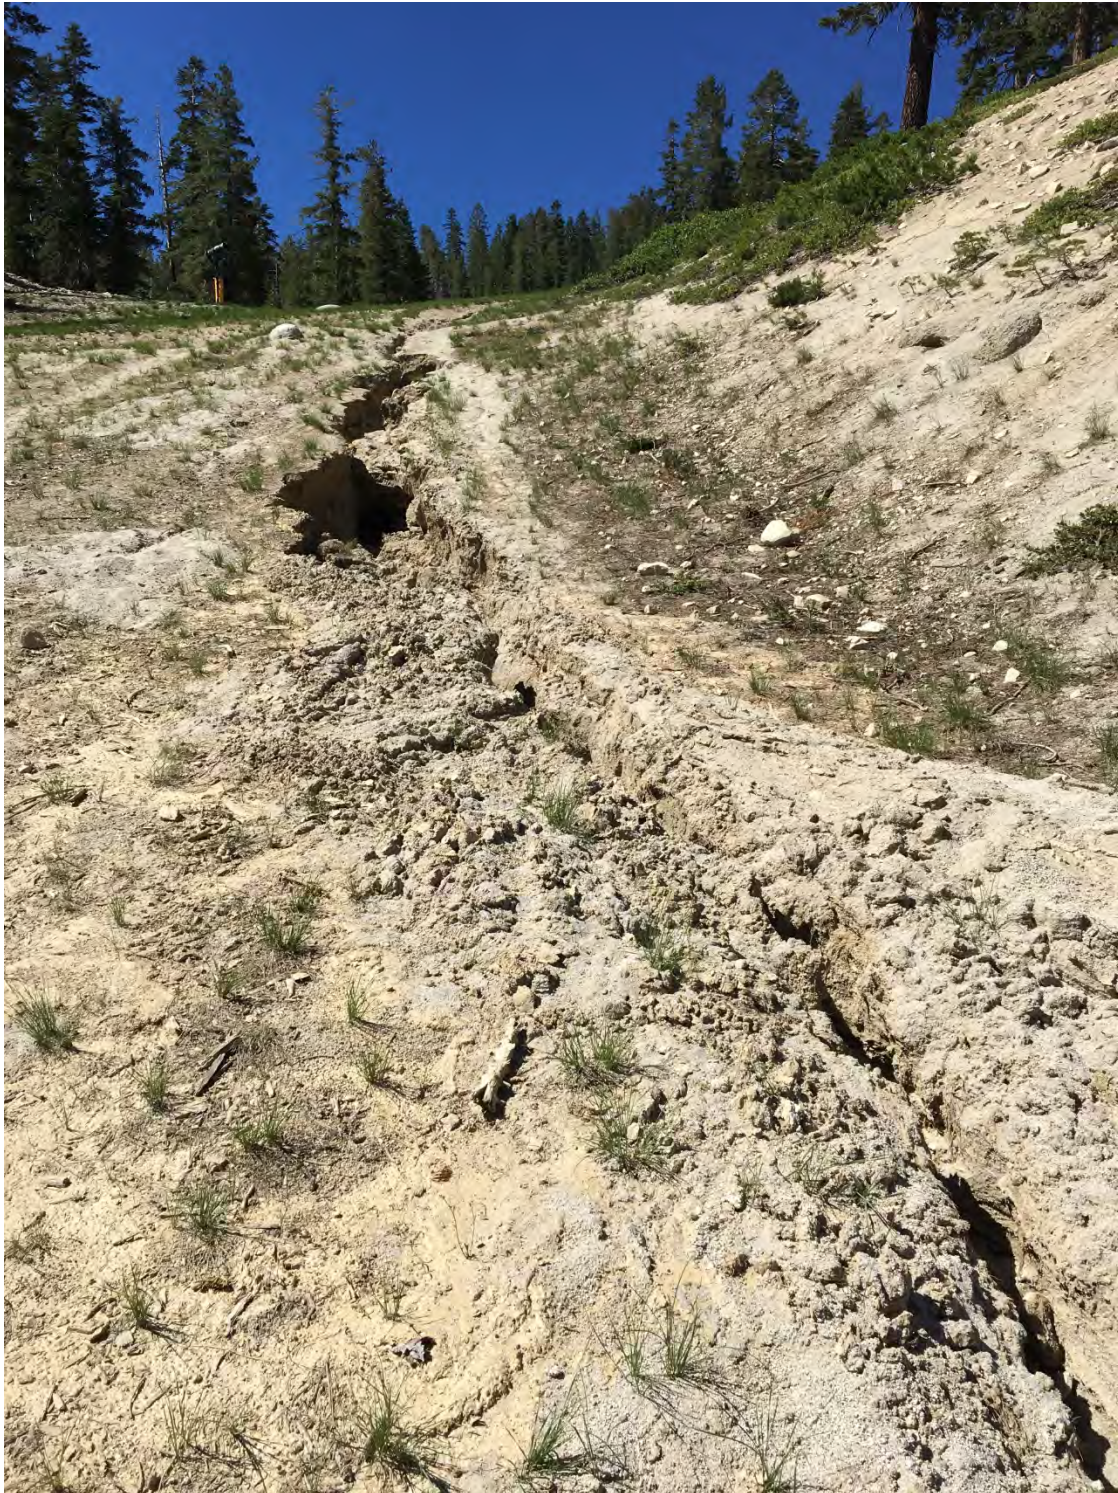
Middle Stagecoach, a NV run erosion before treatment after historic 16/17 winter:

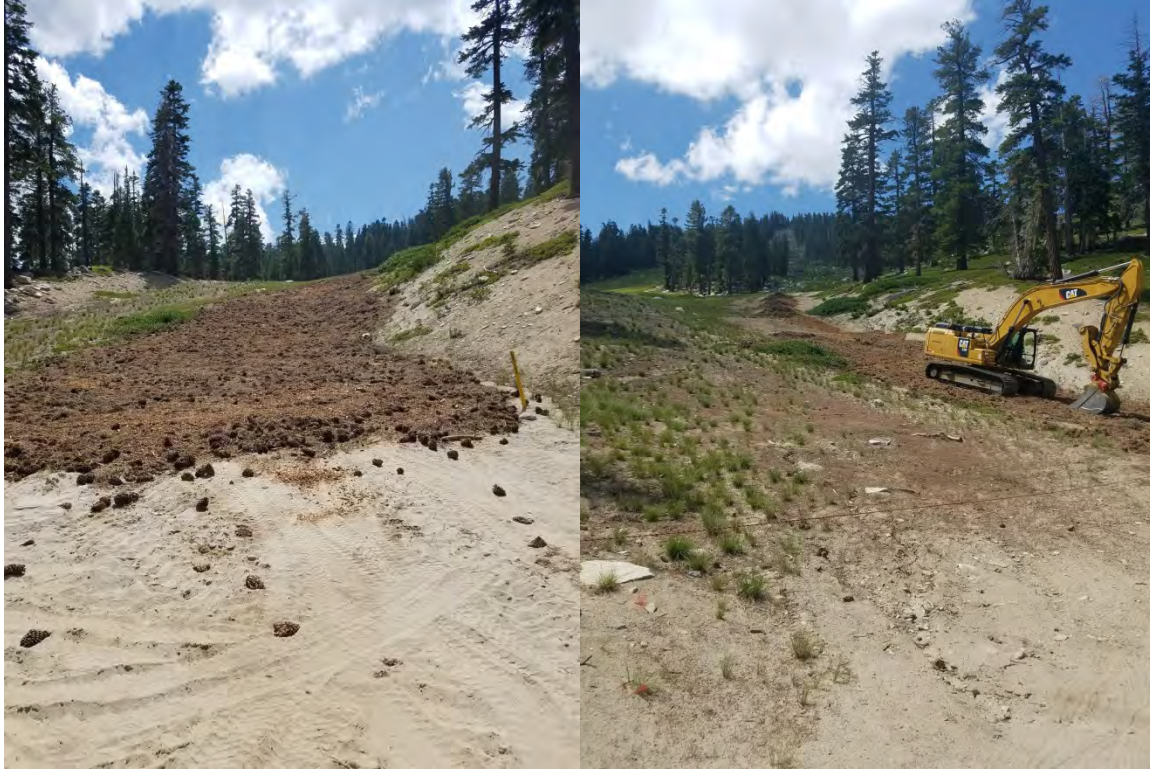
Middle Stagecoach Run Erosion Treatment finished:

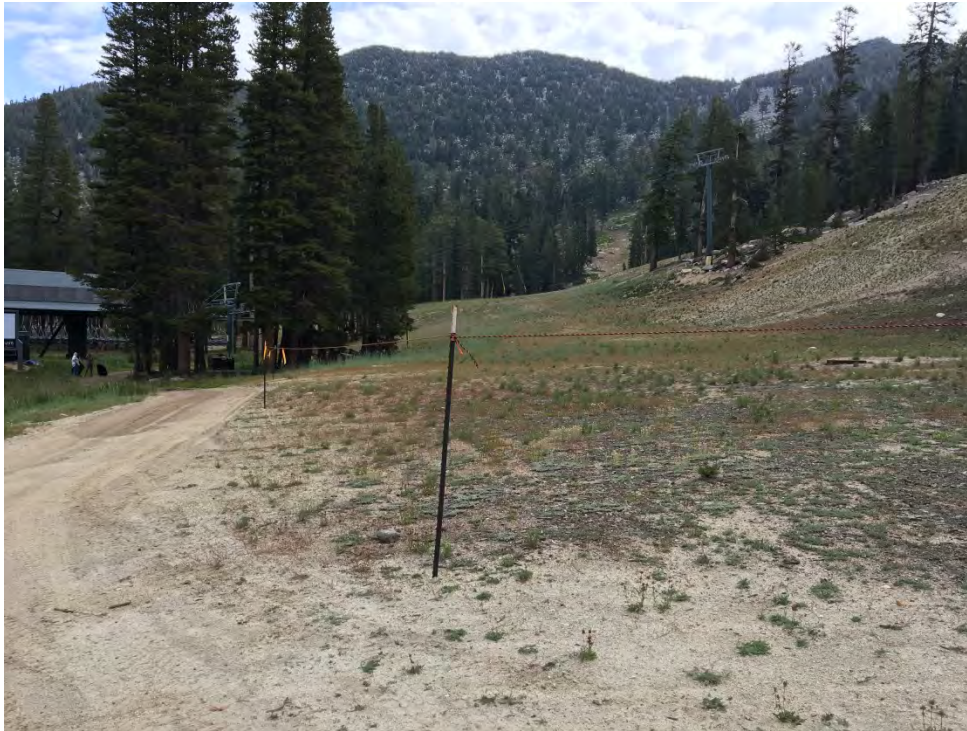
Sky Meadows above the road, near base of Canyon Express:

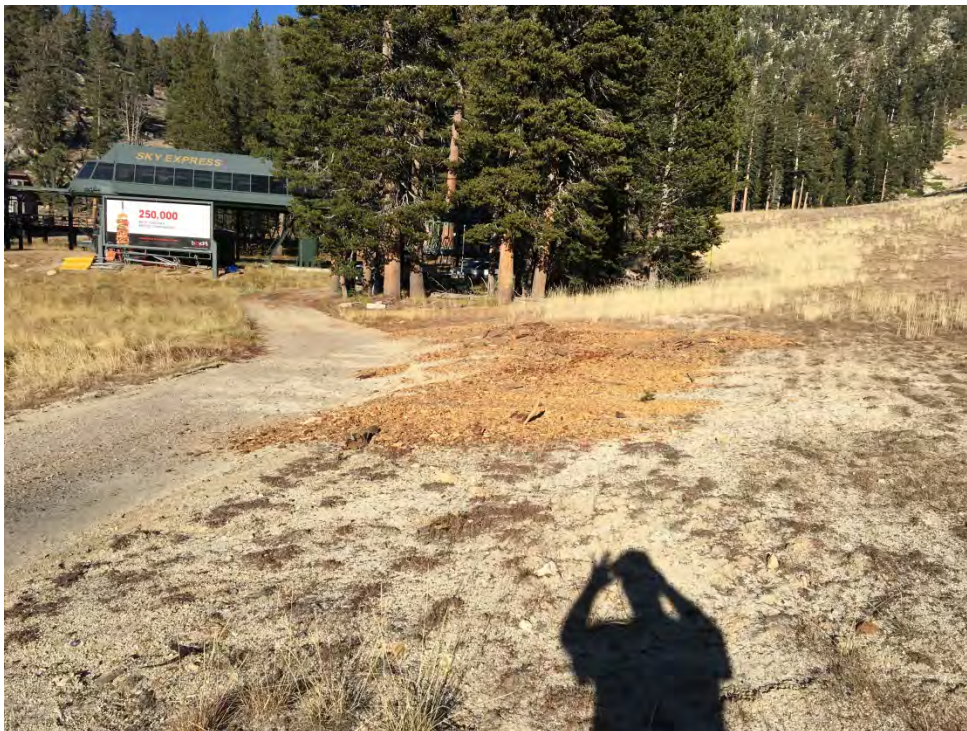
Sky Meadows above the road near the base of Canyon Express after wood chips applied:
