Heavenly Mountain Resort

Mitigation and Monitoring Plan
Annual Report (October 2016 –
September 2017)

Prepared for
Tahoe Regional Planning Agency

May 1, 2018

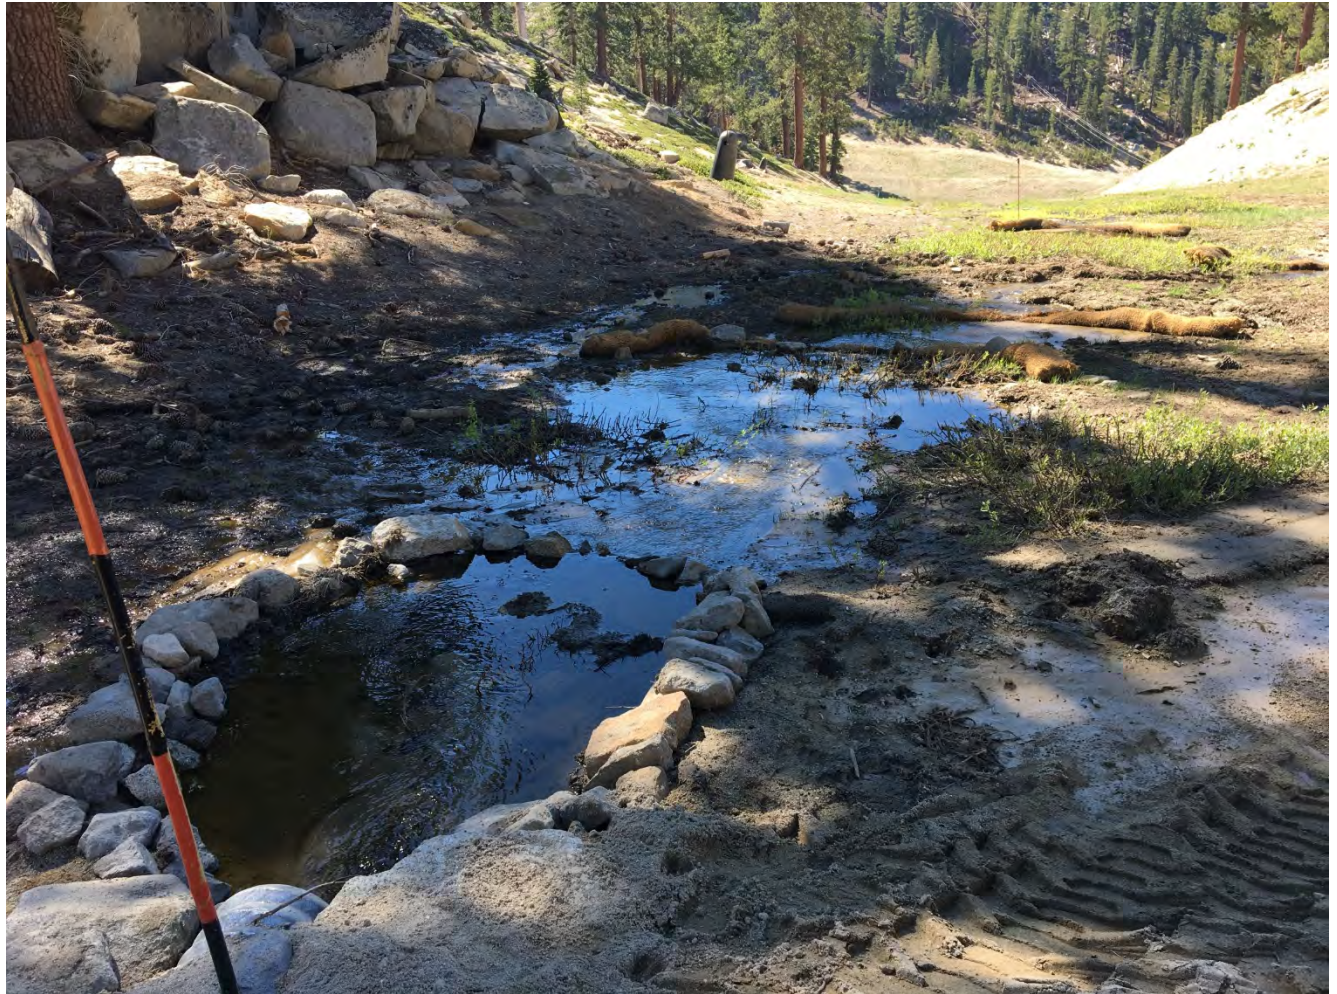
Below the Upper Shop, a new culvert crossing under road and drainage/road improvements in late June 2017:

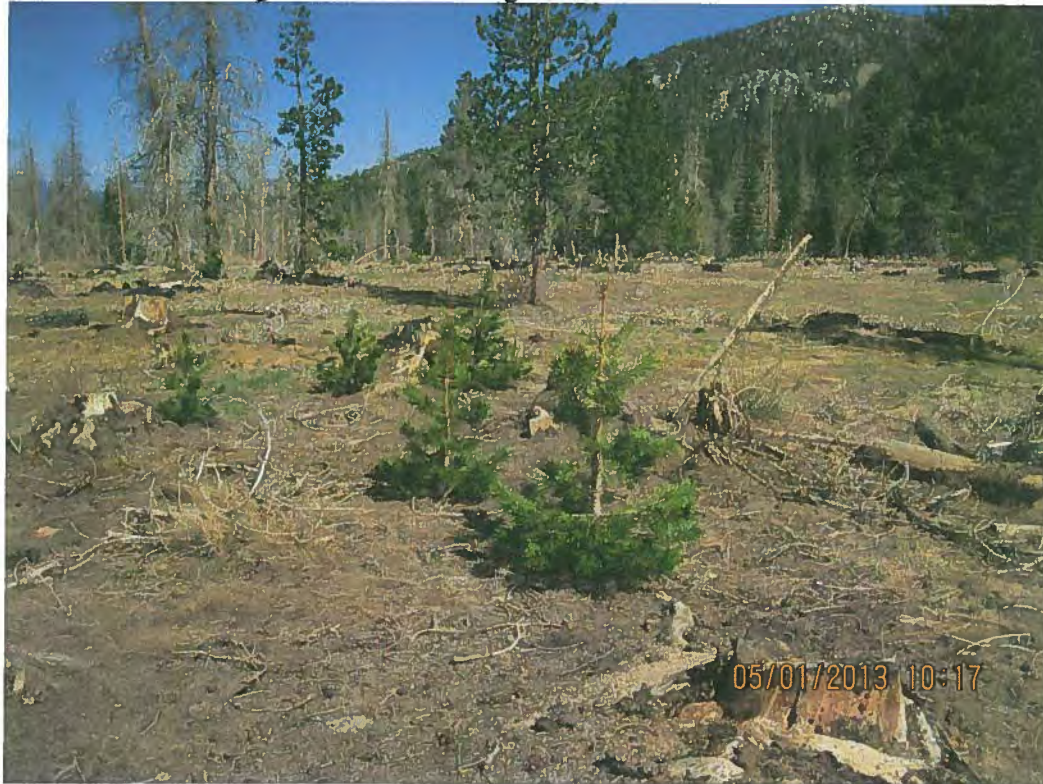
Photo 2: Natural regeneration occurring within the stand.

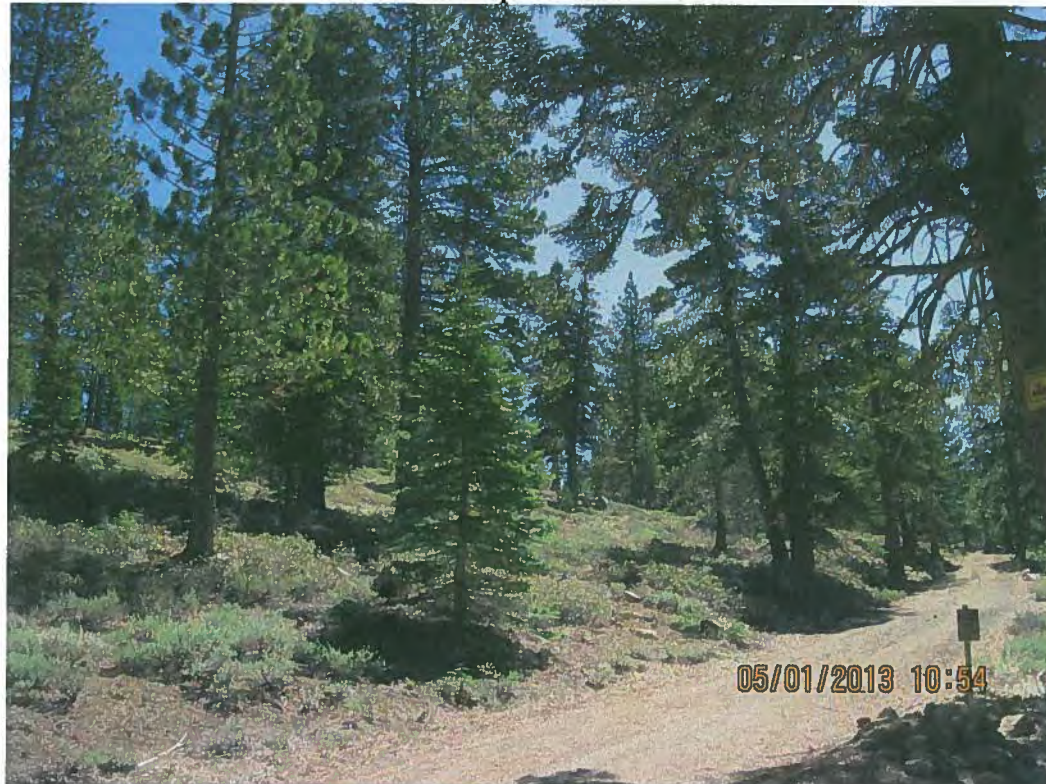
Photo 3: Enhancement of older forest portion of the stand.

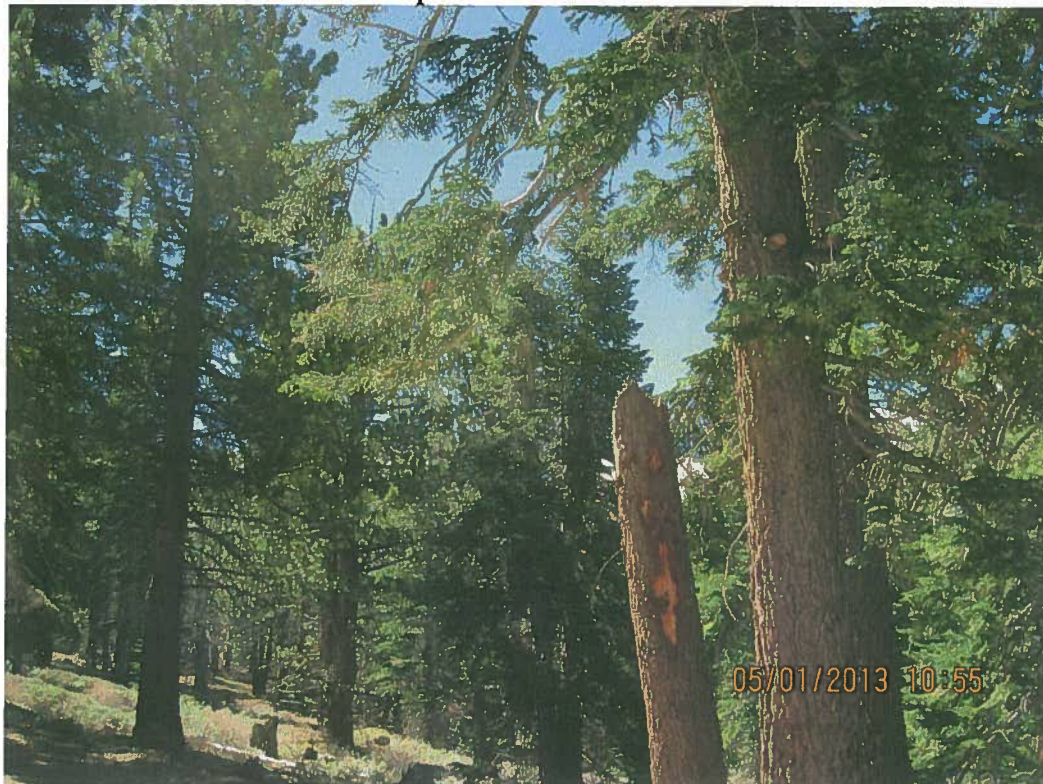
Photo 4: Enhancement of older portion of the stand.

This report certifies that the treatment goals for the mitigation stand have been met. As a result of the monitoring conducted, there is no further need for monitoring.
