Heavenly Mountain Resort Mitigation and Monitoring Plan Annual Report (October 2010 - September 2011)

May 1, 2012

Prepared For Tahoe Regional Planning Agency

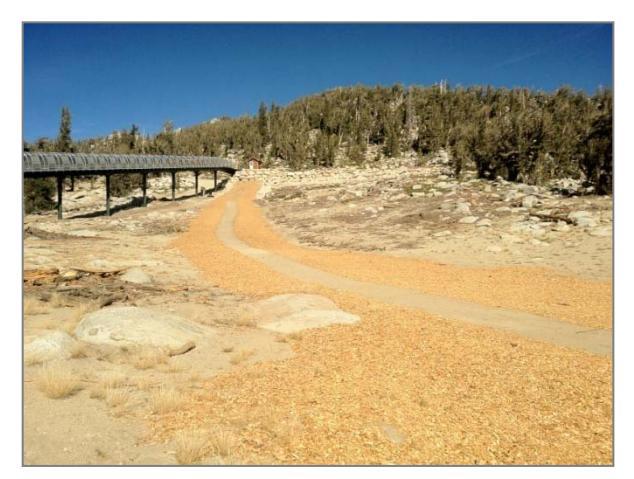
Figure 23. Tubing lift, area B, showing disturbed areas covered in wood chip mulch in fall 2011.

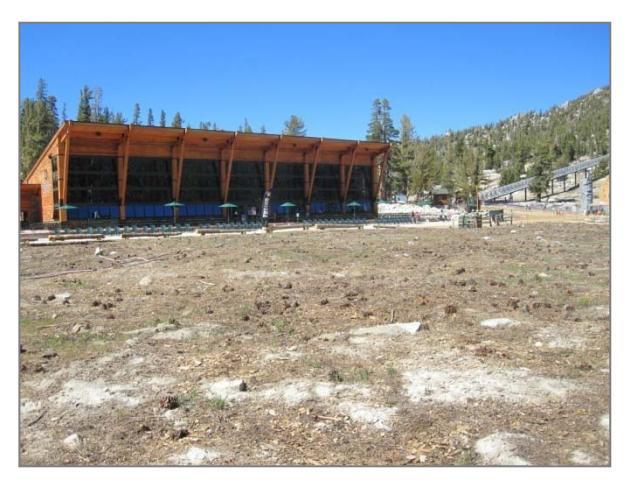
Figure 32. Gondola Lodge site after construction, October 2011.

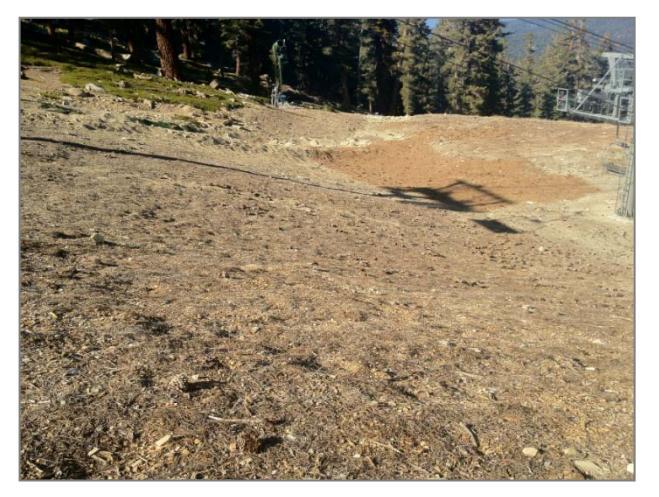
Figure 40. Olympic lift bottom, treatment area A, October 2011. Thick mulch cover may be limiting plant establishment but it is effectively controlling erosion. Soil investigation planned for 2012.

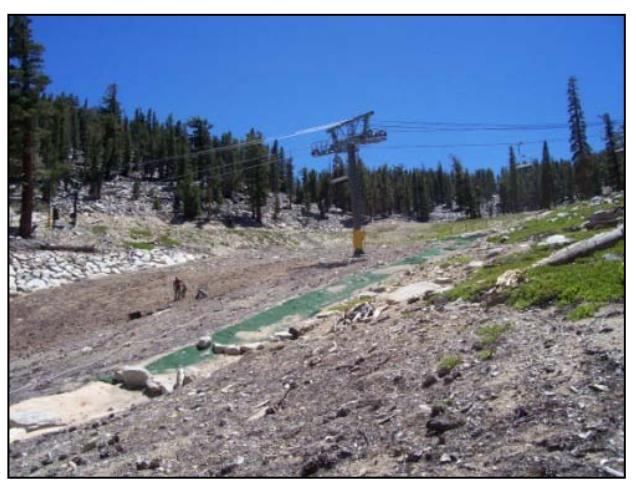
Figure 39. Olympic lift bottom, treatment area A, post-treatment, 2010. The re-mulched area is on the left.

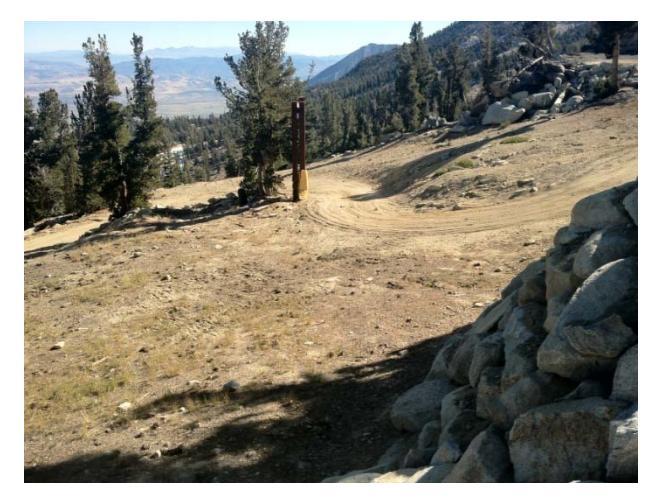
Figure 43. Olympic lift top, post-treatment, 2011. Note vehicle tracks in treatment area.

In 2010, at the Olympic lift bottom plots, all of the success criteria were met, except for the plant cover criterion. Current site conditions (including a 3+" mulch layer on treatment area A) are providing a high level of erosion resistance (as indicated by past rainfall simulation monitoring results), despite having less than 10% plant cover. Soil investigation is recommended for 2012 to evaluate the trajectory of the soil-plant system. The plant cover criterion was met at the Olympic lift top; however, obvious vehicle disturbances in the treatment area now require that a portion of the area below the lift terminal (see Figure 43) be retreated.

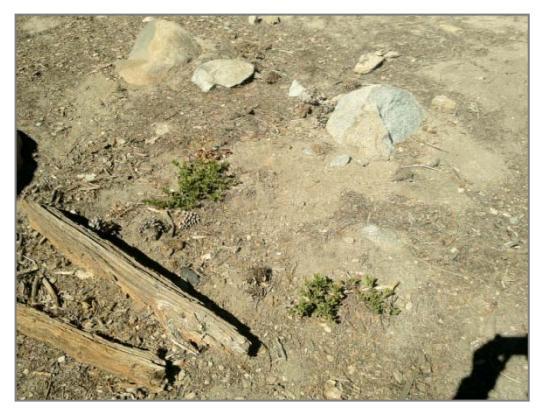
Native pine mat manzanita transplanted into treatment area in summer 2011.

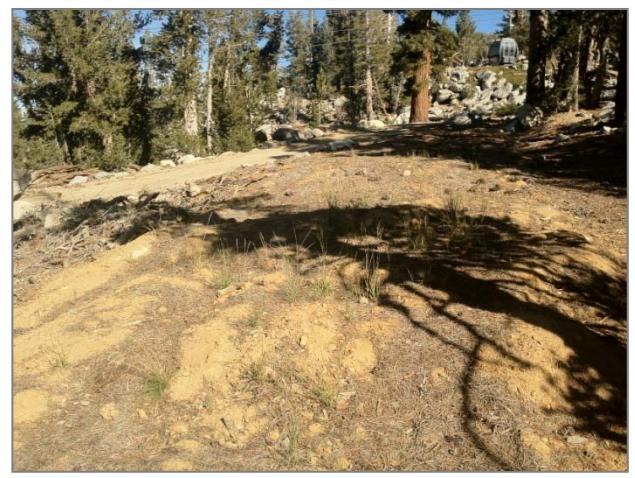
Figure 52. Mid Station Road, grasses beginning to establish, 2011.

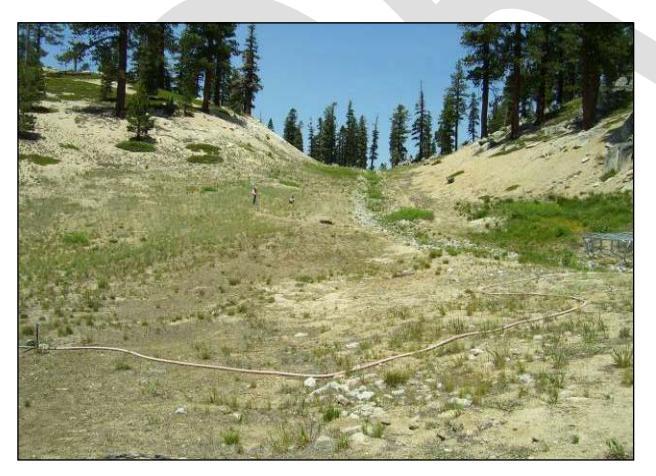
Figure 61. Patsy's Trail, looking up from the Snow Beach area, pre-treatment, 2008.

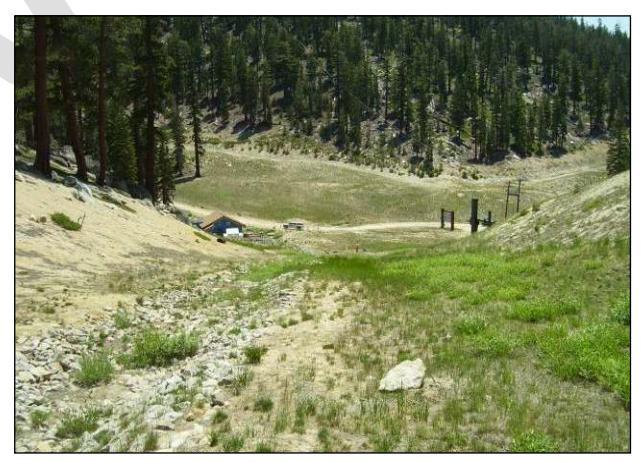
Figure 62. Patsy's Trail, looking down at the Snow Beach area, pre-treatment, 2008.

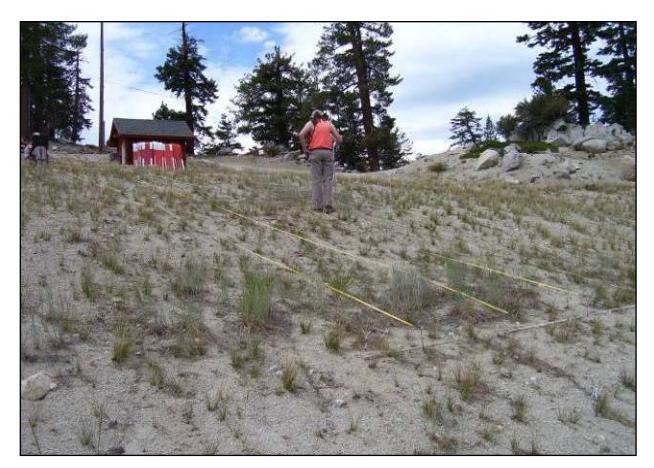
Figure 63. Treatment area A, pre-treatment, August 2008.

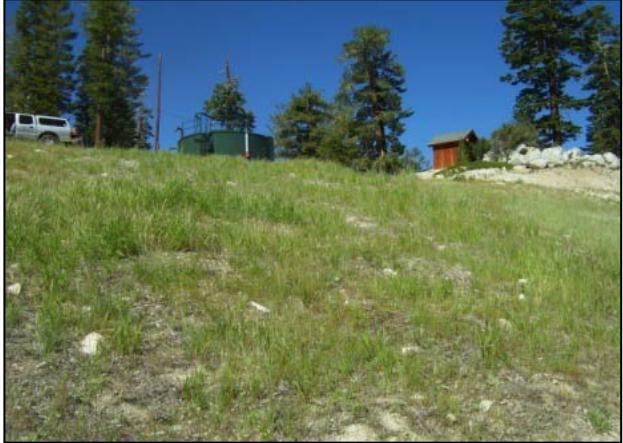
Figure 64. Treatment area A, post-treatment, 2010.

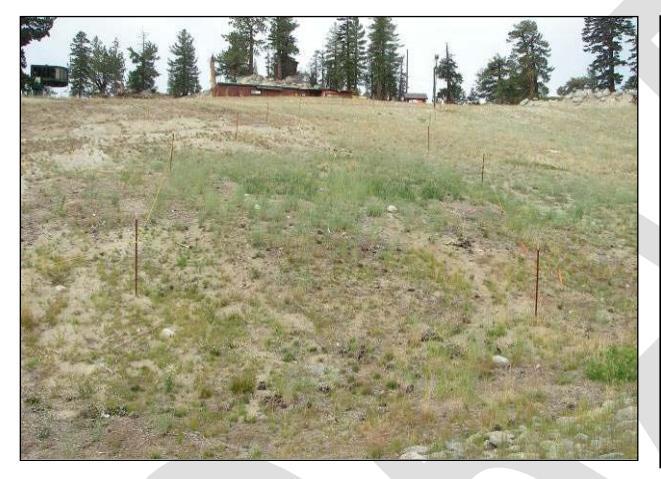
Figure 65. Treatment area B, pre-treatment, August 2008 (photo point B).

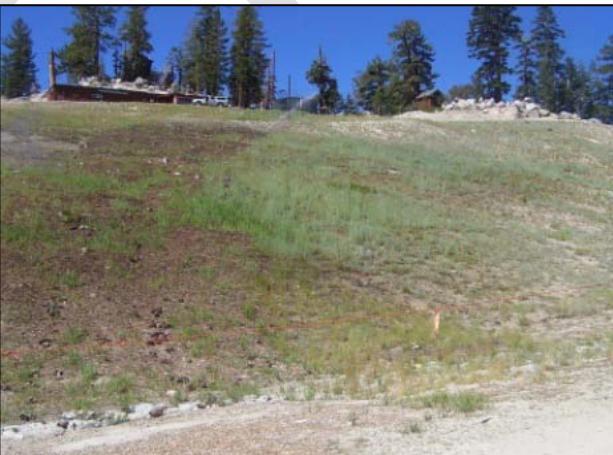
Figure 66. Treatment area B, post-treatment, 2010 (photo point B).

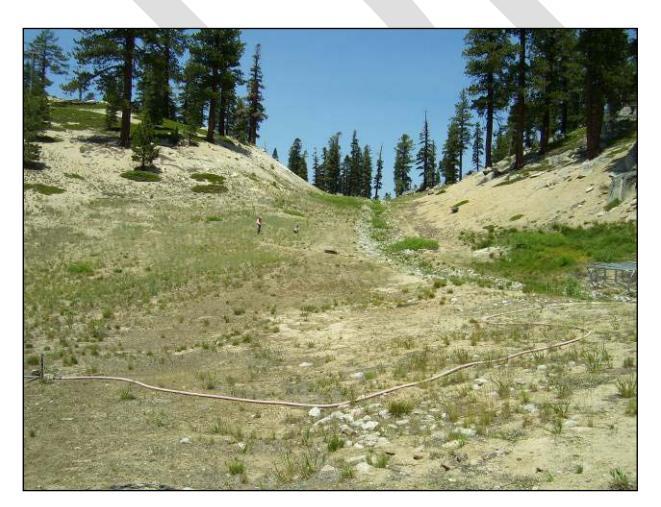
Figure 67. Treatment areas E, F and G, pretreatment, August 2008 (photo point A).

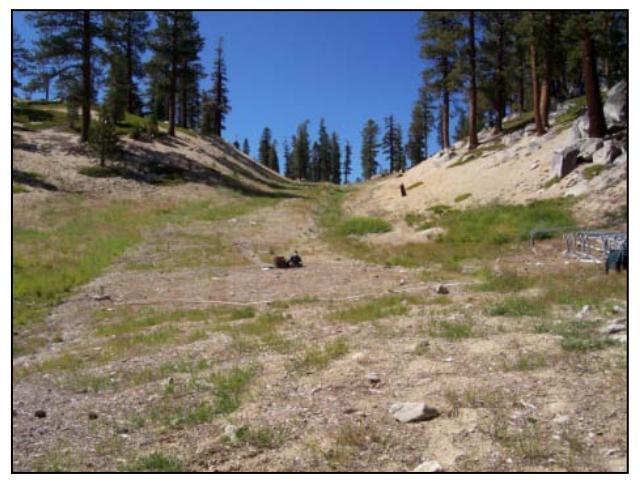
Figure 68. Treatment areas E, F and G, post-second treatment, 2010 (photo point A).

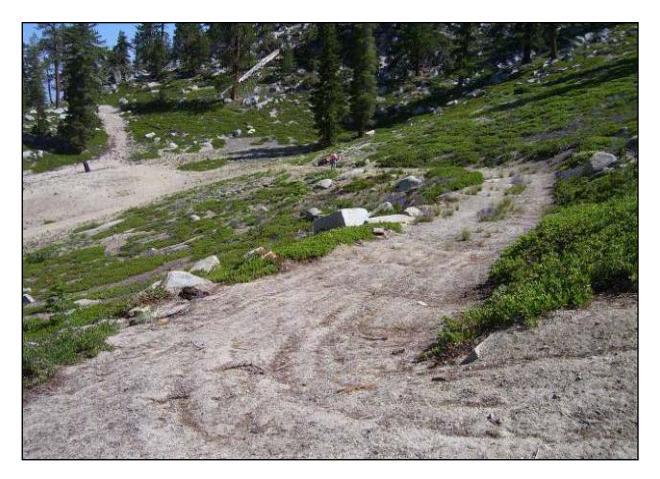
Figure 69. Treatment area H (old water tank road, pre-treatment, August 2008 (photo point A).

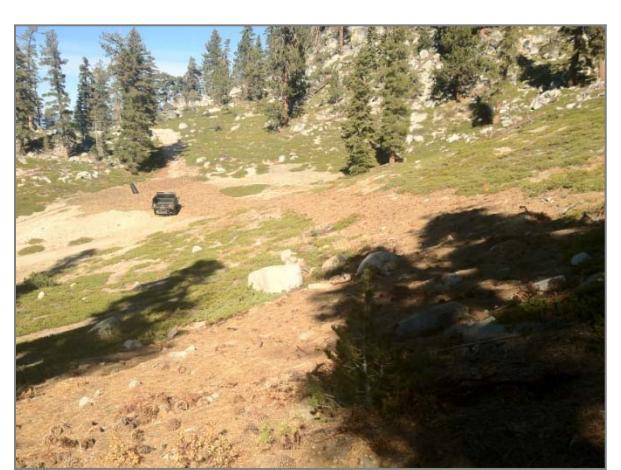
Figure 70. Treatment area H (old water tank road, post-treatment, Oct 2011 (photo point A).

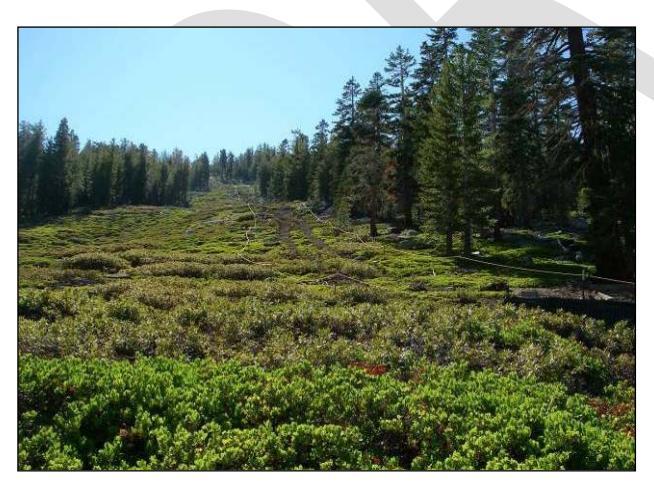
The upper slope is located on the edge of a cleared ski run (Figure 72 and Figure 73). The site faces 30 degrees northeast and has a moderate slope of 16 degrees. The approximate site elevation is 8,362 feet AMSL. The canopy cover is 5% and the solar exposure ranges from 82 to 86% during the summer months. The soil is derived from granitic parent material. The surrounding area is dominated by red fir (*Abies magnifica*) and Western white pine (*Pinus monticola*), while the ski slope is mostly greenleaf manzanita (*Arctostaphylos patula*) with some chinquapin (*Chrysolepis sempervirens*). Nonnative species were not observed in this area.

Figure 72. Stagecoach snowmaking upper slope, pre-treatment, October, 2008.

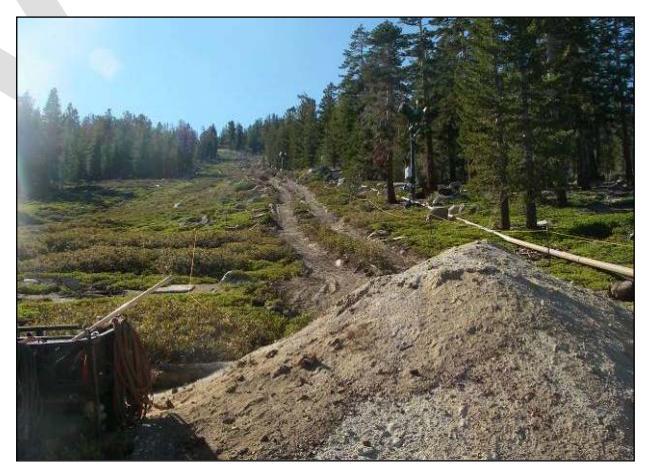
Figure 73. Stagecoach snowmaking upper slope, during treatment, October, 2008.

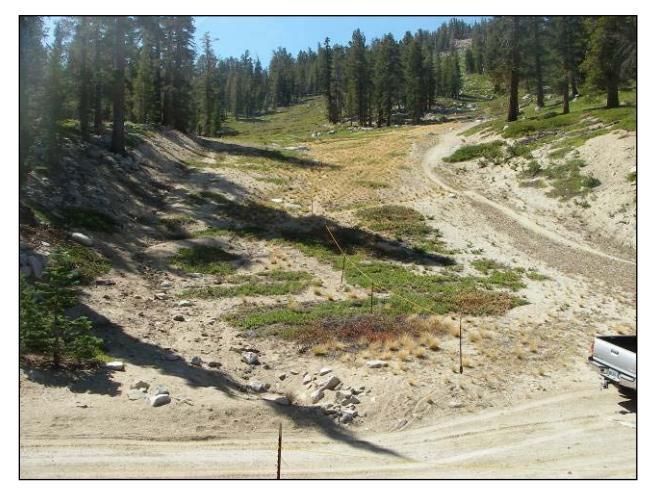
The lower slope is located on the edge of a cleared ski run. The site faces north and has a slope of 24 degrees. The approximate site elevation is 8,224 feet AMSL. There is no canopy cover and the solar exposure ranges from 55 to 70% during the summer months. The soil is derived from granitic parent material. The surrounding forested area is dominated by red fir (*Abies magnifica*), while fir (*Abies concolor*) and Western white pine (*Pinus monticola*), while the ski slope has pinemat manzanita (*Arctostaphylos nevadensis*) Western white pine, and some native grasses and forbs. Non-native species were not observed in this area.

Figure 75. Stagecoach snowmaking lower slope monitoring area, pre-treatment, August 2008.

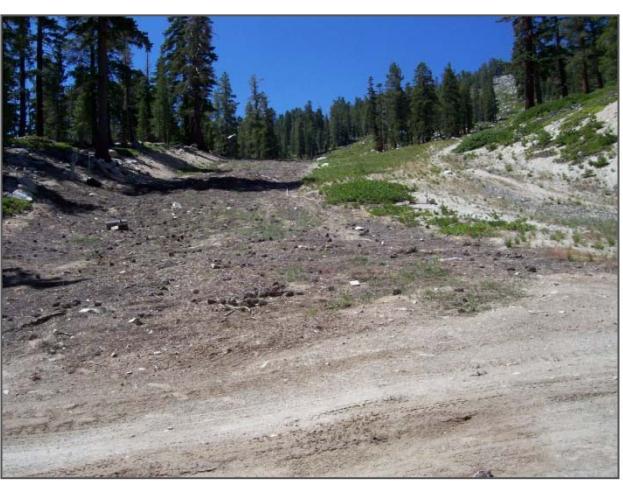
Figure 76. Stagecoach Snowmaking lower slope monitoring area, post-treatment, August 2010.

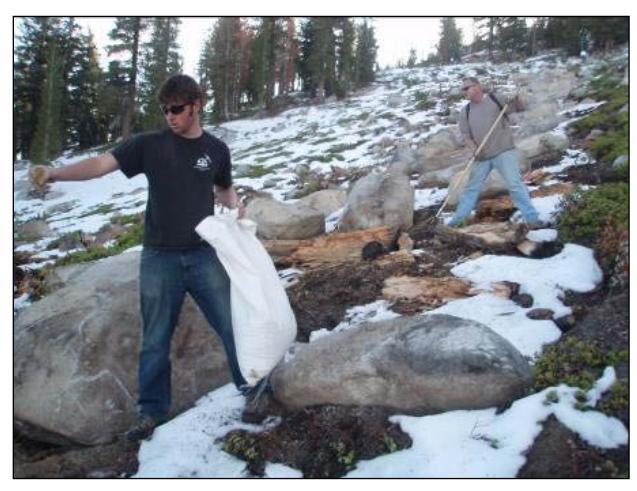
Figure 77. Stagecoach Snowmaking, seeding at treatment area B, November 2008.

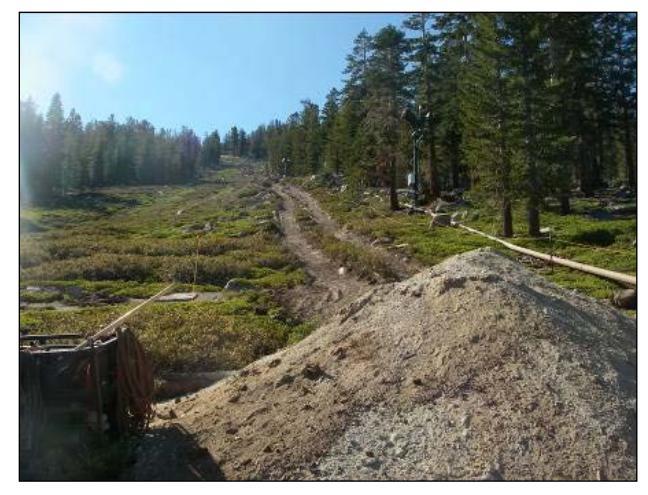
Figure 78. Stagecoach Snowmaking, treatment area B, during construction, September 2008.

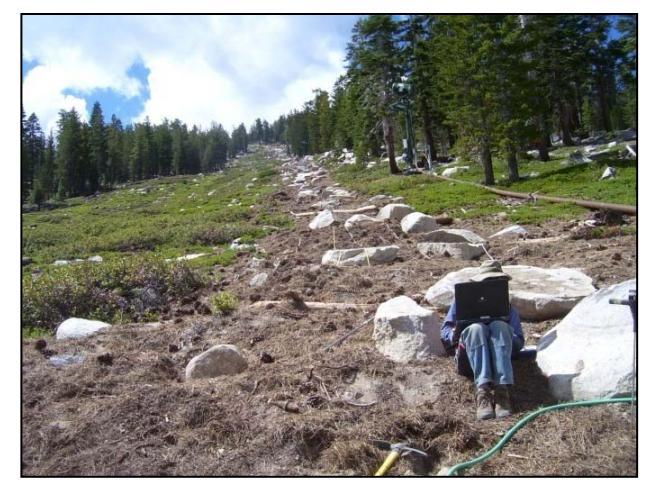
Figure 79. Stagecoach Snowmaking, treatment area B, August 2010.

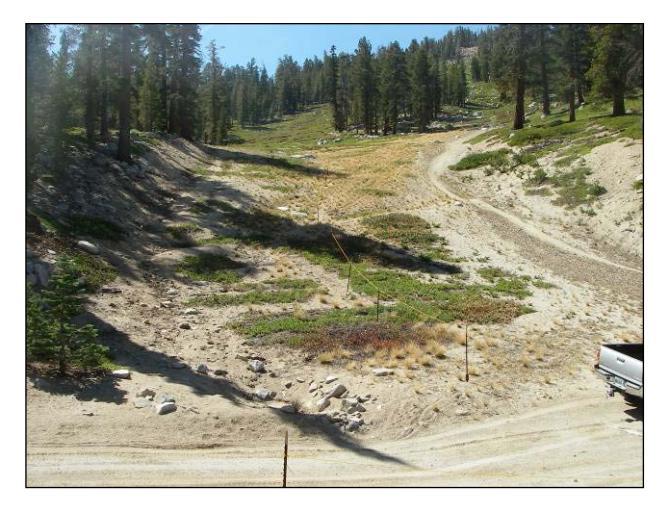
Figure 80. Stagecoach Snowmaking, treatment area C, pre-treatment, August 2008

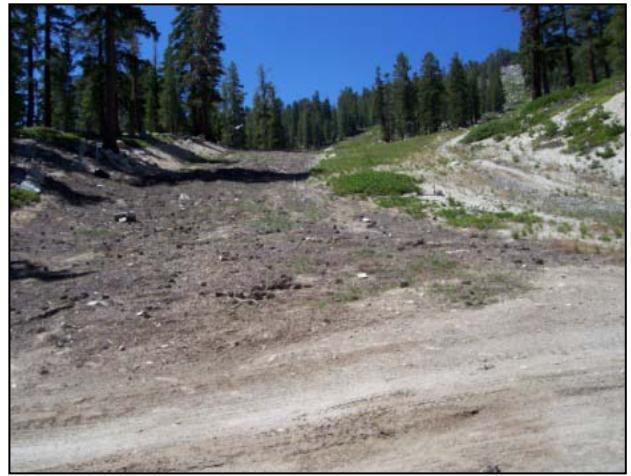
Figure 81. Stagecoach Snowmaking, treatment area C, post-treatment, August 2010.

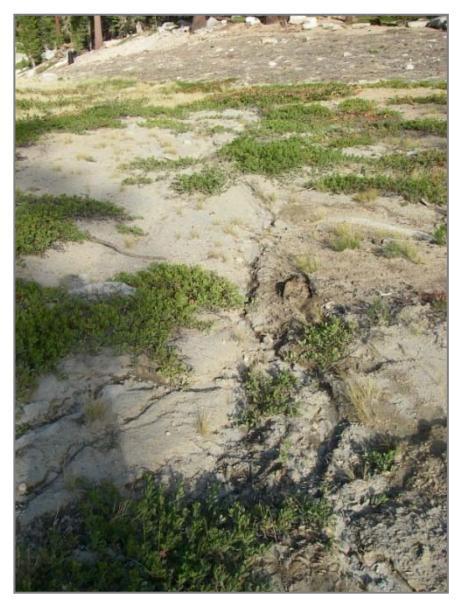
In 2010, at the upper slope, no major signs of erosion were present. However, at the lower slope, concentrated drainage from the road upslope of the lower treatment area caused extensive erosion in the lower treatment area (Figure 82, Figure 83, Figure 84 and Figure 85). The success criterion, which states that no visible signs of erosion, was met for the upper slope, but was not met for the lower slope in 2010. This road drainage issue has not yet been addressed.

Figure 83. Rill formed from road drainage heading toward Stagecoach lower slope treatment area, August 2010.

- Identify, assess and resolve road system drainage issues, particularly those that are impacting recently treated areas such as lower Stagecoach. Nearly all erosion issues observed at restoration projects were related to concentrated run-off from roads upslope of treatment areas.

Project	Treatment Area	Unmet Success Criterion	Management Response	Follow-up Action
				(reference) conditions.
Stagecoach Snowmaking	Lower Slope	Visual Assessment	 Assess road drainage patterns and treatment alternatives Implement road drainage improvements such that water is spread/infiltrated without causing erosion Reapply seed and mulch where sediment has deposited in treatment areas 	 Inspection of road drainage improvements during and after implementation Visual erosion assessment after rain event (after road improvements are completed)
